Arboricultural Appraisal Report

Subsidence Damage Investigation at:

Flat 3
21 Mount Park Road
London
W5 2RS

CLIENT:	QuestGates
CLIENT REF:	QG1T1228431
MWA REF:	SUB230811-14037
MWA CONSULTANT:	Andy Clark
REPORT DATE:	28/09/2023

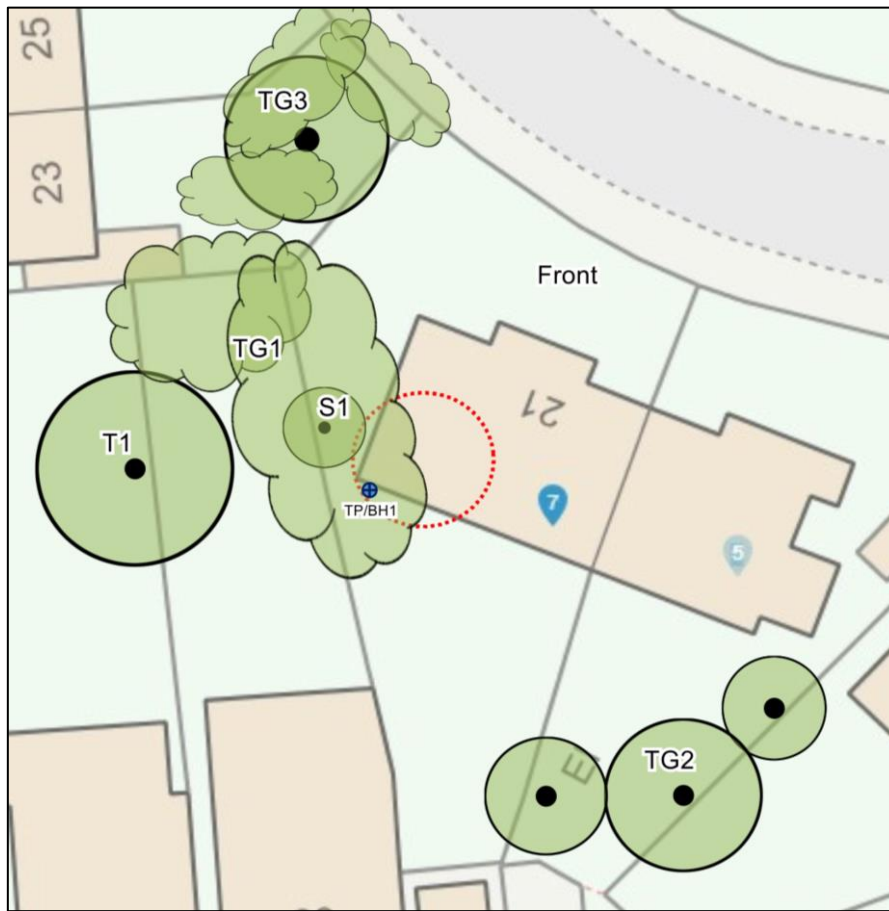
Site Plan

Approximate areas of damage

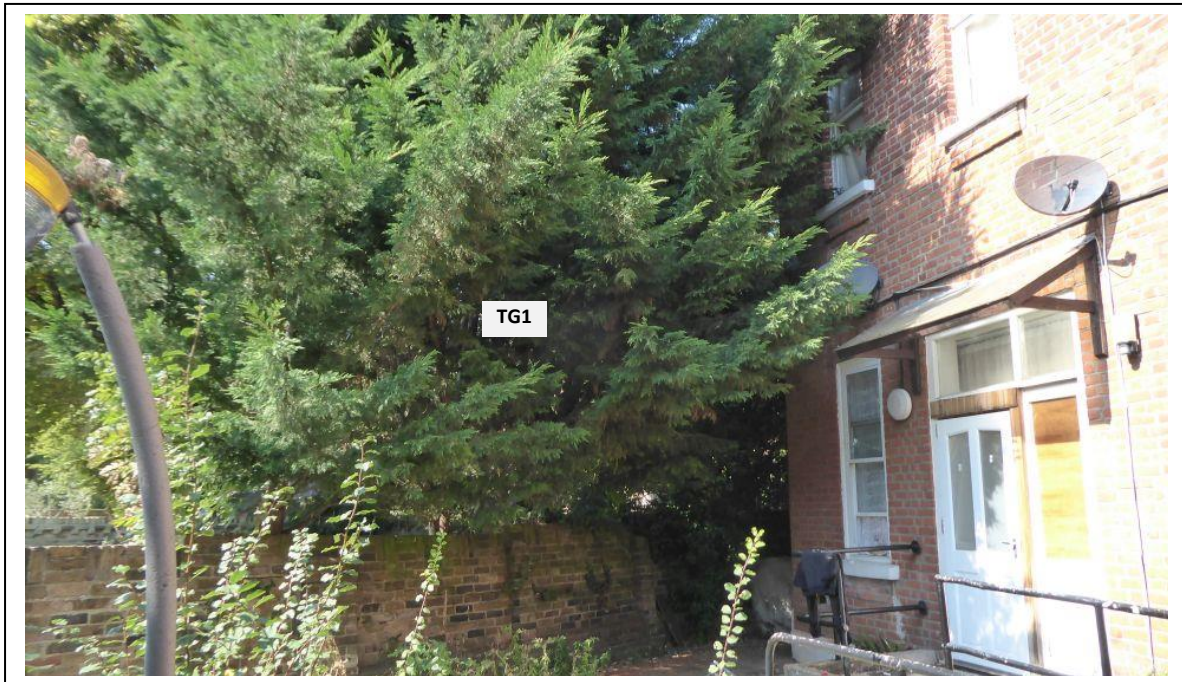
Roots were observed to a depth of 2.9m bgl in TP/BH1, and recovered samples have been positively identified (using anatomical analysis) as Cupressaceae spp. and a shrub species similar to either Euonymus spp., Cistaceae spp. or Lavandula spp. [very thin samples]; the origins of which will be the Cypresses of TG1 group and S1 Euonymus, confirming their influence on the soils below the foundations.

View of TG1 group

If an arboricultural solution is to be implemented to mitigate the influence of the implicated trees/vegetation we recommend that TG1 Cypress group and the S1 Euonymus are removed. Other vegetation recorded presents a potential future risk to building stability and management is therefore recommended. Recommended tree works may however be subject to change upon receipt of additional information.

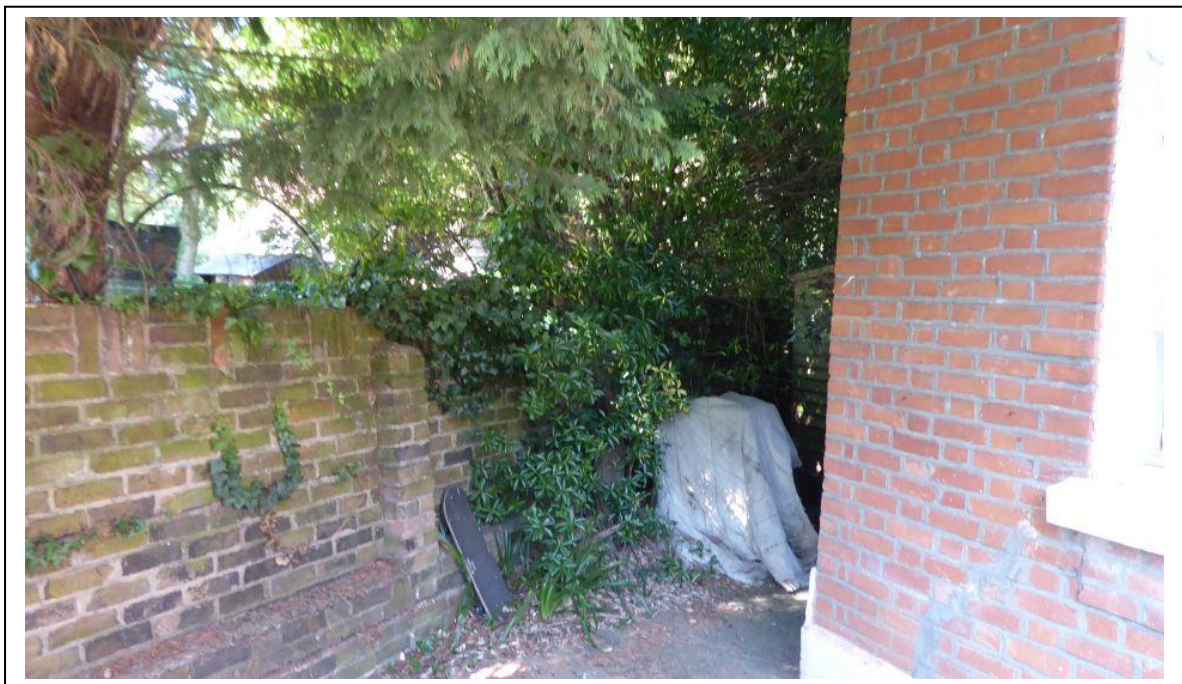
View of S1 Euonymus

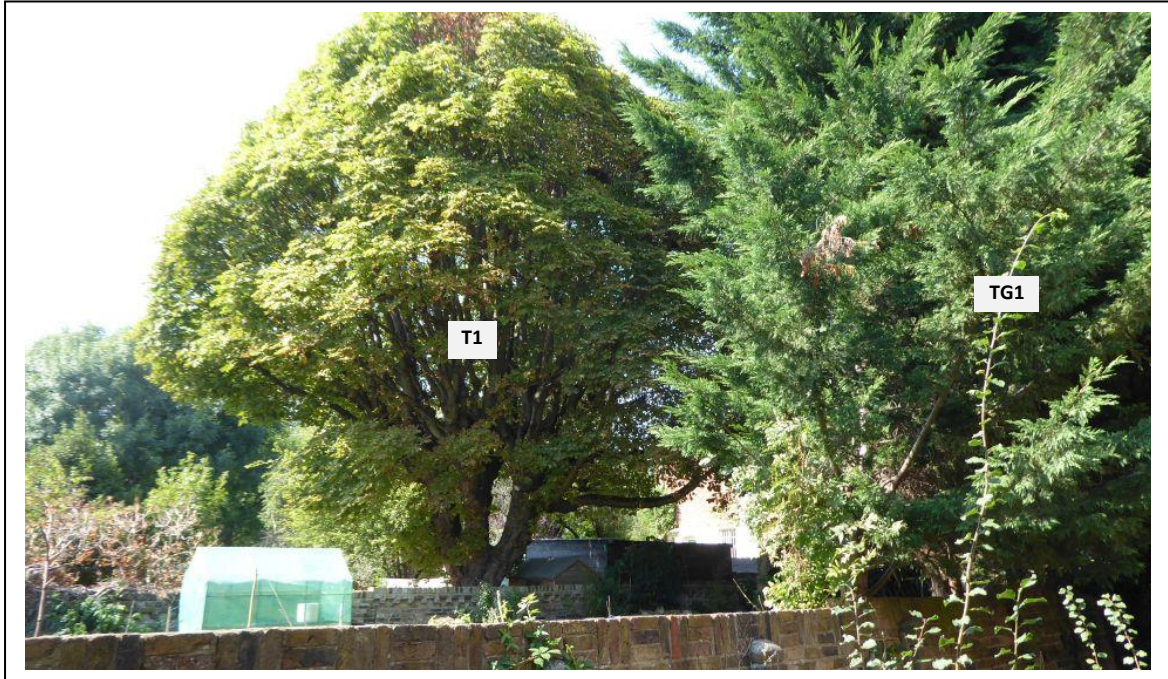
Irrespective of the identification of recovered root samples, the roots of the much larger but more distant Horse Chestnut T1 may also be present below foundation level in proximity to the area of movement/damage and influencing soil moisture and volumes. The larger elements of TG3 at the property frontage may also be involved. However this cannot be determined while the more proximal vegetation remains an active influence on the soils below the building.

View of T1 Horse Chestnut with TG1 group visible to right of frame

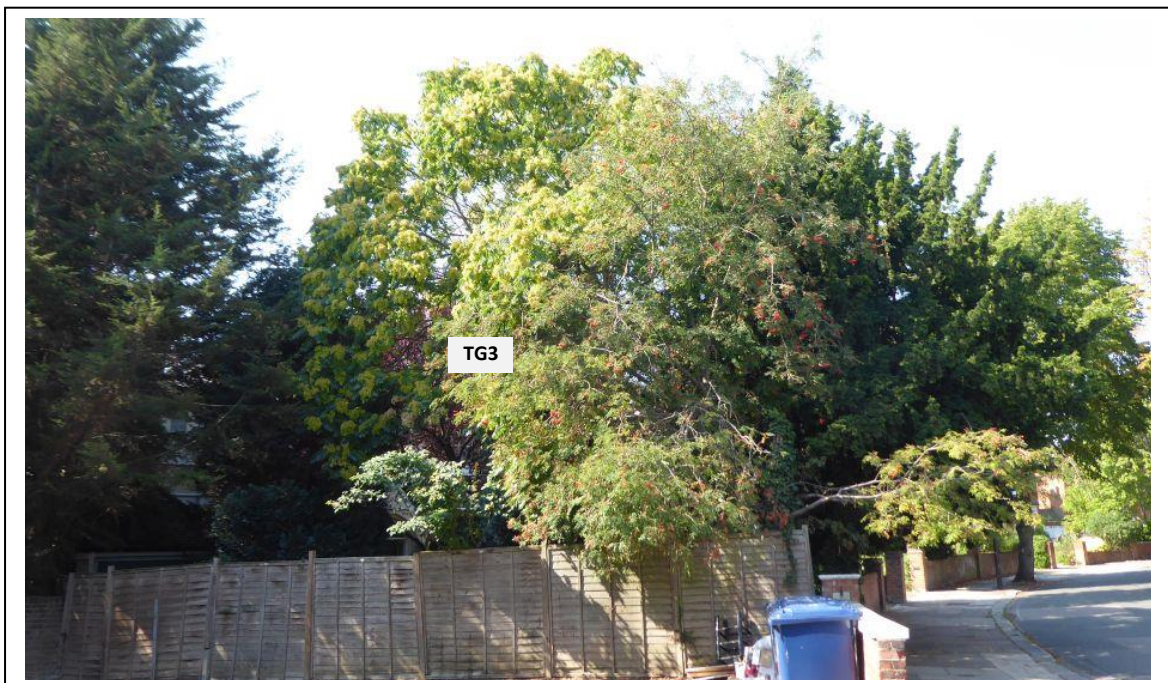
View of TG3 group beyond front right-hand corner
