Site Investigation Report

152939.1.1.BSI

Job Summary

Auger were commissioned by to undertake a site investigation and CCTV inspection of the underground drainage within the area of concern (AOC) at the property.

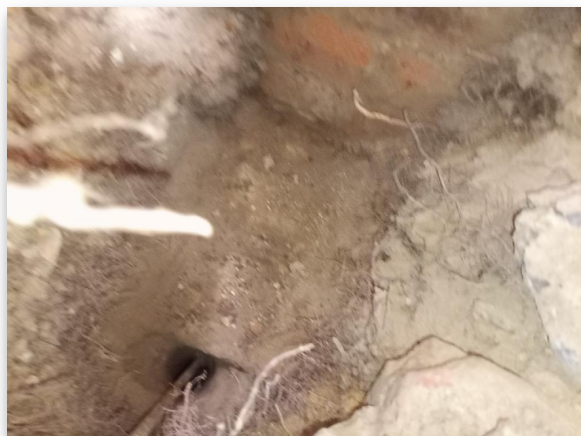
Fig 1.2: Trial Hole 1 Footing

Within TH1 we revealed the footing and augered to the required depth (3m) in the proposed location. We took soil and root samples. These measurements are shown in Trial Hole Log 1 below.
