SPECIFIC INSPECTION REPORT
upon property situate and known as:-

The Pool House
High Street
Acton
Sudbury
Suffolk
CO10 0AJ

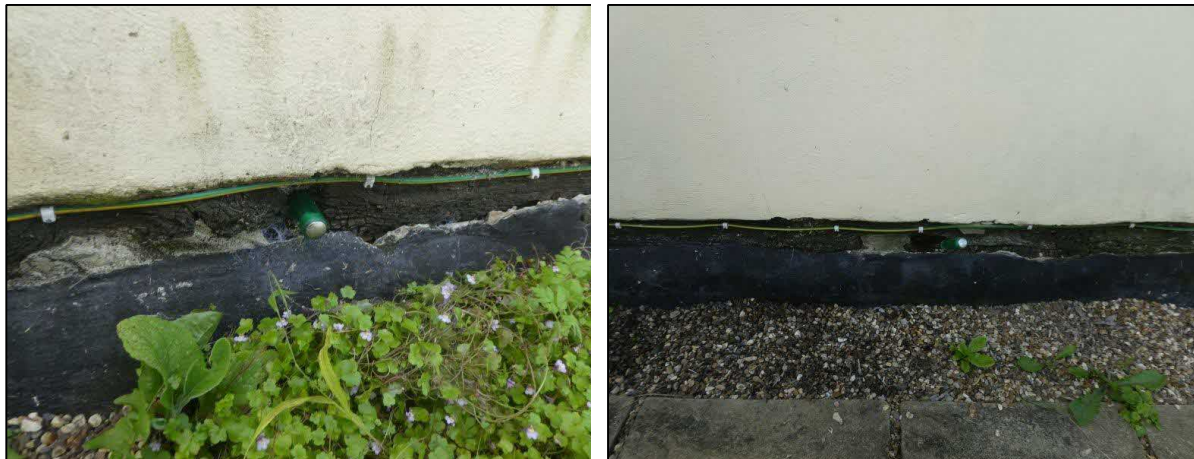
The sole plate, exposed both inside and outside, has been subject to damp related deterioration, which has caused some localised softening to the underside and also more pronounced decay in three areas, (i) to the left of the window, (ii) beneath the window, and (iii) between the window and door. Here, a screwdriver can be driven into the centre of the beam, indicating significant decay.

Rot to sole plate

The deterioration to the soleplate been caused by; i) a lack of effective damp proof course and ii) elevated ground levels and ineffective drainage. There are a number of improvements which we would recommend and some repairs that you can consider.

Although replacement of the sole plate is not necessary presently, this will be required at some stage in the future. When these works are carried out, it is best that long lengths of the beam are replaced in one go. Over an 8 metre stretch, this should ideally be carried out in 4 meter or 2 meter intervals.

The rotted areas can be patch repaired, though our suspicion is that the cost of undertaking piecemeal improvements may be high and, to that end, total replacement may be more economical, albeit not entirely necessary presently. Quotations should be sought for both (patch repair or replacement) and a decision taken as to the most cost effective solution.

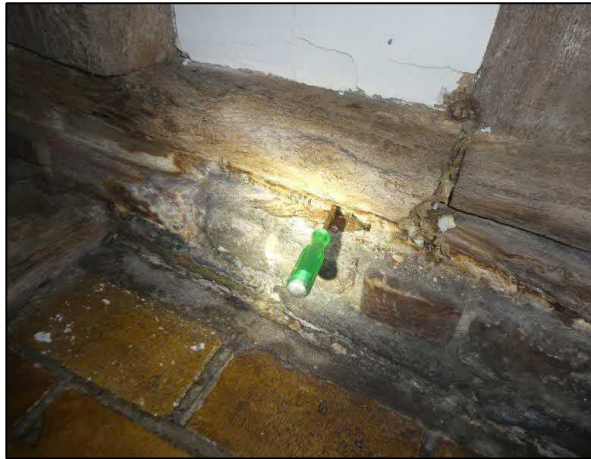
Rot to plate internally

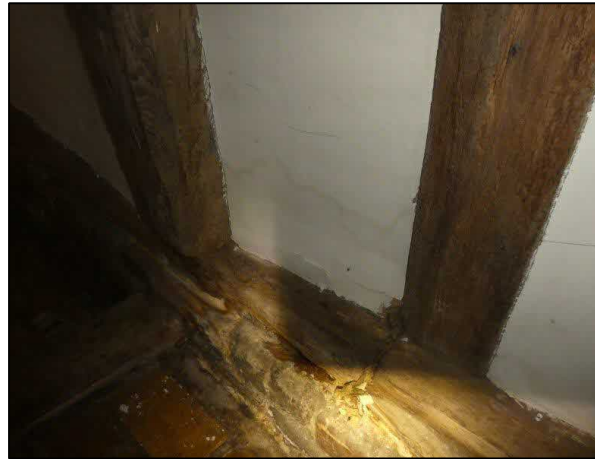
Damp staining

Inside, the brick plinth shows visual signs of dampness, crumbling mortar, discolouration, etc. There are also damp stains to the plaster panels between the studs. The plinth and panels when tested returned elevated damp readings.

Externally, the bitumen painted cement render that covers the brick plinth should be removed. This is an unhelpful covering, which is trapping moisture. Once exposed the bricks should be repointed in a lime based mortar – *cement must be avoided*. The same repointing to the plinth should be carried out internally.

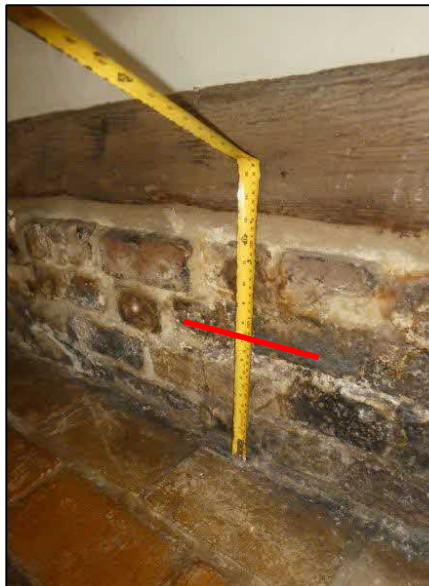
Approximate external ground level shown

The external ground level is high in respect of the interior. This can be determined by the fact that one steps down into the building and is also evident when basic measurements are taken around the window inside and outside. At this point, the internal ground level is 18cm lower than the exterior. The main issue here is that dampness is able to pass sideways through the bottom of the wall.

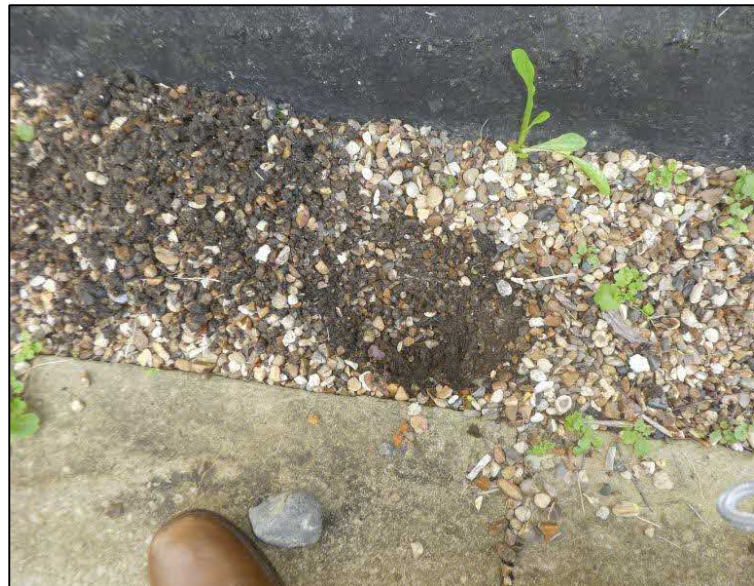
Shingle full with dirt

In an attempt to reduce moisture ingress through the plinth, a gravel drain has been set to the base of the wall. This is a form of French drain, a damp management technique whereby water is allowed to drain into the ground, as opposed to stagnating at the bottom of the wall, where it is more likely to pass inside. Our examination found that the shingle is not draining, largely due to a build-up of vegetation and also mud.

We would recommend that the shingle be removed, the ground level be reduced and fresh shingle installed. This detail is most effective when combined with a land drain – this is a

perforated pipe set to a fall, and which allows rainwater to drain away from the property. This would be a sensible addition and, as discussed at the time of the inspection, it may be possible to route this into the adjacent well.
