# ARBORICULTURAL ASSESSMENT REPORT

Flat 2 Kenilworth Place, Basildon, SS15 4DQ

PRI Ref: 270358

Survey Date: 25/08/2023

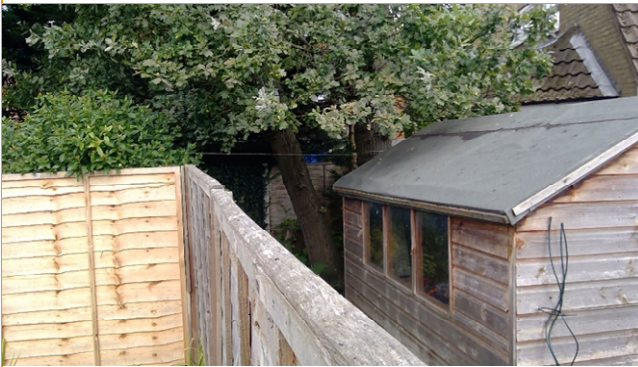
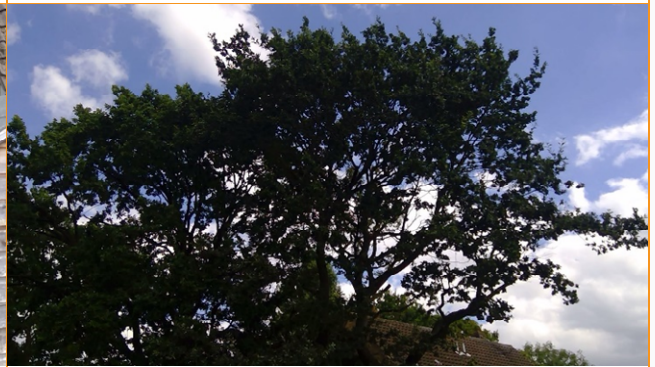
T4 - Oak (English)

Tree No:	Species	Works Required	CA	TPO	Ownership
T4	Oak (English)	Fell and treat stump with eco plugs (broadleaved)	Yes	No	P3P
T5	Oak (English)	Fell and treat stump with eco plugs (broadleaved)	Yes	No	P3P
T6	Oak (English)	Fell and treat stump with eco plugs (broadleaved)	Yes	No	P3P
T7	Oak (English)	Fell and treat stump with eco plugs (broadleaved)	Yes	No	PH

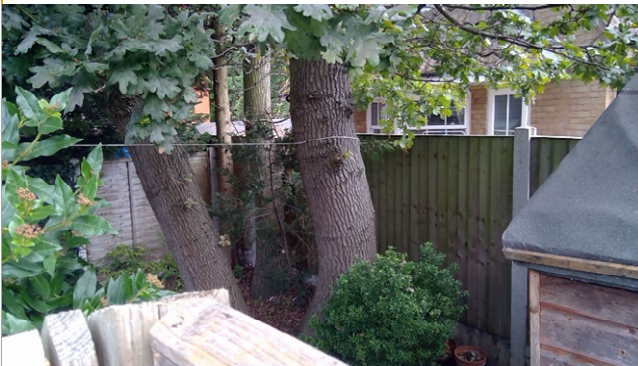
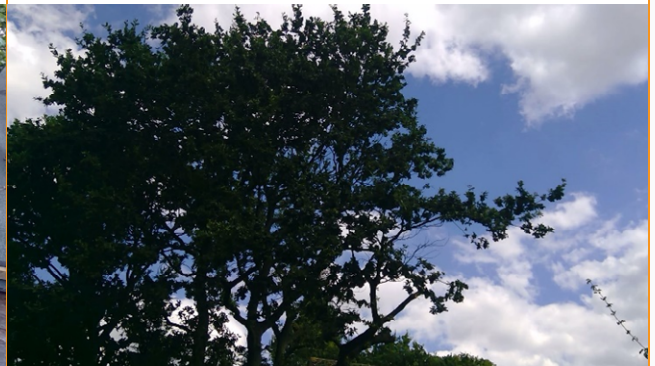
T5 - Oak (English)

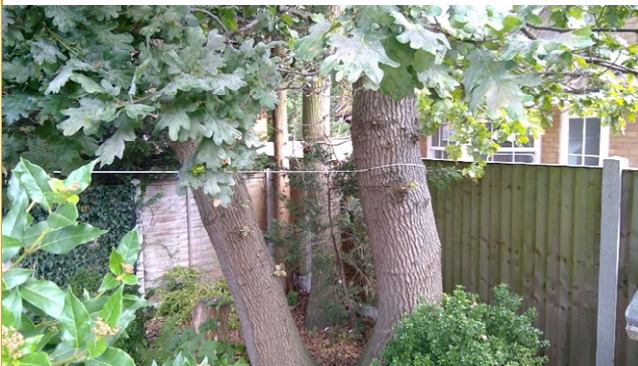
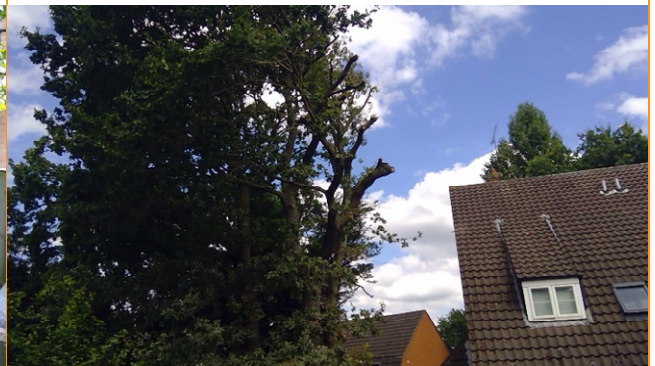
T6 - Oak (English)

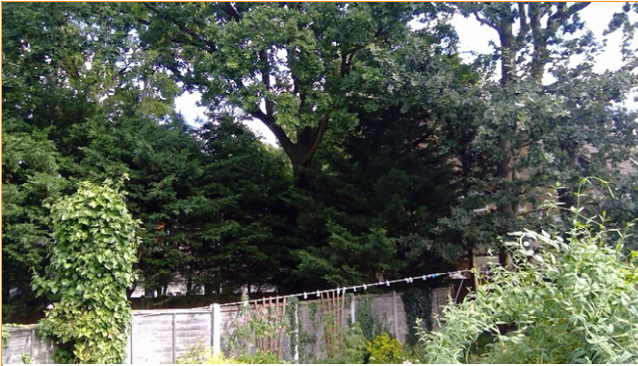
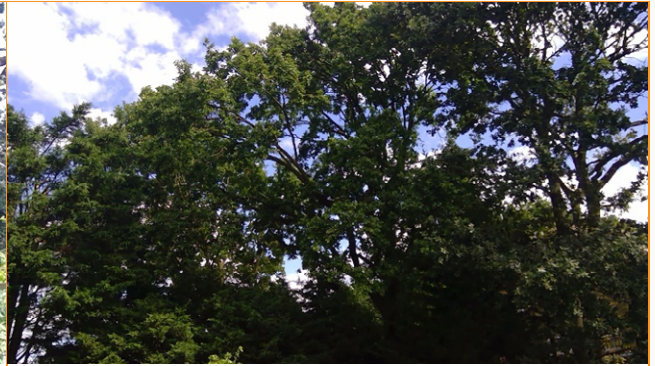
T7	Oak (English)	Mature	Fair	13.0	17.50*	580*	17.09	Y	No significant past tree works.	Fell and treat stump with eco plugs (broadleaved).			60 Kenilworth Place Basildon SS15 4DQ	PH

T7 - Oak (English)
