Report prepared for: Tony Blair

For the Site of: 25 Church Street, Stanwick, NN9 6PS

Preliminary Roost Assessment (PRA)

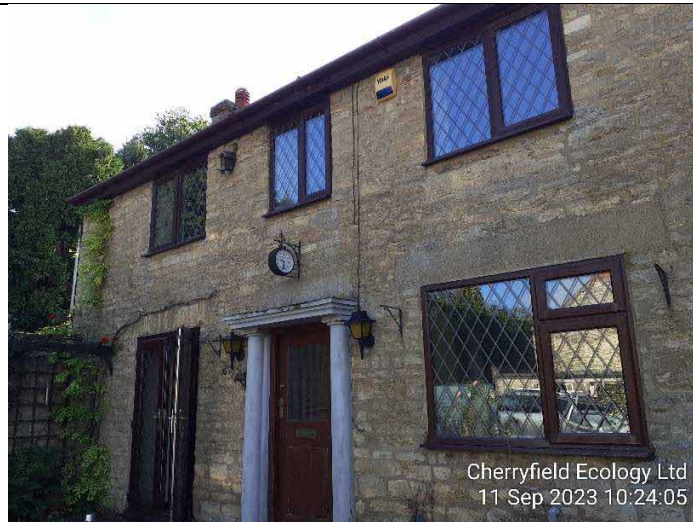
Figure 2- Western facing side of the main house (B1).

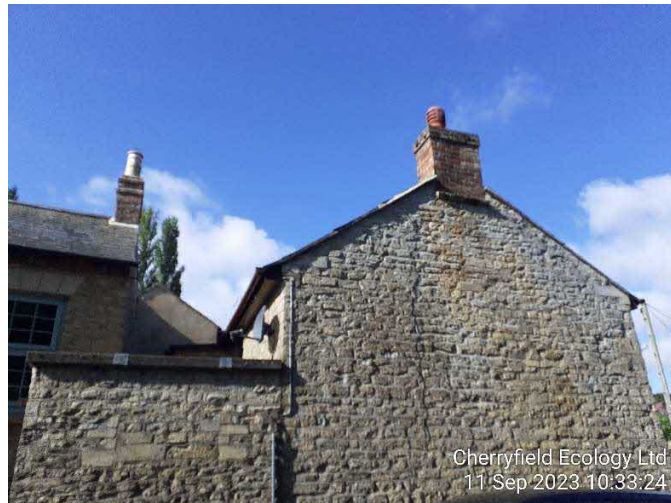
Figure 3- Main house with external walls and windows (B1).

A brick chimney extends out of the roof.

The roof is pitched with a ridge that runs along the centre of the roof. Clay tiles are present on the roof.

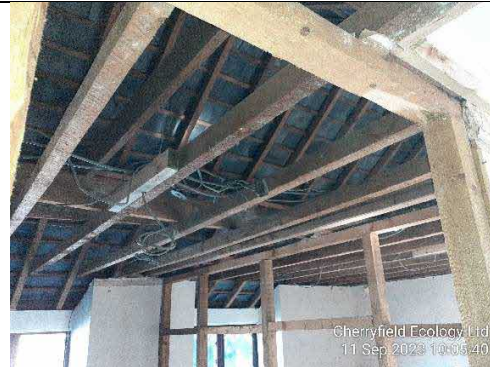
The interior of the second storey of the main house has no ceiling or insulation present within the loft, the loft comprises only of wooden joists and rafters which are exposed.

Figure 4- Exposed joists and rafters in second storey of the house.

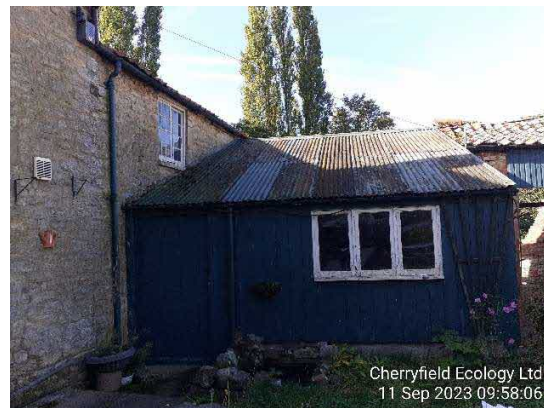
The main house is joined to a wooden paneled building with a pitched roof comprising of metal sheets. PVC windows are present within the exterior of the building. A wooden door and door frame are present.

Figure 5- Wooden paneled building joined to the main house.

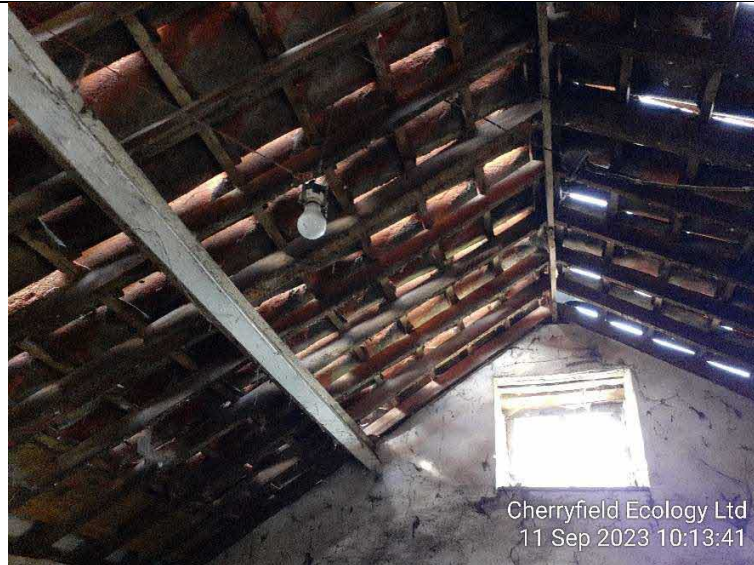
A two-storey section with a mezzanine floor and exposed wooden stairs is present. The ceiling of the building is exposed, with visible rafters, batons and tiles from the roof. Wooden joists run across the top of the building. To the side of this, is a room with metal sheet ceiling.

Figure 6- Ceiling with exposed tiles.

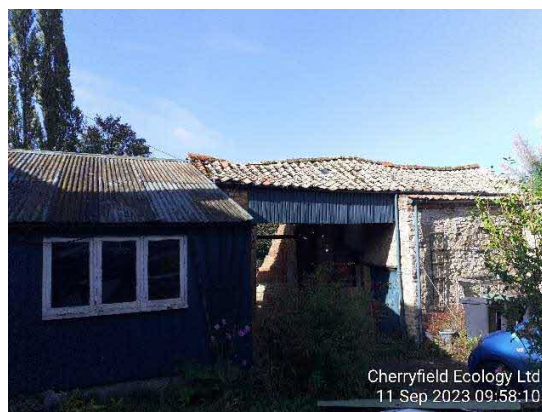
A pitched roof extends from B1a to a building comprised of traditional stone and brick (B1b). The roof is comprised of interlocking clay tiles. The ridge board and associated rafters are comprised of timber in poor condition and have warped over time.

Figure 7- Pitched roof joining the buildings.

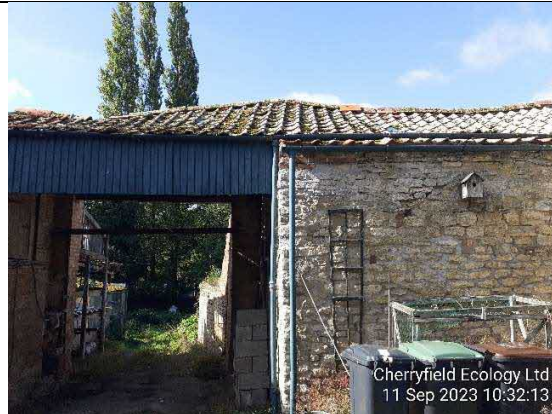
The building has warped over time and the exterior brickwork and walls lean at an angle.

The roof is comprised of interlocking clay pantile tiles on top of wooden rafters and batons.

Figure 8- Building (B1b) with clay tile roof.

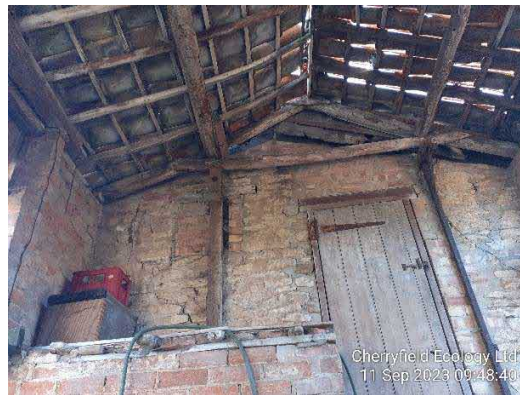
The roof and associated building have rafters which are undersized resulting in gaps between the rafters and the ridge. The brickwork and stone are in poor condition with cracks extending throughout the wall and localised areas of stone and brickwork missing. The rafters have shifted over time leading to gaps between the wall plate.

Gaps between the tiles are visible.

Figure 9- Rafters and joists in poor condition across the roof of the building.

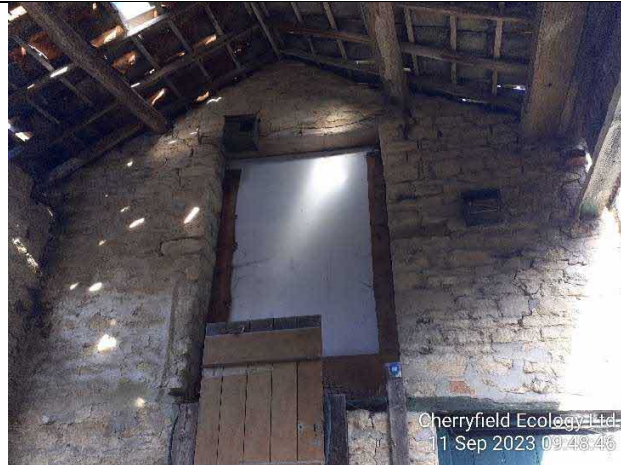
Figure 10- Interior wall of building with door.

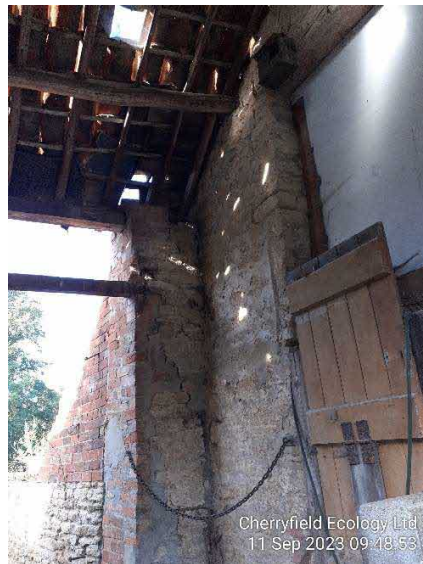
Figure 11- Internal brickwork of building.

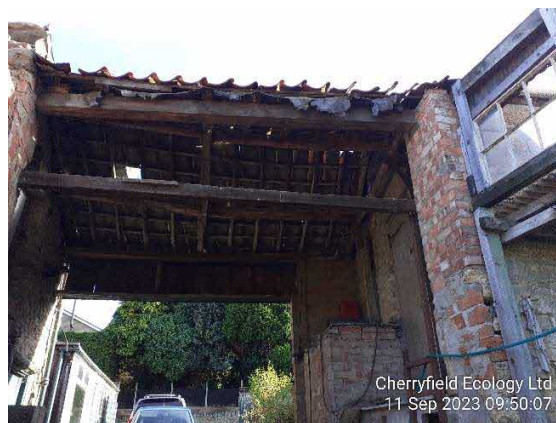
Figure 12- Underside of roof.

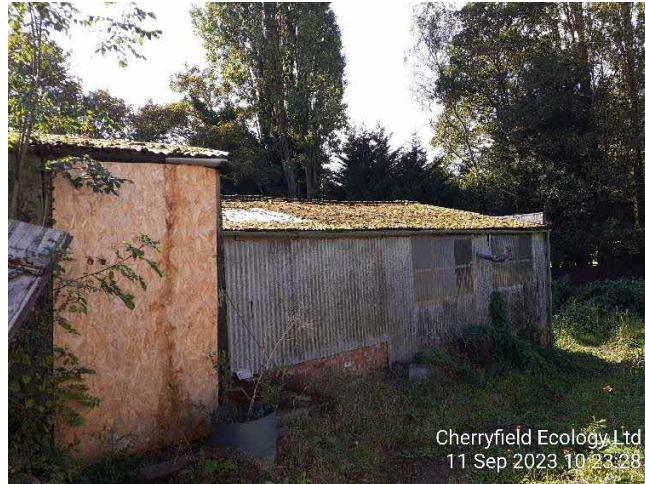
The old building yard is comprised of metal sheeting with a metal roof which is joined internally to the main house.

Figure 13-Metal sheet building joined to the main house.

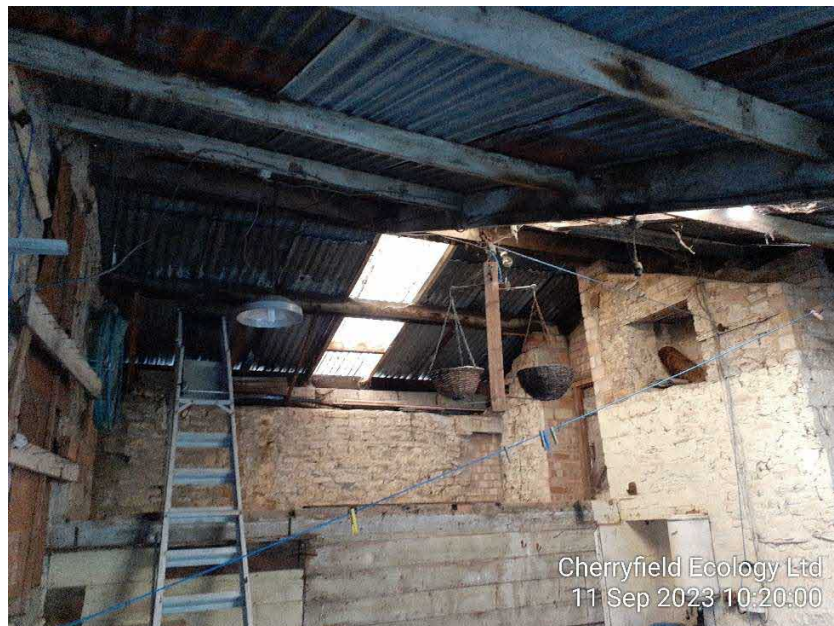
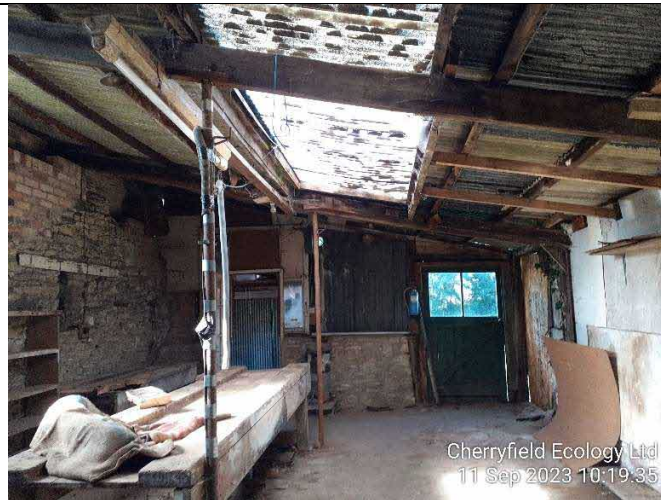
The internal of a section of the building yard has metal sheet ceiling with metal joists. Exposed brickwork walls are present.

Figure 14- Interior of building yard (B1c).

Figure 15- Interior of building yard (B1c).

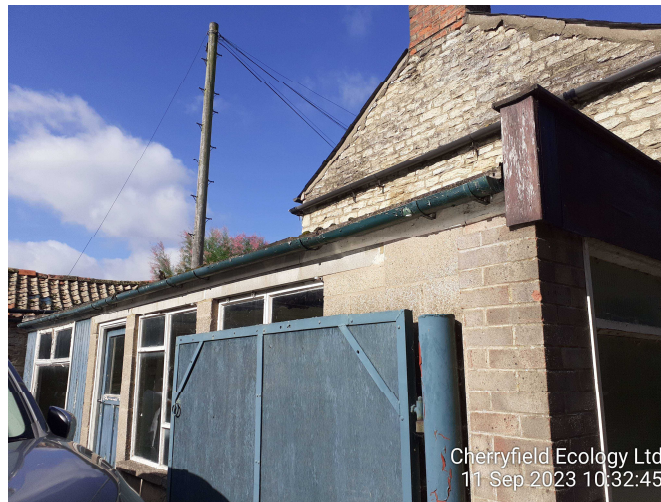
B2 is a small flat roofed outbuilding comprised of brick. Plastic guttering extends around the roof. PVC windows are embedded into the brickwork. No soffit or fascia boards are present.

Figure 16- Exterior of B2.

B2 has likely asbestos ceiling within the interior so the building was not entered.

B2- No further survey required, if a bat is found, works are to stop and an ecologist consulted.

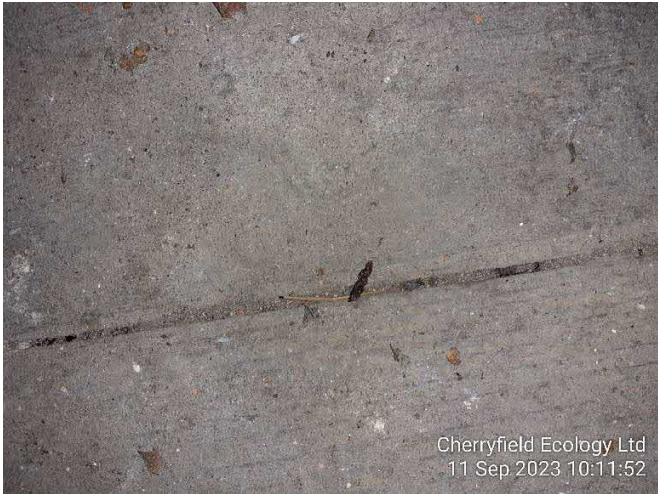
Bats found	No bats were found at the time of the survey
Evidence of bat use	<p>Several bat droppings (six) were found on the floor and stuck to the wall in two separate locations within B1. These were collected for eDNA analysis to determine species.</p>

<p>Figure 17- Bat dropping identified within B1a.</p>

There is therefore a confirmed roost located within B1. Several potential roost features are located throughout the building including damaged rafters, gaps on top of the wall plate and crevices within the brickwork.

B1 – Full roost characterisation surveys will be required to determine species, population and the entry/exit points used (three surveys, a minimum of three weeks apart).

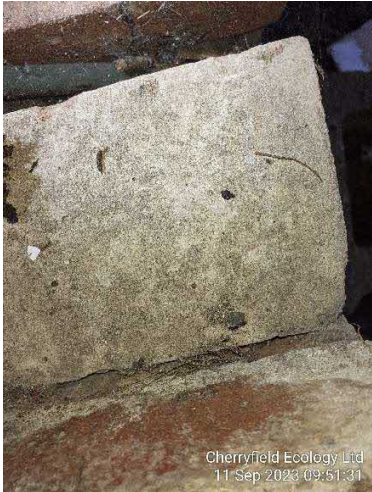
<p>Figure 18- Bat dropping identified within B1b.</p> <p>Scattered feeding remains including insect wings were identified within the building (B1a).</p>

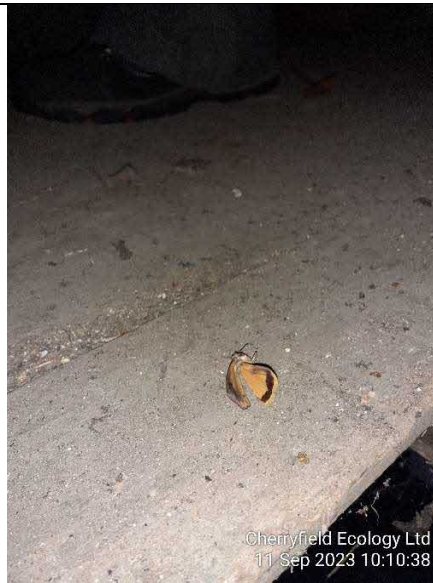
Figure 19- Feeding evidence identified within B1a.

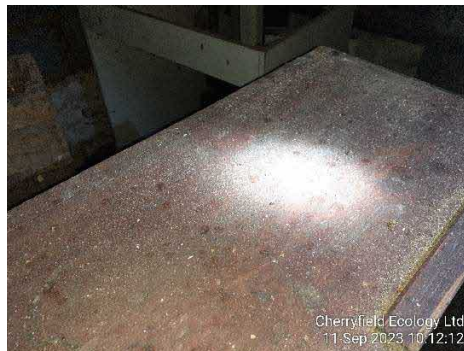
Urine staining was present in localised areas within the second storey of B1a.

Figure 20- Urine staining within B1a indicating bat presence.

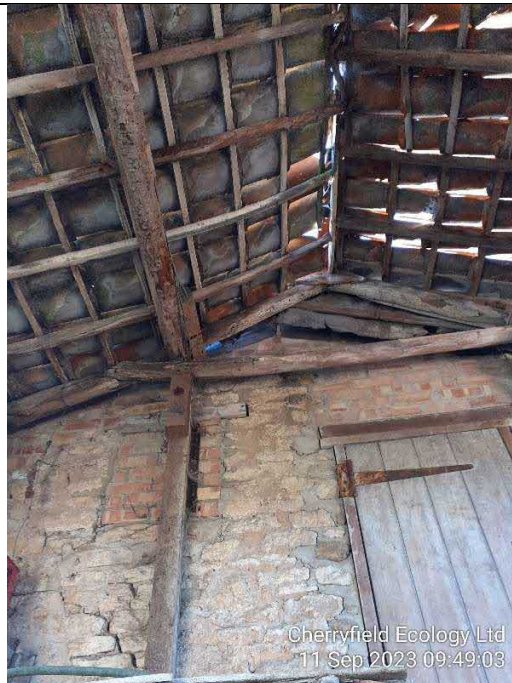
Figure 21- Cracks within the brickwork of B1b.

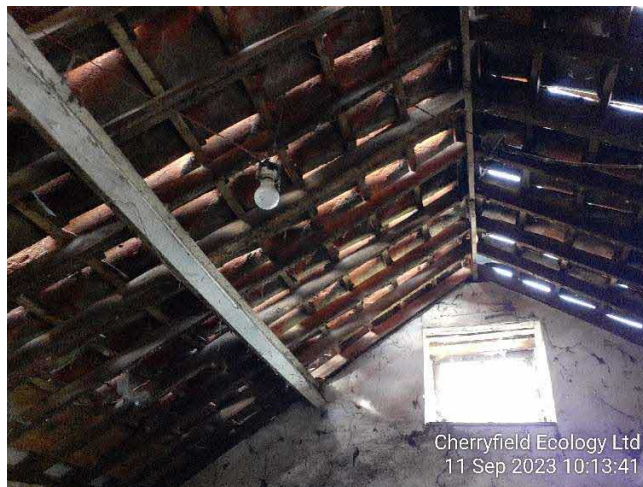
Figure 22- Gaps between rafters and wall plate of B1a.
