**RE: 25 CHURCH STREET, STANWICK, NN9 6PS**

Thank you for your request for us to carry out a visual structural inspection of the Barns to the rear of the above property. We confirm inspecting 2No. Barns, 1 the Plumbing Shop and also the Loft Barn. For clarity within this report, we will comment on those individually.

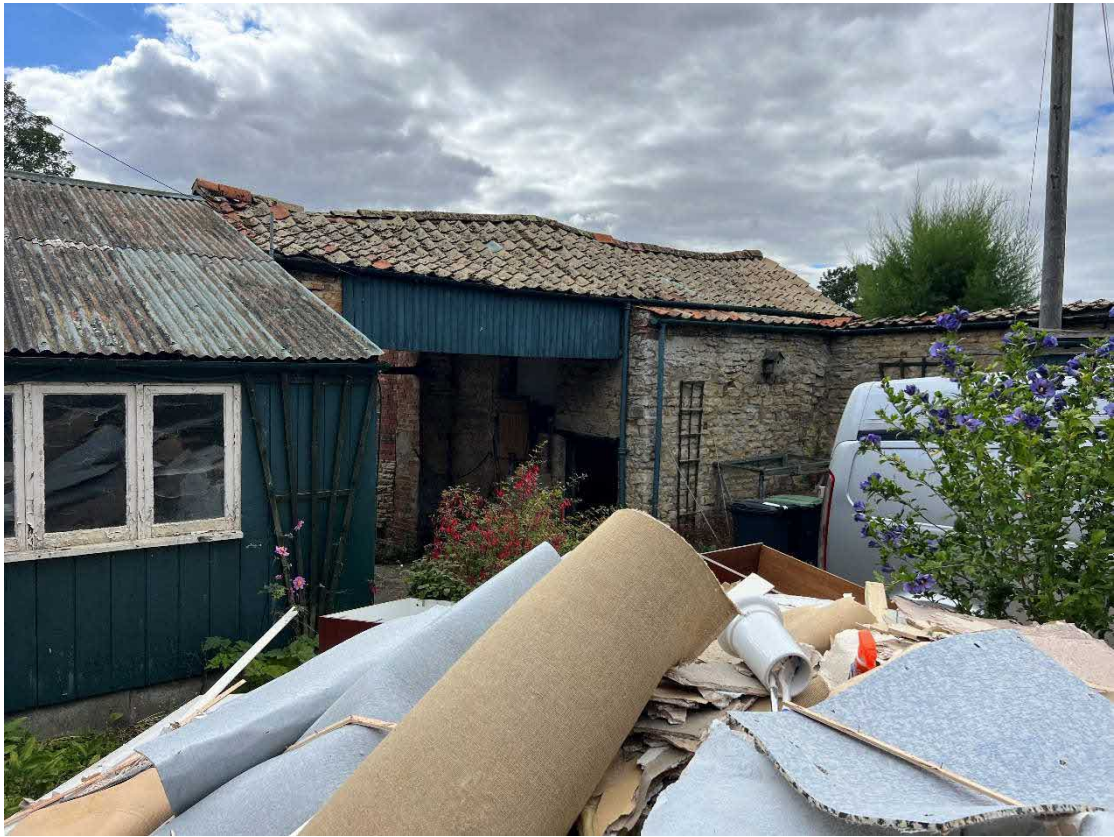
Photograph 1

In principle, this is a double height stone-built brick Barn with a duo pitch concrete tile roof covering. We can confirm that the roof structure is in very poor condition and shows considerable deviation both over the Barn and the flyover. The ridge has deflected significantly due to the rotting of the ridge board and some of the rafters have deflected and snapped. The rafters are very small and are not fit for purpose. Therefore, we recommend that the roof is removed and replaced with modern sawn cut timbers, appropriate felt and batons. Please refer to Photographs 1 – 4 in Appendix A.
