**Re: Chipchase House, Station Road, Forest Hall, NE12 9NQ**

Acting on your instructions I have now inspected the trees at the above location.

This report is concerned with recording the species, size, and condition of the trees. Recommendations are made where appropriate to establish acceptable levels of safety for the site and a higher level of arboriculture management if required.

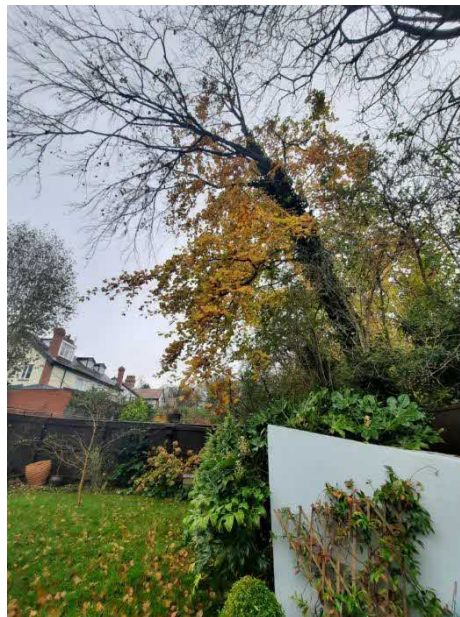
Tree 73 is a Beech tree that overhangs the neighbouring garden as shown on the below picture. The appraisal recommends branches overhanging the garden are pruned back due to the extent of the overhang.

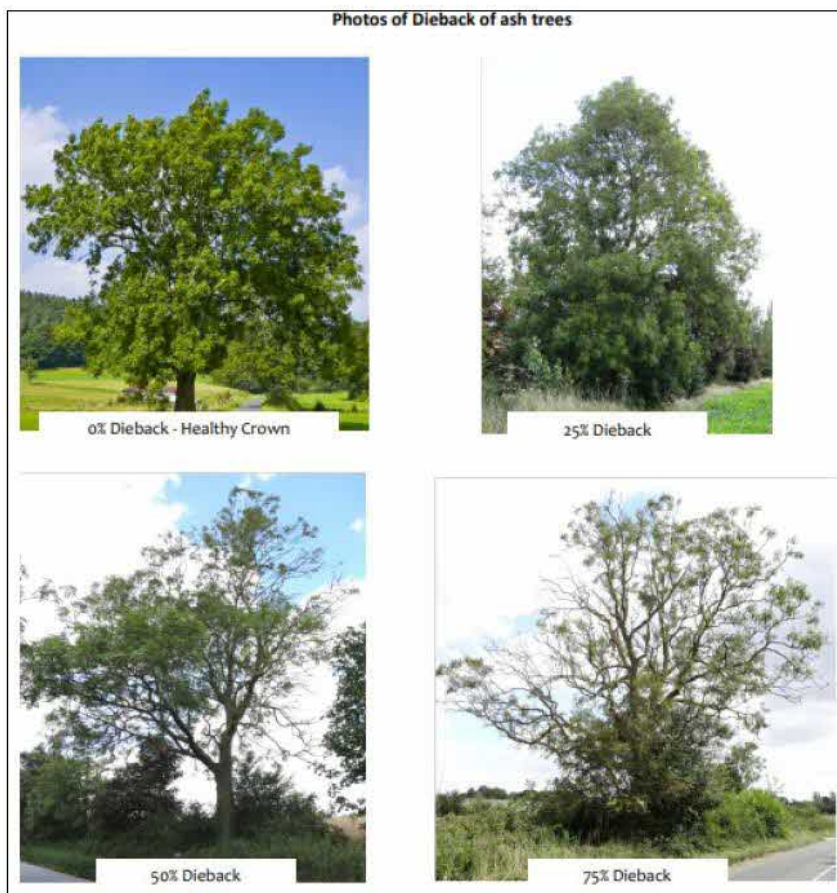
## Ash Dieback (*Hymenoscyphus fraxineus*)

Ash Dieback is a fungal disease formally known as *Chalara fraxinea* which is spread naturally by windborne spores. It has become an endemic in the whole of Britain over the last few years and is known to block the water transport system in trees. This causes leaf loss, lesions in the branches and then as the name suggest the die back of the trees crown. Younger Ash trees are more vulnerable and die quickly once they catch the disease, older trees decline more slowly with the crown gradually dying back further on a yearly basis. This can increase a potential health and safety risk as the pathogen weakens the structural strength of the tree as it dies back, this is specifically important to monitor if the tree is located in a high target area. There is currently no known cure for Ash Die Back.

We recommended that trees are checked for fungus growing on, or around the base in the Autumn. This is generally the time of year most fungus produces fruiting bodies, but the first frost of winter often kills them off so the window to detect this disorder is short. If fungus is noted on or around the base of tree's, please contact our office to arrange a further assessment.
