**Re: Chipchase House, Station Road, Forest Hall, NE12 9NQ**

Acting on your instructions I have now inspected the trees at the above location.

This report is concerned with recording the species, size, and condition of the trees. Recommendations are made where appropriate to establish acceptable levels of safety for the site and a higher level of arboriculture management if required.

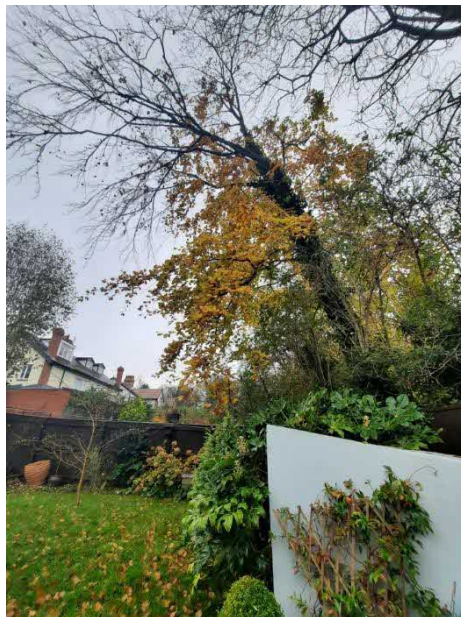
Tree 73 is a Beech tree that overhangs the neighbouring garden as shown on the below picture. The appraisal recommends branches overhanging the garden are pruned back due to the extent of the overhang.
