LEVEL 1 PHOTOGRAPHIC SURVEY

Cottage & Cider Mill at Fern Bank, Whitebrook, Monmouth NP25 4TT

PREPARED BY: GARETH PRICE ARCHITECT

DATE: APRIL 2023

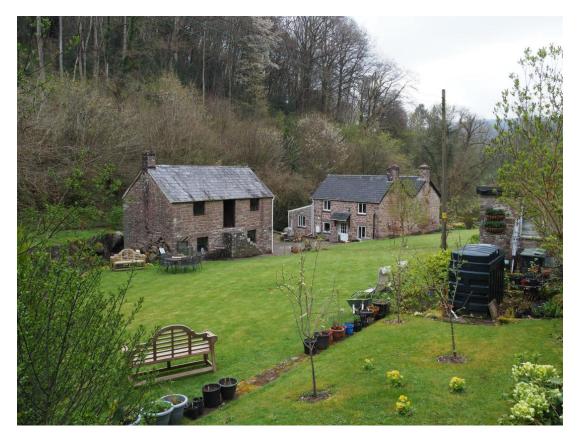
Plate 1: General view of building grouping from south west.

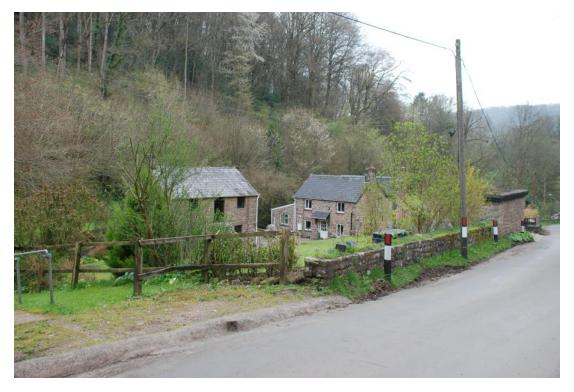
Plate 2: Site from south west.

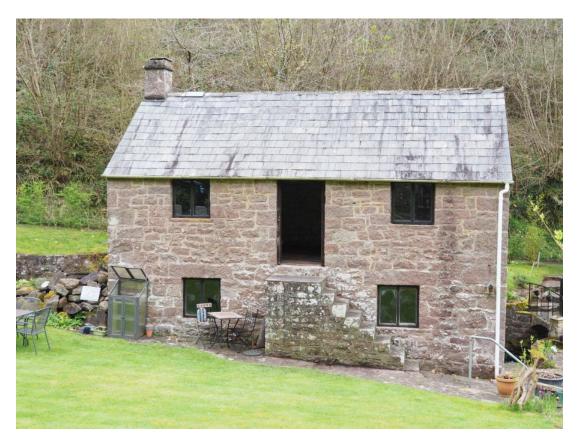
Plate 3: Cider Mill south elevation.

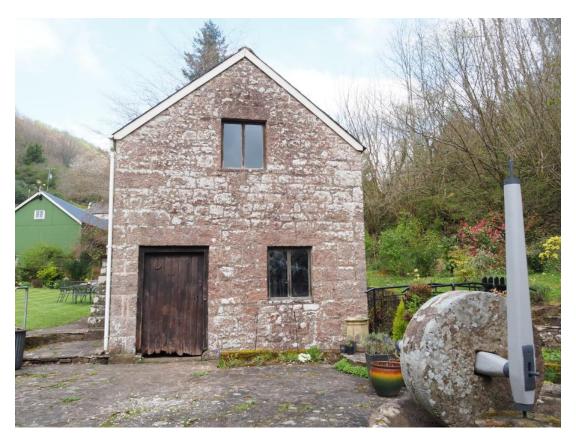
Plate 4: Sider Mill east elevation with millstone bottom right.

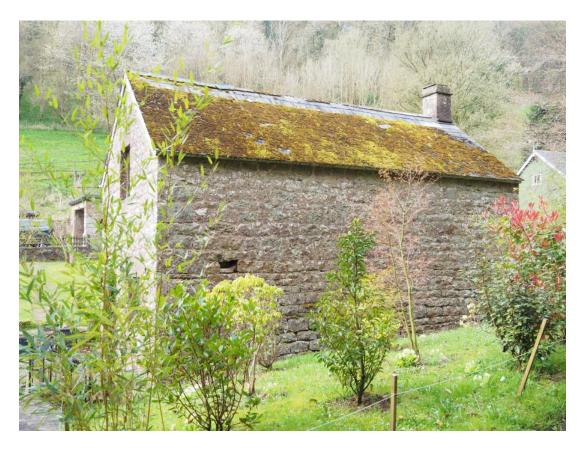
The roof is constructed from two oak trusses supporting purlins and rafters, the roof pitch is approximately 40 degrees. The roof is covered with Welsh slate with some missing ridge tiles, the north facing roof plane is heavily covered with lichen.

Plate 5: Cider Mill oblique north elevation.

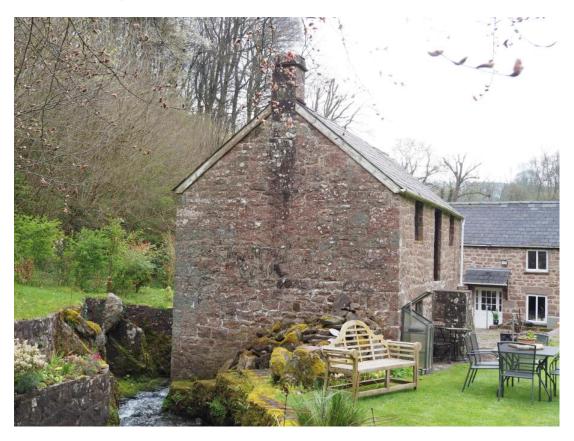
Plate 6: Cider Mill oblique west elevation with cottage in background.

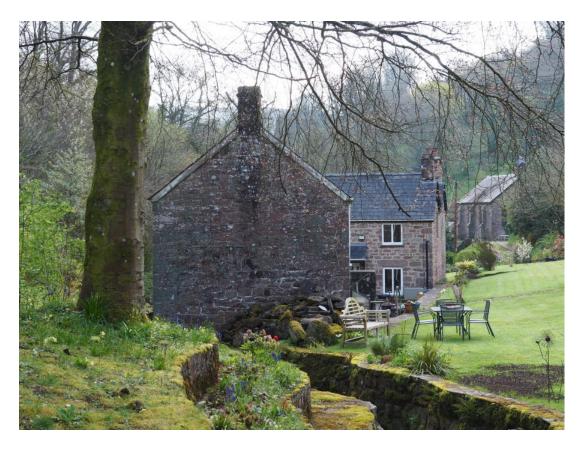
Plate 7: Cider Mill west elevation with cottage in background.

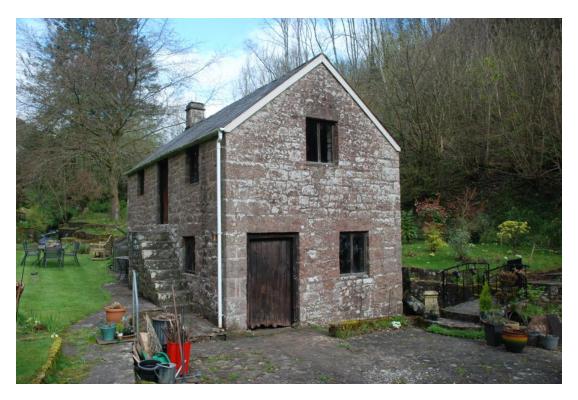
Plate 8: Cider Mill from south east with footbridge to right hand side.

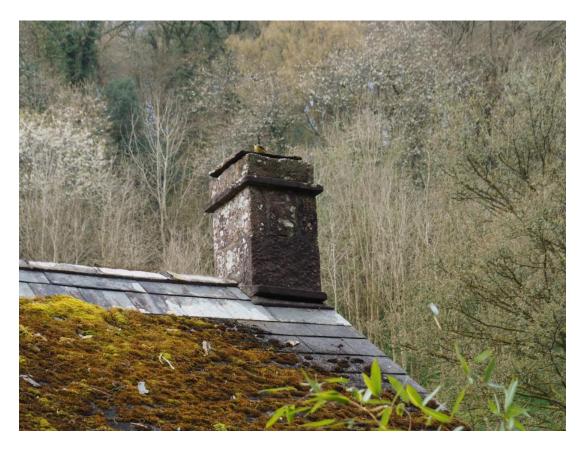
There is a dressed stone chimneystack to the north west gable with the corresponding fireplace at first floor level, suggesting that the upper floor has historically had a domestic use.

Plate 9: Cider Mill chimney stack/roof detail.

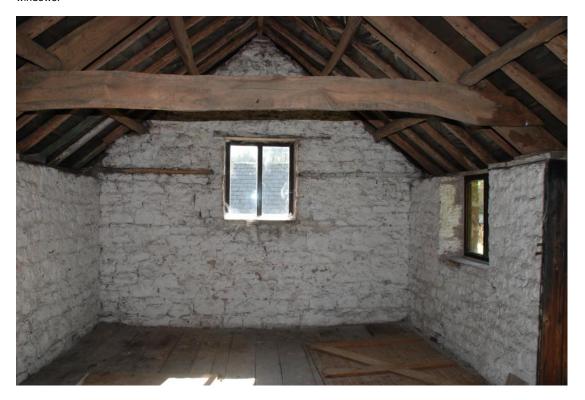
Plate 17: Cider Mill FF loft general interior view to east showing roof structure.

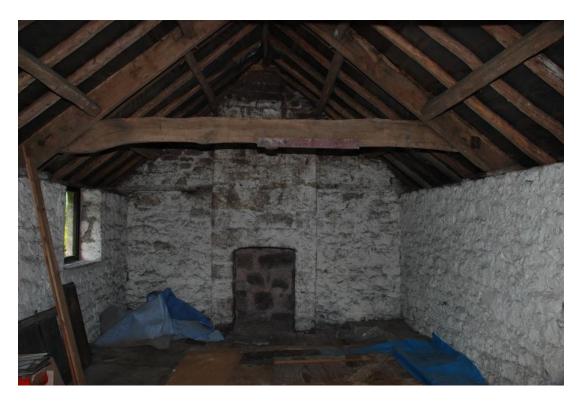
Plate 18: Cider Mill FF loft general interior view to west showing fire place and roof structure.

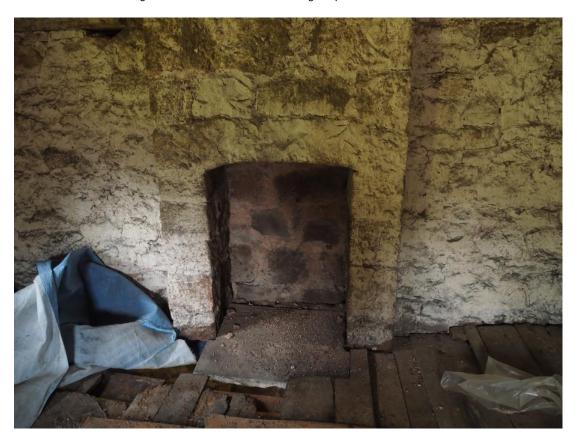
Plate 19: Cider Mill FF loft detail of fireplace and stone hearth.

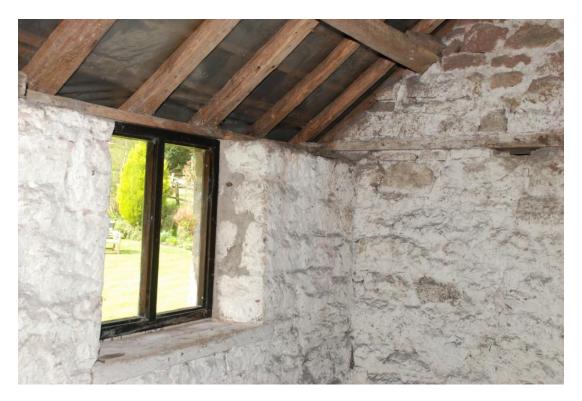
Plate 20: Cider Mill FF loft detail of south west corner showing window, part roof and timber wall ties.

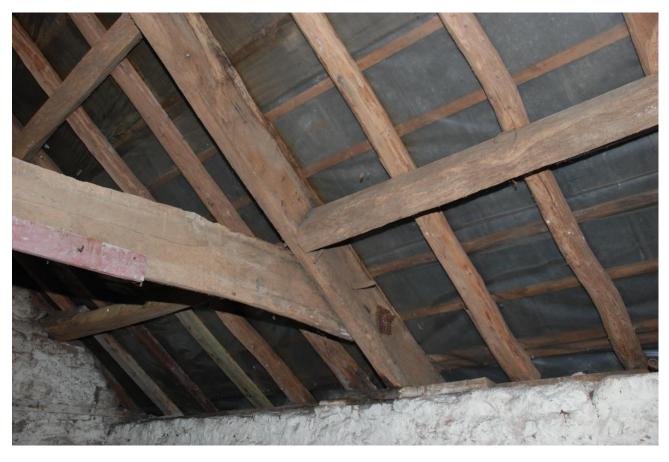
Plate 21: Cider Mill FF loft roof structure detail showing truss/purlin connections.

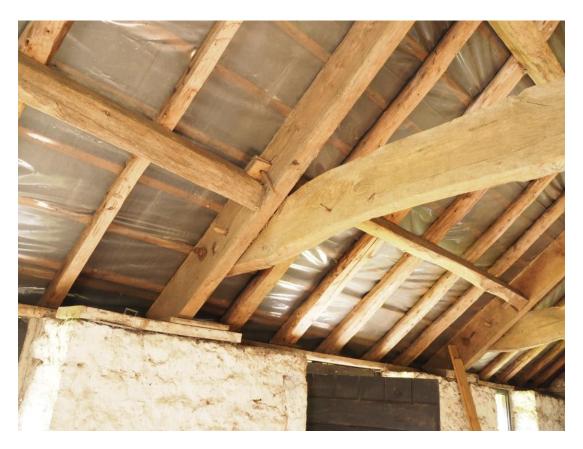
Plate 22: Cider Mill FF loft roof structure detail showing truss/purlin connections.

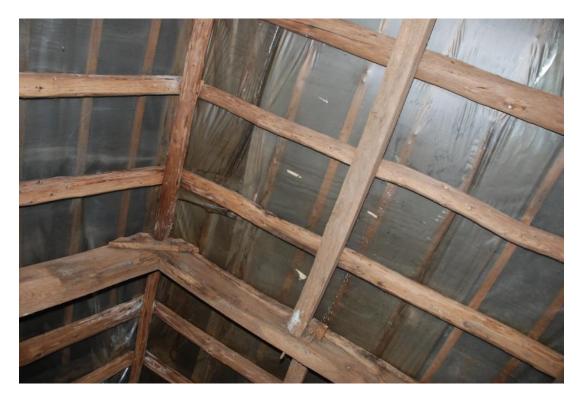
Plate 23: Cider Mill FF loft roof structure detail showing ridge.

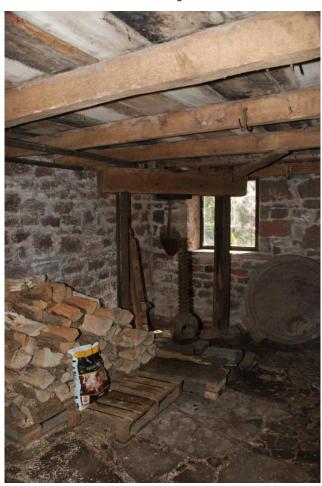
The ground floor cider house has an irregular flagstone floor laid on compacted earth with some flags missing. The apple press frame is still in situ in the front corner, it is mostly intact with some missing parts, the millstone apple crusher is in the yard outside.

Plate 28: Cider Mill GF Cider House interior showing apple press.

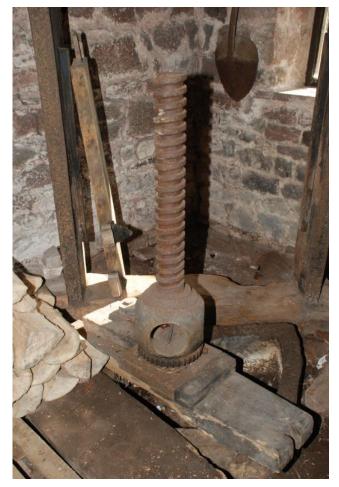
Plate 29: Cider Mill GF Cider House apple press detail.

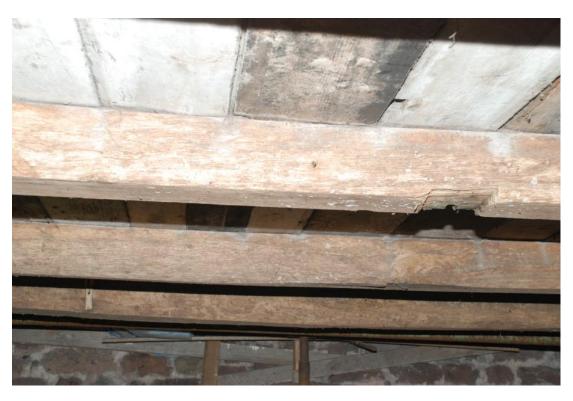
The first floor consists of thick butt jointed boards supported by 100 x 150 mm oak beams parts of the floor show signs of decay.

Plate 31: Cider Mill GF Cider House detail of FF beams and floorboards.

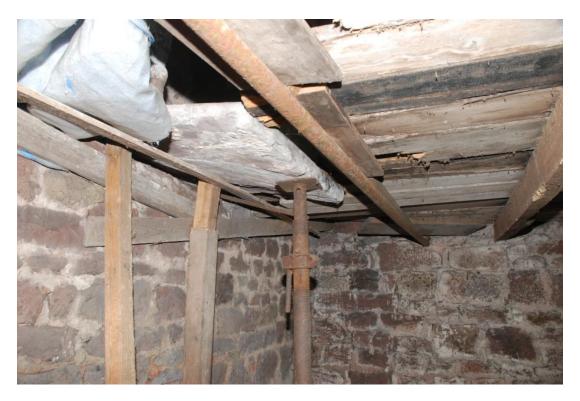
Plate 32: Cider Mill GF Cider House temporary propping to first floor showing underside of hearth stone.

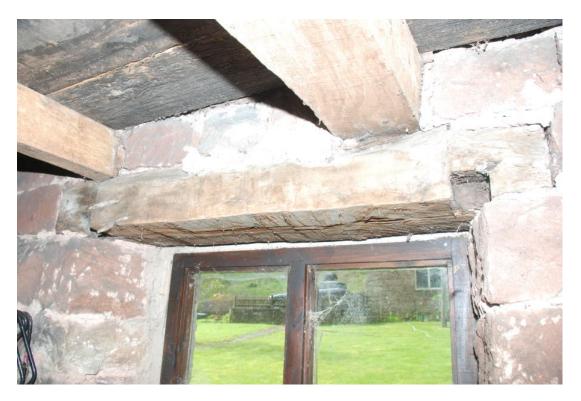
Plate 33: Cider Mill GF Cider House detail of first floor beams and window lintel.
