HISTORIC BUILDING IMPACT ASSESSMENT

HORSESHOE HOUSE,

WOOTTON, OXFORDSHIRE

NOVEMBER 2023

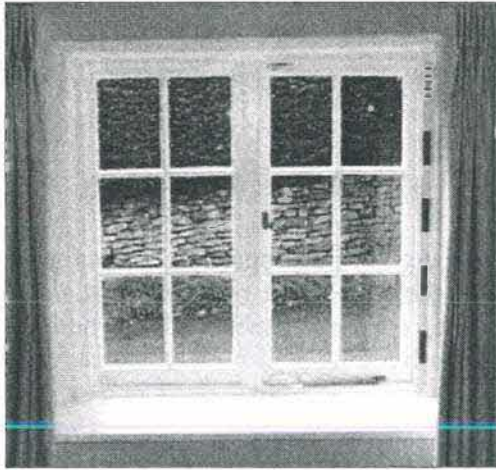
Plate 2: Window 1

A 20th century window. The two lights are divided by a wooden mullion and sit within an undecorated surround. Each light has ovolo and fillet moulded glazing bars c.21mm in thickness. The casement has a painted iron spiral handled cockspur catch and spiral handled stay. The simple iron spiral handled cockspur catch is difficult to date and is found in houses from the early 18th century onwards, with the design

remaining popular into the early 20th century (Hall 2005, 90; Hall 2001) and still produced today. The hinged spiral handled stay is probably 20th century in date.

Proposed Alteration	Fabric at Risk	Significance of Element	Degree of Harm (to element)	Reasoning
Removal and replacement of existing window	Window 1	Low	Substantial	The window is a 20 th century replacement of low historic value; it does not contribute substantially to the overall significance of the building, though does demonstrate its ongoing development. Removal would result in substantial impact to the window, removing any significance it holds (which is minimal in relation to the overall significance of the building).
Removal and replacement of existing window	Window 2	Low	Substantial	The window is a 20 th century replacement of low historic value; it does not contribute substantially to the overall significance of the building, though does demonstrate its ongoing development. Removal would result in substantial impact to the window, removing any significance it holds (which is minimal in relation to the overall significance of the building).

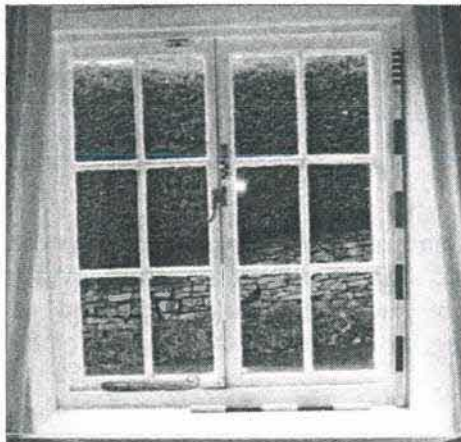
Plate 3: Window 2

A 20th century window. The two lights sit within an undecorated surround. Each light has ovolo and fillet moulded glazing bars c.21mm in thickness. The casement has a spiral catch and stay, both of historic design though most probably later replacements.

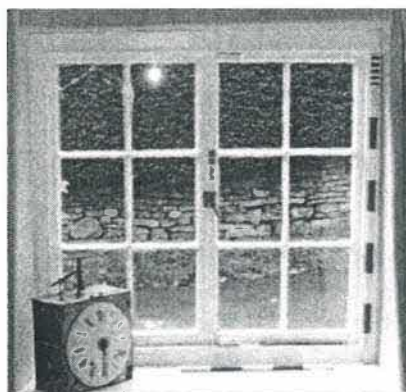
Plate 4: Window 3

A probable 19th century window. Internally the window sits within a surround that has a simple beaded moulding. The window has thin ovolo and fillet moulded glazing bars (c.18mm in thickness), and is fitted with a spiral cockspur catch, and a simple hook stay. The hook stay is of probable late 19th century date and is likely to be contemporary with the window (Hall 2005, p.91), though the latch is a later 20th century replacement.

Removal and replacement of existing window	Window 3	Moderate to High	Substantial	The window dates to the 19 th or early 20 th century and is of moderate to high historic value. Panes of historic glass remain extant and the latch is likely to be an original feature. Removal would result in substantial impact to the window, removing the significance it embodies.
Removal and replacement of existing window	Window 4	Low	Substantial	The window is a 20 th century replacement of low historic value; it does not contribute substantially to the overall significance of the building, though does demonstrate its ongoing development. Removal would result in substantial impact to the window, removing any significance it holds (which is minimal in relation to the overall significance of the building).
Removal and replacement of existing window	Window 5	Low	Substantial	The window is a 20 th century replacement of low historic value; it does not contribute substantially to the overall significance of the building, though does demonstrate its ongoing development. Removal would result in substantial impact to the window, removing any significance it holds (which is minimal in relation to the overall significance of the building).

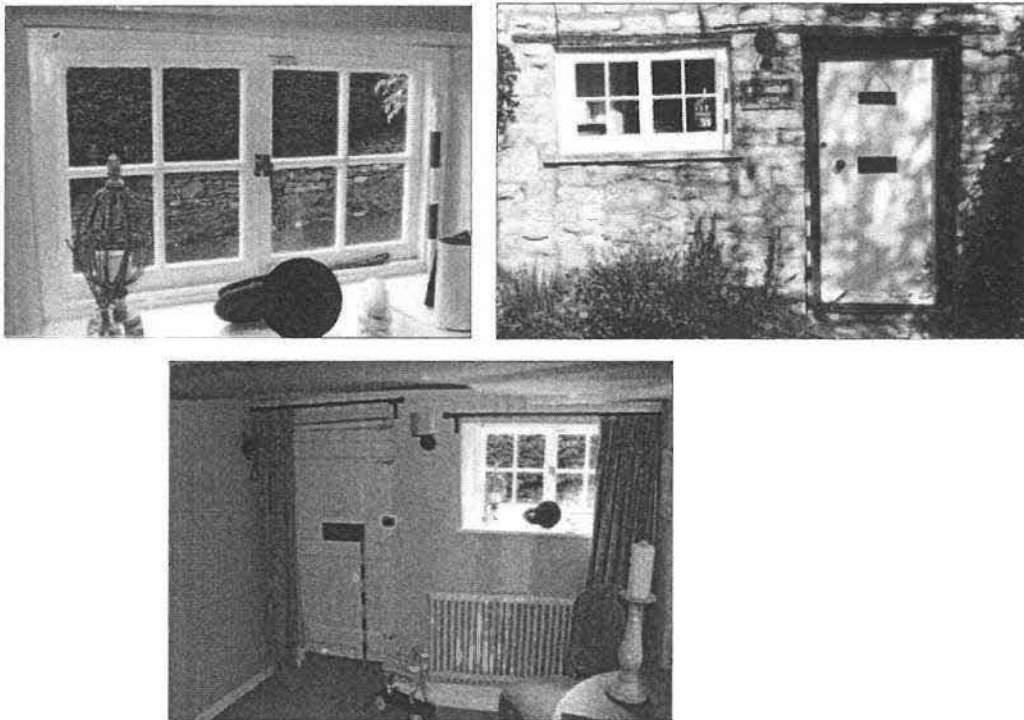
Plate 5: Window 4 and Door 1

Window 4 lights the front hallway, to which Door 1 provides access. The openings are topped with a wooden lintel that extends the length of both, while a dressed stone sill is present below Window 4.

A small two light side hung casement with a flying mullion; each light has two panes over two. The window is of 20th century date. It has ovolo moulded glazing bars c.21mm in thickness and fittings comprise a spiral cockspur catch and spiral stay, which have been painted; though of historic design it is probable that both are modern replacements. The window sits within an undecorated surround.

Removal and replacement of existing door	Door 1	Low	Substantial	The door is a 20 th century replacement of low historic value; it does not contribute substantially to the overall significance of the building, though does demonstrate its ongoing development. Removal would result in substantial impact to the window, removing any significance it holds (which is minimal in relation to the overall significance of the building).

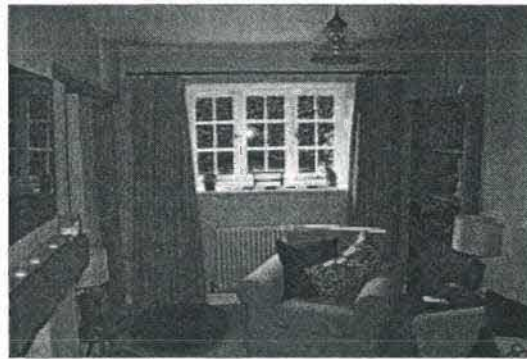
Plate 6: Window 5

Window 5 lights a small sitting room. The window sits within an opening topped with a timber lintel and has a dressed stone sill; this window sits in the location of the former bay window, visible on historic maps and photographs in the early 20th

century. The window, dating to the 20th century, comprises three lights, with a fixed light flanked by two side-hung casements; the lights are separated by plain timber mullions and sit within an undecorated surround; each light has two panes over three. Each light has ovolo and fillet moulded glazing bars c.21mm in thickness. The two casements have spiral cockspur catches and thumb screw casement stays. The spiral catches are a historic design though most probably later replacements; the stays are 20th century in date.

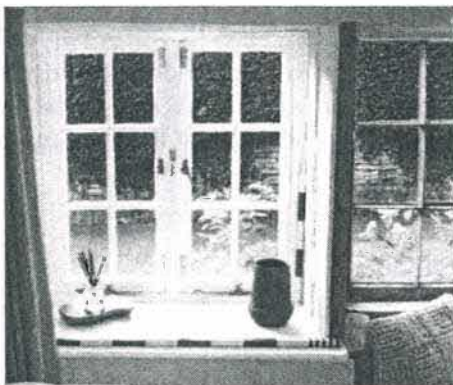
Plate 7: Window 6

A 20th century window. Two side-hung casements that are separated by a plain wooden mullion and sit within an undecorated surround; each light has two panes over three. The right hand window (as viewed from the interior) is the same as Windows 1, 2 and 5, while the left hand is the same as Window 4; both have ovolo and fillet moulded glazing bars c.21mm in thickness. Both lights have modern: spiral catches and thumb screw casement stays.

Removal and replacement	Window 6	Low	Substantial	The window is a 20 th century replacement of low historic value; it

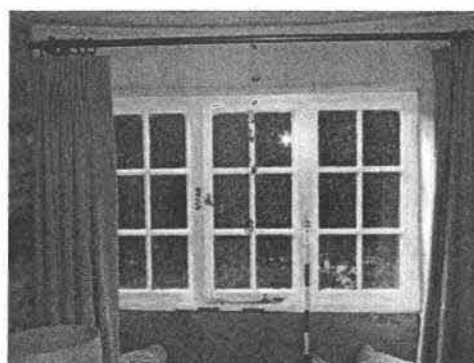
Plate 8: Window 7

A 20th century window. The window comprises three lights; a central side-hung casement of two panes over three flanked by two fixed lights of two panes over three; each light is divided by a plain wooden mullion and sits within an undecorated surround. The window has ovolo and fillet moulded glazing bars c.21mm in thickness. The casement has a modern spiral catch and a thumb screw stay.

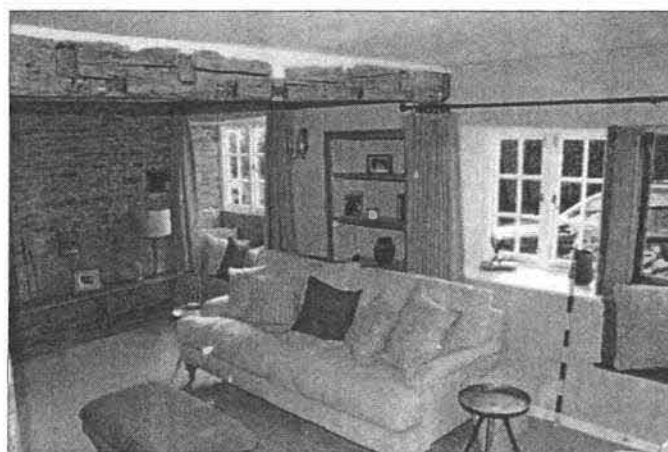
Plate 9: Windows 6 and 7

Windows 6 and 7 light the lounge. Window 6 sits within an opening topped by a wooden lintel and has a dressed stone sill; the condition of the sill and lintel suggests it is a later replacement, and in fact historic photographs demonstrate that this opening was a doorway in the early 20th century. Window 6 is separated from a historic fixed light window of probable 19th century date (not part of this report) by a timber post. Window 7 sits within an opening topped by a timber lintel and has a dressed stone sill.

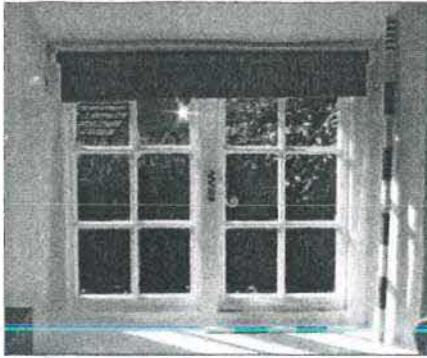
Plate 10: Window 13

A 20th century window similar in form to those seen on the ground floor. A central wooden mullion divides the window into two lights; each light sits within a plain surround. Both lights have ovolo and fillet moulded glazing bars c.21mm in thickness and the casement is fitted with a spiral cockspur catch and spiral stay.

Removal and replacement of existing window	Window 13	Low	Substantial	The window is a 20 th century replacement of low historic value; it does not contribute substantially to the overall significance of the building, though does demonstrate its ongoing development. Removal would result in substantial impact to the window, removing any significance it holds (which is minimal in relation to the overall significance of the building).
Removal and replacement of existing window	Window 14	Low	Substantial	The window is a 20 th century replacement of low historic value; it does not contribute substantially to the overall significance of the building, though does demonstrate its ongoing development. Removal would result in substantial impact to the window, removing any significance it holds (which is minimal in relation to the overall significance of the building).
Removal and replacement of existing window	Window 15	Low	Substantial	The window is a 20 th century replacement of low historic value; it does not contribute substantially to the overall significance of the building, though does demonstrate its ongoing development. Removal would result in substantial impact to the window, removing any significance it holds

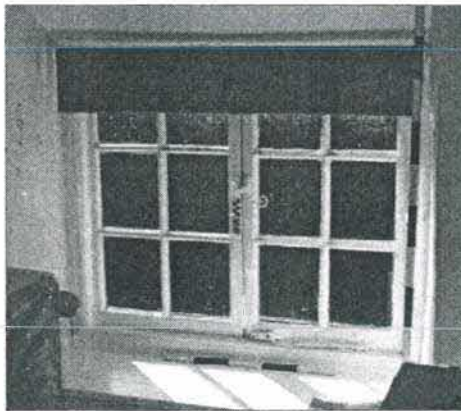
Plate 11: Window 12

This window is of two phases, though both of 20th century date. The casement has ovolo and fillet glazing bars c.20mm in thickness, with a spiral catch and stay. The fixed window has glazing bars c.19mm in thickness, also with ovolo and fillet mouldings. It is possible that the fixed window is a later replacement, as stylistically it matches ground floor windows 4 and 7. Both lights sit within a simple moulded frame.

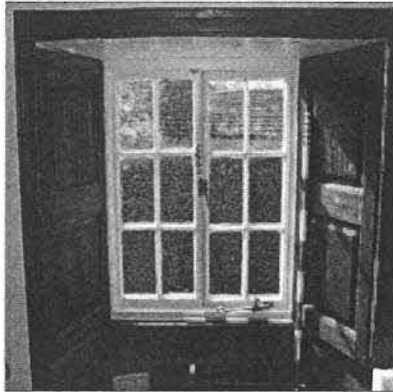
Plate 13: Window 11

Window 11 lights a bathroom. The window sits within an opening topped by a timber lintel and has a dressed stone sill. The window comprises two lights; a left-hand side-hung casement of two panes over three and a fixed light also of two panes over three. Internally the window sits within a moulded frame and is associated with wooden panel shutters of 18th or early 19th century date. The window itself is of probable 19th century date. Both lights have thin ovolo and fillet moulded glazing bars of c.17mm thickness. The fixed light has a beaded moulding on its right hand side. The casement has a modern spiral cockspur latch, and a modern thumb screw stay that matches those seen on a number of ground floor windows.

Proposed Alteration	Fabric at Risk	Significance of Element	Degree of Harm (to element)	Reasoning
				holds
Removal and replacement of existing window	Window 11	Moderate to High	Substantial	The window dates to the 19 th century and is of moderate to high historic value. Panes of historic glass remain extant, though the fittings have probably been replaced. The similarity with windows 8 to 10 demonstrates that they are contemporary and therefore represent an identifiable phase in the development of the building. The window also sits within an historic moulded surround and is associated with interior shutters and a window seat, though these features are likely of an earlier phase. Removal would result in substantial impact to the window, removing the significance it holds
Removal and replacement of existing window	Window 12	Low	Substantial	The window is a 20 th century replacement of low historic value; it does not contribute substantially to the overall significance of the building, though does demonstrate its ongoing development. Removal would result in substantial impact to the window, removing any significance it holds (which is minimal in relation to the overall significance of the building).

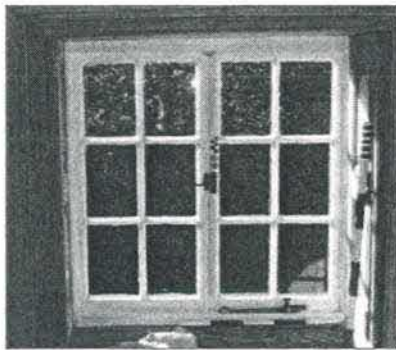
Plate 15: Window 10

Window 10 lights a bedroom. The window sits within an opening topped by a timber lintel and has a dressed stone sill. The window comprises two lights; a left-hand side-hung casement of two panes over three and a fixed light of two panes over three. Internally the window sits within a moulded frame and is associated with wooden panel shutters of 18th or early 19th century date.

The window itself is of probable 19th century date. Both lights have thin ovolo and fillet moulded glazing bars of c.16-17mm thickness. The mullion of the fixed light has a beaded moulding on its right hand side. The casement has a brass latch, with a replacement thumb screw stay that matches those seen on a number of ground floor windows; both are modern additions.

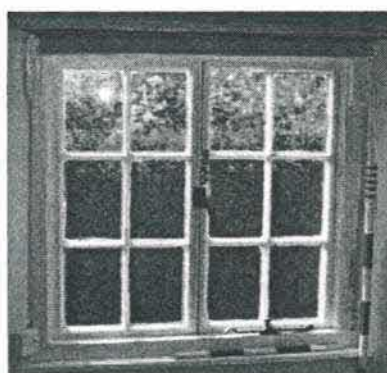
Plate 17: Window 9

Window 9 also lights a bedroom. The window sits within an opening topped by a timber lintel and has a dressed stone sill. The window comprises two lights; a left-hand side-hung casement of two panes over three and a fixed light of two panes over three. Internally the window sits within a moulded frame, over a stone window seat. The window is of probable 19th century date. Both lights have thin ovolo and fillet glazing bars of c.16-17mm thickness. The fixed light has a beaded moulding on its right hand side. The casement has a spiral latch, with a replacement thumb screw stay that matches those seen on a number of ground floor windows.

Removal and replacement of existing window	Window 9	Moderate to High	Substantial	The window dates to the 19 th century and is of moderate to high historic value. Panes of historic glass remain extant, though the fittings have probably been replaced. The similarity with windows 8, and 10 to 11 demonstrates that they are contemporary and therefore represent an identifiable phase in the development of the building. Removal would result in substantial impact to the window, removing the significance it holds
Removal and replacement of existing window	Window 10	Moderate to High	Substantial	The window dates to the 19 th century and is of moderate to high historic value. Panes of historic glass remain extant, though the fittings have probably been replaced. The similarity with windows 8, and 10 to 11 demonstrates that they are contemporary and therefore represent an identifiable phase in the development of the building. The window sits within an historic moulded surround and is associated with interior panelled shutters and a window seat, though these features are likely of an earlier phase. Removal would result in substantial impact to the window, removing the significance it

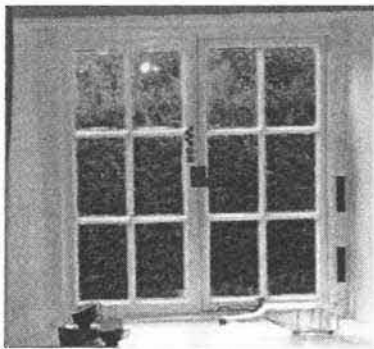
Plate 19: Window 8

Window 8 lights a bedroom. The window sits within an opening topped by a timber lintel and has a dressed stone sill. The window comprises two lights; a left-hand side-hung casement of two panes over three and a fixed light of two panes over three. Internally the window sits within a moulded frame.

This window is also of probable 19th century date, similar in form to those in Bathroom 4 and Bedrooms 3, 4 and 5. Both lights have thin ovolo and fillet moulded glazing bars of c.16-17mm thickness. The fixed light has a beaded moulding on the casement side. The casement has a spiral cockspur catch, with a replacement thumb screw stay that matches those seen on a number of other windows in the building; both are modern replacements.

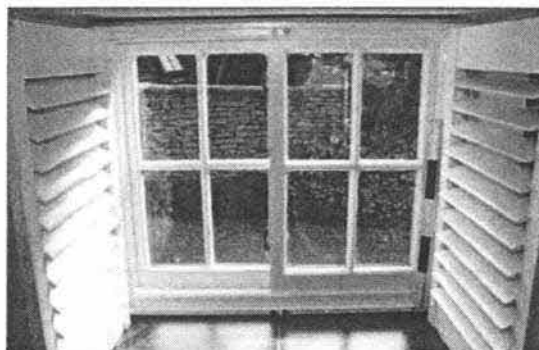
Plate 20: Window 14

Window 14 lights a utility room. The window sits within an opening topped by a timber lintel and has a dressed and painted stone sill; the sides of the aperture are brick. The window is a horizontally sliding sash of two lights, both two panes over two. The ovolo and fillet moulded glazing bars measure c.21mm in thickness and the window has two modern sash fasteners. The window is a mid to late 20th century replacement that sits within a plain frame.

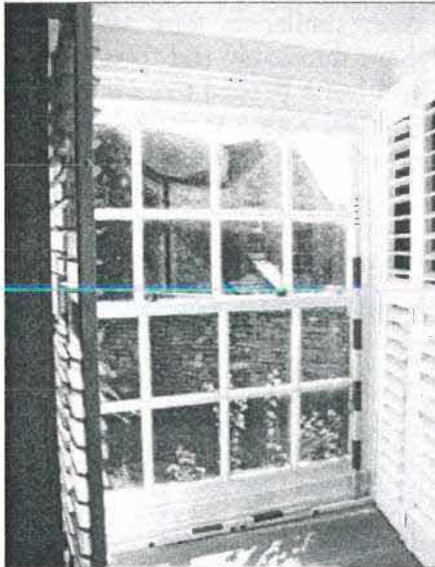
Plate 21: Window 15

Window 16 lights the Boot Room. The window sits within an opening topped by a timber lintel and has a dressed stone sill. The unit, which sits within a plain surround, is a sash window of mid to late 20th century date. The ovolo-moulded glazing bars measure c.21mm in thickness and modern sash fasteners are present.

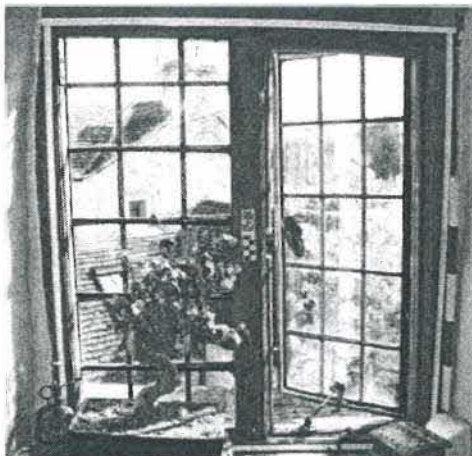
Plate 22: Window 16

Window 16 lights a home office. The window sits within an opening topped by a timber lintel and has a dressed stone sill. Internally the jambs and mullion are moulded. The window has cast iron glazing bars; the casement has horizontal saddle bars, to which the leaded light is hung. The casement is hung on decorative iron pintles and has a turnbuckle catch; analogous examples are dated to the mid-19th century (Hall 2005, p.90). The leaded panes contain plate or crown glass.

Proposed Alteration	Fabric at Risk	Significance of Element	Degree of Harm (to element)	Reasoning
				(which is minimal in relation to the overall significance of the building).
Removal and replacement of existing window	Window 16	High	Substantial	The window is an 18 th or early 19 th century metal casement, with moulded wooden mullion and jambs. The window has high evidential value; its contrast with the wooden casements on the southern elevation helps to demonstrate the development of the building and significance of the southern elevation as the principal facade of the building.
Removal and replacement of existing window	Window 17	High	Substantial	The window dates to the 19 th century and is of high historic value. The window is contemporary with the 19 th century rear extension within which it is located. The window sits within a historic moulded surround and is associated with interior shutters. These features are likely to be contemporary with the window; the variation of this window with those on the southern elevation demonstrates the evolution of the building and changes in vernacular construction, contrasting with the smaller wooden casements on the southern and eastern elevation.

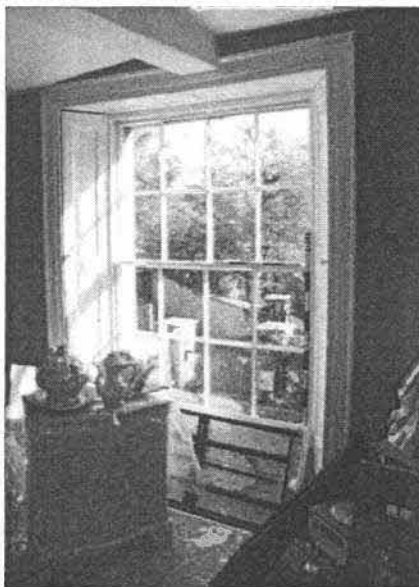
Plate 23: Window 17

Window 17 lights a store room. The window sits within an ashlar-edged opening, topped with a soldier arch, also in ashlar, and has a stone sill. The window is a double hung 19th century sash, most probably contemporary with the extension in which the window is located. The window has a moulded surround with associated shutters, likely contemporary to the window. Each light has thin ovolo and fillet moulded glazing bars c.16/17mm in thickness, with plate glass panes present.

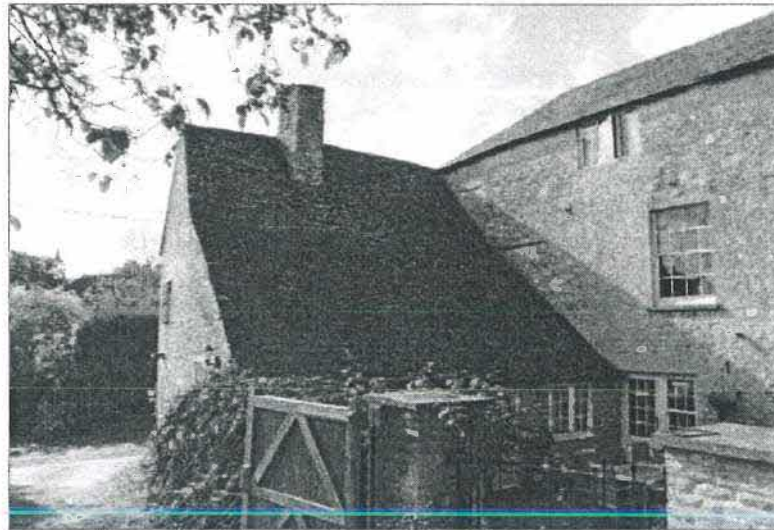
Plate 24: Rear roof at the eastern end of the building

This report focuses on the part of the roof that covers the easternmost part of the main range and the rear single storey outshut extension, thus forming a large catslide roof. The roof is clad in graduated Stonesfield slate; many of the slates appear to be in a fragmentary condition and have slipped. A ridge stack of roughly squared limestone bisects the roof and probably marks the former gable end of the main range, which has been extended to the east, creating a single cell addition to the main range.

Proposed Alteration	Fabric at Risk	Significance of Element	Degree of Harm (to element)	Reasoning
Replacement of slates, battens; repairs/renew rafters where necessary; new breathable sarking felt; new battens where necessary. Replacement of stone slates with Cardinal slates	Rear roof of eastern range and catslide extension; underlying roof structure	High	Substantial	The slates are a historic roof covering and as such hold evidential value, illustrating vernacular construction methods and materials. The roof covering also contributes to the character of the building, and forms a significant visual element of the rear of the building. The underlying roof structure has high evidential value and is likely to be one of the oldest elements of the building, though the primary roof structure itself is unlikely to suffer significant impact.

The proposed replacement slates are designed to accurately imitate the varied nature of the natural stone thus ensuring that the character.

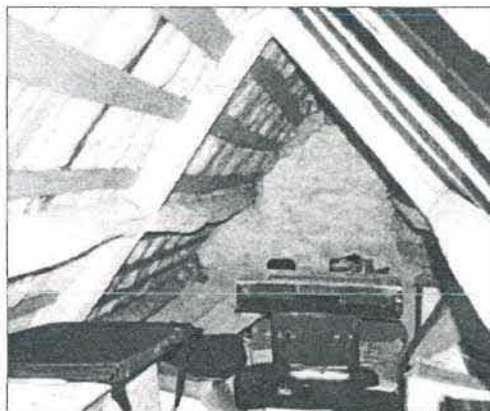
Plate 25: Roof structure in eastern end of the main range

The roof structure of the main range was accessed; this part of the roof comprises three bays formed from two principal rafter trusses, with tenoned purlins; no evidence for collars or tie beams is present. The rafters meet at a ridge plank. Historic timber studwork finished with a lath and plaster finish is present under the eaves; the skelting is also finished in lath and plaster in places, and the stonework of the east and west walls is plastered; both the timbers and plaster is whitewashed. The level of finish in the loft indicates that the room must have been occupied to some extent. In places the plaster has been removed and battens have been added in order to secure modern insulation.

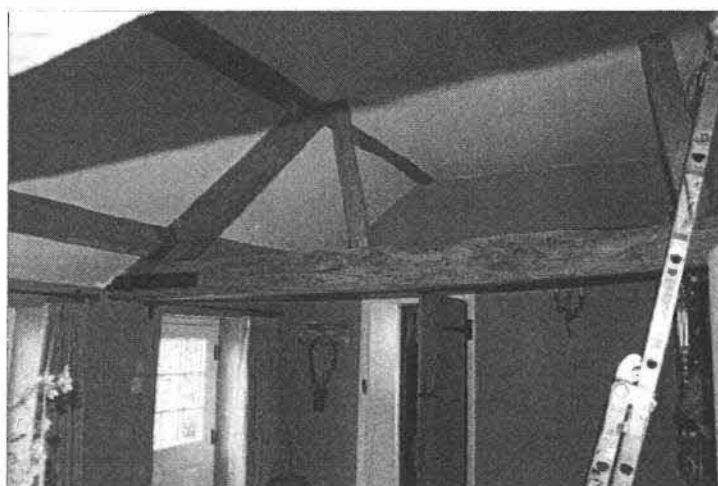
Plate 26: Roof structure of the outshut extension

The roof structure of the single storey extension comprises three bays, formed by a single principal truss with tie beam and raking struts and a stone wall that divides the hallway and western extension. Three rows of tenoned purlins support common rafters. The roof is exposed in the hallway, which is partly open to the roof; the upper part of the roof is obscured though accessible through a hatch. The western wall of the roof space is formed by the 19th century rear extension, which in this location clearly butts against the main range; this appears to be the case at the western end too, though the evidence is less definitive. The roof structure displays a range of re-used and modern timber, suggesting extensive rebuilding or repair.
