**ARBORICULTURAL SAFETY  
SURVEY**

**Larchwood  
Woodlands Drive  
Leeds  
West Yorkshire**

Craggwood Management  
Committee

21111/EW

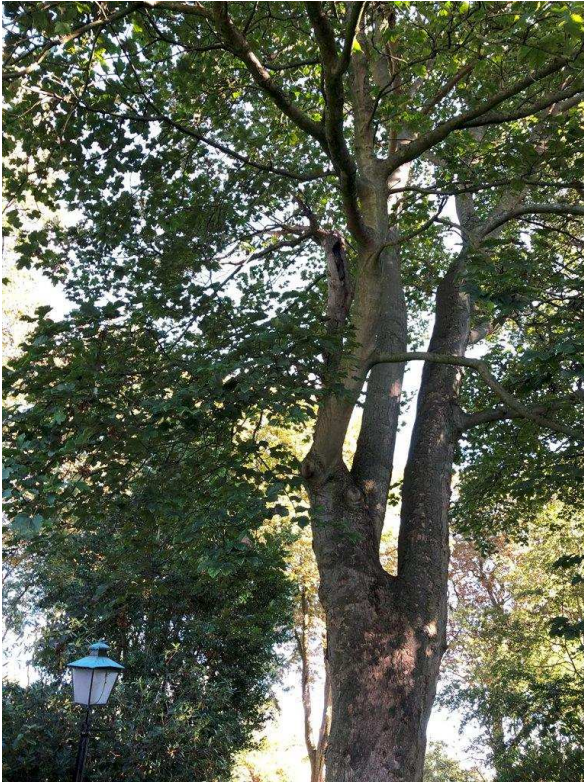
Photo 1: T17 Sycamore - limb to be removed

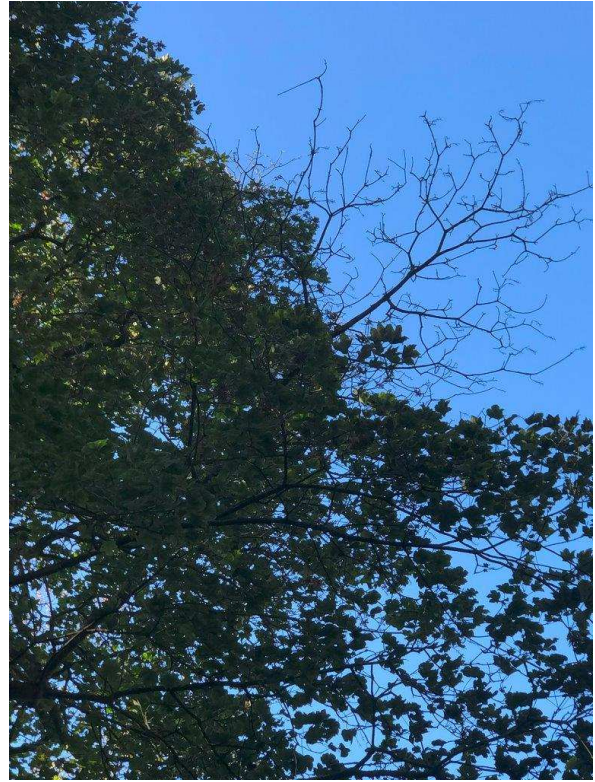
Photo 2: T17 Sycamore - dieback

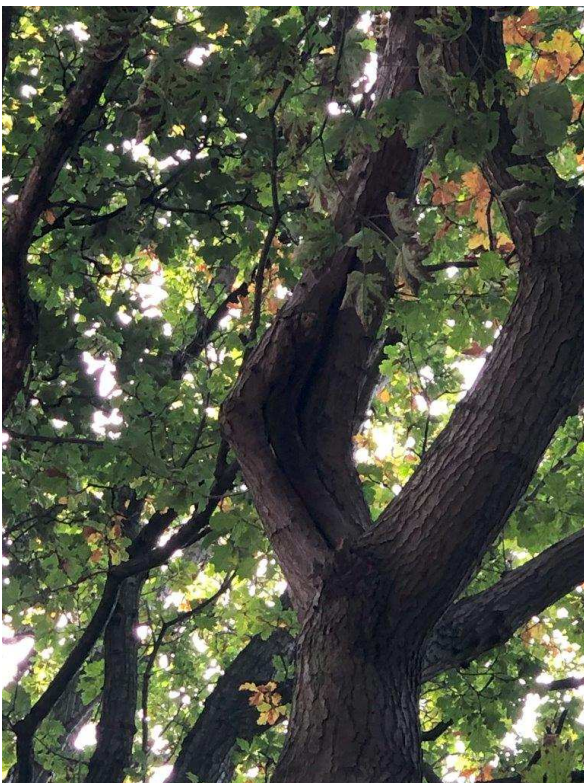
Photo 3: T55 Oak - Reduce limb with hazard beam

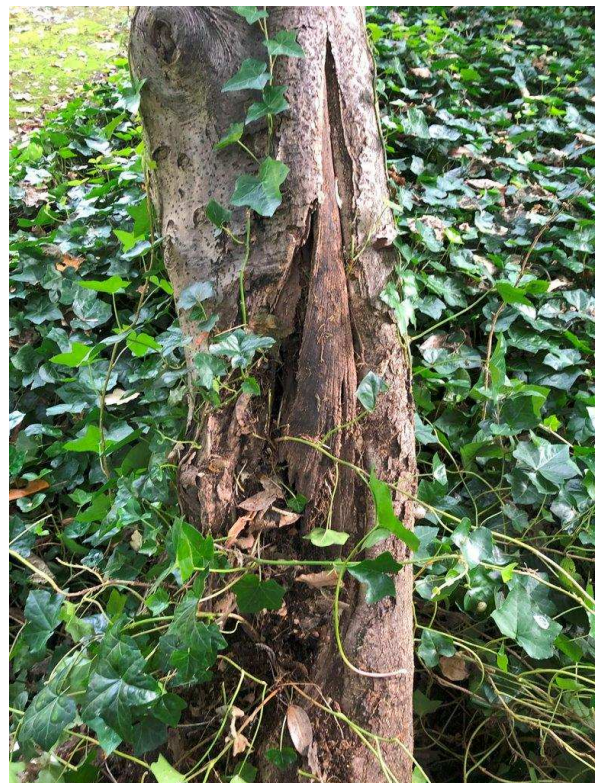
T 57	Early-mature Common Holly <i>Ilex aquifolium</i>	7	2	37	6	Single-stemmed with a heavy lean and an offset crown. Dieback to crown, overhanging the car park. Basal decay extending up the main stem to 1.5m.	POOR	POOR	<10	MOD	Remove. Leave stem in large length in the woodland.	MOD	R	N/A
T 58	Early-mature Sycamore <i>Acer pseudoplatanus</i>	14	3	2 x 30 avg.	10	Twin-stemmed at ground level with a slightly unbalanced crown. Small amount of included bark at union and minor wound with the onset of decay, affecting both stems at one side of the union, other side has exposed wood along the union.	GOOD	GOOD	20-40	MOD	Monitor union at next biennial inspection.	N/A	A	2
T 59	Semi-mature Sycamore <i>Acer pseudoplatanus</i>	12	2	20	5	Significant decay column to the lower stem and at 3m. Adjacent to footpath in woodland.	POOR	POOR	<10	MOD	Remove - retain stem within the woodland.	MOD	R	N/A
T 60	Mature English Oak <i>Quercus robur</i>	18	10	85	18	Twin-stemmed at 6m with a slightly unbalanced crown. Bark/cambium dysfunction from the base to 6m. Large wound from 4-6m - exposed wood with good surrounding wound wood. Potential co-dominant stem failure but low target into the woodland.	FAIR	FAIR	20-40	MOD	No action required.	N/A	A	2

Photo 4: T57 Holly - to be removed

- 5.3.1 The removal of **T57, T59, T68, T70** and **T71** is of **moderate priority**.
  - 5.3.2 The removal of **T63, T74, T75, T76** and **T77** is of **low priority**.

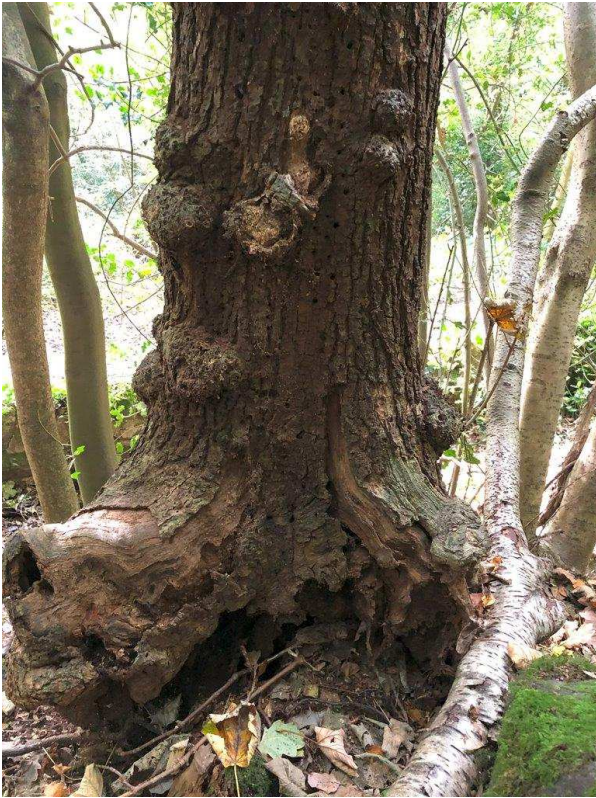
Photo 5: T63 Oak to be reduced

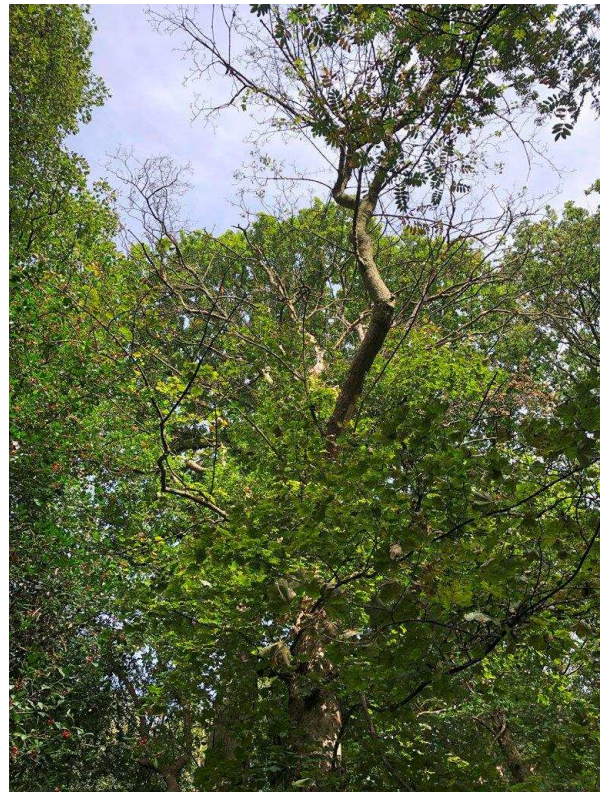
T 68	Mature Sycamore <i>Acer pseudoplatanus</i>	14	1	60	6	Single-stemmed and vertical. Decay cankers at the base. Dieback to the crown. Moribund Bark necrosis to the lower stem. Within falling distance of the track.	FAIR	FAIR	10-20	MOD	Fell leaving 3 to 5 metres standing stem. Leave the Felled stem in the woodland.	MOD	R	2
T 69	Mature Sycamore <i>Acer pseudoplatanus</i>	18	5	75	11	Single-stemmed with a slight lean and offset crown. Some cavities around the base of the stem. Good buttressing. Canopy appears healthy.	GOOD	FAIR	40+	MOD	No action required.	N/A	A	2
T 70	Mature Sycamore <i>Acer pseudoplatanus</i>	18	8	#80	#12	Single-stemmed with a large decay cavity at the base, extending to the underside of adjacent buttress roots. Within falling distance of the track and road below.	FAIR	POOR	<10	MOD	Reduce main stem to leave habitat stem. Height is at the discretion of the contractor.	MOD	R	2

Photo 6: T68 Sycamore to be removed – dieback

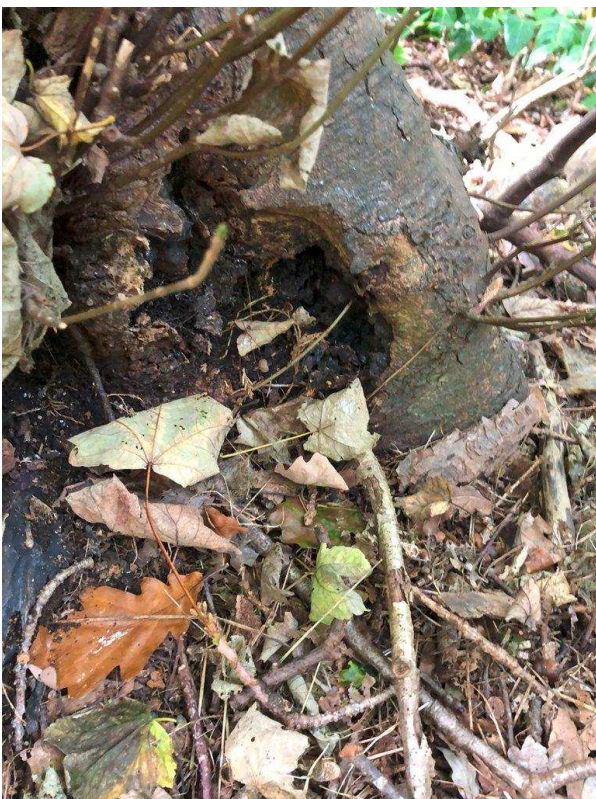
Photo 7: T68 - Cavity

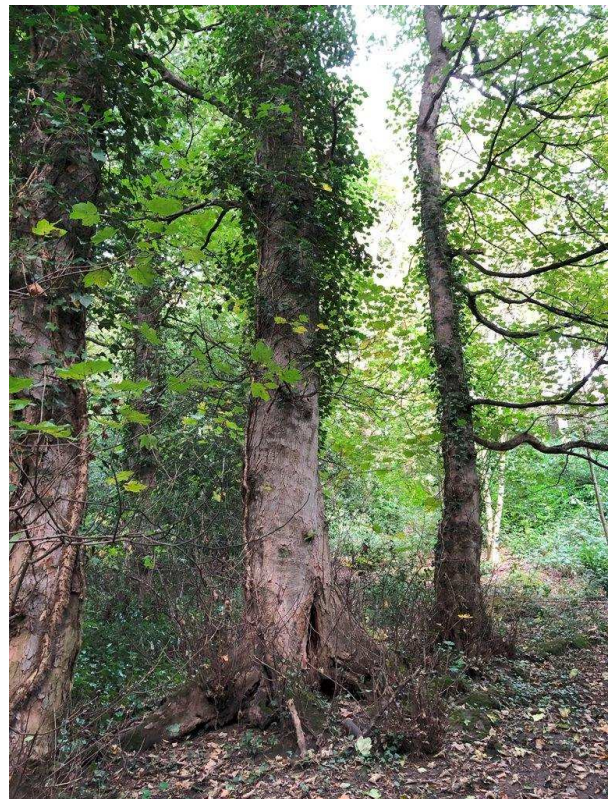
Photo 8: T70 Sycamore to be removed

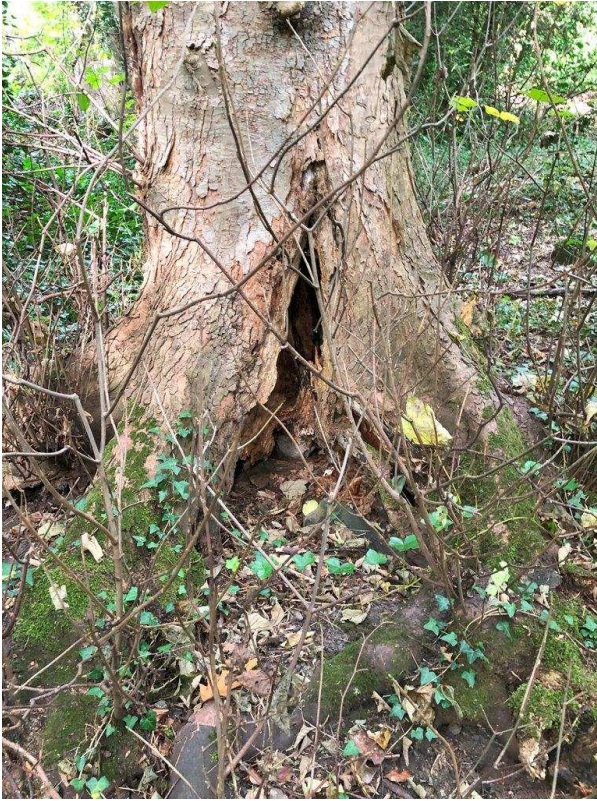
Photo 9: T70 – cavity

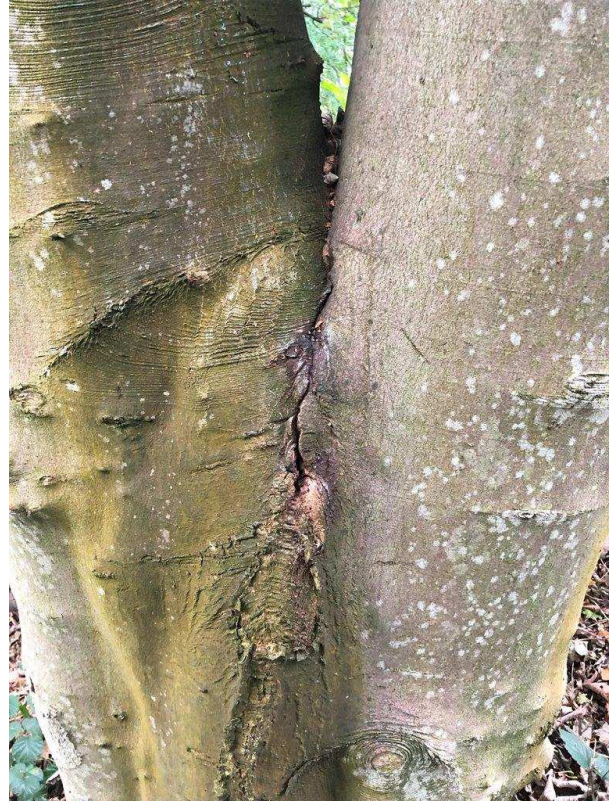
Photo 10: T71 Sycamore to be removed - weak union
