Kingswood Estate, Dashwood House SE21 8PA

RE: Dashwood House, Kingswood Estate, London SE21 8PA

Structural Engineer's recommendations to mitigate the subsidence risk due to near trees

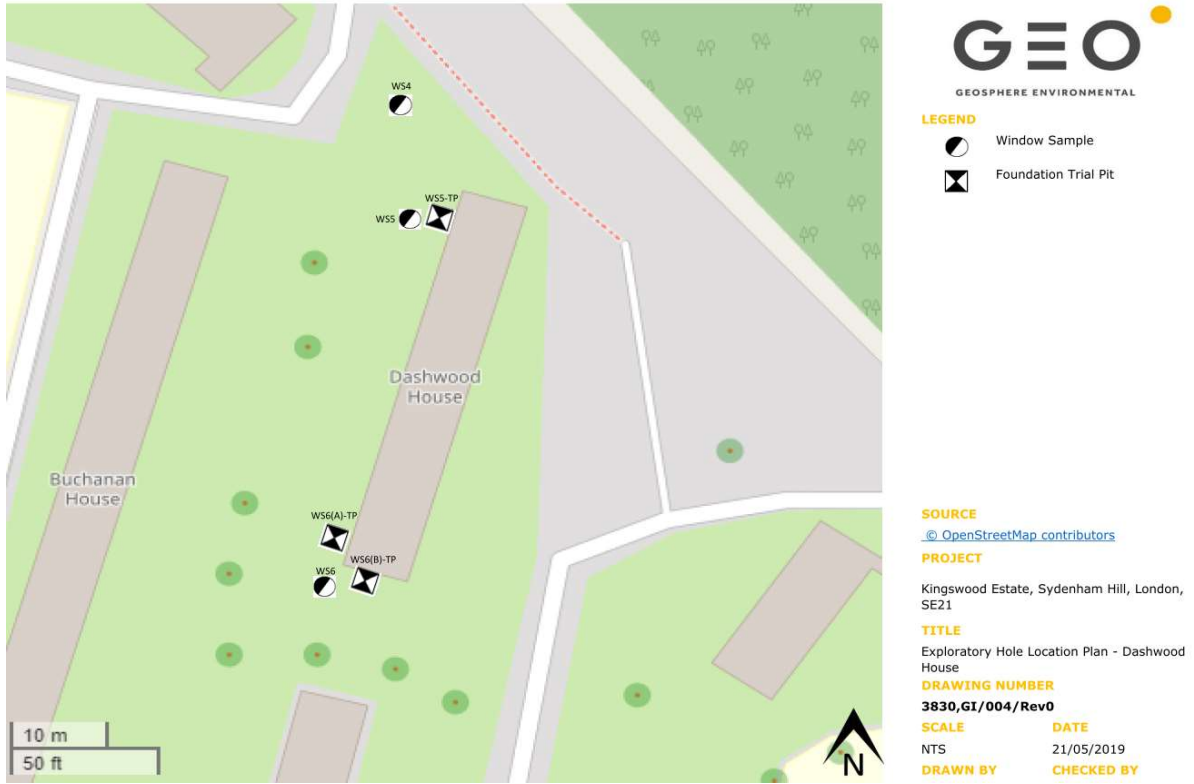
GEO's ground investigation at Dashwood house revealed that;

Figure 1 - Extract from GEO report, showing investigation locations at Dashwood House.

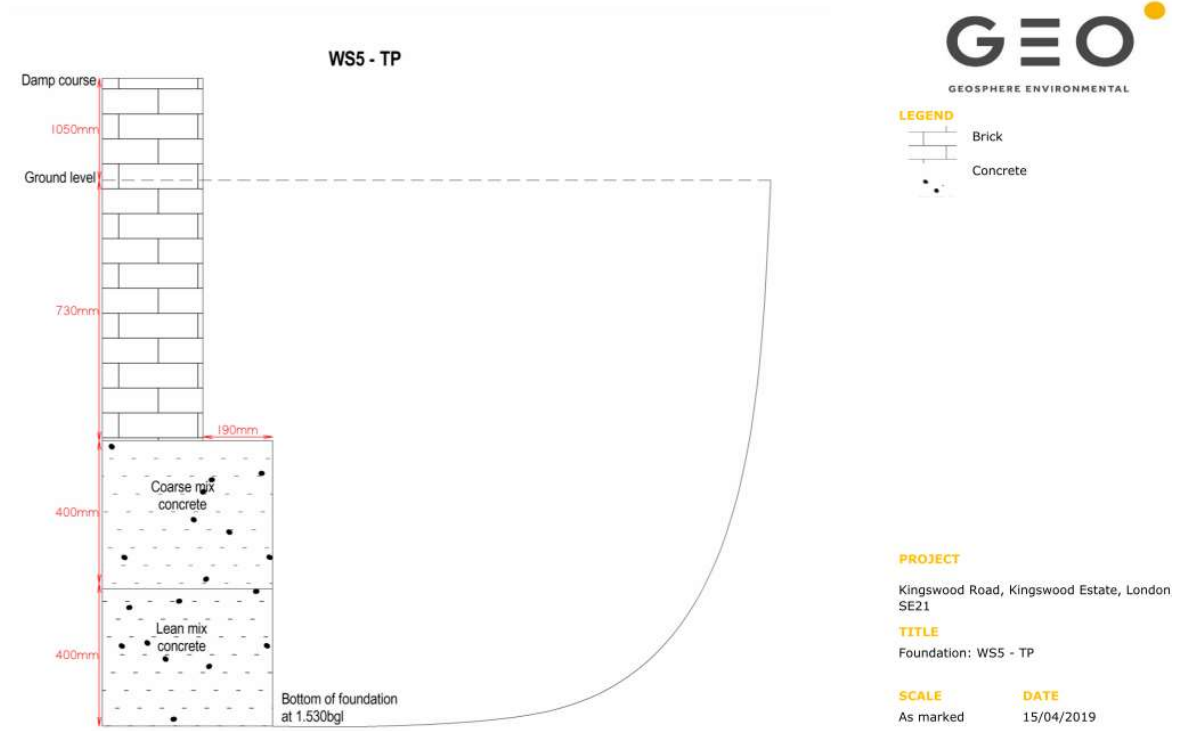
- The foundations are relatively deep considering the age of the building at 1.5m BGL . They consist of brickwork extending to approximately 0.75m BGL, sitting onto a concrete foundation down to approximately 1.50mBGL. The concrete foundation extends approximately 0.25m from the face of the brick wall.

- The foundations are in “good condition, with no visible defects, damage or weaknesses”.
- The ground conditions consist of Made Ground (to an average depth of 0.5m BGL) overlying firm London Clay, becoming stiff at depth.

Figure 2 - Extract from GEO report, showing typical Trial Pit at Dashwood House.

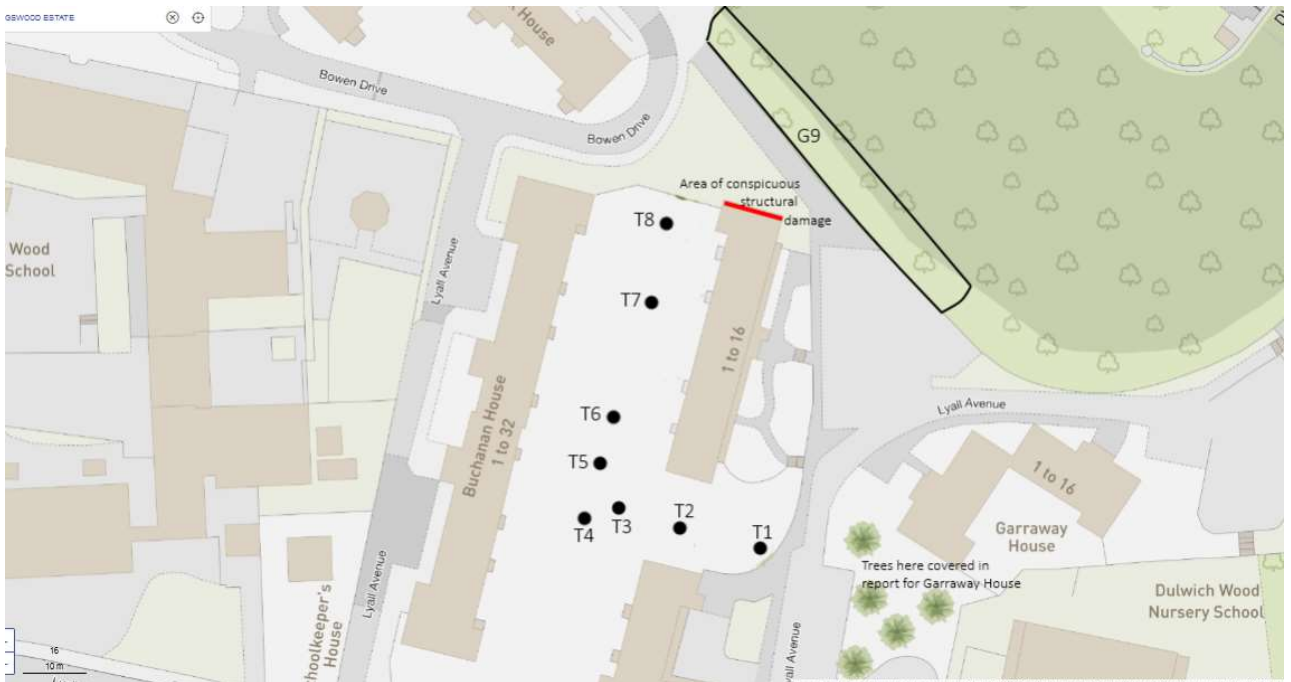
Below can be found the Key Plan with the trees at 30m of Dashwood House and a table with their findings.

T4	Pedunculate oak (<i>Quercus robur</i>)	16	SM	12.5	High	30.00	Medium	Kingswood Estate	<u>Fair</u>	<u>Fair</u>	Moderate / High	65% chance / Prolonged duration	Located within lawn area inbetween Dashwood and Buchanan House. No recent previous management noted
T5	Small-leaved lime (<i>Tilia cordata</i>)	17	SM	10.5	Moderate	20.00	High	Kingswood Estate	Large surface roots present as if ground level has been lowered in the past. Twin-leader (fork at 2m). The fork here is a tight, compression fork - potential point of failure	<u>Good</u>	Moderate	50% chance / Moderate duration	Located within lawn area inbetween Dashwood and Buchanan House. No recent previous management noted
T6	Whitebeam (<i>Sorbus aria</i>)	10	EM	11.0	Moderate	11.00	Medium	Kingswood Estate	<u>Fair</u>	<u>Fair</u>	Very Low	<10% chance / Short duration	Located within lawn area inbetween Dashwood and Buchanan House. No recent previous management noted

T7	Small-leaved lime (<i>Tilia cordata</i>)	18	SM	9.0	Moderate	20.00	High	Kingswood Estate	Large surface roots present as if ground level has been lowered in the past	<u>Good</u>	Moderate	50% chance / Moderate duration	Located within lawn area inbetween Dashwood and Buchanan House. No recent previous management noted

The table below shows the proposed measure for the trees near the building in order to mitigate the subsidence risk if underpinning is not adopted.

1	2	3	4	5	6
Tree	Description	Distance to the building (m)	Measured Height (m)	Recommend Height (m)	Measures
T1	Pedunculate oak (Quercus robur)	14.0	20.0	11.0	<ul style="list-style-type: none"> - Reduce the tree height to the recommended height (column 5). - Periodical maintenance to control that the tree's height does not exceed the recommended height.
T2	Pedunculate oak (Quercus robur)	7.5	20.0	7.0	<ul style="list-style-type: none"> - Reduce the tree height to the recommended height (column 5). - Periodical maintenance to control that the tree's height does not exceed the recommended height.
T3	Pedunculate oak (Quercus robur)	8.5	16.0	8.0	<ul style="list-style-type: none"> - Reduce the tree height to the recommended height (column 5). - Periodical maintenance to control that the tree's height does not exceed the recommended height.
T4	Pedunculate oak (Quercus robur)	12.5	16.0	11.0	<ul style="list-style-type: none"> - Reduce the tree height to the recommended height (column 5). - Periodical maintenance to control that the tree's height does not exceed the recommended height.
