REMEDIATION AND ENABLING WORKS VALIDATION REPORT

Land at Maple Avenue,
Shildon,
DL4 2AG

Report Ref: 22-1155-VAL
Date Issued: November 2023

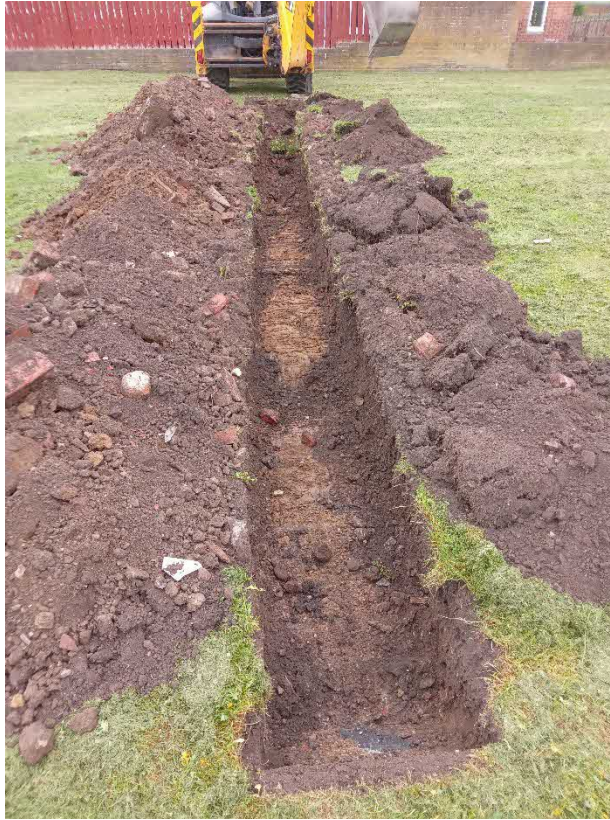
**PLATE 1 – 28.04.22 TRIAL TRENCHING WITHIN AREA OF FORMER PUBLIC HOUSE
TO CONFIRM ABSENCE OF RELIC FOUNDATIONS**

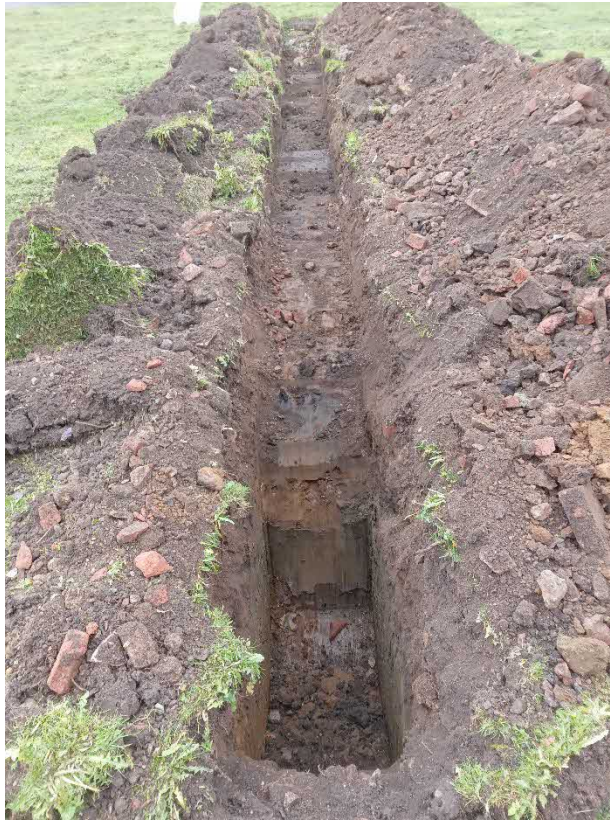
**PLATE 2 – 28.04.22 TRIAL TRENCHING WITHIN AREA OF FORMER PUBLIC HOUSE
TO CONFIRM THE ABSENCE OF RELIC FOUNDATIONS**

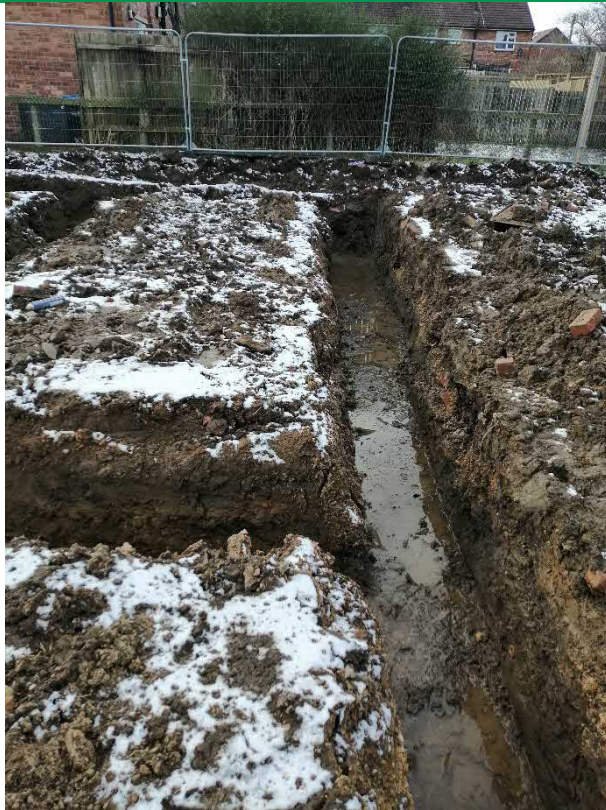
Following completion of the demolition of plots within the western and southern site area ERGO attended site to inspect trial trenches to ensure adequate removal of foundations/obstructions, confirm the nature of in-situ materials and confirm the absence of visual/olfactory evidence of contamination.

No evidence of contamination was identified, and no further analysis was deemed to be required at that point.

PLATE 3 – 19.01.23 INSPECTION OF FOUNDATION TRENCHES WITHIN WESTERN SITE AREA PRIOR TO CONCRETE POUR

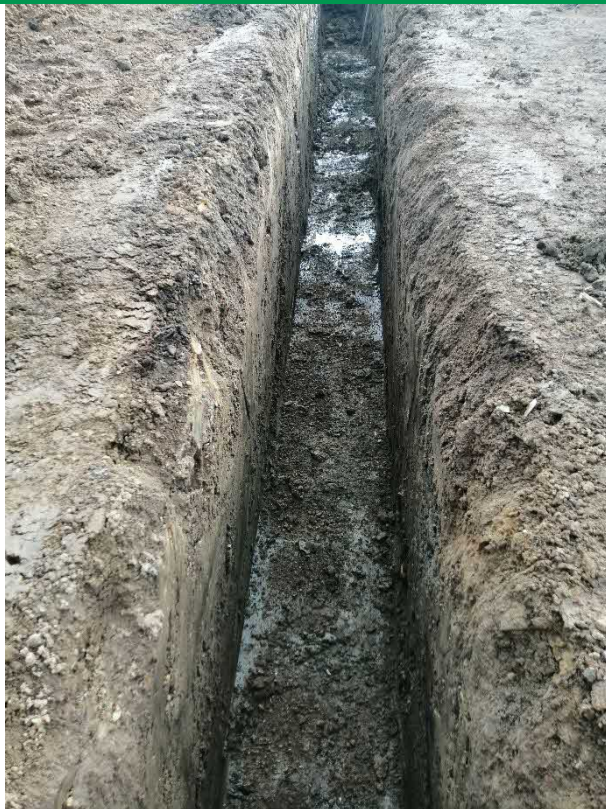
PLATE 4 – 19.01.23 INSPECTION OF FOUNDATION TRENCHES WITHIN WESTERN SITE AREA PRIOR TO CONCRETE POUR

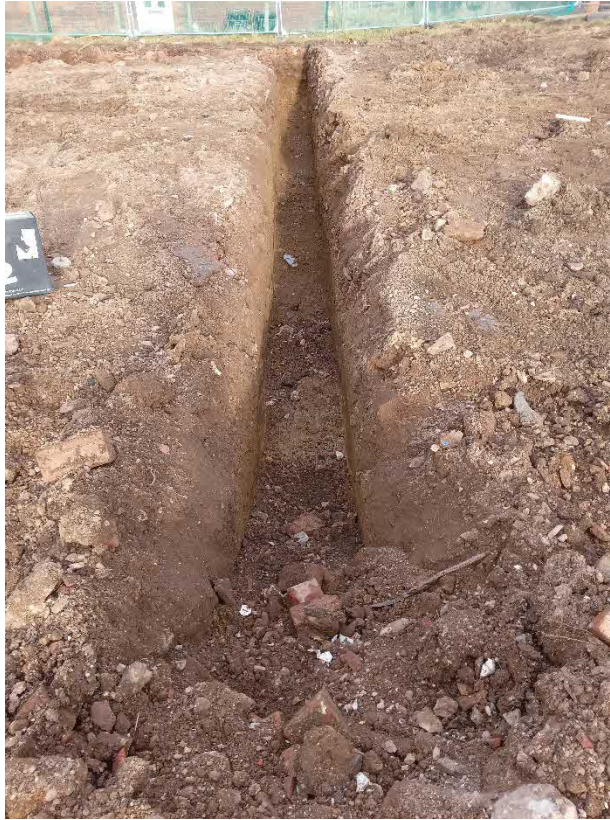
PLATE 5 – 03.02.23 INSPECTION OF TRIAL TRENCHES WITHIN SOUTHERN AREA OF THE SITE

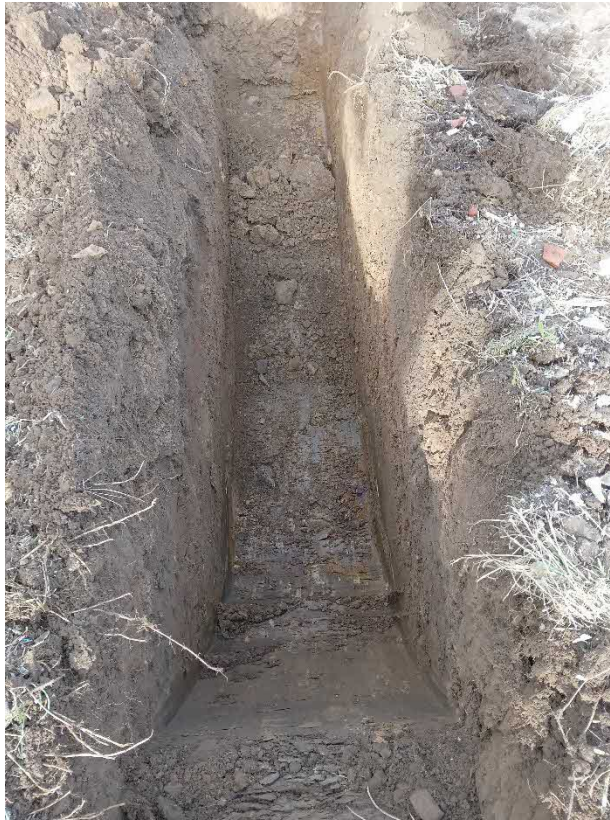
PLATE 6 – 03.02.23 INSPECTION OF TRIAL TRENCHES WITHIN SOUTHERN AREA OF THE SITE

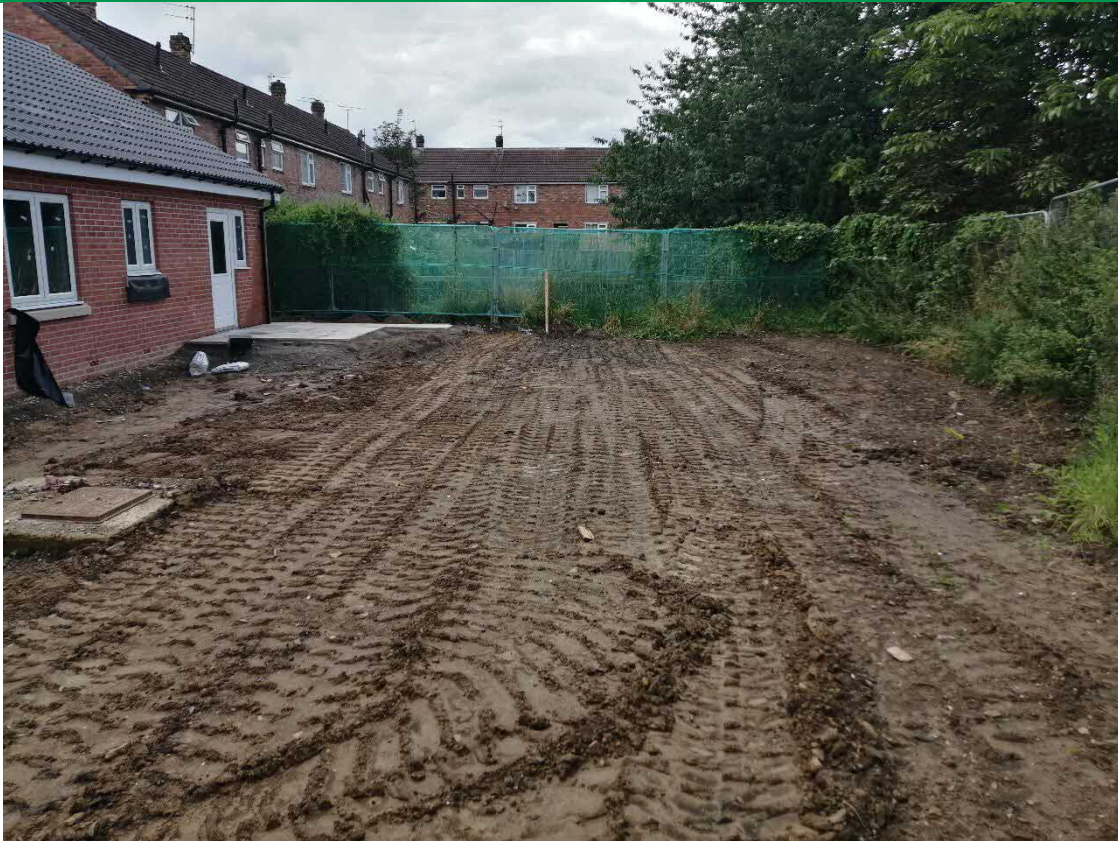
A clean cover system of at least 600mm including a minimum of 150mm of suitable topsoil was required within all plots.

This was confirmed by ERGO on a plot-by-plot basis during the garden validation visits (ref:22-1155-GV1, dated October 2023 and 22-1155-GV2, dated November 2023).

PLATE 7 - 15.08.23 INSPECTION OF REAR GARDENS WITHIN PLOTS 4-5

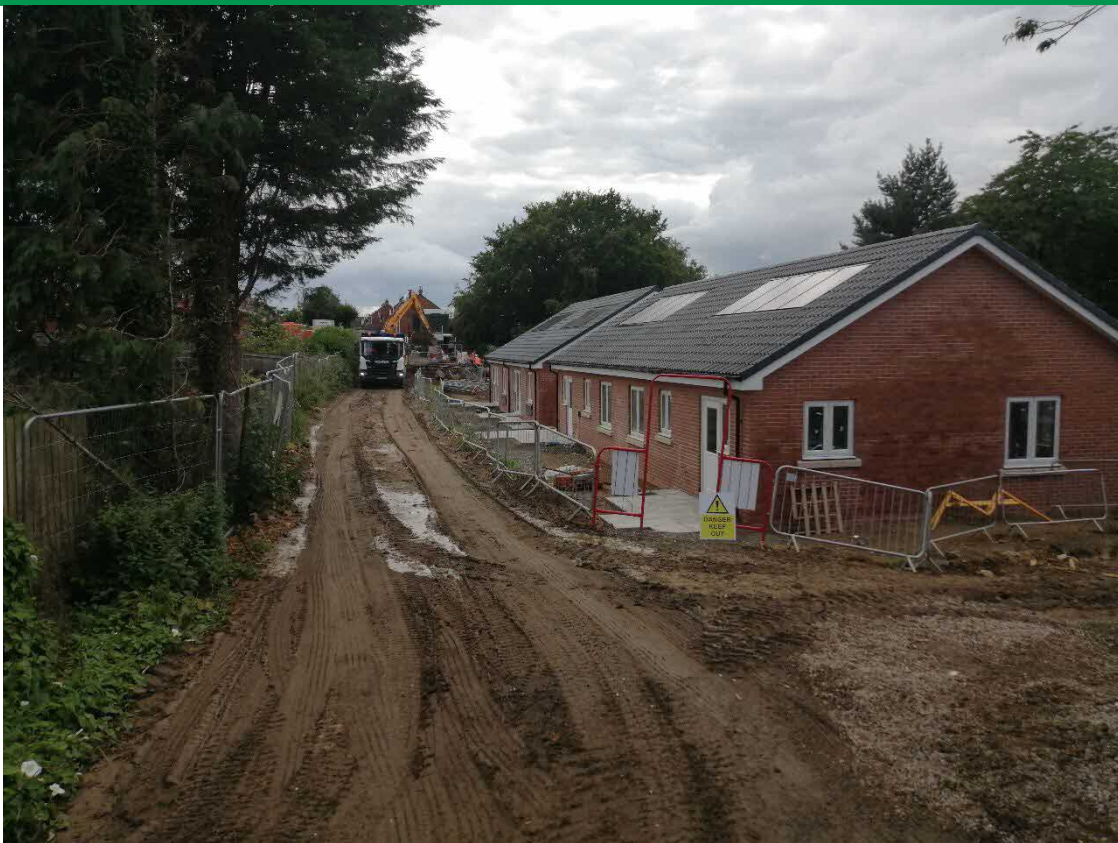
PLATE 8 - 15.08.23 HAUL ROAD TO REAR OF PLOTS 6-9

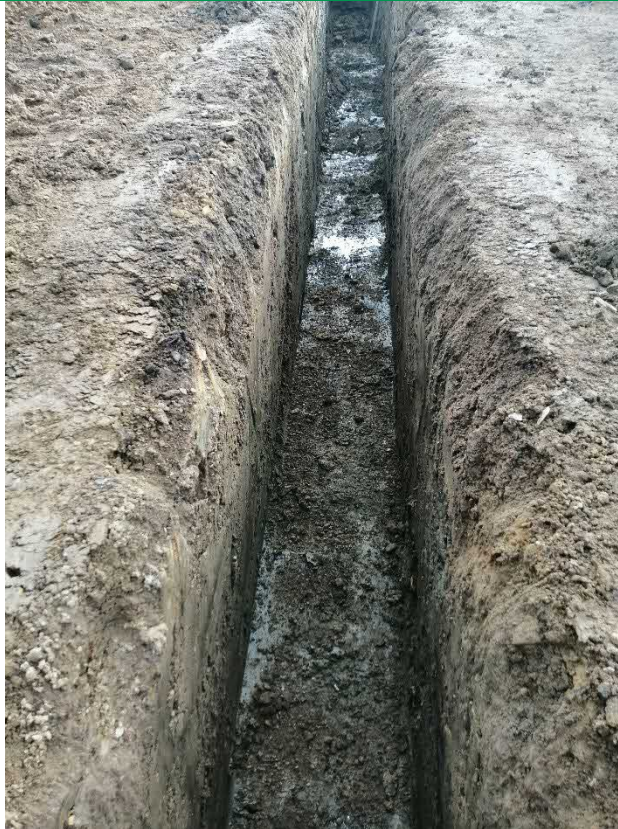
Ground conditions generally comprised a thin veneer of Made Ground noted to be locally deeper where former utilities services were identified overlying a greyish/brown clayey slightly gravelly SAND in turn overlying a firm to stiff greyish brown sandy gravelly CLAY. Localised materials encountered were noted to be water softened. No visual/olfactory evidence of contamination was identified.

Based on the encountered ground conditions within the advanced locations, inspection of the foundation excavations and foundation arisings and an inspection of the cut surface, ERGO consider there to be no evidence of unforeseen contamination within the footprint of the former onsite structures inspected.

PLATE 1 – SHOWING FOUNDTION EXCAVATION IN CENTRAL SITE AREA

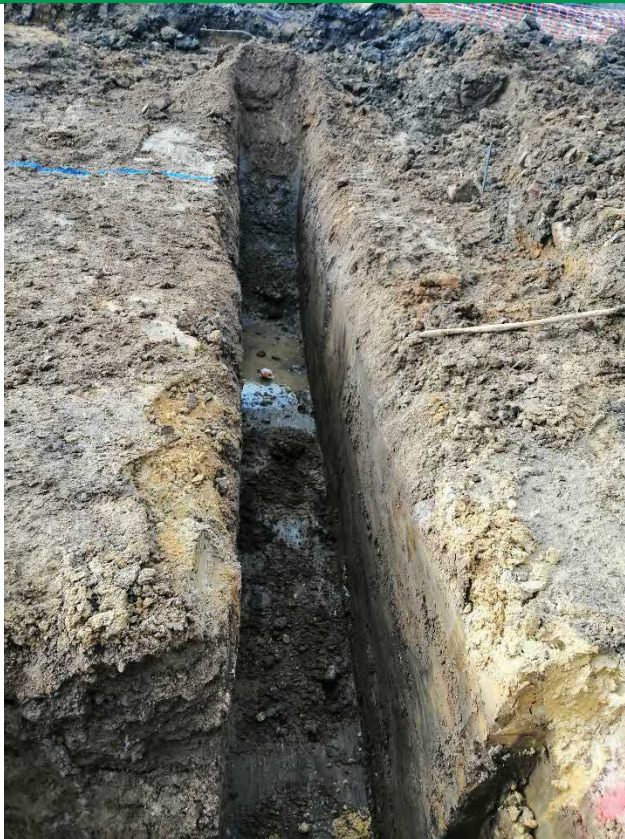
PLATE 2 – SHOWING FOUNDTION EXCAVATION IN CENTRAL SITE AREA
