## Tree Condition Assessment Prepared for

The Treehouse  
73a Glenholt Road  
Plymouth  
Devon  
PL6 7JD

Client:	Louise Marsh	Ref:	AK/548/200923
Location:	The Treehouse 73a Glenholt Road Plymouth Devon PL6 7JD		
Date of site Inspections:	29 <sup>th</sup> August 2023		
Survey Inspector(s):	Aran Kimberlee BSc (Hons) Arboriculture M Arbor A, PTI.		
Report Author:	Aran Kimberlee BSc (Hons) Arboriculture M Arbor A, PTI.		
Signature:	 	Date:	20 <sup>th</sup> September 2023

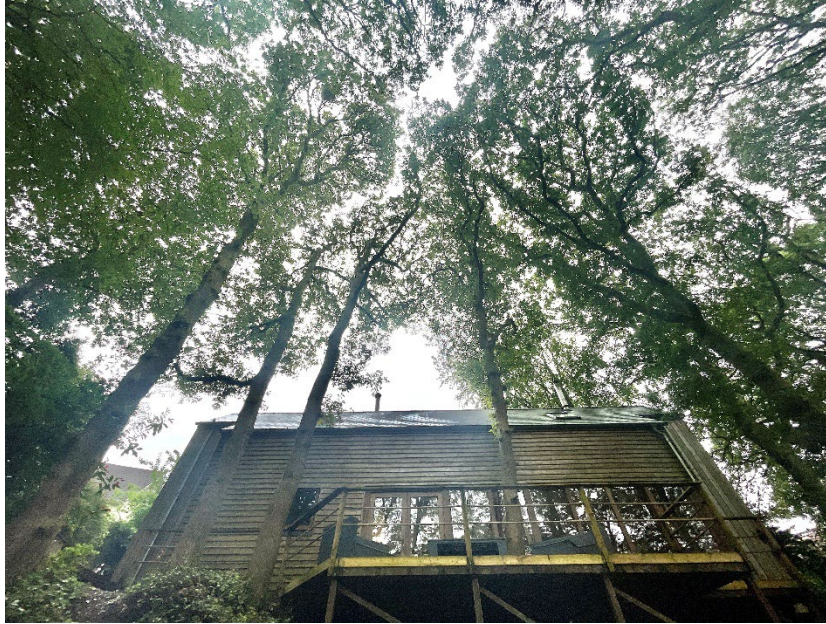
Photograph 1: Trees growing around and incorporated in house design.

- 4.1.2 The trees which are directly overhanging The Treehouse have been previously cut back to prevent overshadowing and branches encroaching on the property. I recommend this to be continued every 3-5 years.
- 4.2 T1440 is a large beech tree growing in the south-western corner of the woodland. The main trunk of the tree bifurcates at approximately 4 metres from ground level and there is a significantly included union between the two primary stems.

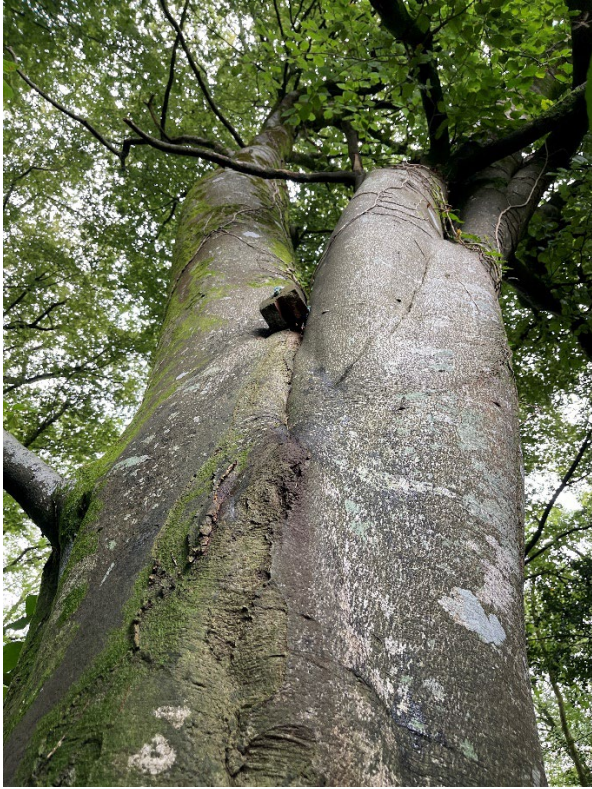
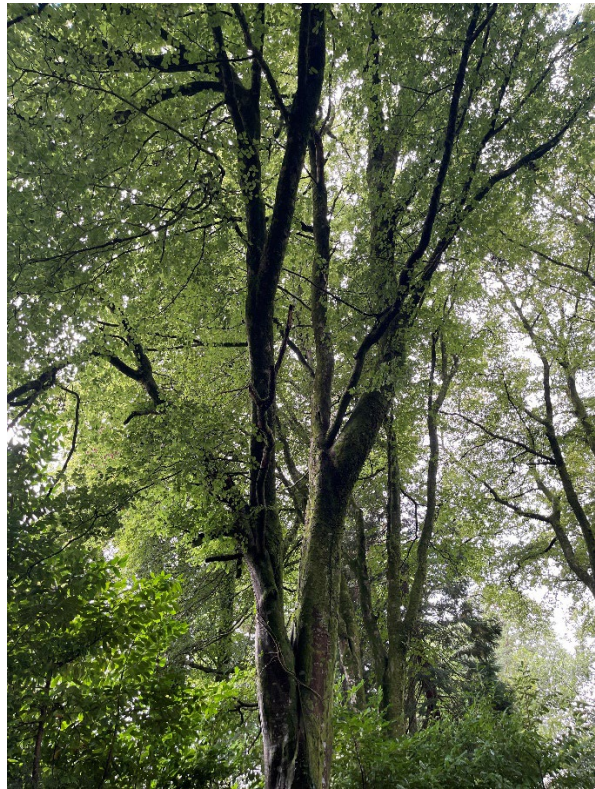
Included unions or bark inclusions can form where stems or branches growing in close contact to one another can form inherently weak unions to a main trunk or subsidiary stems. This is where the union of the two stems or branches do not unite with one another, and the presence of the stem bark ridge rolls inward and creates bark to bark contact. As the two members grow, load stress (usually from wind and weight) creates pressure between the two stems and the tree produces adaptive growth to compensate for the weak union. This can be observed as an increased formation of wood on either side of the union and is commonly known as a compression fork. The increasing stimulus of growth around the union, the presence of 'pursed lips', cracking and / or watermarking on the main trunk can indicate that a stem or branch is poorly attached and could be represent a high risk of failure.

Photographs 2 and 3: T1440 beech with included unions.

5.8 The risk of harm from T1440, T1441 and T1444 has been calculated within the Tolerable threshold (Where imposed on others) Risks are tolerable if as low as reasonably possible (ALARP). At this risk level the owners of the tree should consider the costs required against the benefits of risk control.

I believe that the sub-dominant stem growing to the east and towards the cabin has the highest risk of failure and therefore, I recommend reducing this stem via thinning by removing 3-4 dominant stems approximately 4 metres. In addition I recommend installing a flexible (4ton) cable bracing system between three stems in a triangular formation at approximately 12-14 metres in height from ground level.

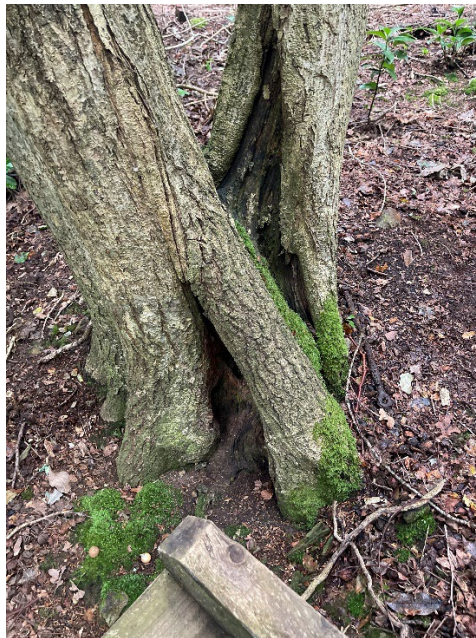
- 4.3 T1441 is a small twin stemmed oak tree which leans heavily towards the footpath and track which leads to Glenholt Campsite. The tree has significant basal decay on both stems and has a high risk of failure. I recommend removing both stems or reducing to a deadwood monolith.

Photograph 4: T1442 oak with decay and twin stems leaning over track.

T1441	Oak	<ul style="list-style-type: none"> <li>Twin stemmed tree leaning over track and footpath with significant decay at base.</li> </ul>	<ul style="list-style-type: none"> <li>Fell or monolith at approx. 6 metres in height.</li> </ul>	<b>Medium - Works recommended within 6 months</b>
T1442	Oak	<ul style="list-style-type: none"> <li>Small dead tree near cabin.</li> </ul>	<ul style="list-style-type: none"> <li>Reduce to deadwood monolith at approx. 7-8 m</li> </ul>	<b>Low – Works to be carried out within 12 months</b>
T1443	Oak	<ul style="list-style-type: none"> <li>Large oak in woodland with large broken hanging branch in crown on eastern aspect.</li> <li>Low risk of harm</li> </ul>	<ul style="list-style-type: none"> <li>Remove broken hanging branch or retain for habitat feature considering risk level.</li> </ul>	<b>Low – Works to be carried out within 12 months</b>
T1444	Beech	<ul style="list-style-type: none"> <li>Main trunk bifurcation at approx, 4 m with included union and cracking/ bark movement at union.</li> <li>Cavities partially occluded on western aspect of main trunk with decay.</li> <li>Decay appears to extend up through main trunk to weakened fork.</li> </ul>	<ul style="list-style-type: none"> <li>Install 6-8 ton steel cable brace, using stainless steel bolts and cables at 3-5 metres above union between two main stems.</li> </ul>	<b>Medium - Works recommended within 6 months</b>

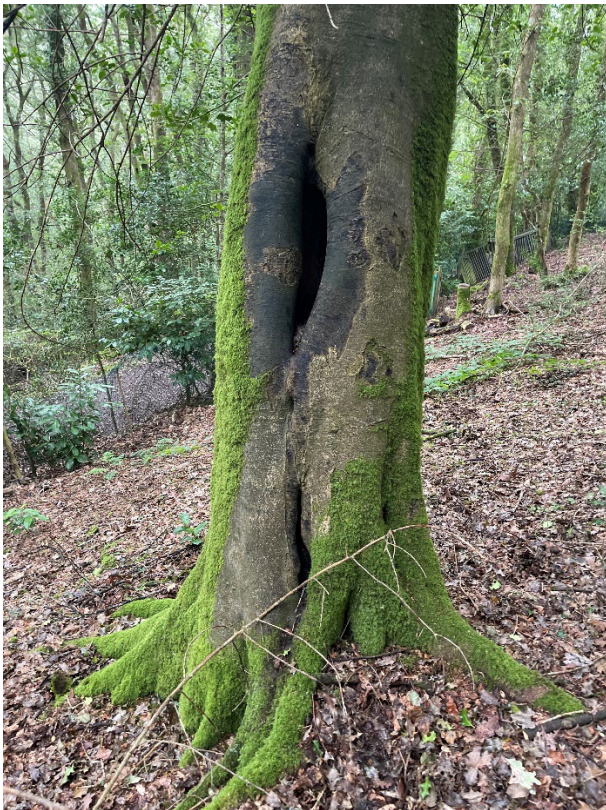
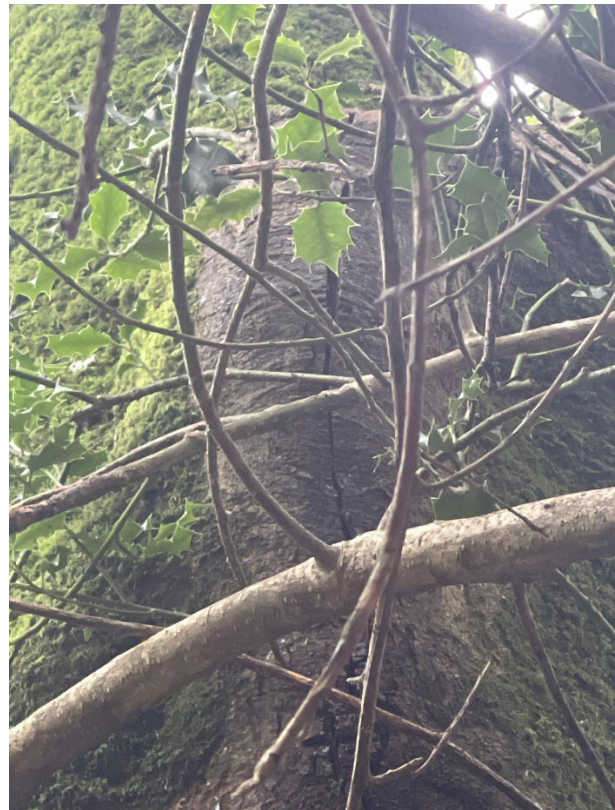
- 4.5 Another large beech is located further down the slope in the woodland towards the northern boundary. T1444 has a large, decayed cavity on the western aspect of the main trunk from 1 -2 metres in height. Reactive wood has partially closed the damaged area, but it is likely that the decay extends further up the main trunk close to the main union. The main trunk bifurcates at approximately 4 meters above ground level with a significantly included union between both stems. The union appears to be cracking and has large 'ear' formations on both sides of the union. Therefore, I recommend a stainless-steel cable brace be installed (6-8 ton) using static steel cables and eye bolts at appropriately 3-5 metres above the included union.

Photographs 5 and 6: T1444 beech tree with cavities and cracking union.
