# Tree Management Report

**Littlewood, Ballater Road, Aboyne  
Aberdeenshire AB34 5HY**

November 2023

Julian Barclay Ltd.,  
8, Parkhouse Close,  
Tarland,  
Aberdeenshire  
AB34 4UZ

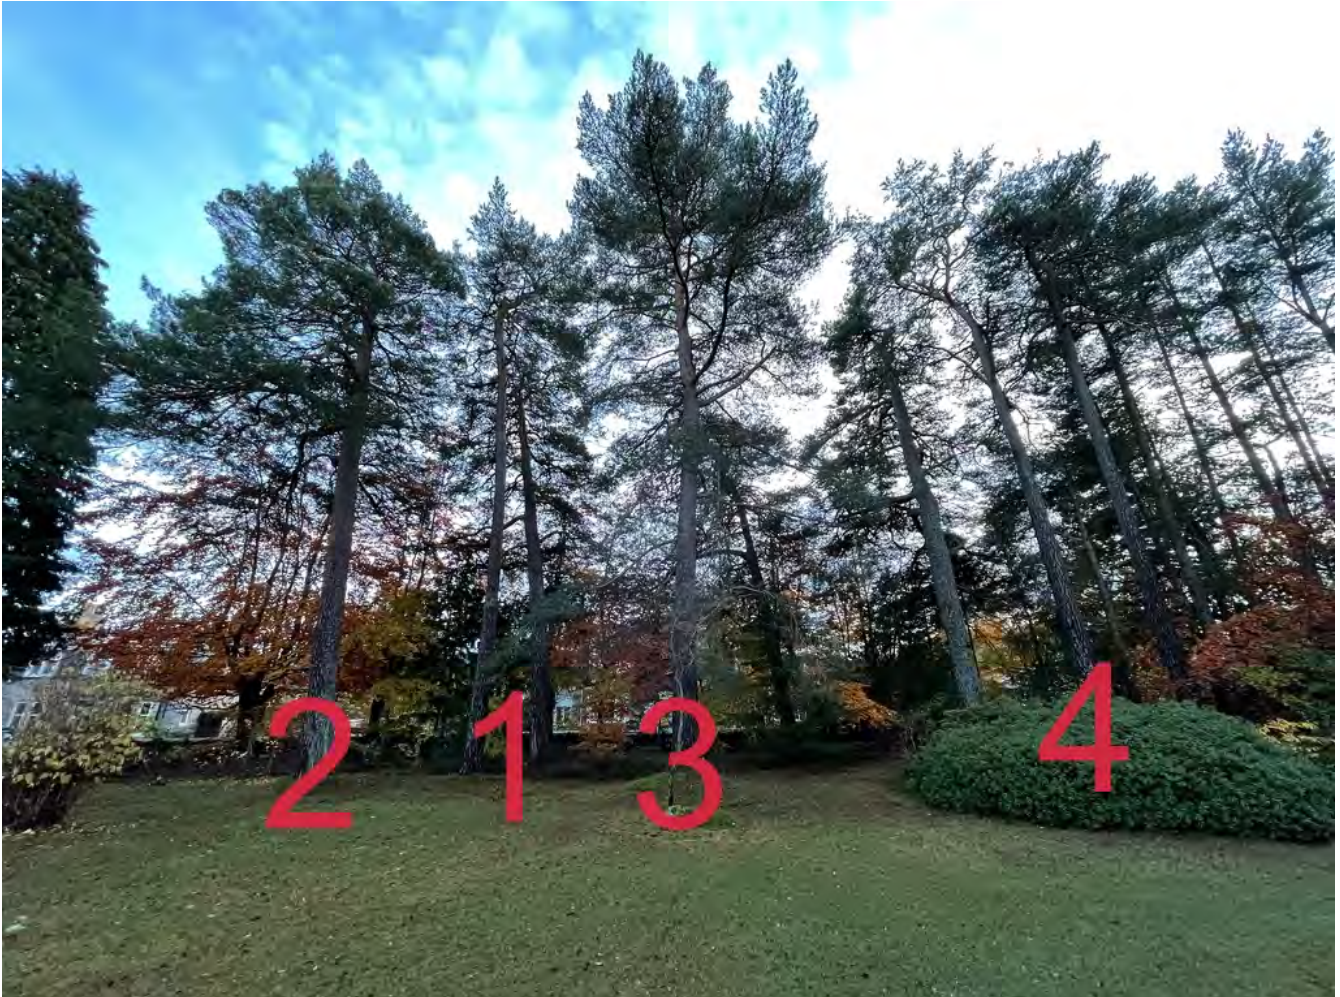
It is therefore recommended that 5 of the trees located on the South (front) boundary are removed completely to stump level to eradicate the risk of falling or collapse. These trees are identified as being poor specimens in terms of aesthetics (with growth only in the upper canopy), and one tree in particular (tree 1 – see photographs later) that has a substantial lean over the A93 trunk road. Their removal will also enable the owners to replant with more aesthetical varieties of broad-leaved trees being a more natural and uniform fit with other properties in the immediate area. There is a well-established mixed species hedge (mainly consisting of Beech and Cypress) that has suffered due to the shading caused by all the trees along this boundary and opening up the canopy can only be beneficial to the hedge. Indeed, the selective removal of the 5 trees will also enable the remaining Scots Pines to flourish and encourage new growth from the previously shaded parts of each tree.

**Photograph 1** – Southern boundary of front garden bordering Ballater Road. Photograph taken from the front of the house looking South. This photograph clearly shows the size of the trees in terms of width and height.

Reduce the height of the spindly Scots Pine trees in the front left-hand corner of the property to reshape and encourage growth lower down the trees' overall heights. The structurally larger Scots Pines in the front garden (numbers 2 & 3 – see photographs) are recommended to be reduced by 15-20% to reduce the weight of the canopy giving the trees greater stability as well as opening up the canopy for enhanced light penetration to the house and front garden beneath. The work will be undertaken with the sympathy of the trees as utmost importance given that they really are the only two trees in the front garden with any aesthetical value. Both of these trees have abundant lower growth meaning that reduction work is possible to the benefit of the trees in their setting.

### **Recommendations from photograph 1:**

**Trees 1:** Remove both trees. Significant lean over A93, poor canopy in neighbouring tree.

**Tree 2:** 15% Crown reduction

**Tree 3:** 15-20% Crown Reduction

**Tree 4:** Remove – damaged crown, no lower growth.

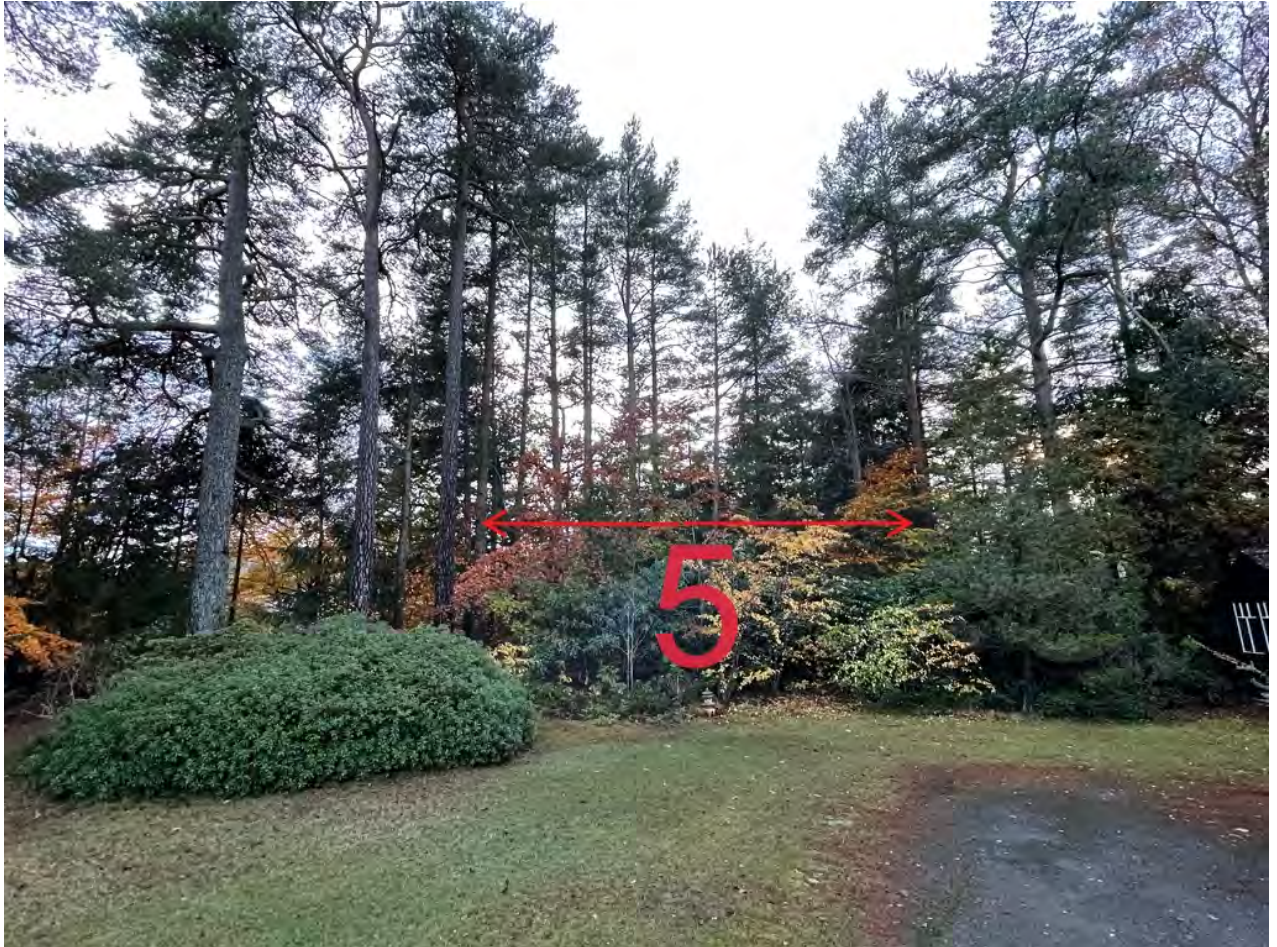
**Photograph 2** – South-East corner of front garden. Photograph taken from the front of the house looking South-East. This photograph shows the thin, spindly growth nature of the trees.

**Recommendations from photograph 2 (treat as a whole - 5):**

- Remove the 2 x tallest, spindly trees from this area.
- Selectively reduce and reshape the remaining trees.

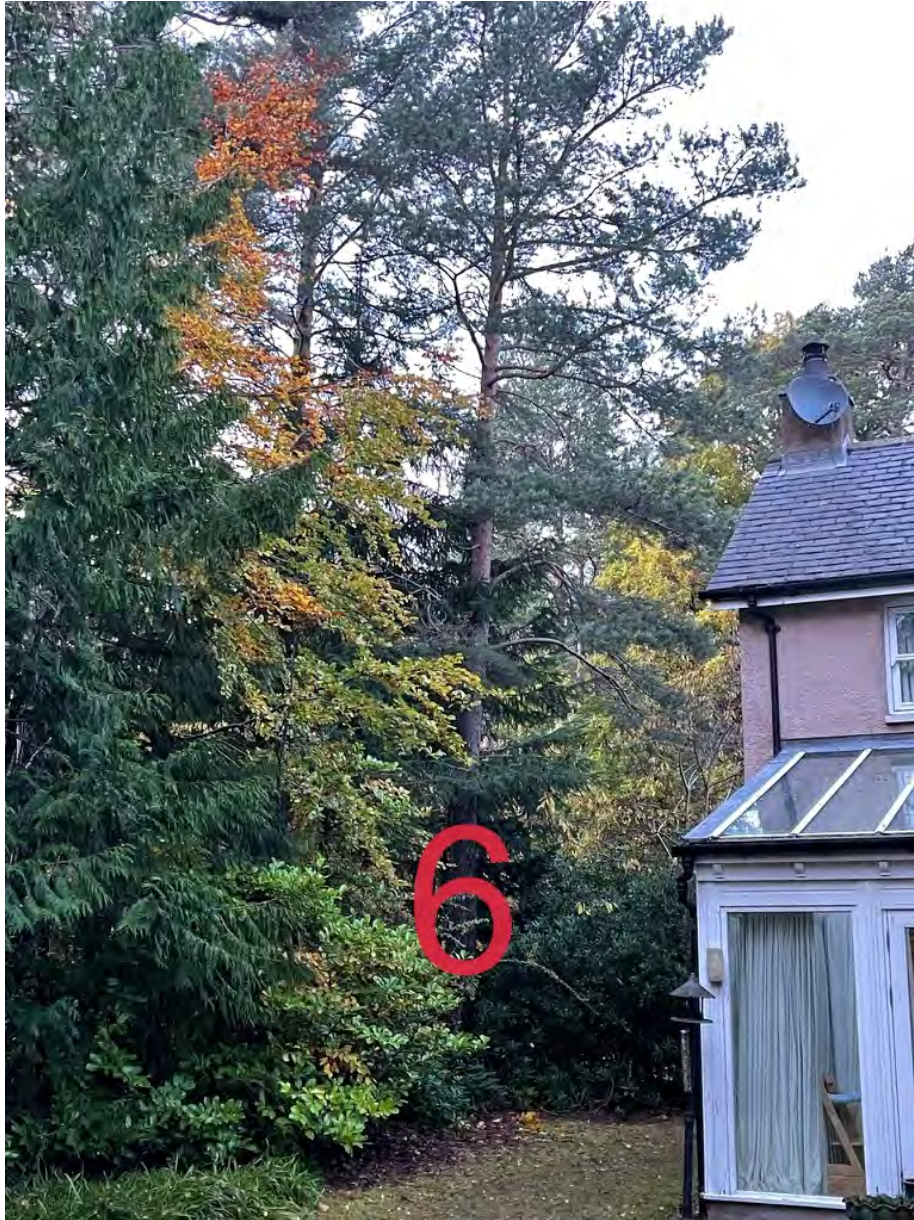
On the Eastern side boundary of the property exists a tall (35m) Scots Pine that dominates the house due to its proximity. Considering the trees' location within a densely planted area of the garden in terms of other trees and large shrubs, the tree has no aesthetical or wildlife value of any importance. Its removal is therefore recommended to encourage more light penetration and remove current adverse effects to the house.

**Photograph 3** – Showing the close proximity of the Scots Pine tree on the Eastern aspect to the house. Note the dominance of moss rather than grass lawn in this area and dampness to the roof of the conservatory and house.

**Recommendations from photograph 3:**

- Remove this tree (6).

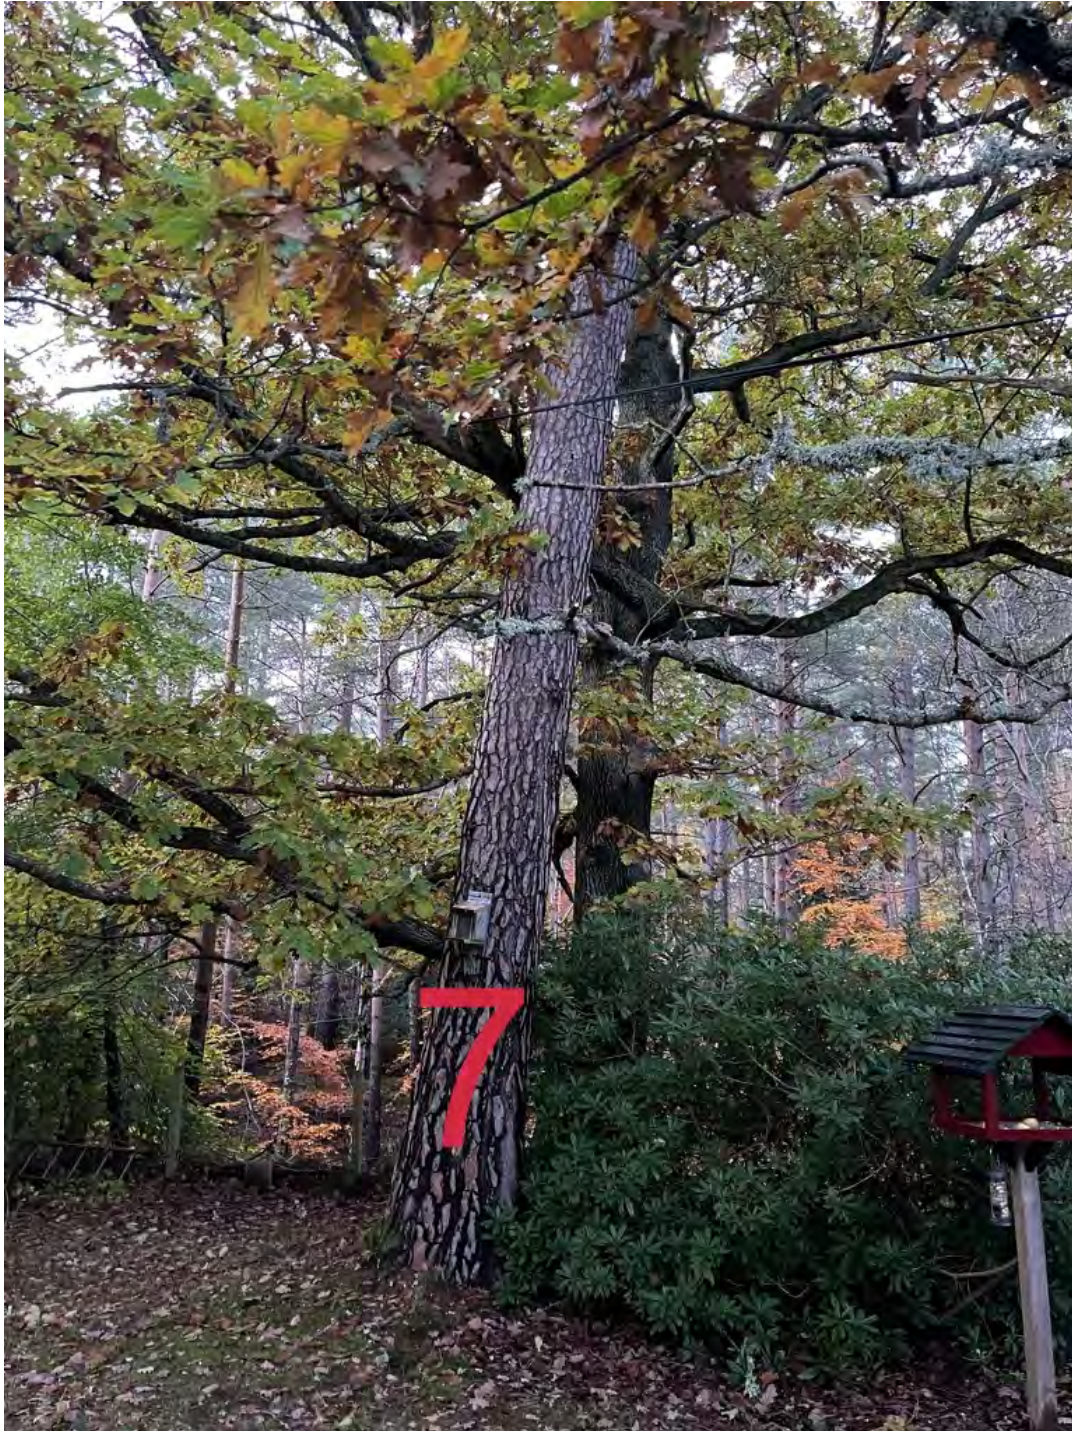
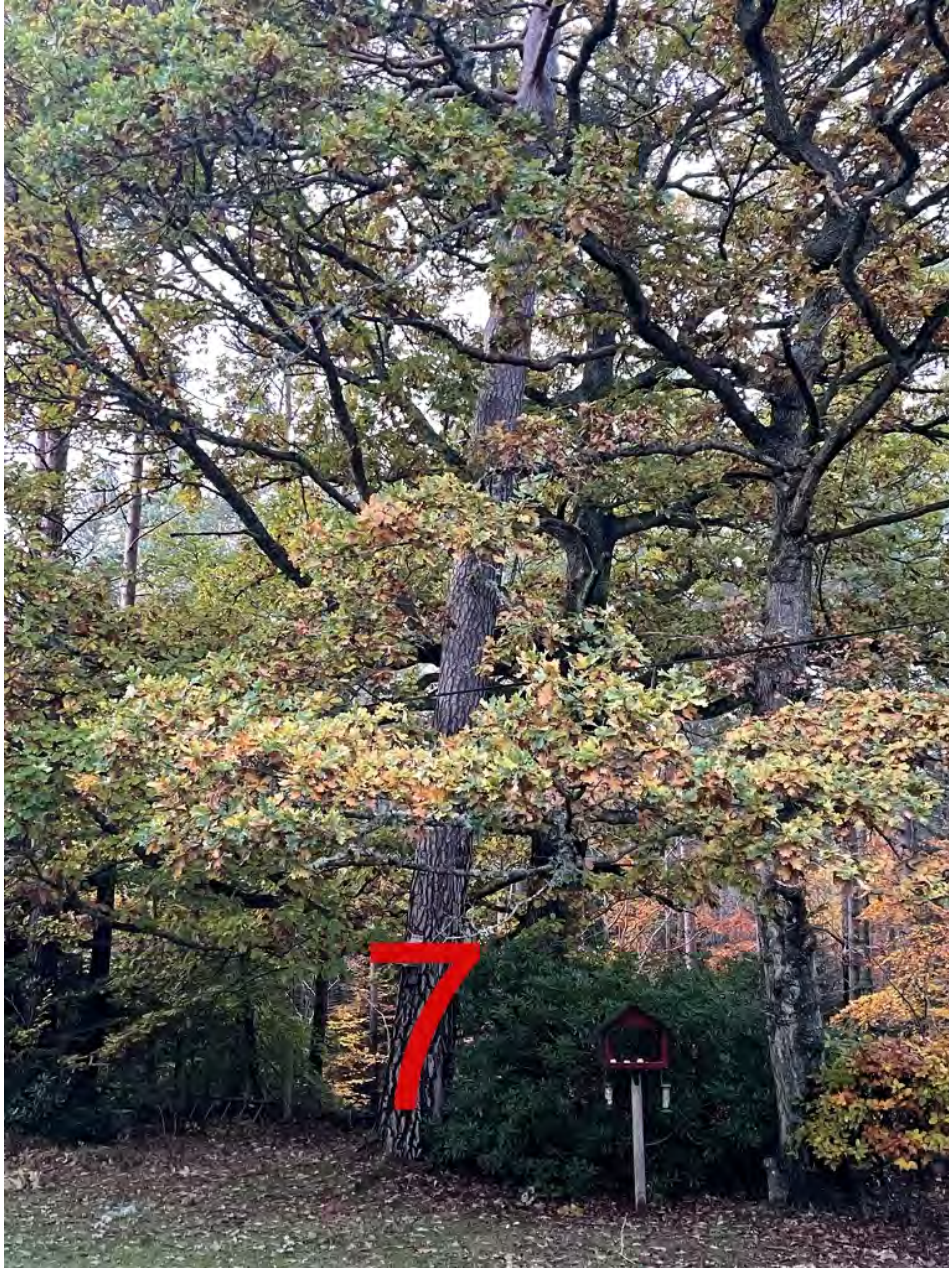
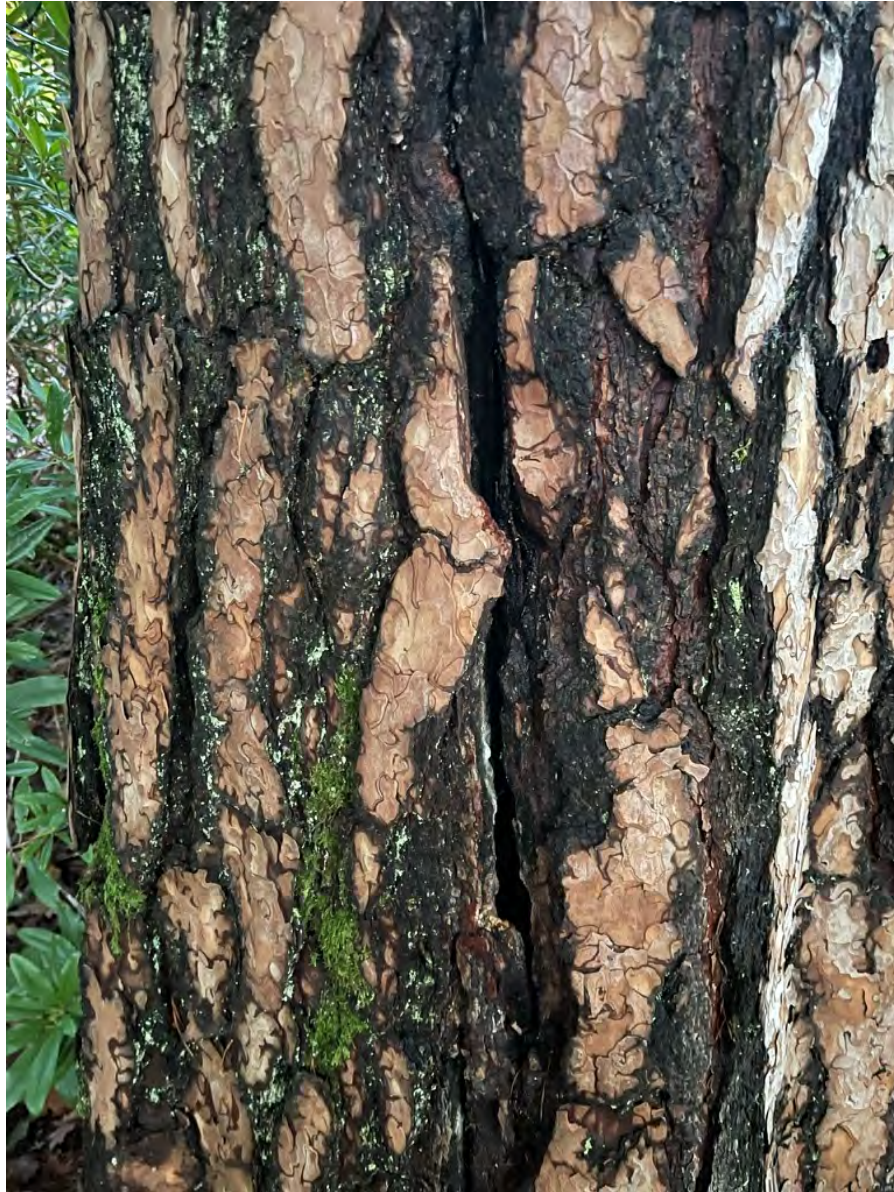
To the rear of the garden (North aspect) exists a very tall and large Scots Pine (tree 7 – see photographs later). The tree is within very close proximity of the electricity overhead cables that run directly beneath the canopy of the tree. Coupled to this problem the tree also obstructs the view from the house of the large and dominant Oak tree, through which the Scots Pine is growing and damaging the development of the Oak tree's crown. Further investigation of the tree also revealed a large crack in the trunk approximately 1m from ground level. Using a measuring and flexible lighting probe it was noticed that rot is evident within the structural wood, extending to  $\frac{3}{4}$  width of the tree trunk. The tree is leaning towards the Deeside Way public footpath quite severely. Should it fail, it would only be the Oak tree that would prevent a potentially serious accident from occurring, and in any case would severely damage the Oak. This Scots Pine has exceeded any beneficial value to the environment in which it is located, in fact that opposite is true. Given the damage to the lower trunk and subsequent internal rotting, this tree is recommended for immediate removal as a matter of urgency.

**Photo 4 (a)** - Showing the large, tall Scots Pine tree located in the rear garden (North aspect). Note the location of the main power lines and the damage being caused to the Oak Tree.

**Photograph 4 (b):** As photograph 4 (a) but zoomed out to show upper canopy.

**Photograph 4 (c):** Showing the large crack at 1m above ground level at the base of the trunk.

**Recommendations from photographs 4 (a), 4 (b) and 4 (c):**

- Immediate and urgent removal of this tree (7).
