CONDITION SURVEY AND DESIGN STATEMENT

ALTERATIONS & EXTENSION TO B LISTED HOUSE

23 Market Street,
St Andrews KY16 9NS

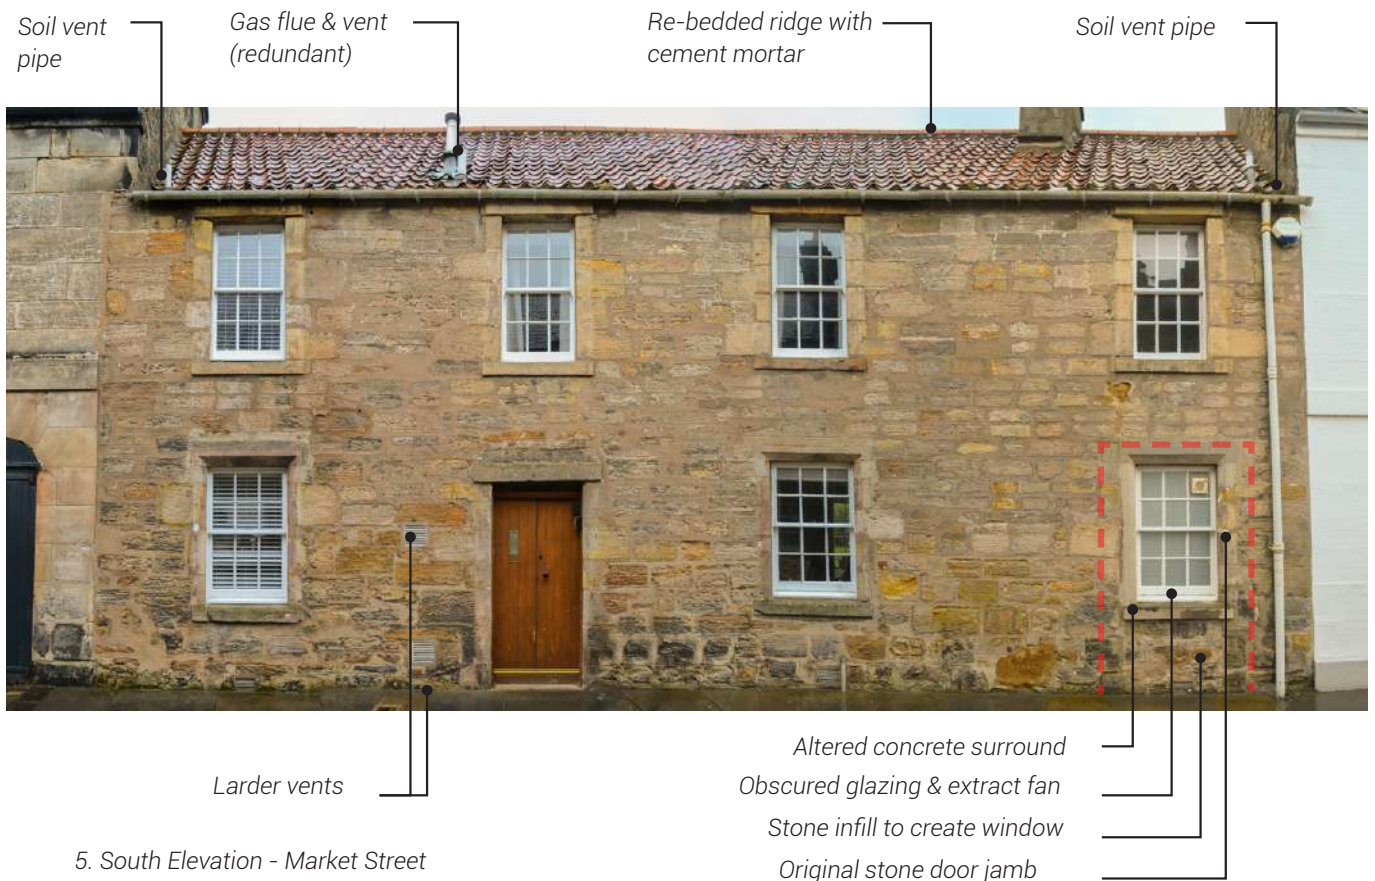
The diverse alterations observed on the southern elevation are noted on the diagram below:

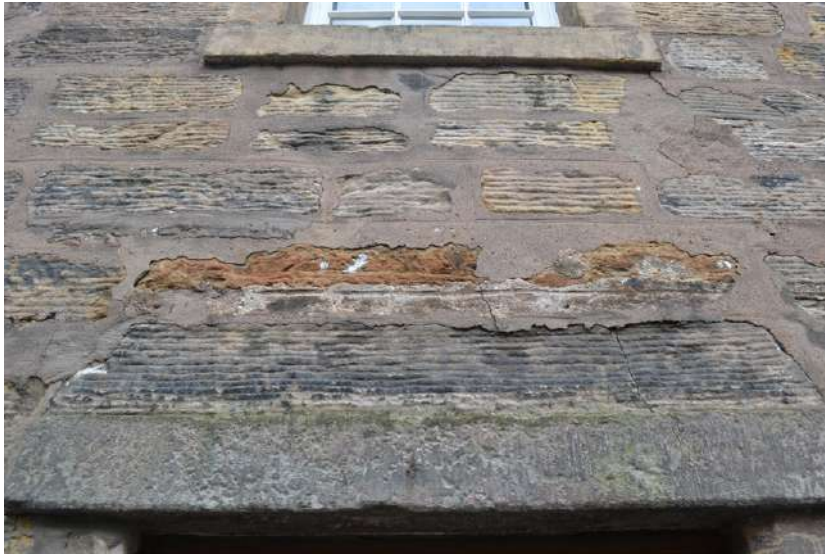
The street elevation of 23 Market Street presents a traditional coursed, parallel punched sandstone, traditional for the time of construction. However, insensitive cement mortar pointing carried out at a later stage has altered the quality of the elevation and partially hides the coursing in places.

6. Cement mortar pointing on south elevation

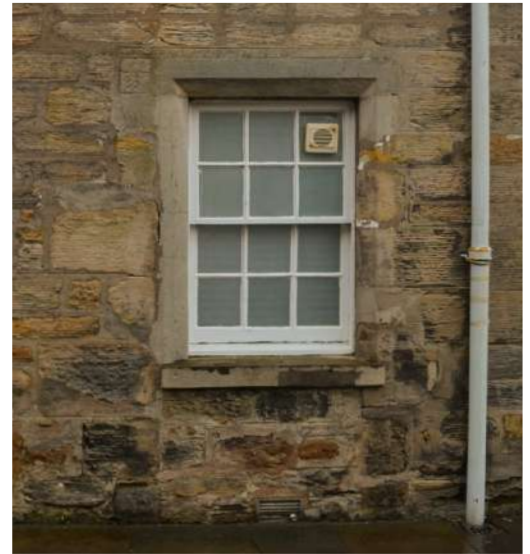
All windows are traditional sash and case timber, 12 panes with traditional astragal profile, painted white. The front door and most windows present traditional sandstone quoin stones, cast stone lintels, cills and surrounds with traces of residual paint. However the ground floor windows present signs of alterations to the surround stones. The left jamb stone of the right hand side window particularly has been replaced by cast concrete which clashes with the other windows. A stone infill can be clearly identified under the window cill, indicating the location of a former door, later replaced by a window. Additionally, this window has been altered with obscured glazing and an extract fan when an en-suite was created on the ground floor.

7. Bottom right window with altered concrete jamb, stone infill, obscured glazing & fan, detail

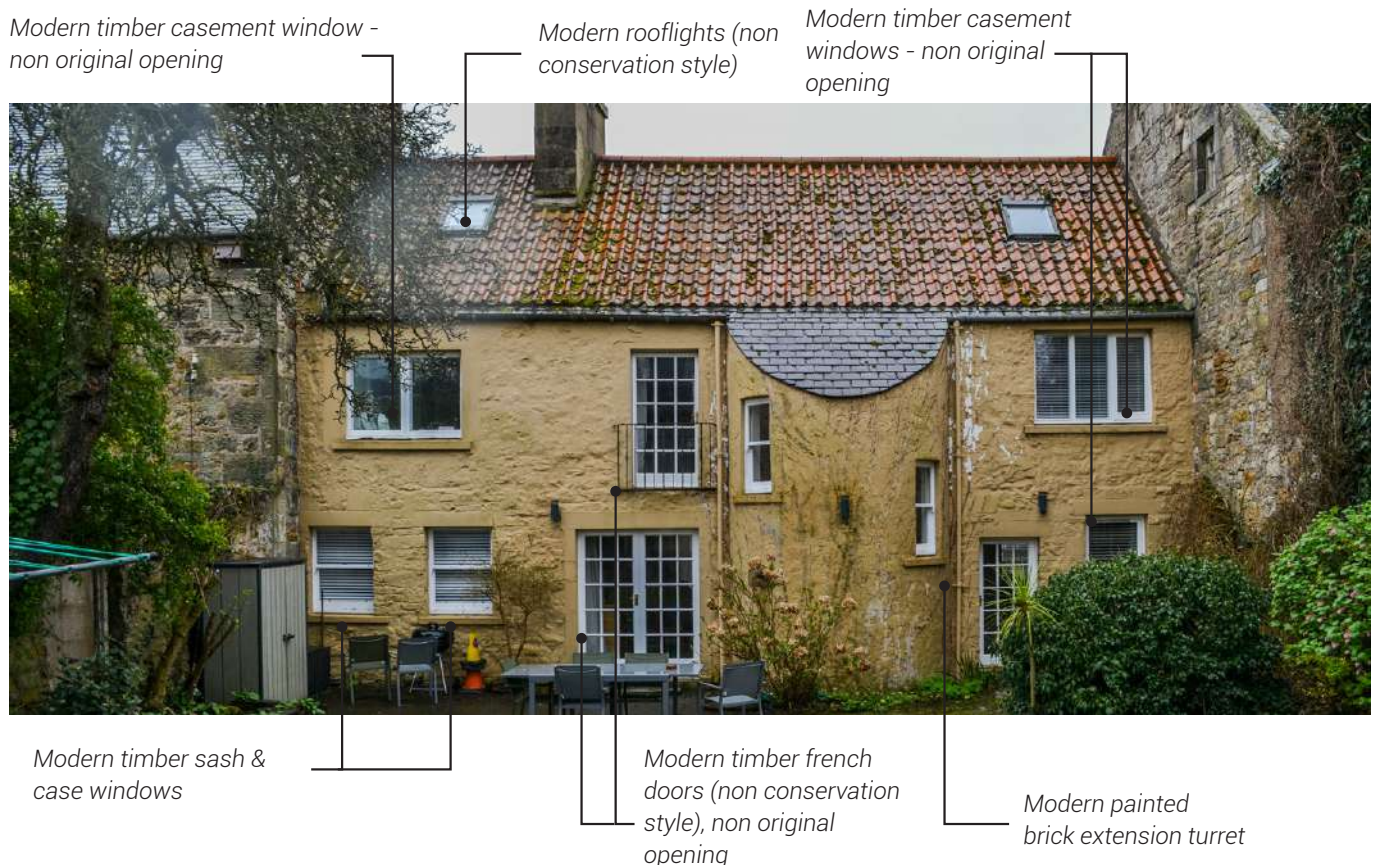
The roof covering however is similar to the southern elevation, consisting of clay pantiles with slated easing course and mortar bedding. On this side the roof presents more moss and vegetation growth which might have impaired the quality of the tiles and will require closer inspection.

8. North Elevation - Garden - Observed alterations

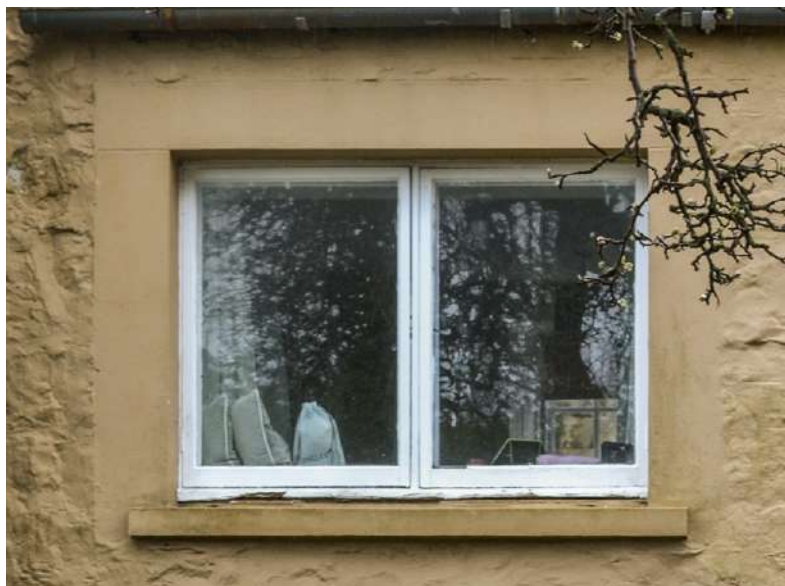
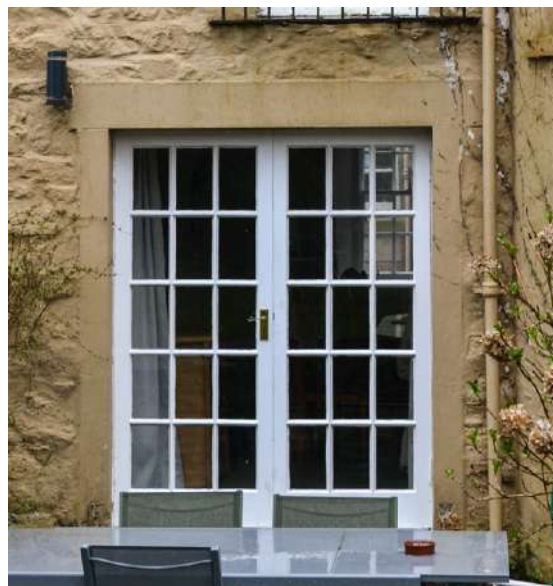
The windows on this elevation are all resulting from the successive alterations to the house, larger in size than traditional windows and of modern proportions, likely dating from the 70s onward. They most likely result from creating larger or new openings in the elevation as their proportions and detailing are not traditional. Although timber framed, their opening systems also reflect their modern nature. They all present painted concrete lintels, cills and surrounds. Additionally two modern rooflights are clear alterations to the roof but with no recorded permission.

9. Modern timber casement window and french doors with concrete lintel, cill and surrounds

To the north elevation, the non original opening and modern windows of the bedroom are proposed to be replaced with more traditionally proportioned ones to restore the elevation to a more original appearance. The current openings are modern alterations with concrete lintels and jambs, and poor quality brick infill in the stone work. Introducing traditional windows will enhance the north elevation's authenticity and aesthetic appeal by replacing modern, unsightly features with historically fitting elements.

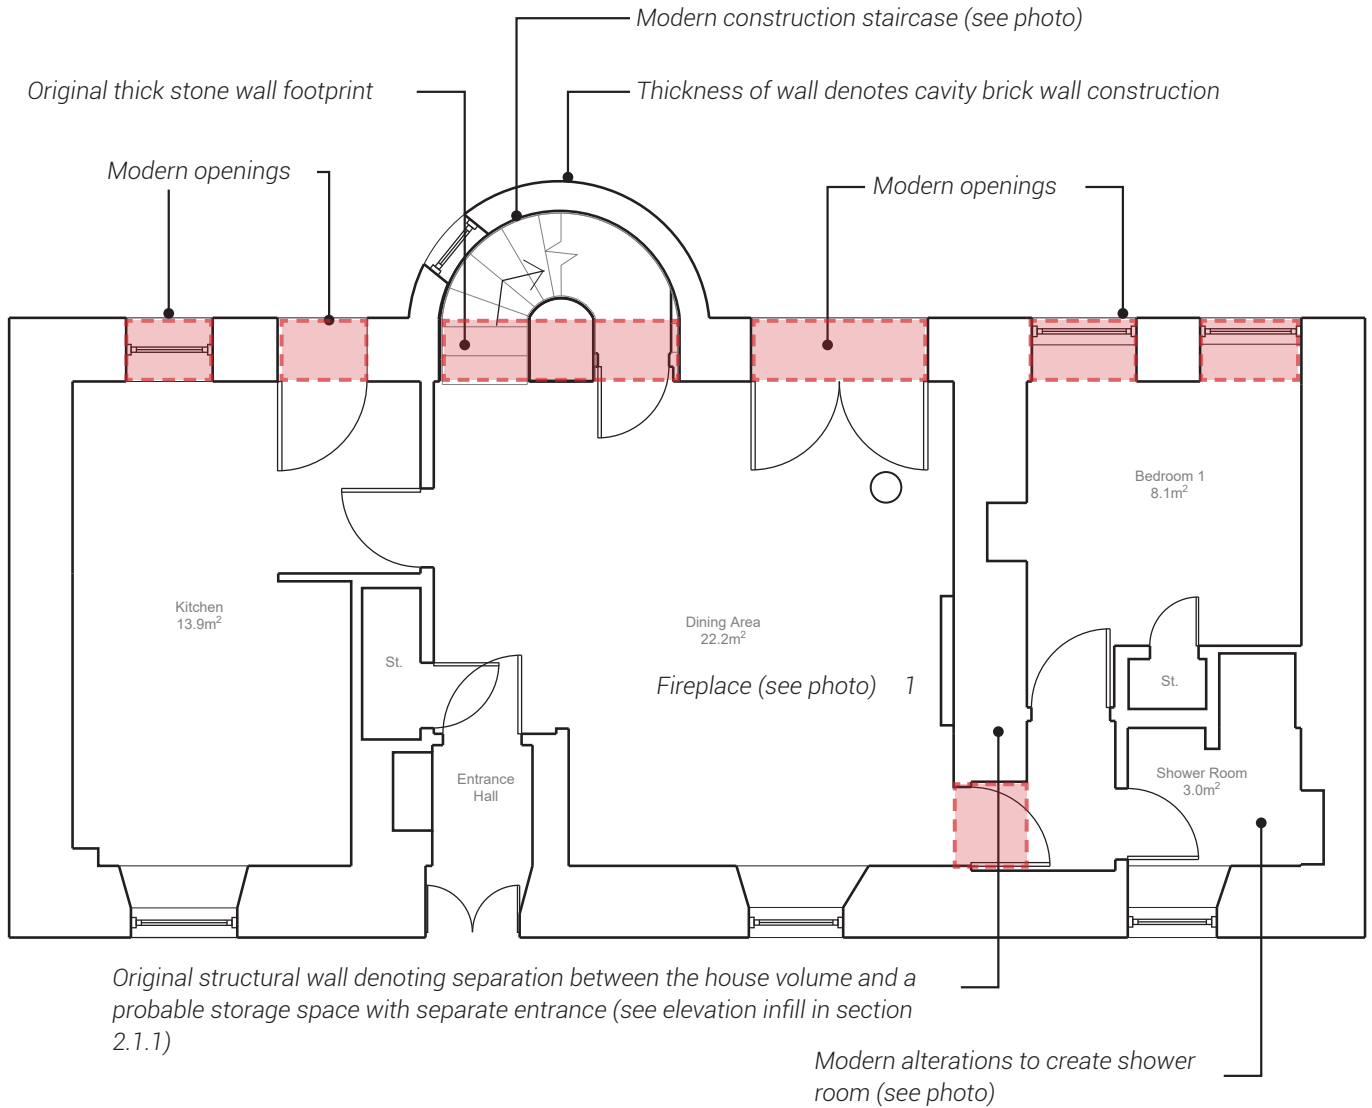
14. Existing Ground Floor Plan & Observed Alterations

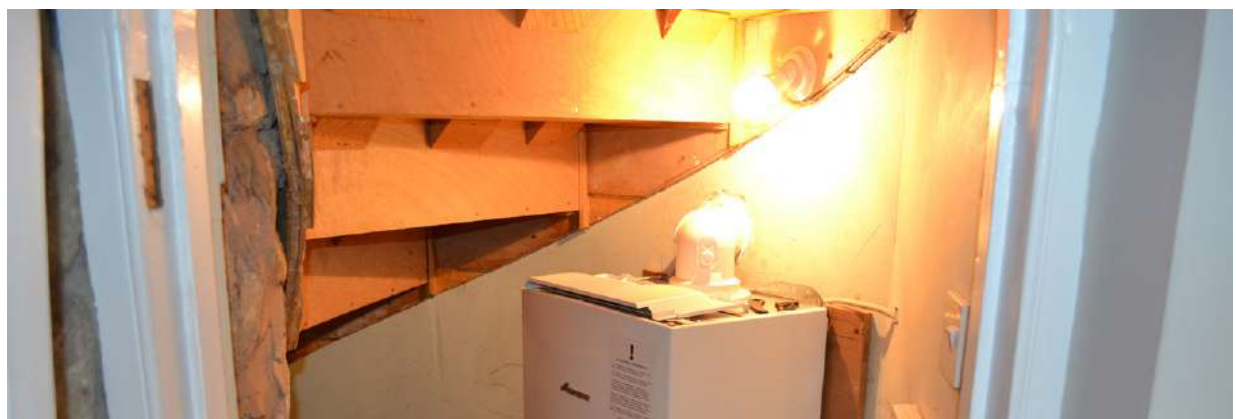
The half round staircase leading to the first floor is a modern plywood construction as shown on the photo below.

19. Underneath of staircase - modern plywood construction

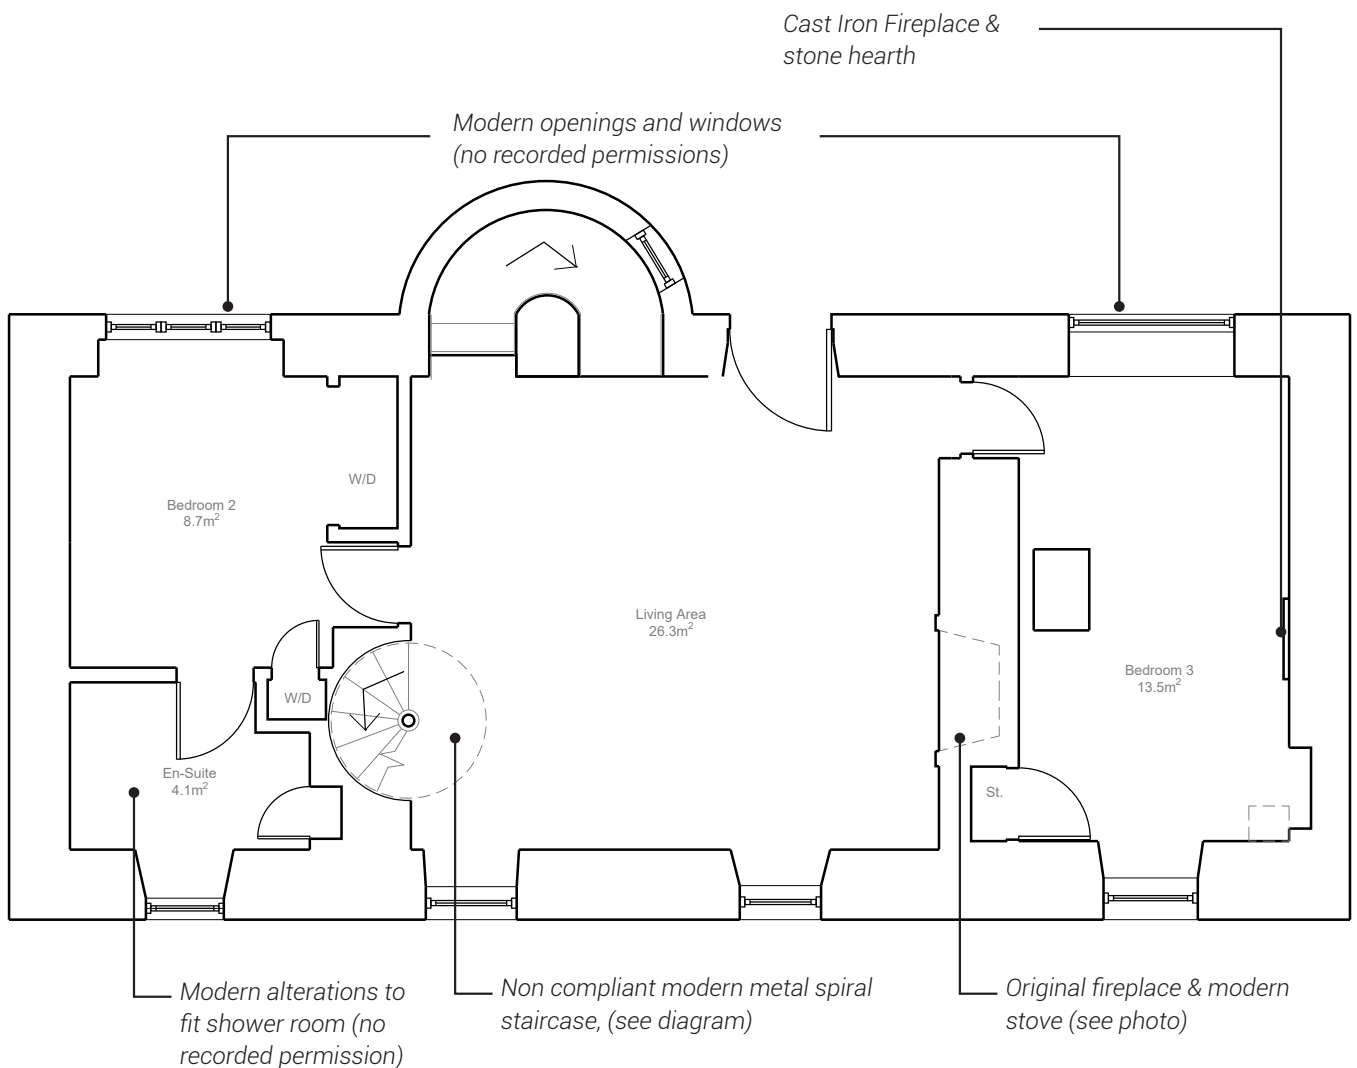
The spiral staircase leading to the mezzanine space, probably fitted around the 80s, does not currently comply with Scottish Building Standards, and was unlikely to have at the time of installation as shown on the diagrams below.

20. First Floor Observed Alterations

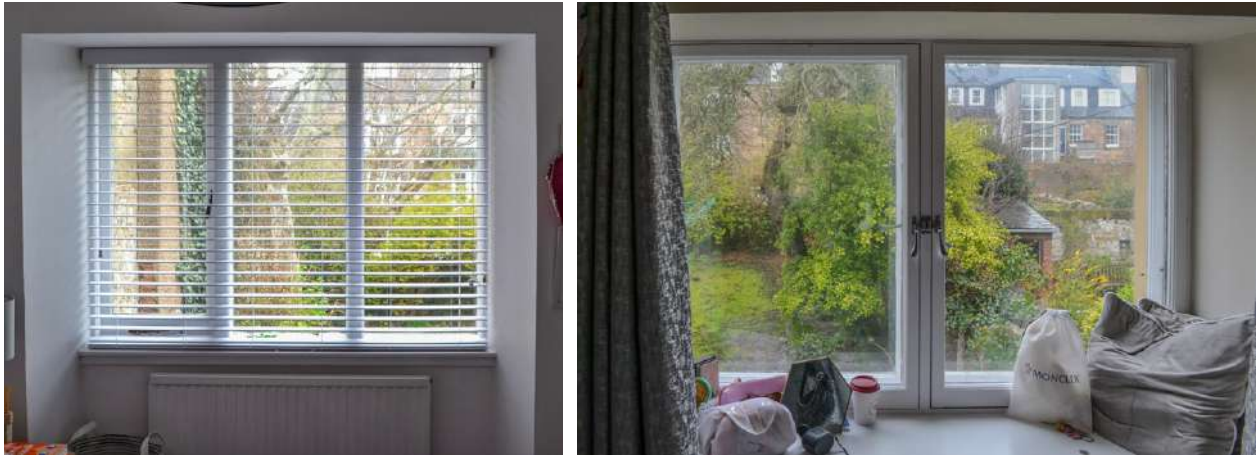
21. Modern timber casement windows - non original openings - no recorded permission

The lounge space is to be retained as existing, including the fireplace and hearth. All the windows to the South elevation on the street are also to be retained. The windows to the rear elevation are proposed to be replaced with more traditionally proportioned and detailed windows to replace the existing modern ones. Those modern additions to the rear elevation are detrimental to the historical aspect of the house, mixing styles and proportions. The proposal will harmonise the existing elevation and restore its historical character.

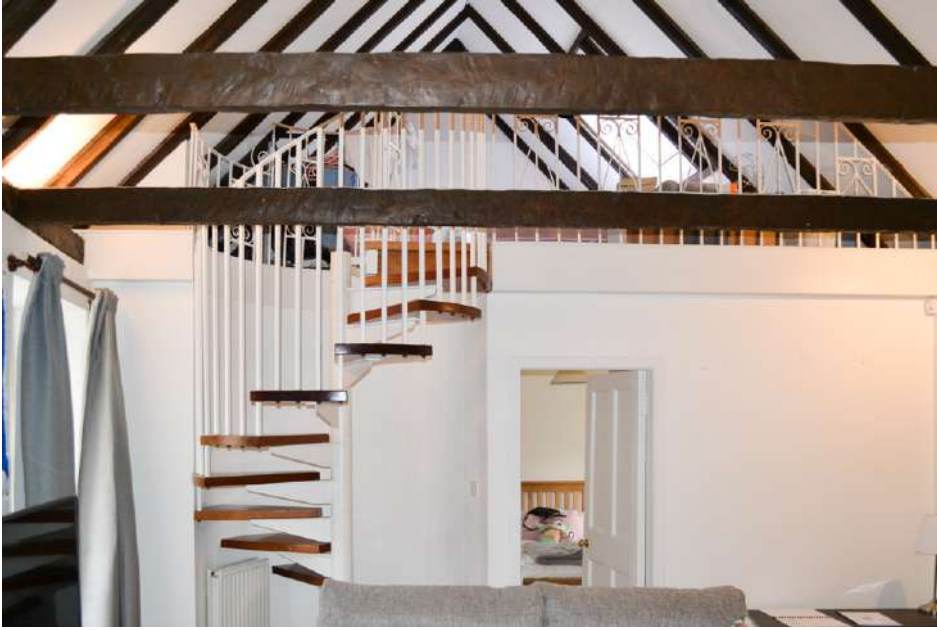
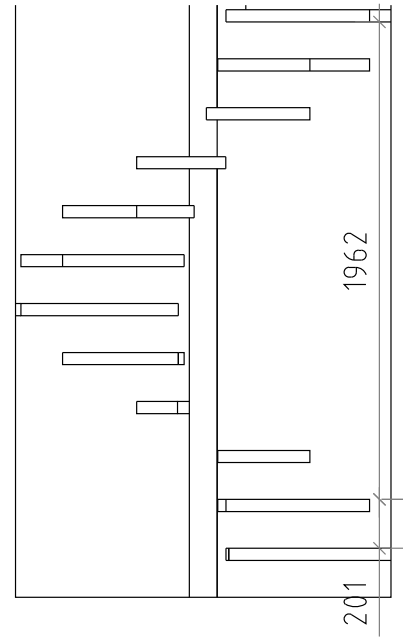
24. Open Spirale Staircase Photo & Elevation

The open spiral staircase is a metal construction, probably originating from the 80s and leading to the mezzanine level above the lounge space. The stairs do not comply with Scottish Building standards as is demonstrated in the diagrams below. There is no recorded building warrant or planning permission available and they likely did not comply with building standards at the time of installation. The going of the stairs is of 210mm contrary to standard 4.3.2 stating that the minimum going should be 225mm. As a result the pitch of the staircase is 43° when the same standards sets the maximum pitch at 42°. Additionally the stair does not provide a clear headroom of 2.0m over the whole flight which goes against standard

Finally, this open staircase leads to the third storey of the building and constitute an unsafe route of escape for occupants of the mezzanine in case of fire. The windows provided on this floor do not comply with escape window standards which makes the top floor of the house dangerous to occupy.

The metal spiral staircase leading to the mezzanine is to be removed as it is unsafe to use, non compliant with building standards and presents a risk to the occupants. This removal will allow for the bedroom 2's en-suite to be extended. A new en-suite is to be created to bedroom 3 as the house currently lacks sanitary facilities with only two private en-suites. A new staircase is to be fitted on the footprint of the existing staircase to lead to the attic floor which will offer a safe and compliant vertical circulation to the second floor.

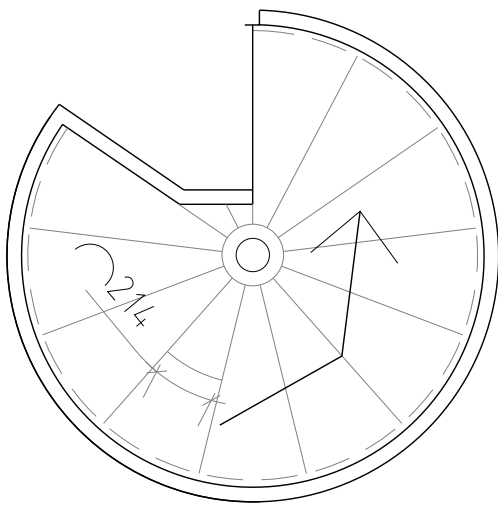
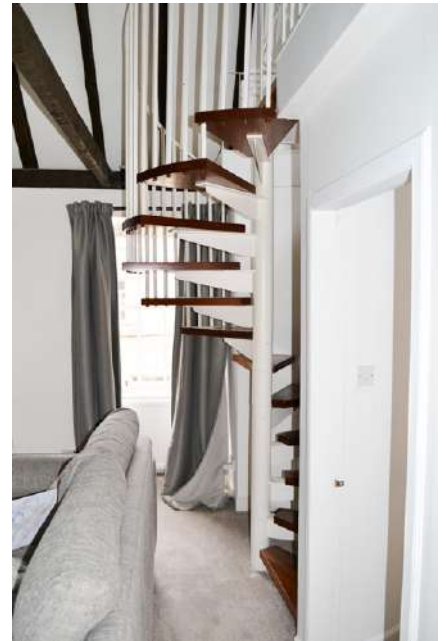
25. Open Spiral Staircase plan & profile

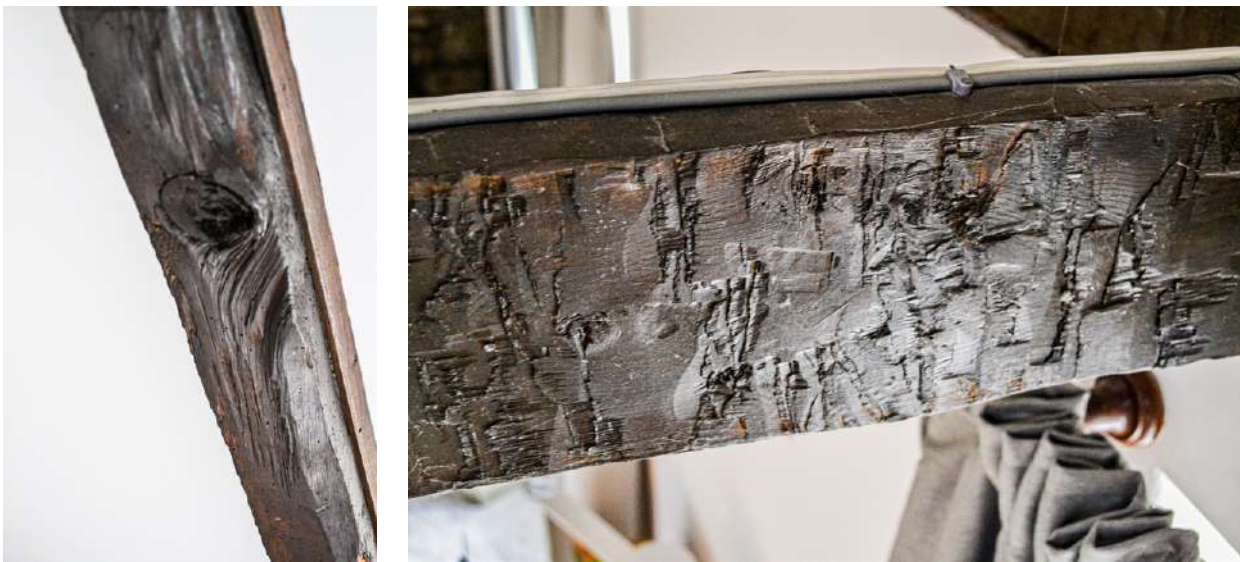
Decorative ceiling joists span across the width of the building. Their appearance suggest that they are a later decorative addition and their texture denotes that they have been artificially aged to mimic the appearance of the existing structure.

27. Texture disparity between original timber structure (left) and decorative joist (right)

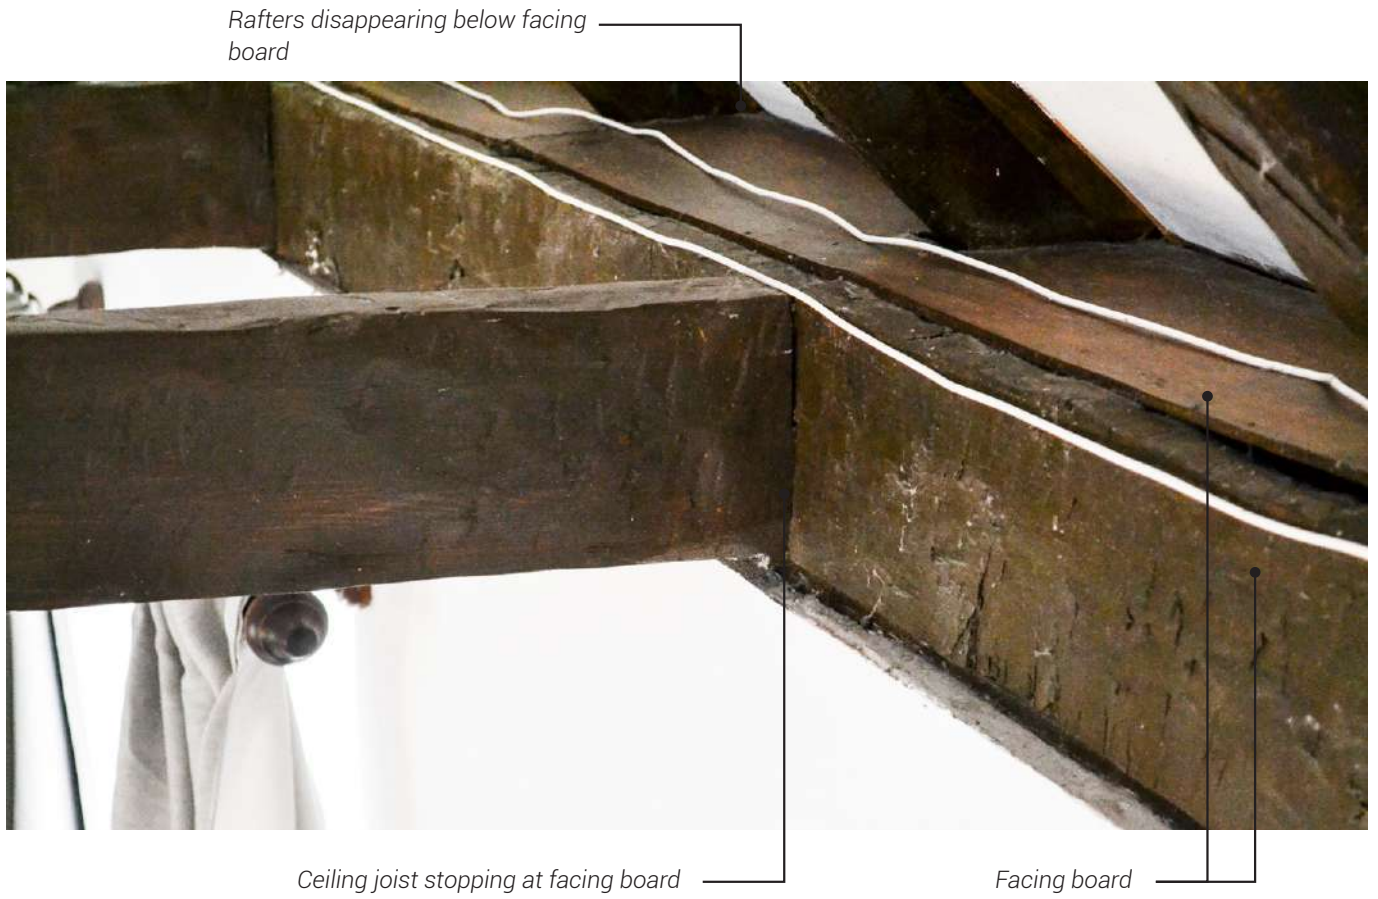
The junction of the ceiling joists with the wall head also reveals that they have no structural purpose, as shown on the photos below. As the ceiling joists stop at the wall head instead of connecting with the rafters and act as tensioner, they do not fulfil any structural role. In a functioning structure system, each rafter should connect to a ceiling joist, which is not the case here.

28. Existing Roof Structure

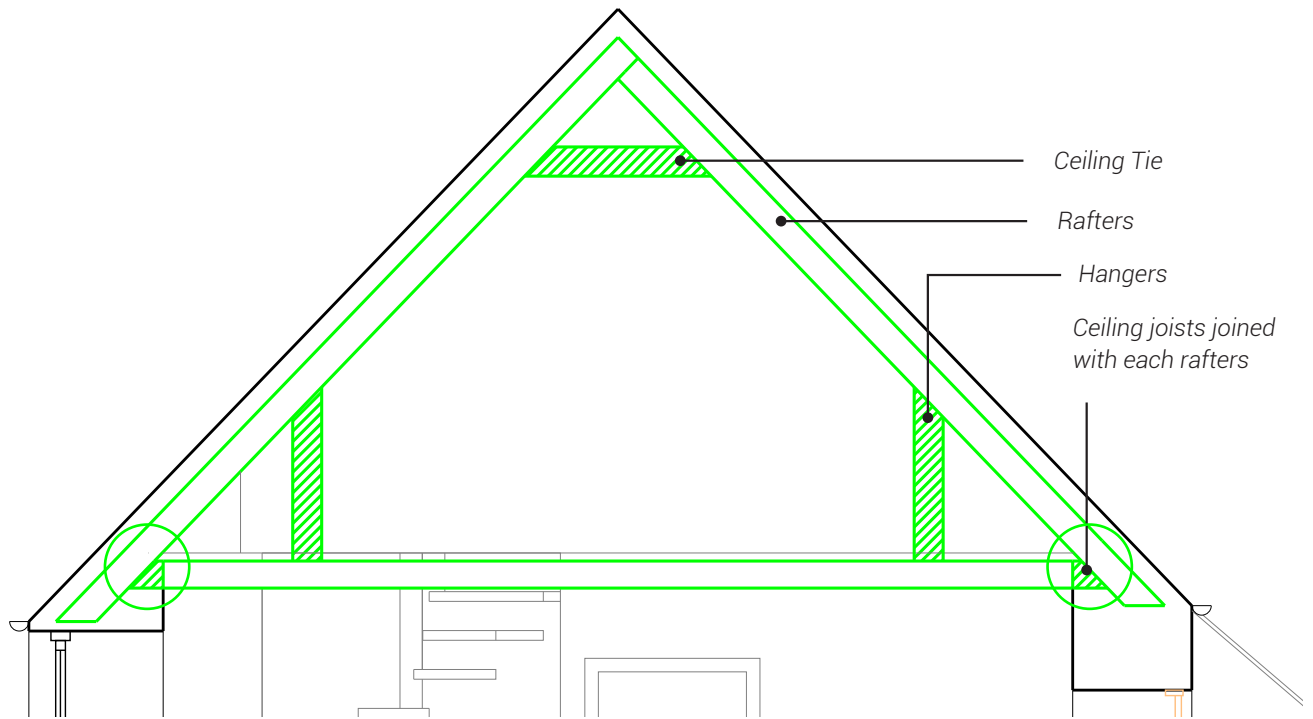
29. Hatched Elements Denote Missing Elements Required for a Functioning Roof Structure

The framework appears to be missing structural elements, jeopardizing its integrity. The absence of structural ceiling joists, ceiling ties connected to the rafters and hangers implies that the rafters are free to move, weighting on the wallheads and that overtime the roof might bow. Lack of bracing also puts the roof's integrity at risk and weakens its resistance to elements.

In conclusion the roof of the property is needing a total refurbishment to be viable. The structure requires to be entirely stripped and rebuilt to safe standards of construction, which will also allow improvement to the efficiency of the thermal and waterproof envelope of the building.

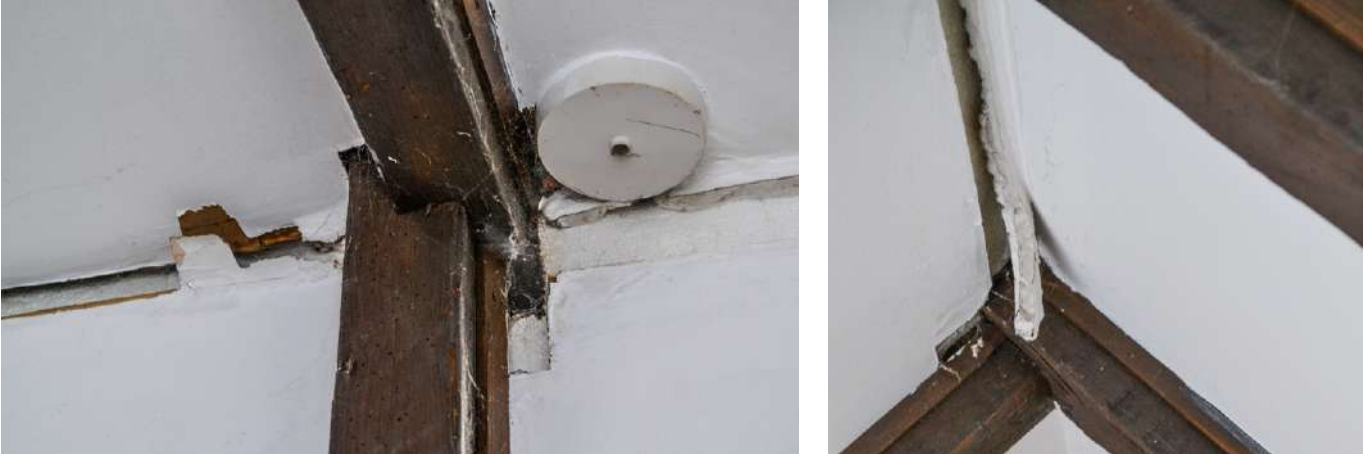
Parts of the ceiling are showing evidence of movement in the roof with the plaster cracking and separating at the ridge as shown on the photos below.

30. Signs of Movements in Roof Structure

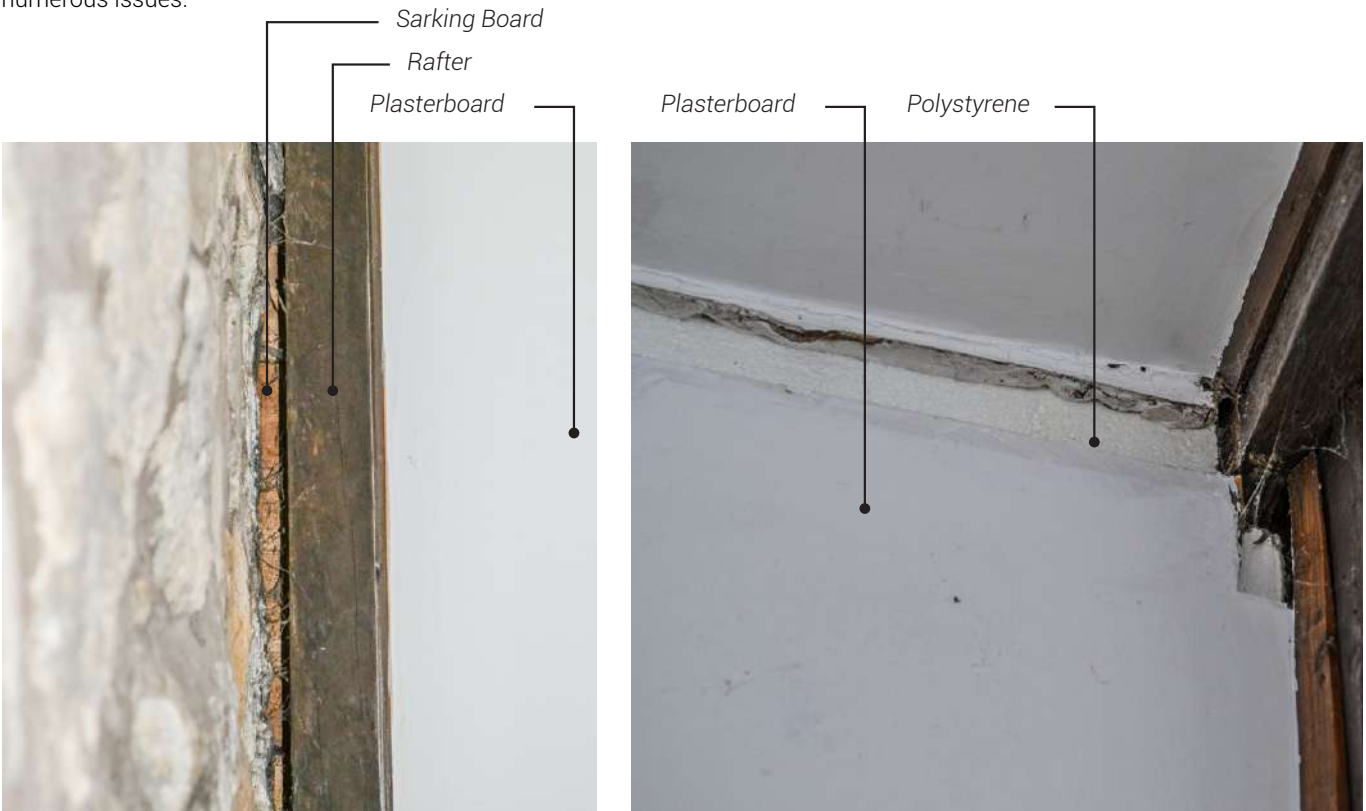
A closer inspection of the roof fabric reveals that the underneath of the sarking board has been lined with a thin sheet of polystyrene, in an effort to insulate the roof space. Plasterboard have been directly fitted to this insulation layer which poses numerous issues.

31. Roof Fabric - Details

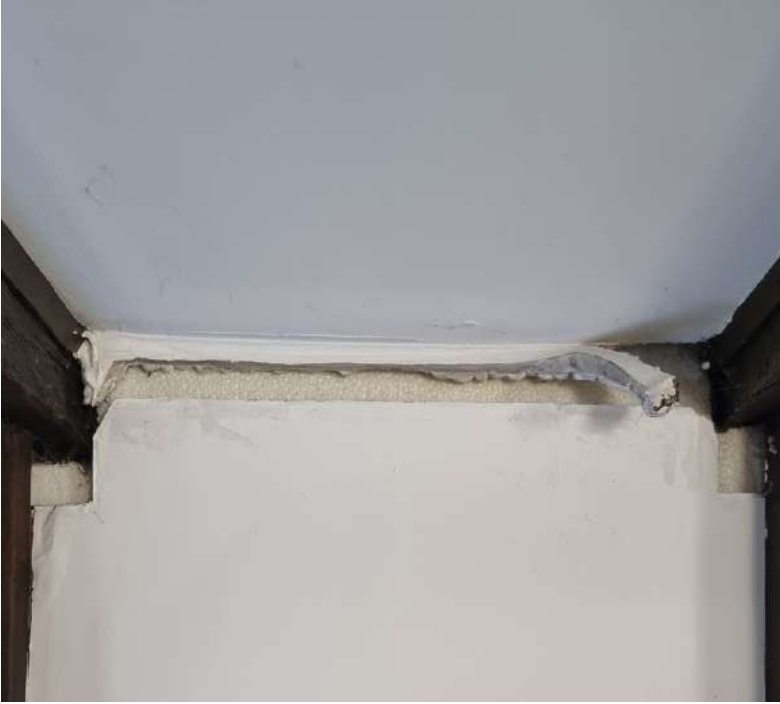
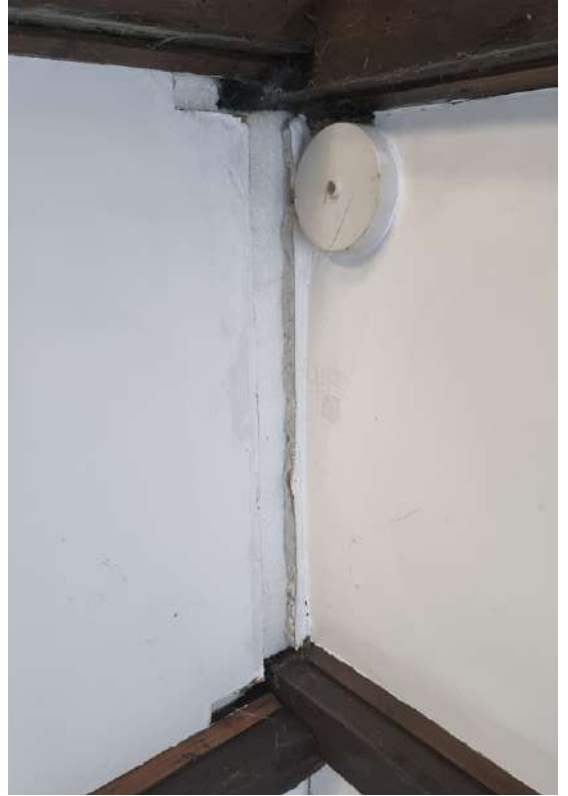
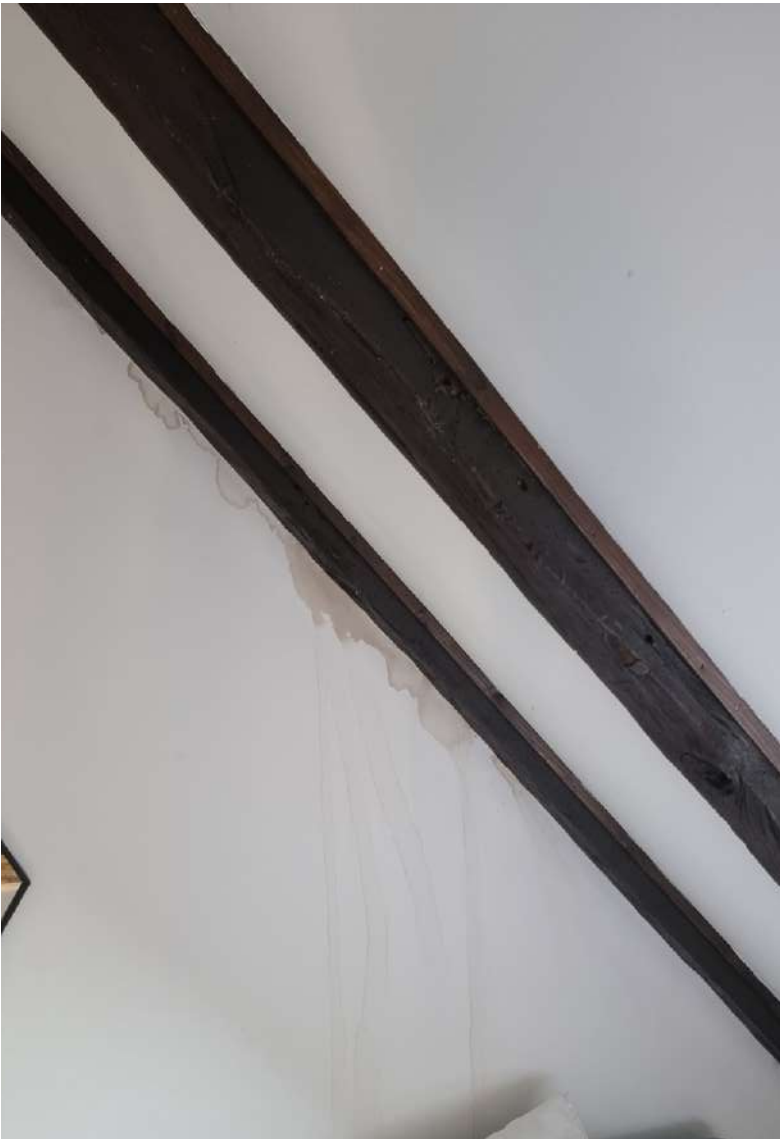
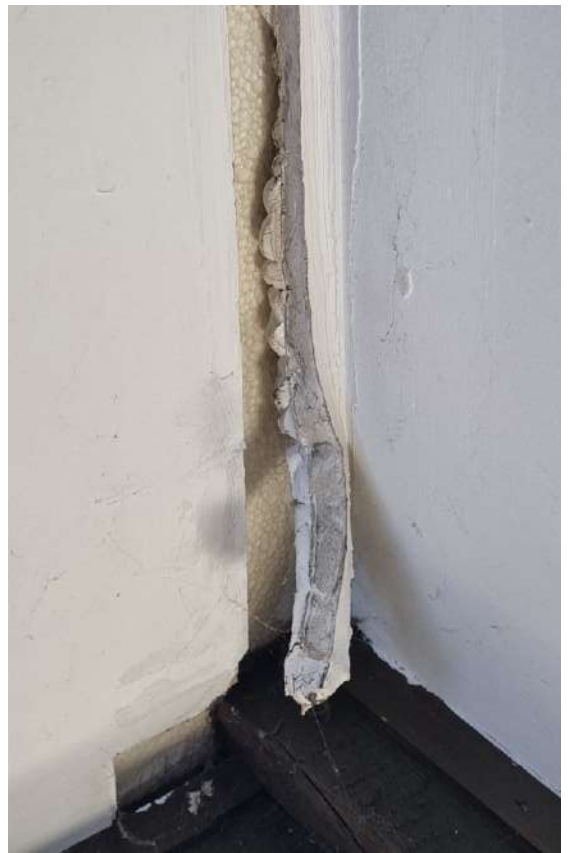
32. Roof Fabric - Details showing obvious signs of movement in the roof structure and the poor quality of the the roof insulation. The signs of water ingress on the gable wall also demonstrate the roof's need of urgent repair.

Firstly, this level of thermal insulation is insufficient to meet the current standards of energy performance and should be upgraded in an effort to future-proof the house and its occupants.

Secondly, the application of a non breathable material directly on the underneath of the roof is preventing any natural ventilation and resulting in moisture building up, impacting the roof's condition. This should also be upgraded to prevent moisture damage to the roof structure.

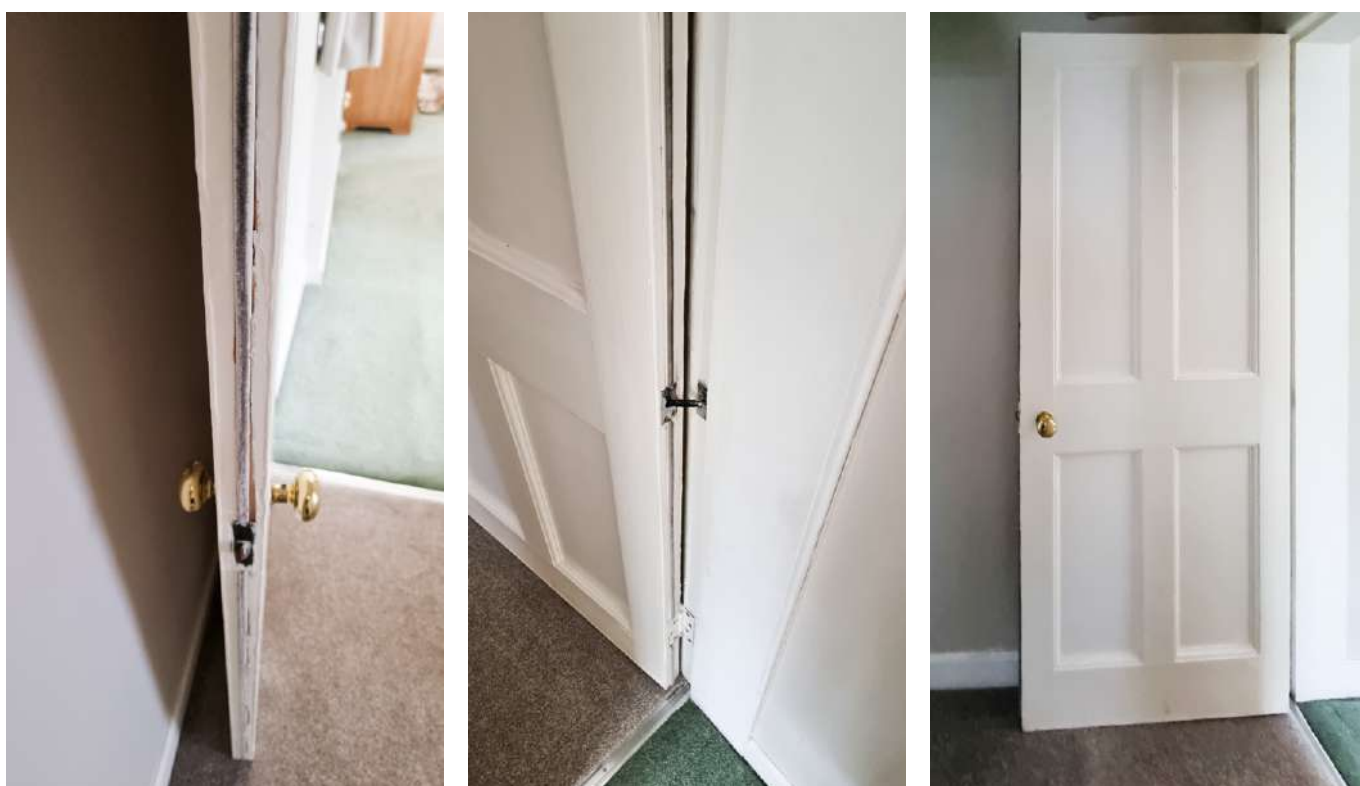
These alterations must have been conducted when the house was leased as a holiday home and obtained the HMO status, with no recorded permission of such change of use and status. Efforts have been made to reuse existing doors which are proposed to be removed in new locations where possible and the proposed new doors will be four panels timber doors, painted to match the existing.

35. Existing Door Showing Modern Alterations
