TREE RISK ASSESSMENT REPORT

20 Damfield Lane, Maghull L31 6DD

1st November 2023

DTCL.2000.TPO.2023

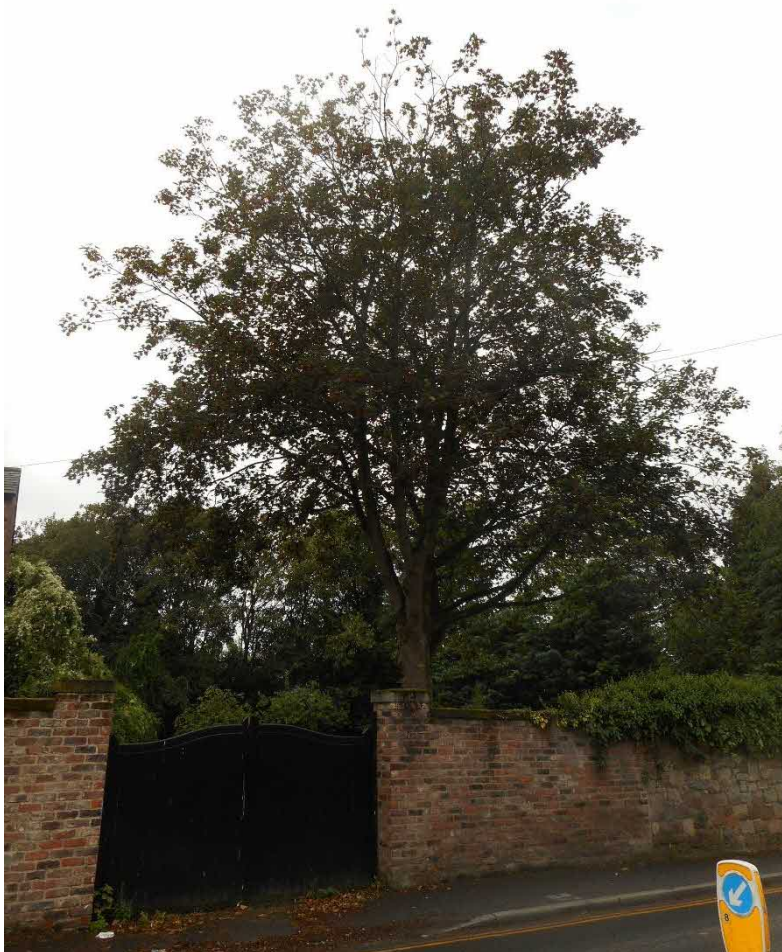
- 3.1 Tree T1 is a mature Sycamore (*Acer pseudoplatanus*) circa 16m in height with crown spread of 17 - 18m. The tree has a single main trunk up to 5m where the primary scaffold divides into four main leaders. It is situated adjacent to a detached garage and borders with a lawn area and tarmacadam hard standing area. The tree is sited 9m from the rear of the property.

Figure 2 - Tree T1 viewed from outside the site

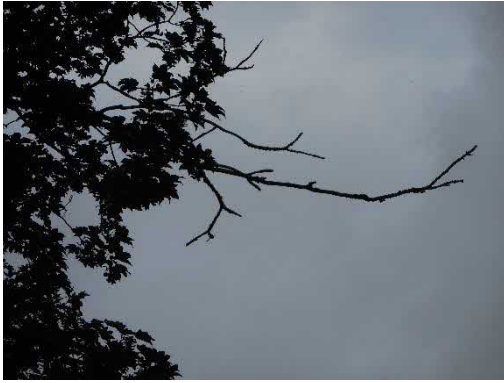
- 3.2 Inspection of the crown revealed significant dieback and the presence of an abnormal quantity of deadwood. This suggests that the tree is stressed and in decline.

Figure 3 - Deadwood in crown

The likelihood of the tree, or parts of the tree failing is 'Probable' and therefore the likelihood of failure and impact is 'Likely', and the consequences of any failure should a failure occur, would be 'Significant'. Using the risk matrix, the risk category is designated as 'High' and the tree should be removed.

Tree #	Proposed works
T1	Fell to ground level and replace with a specimen/location to be agreed with Sefton Council

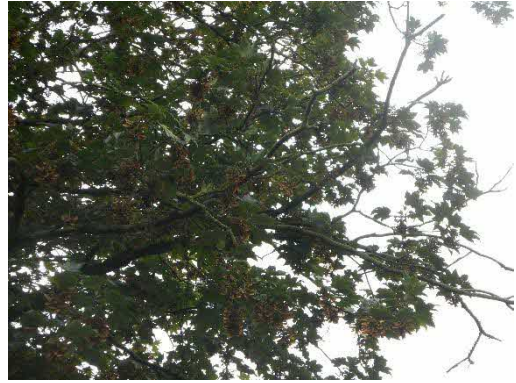
Figure 4 - Deadwood in crown

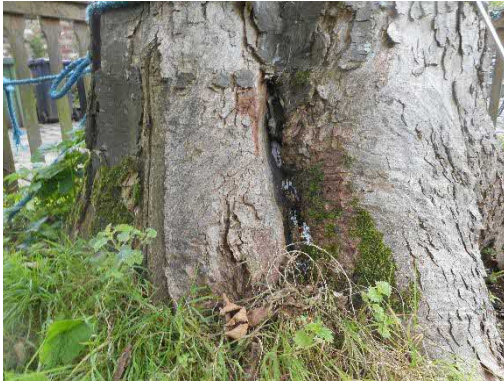
- 3.3 Inspection of the base revealed dysfunctional wood and fruiting bodies between the buttress indicative of internal decay.

Figure 5 - Decay between buttress roots.

- 3.6 While it was not possible to identify the exact cause of the necrosis it is structurally significant and combined with the evidence of crown die back, concerning.

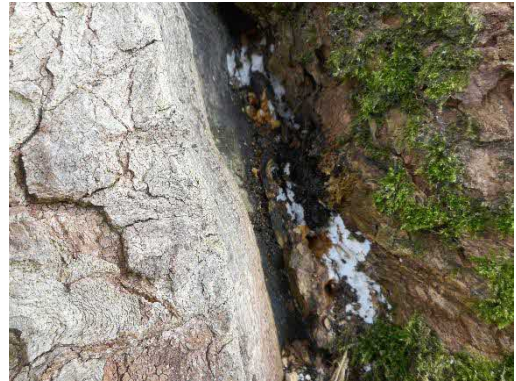
Figure 6 - Fungal fruiting bodies and dysfunctional wood

- 3.4 Samples of the fruiting bodies were recovered and independently identified by the R.A. Bartlett Research Laboratory as being visually similar to the species from the Clavariaceae or Gomphaceae. Members of these groups recorded in the UK all appear to be saprobic, sometimes on dead wood, and therefore should not be a direct concern in terms of tree decay. However, no firm identification was possible.

- 3.5 The fruiting bodies were identified as saprobic meaning that they derive nutrients from decaying organic material. While they are not regarded as a principal decay fungus it is clear by their presence that the structural wood between the buttresses is necrotic and as such dysfunctional.

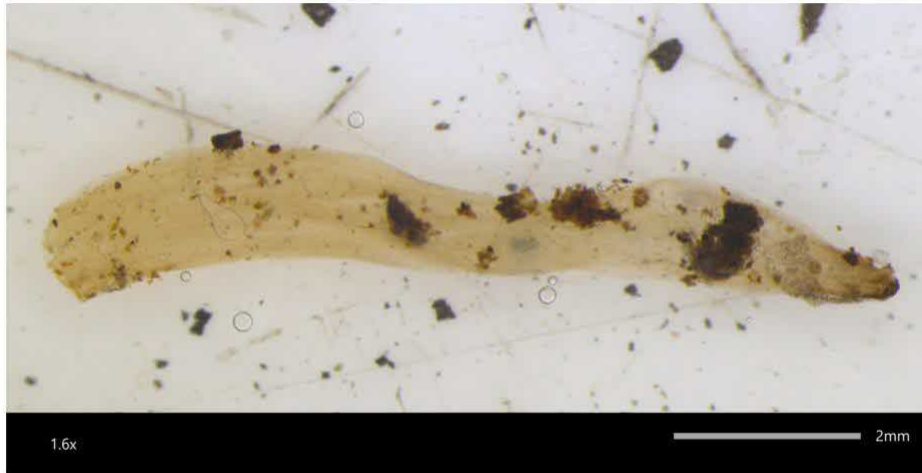
The submitted sample consisted of fragments of suspected fruiting bodies (fig 1) with spores present at the tip (fig 2). These are visually similar to the morphology of species from the Clavariaceae or Gomphaceae. Members of these groups recorded in the UK all appear to be saprobic, sometimes on dead wood, and therefore should not be a direct concern in terms of tree decay. However, no firm identification was possible.

Figure 1. Suspected fruiting body of Clavariaceae or Gomphaceae fungus.

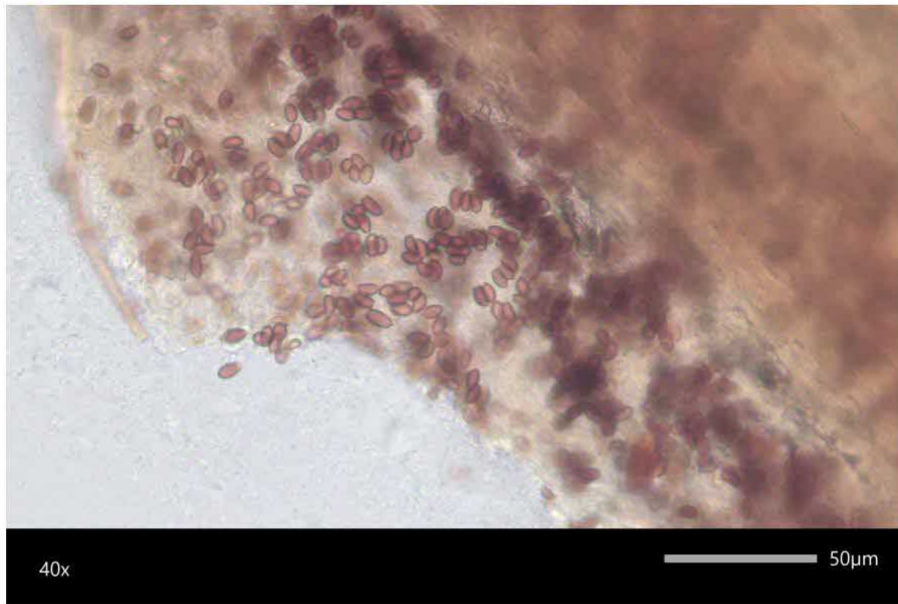
Figure 2. Spores at tip of suspected fruiting body.
