## Specific Defects Survey

23/00002/SDS

King George Playing Field, Meeting House Lane, Cleeve, North Somerset

03/06/2023

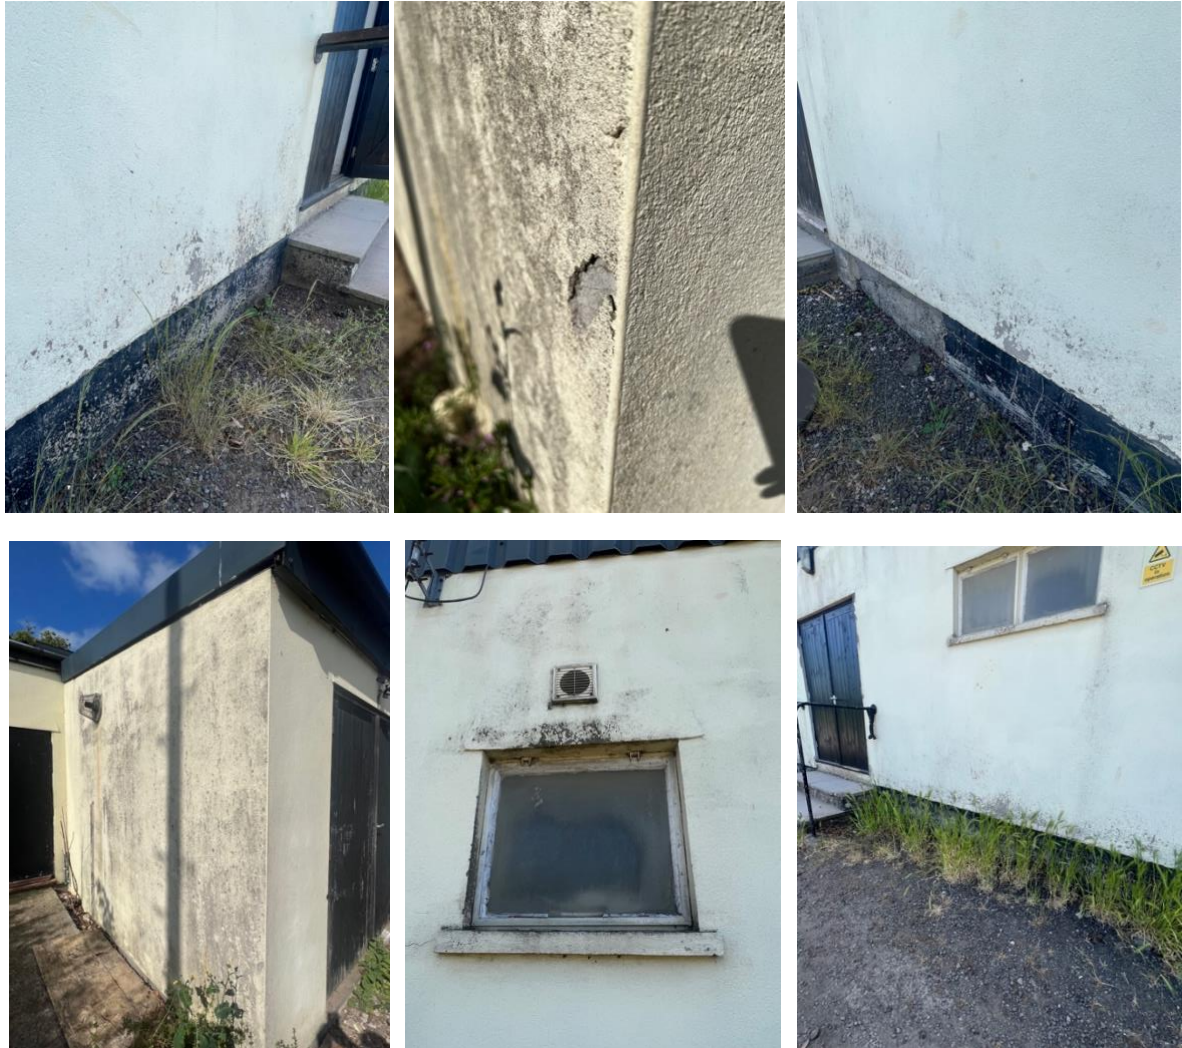
The Paintwork on the exterior of the building is showing evidence of flaking, delamination and general deterioration. The deterioration of the external façade is caused over a long period of time without regular maintenance or remedial action to resolve any identified issues.

The defects identified in regard to the paintwork will continue to worsen and have an effect of the longevity if not addressed.

Without remedial action, there is an increased risk of water/moisture ingress into the render causing further delamination to the façade. In its current condition without action, the appearance of the building will worsen as well as the continuation of falling debris around the building due to the delamination and flaking paint.

The sub-structure has also been painted up to DPC using bituminous paint in order to help prevent rising damp into the building. The bisemous paint is not consistent and also flaking, further contributing to the increased risk of water/moisture ingress.

The external painted finish should be addressed as early as practicably possible.

The buildings walls should be cleaned and any debris removed along with flaking and delaminating paint. Any superficial cracks or holes within the render should be repaired with 'like for like' materials. The render should then be primed prior to redecorating with external grade masonry paint.

The sub-structure should also be addressed in a similar fashion with appropriate waterproofing materials.

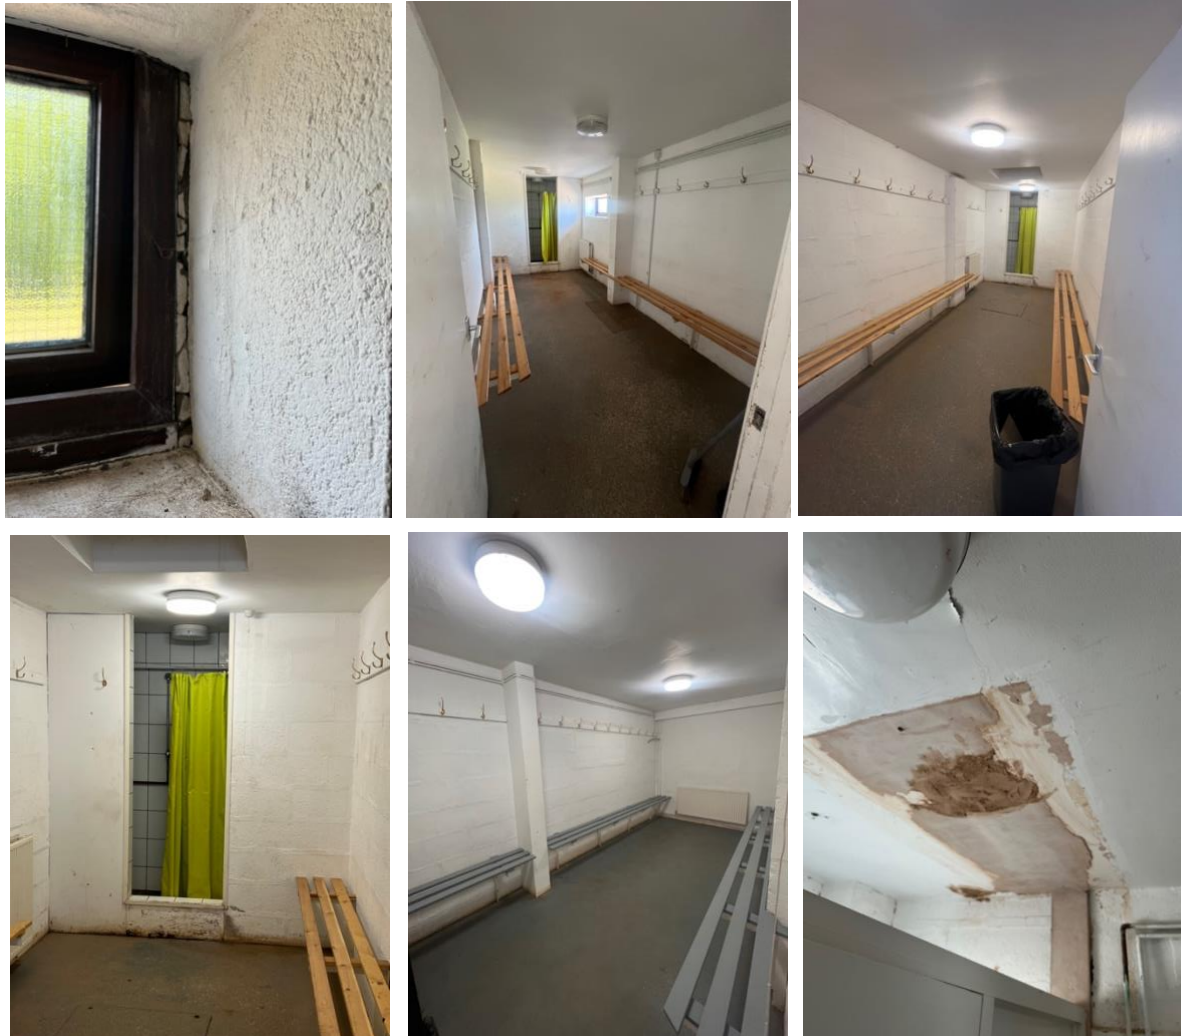
The internal block work appears to have had painted directly applied to the masonry surface.

Similarly to the external paintwork, the internal linings do not appear to have been maintained or refurbished in some time. This has left the walls looking tired and dirty.

There is evidence of moisture on the walls along with mould spores. This is likely to do with the rough and porous surface collecting bacteria and excess moisture remaining on the walls due to inadequate background/mechanical ventilation, cold fabric elements/surfaces and minimal maintenance. The paintwork is also thin in some areas exposing the block surface. There is also some evidence of superficial cracking within the mortar joints which could also be caused by excess moisture increasing expansion and contraction.

Poor repair works have also been carried out to the ceilings in various locations. The repairs have left a very untidy and unsightly finish with inadequate application methods.

The internal linings in their current condition present a potential health and safety risk to those who are using the building and the defects raised should be addressed as soon as practicably possible.

The internal linings should be repaired where appropriate including removing debris, filling superficial loose and/or cracked mortar joints and cleaning the surface. The surface should then be primed and masonry paint applied over as previously carried out. It is recommended that the masonry paint used is wipeable to maintain a hygienic and aesthetically pleasing surface.

The building would also benefit from improved mechanical ventilation to remove moisture within the atmosphere and prevent excess moisture from reoccurring in the future.

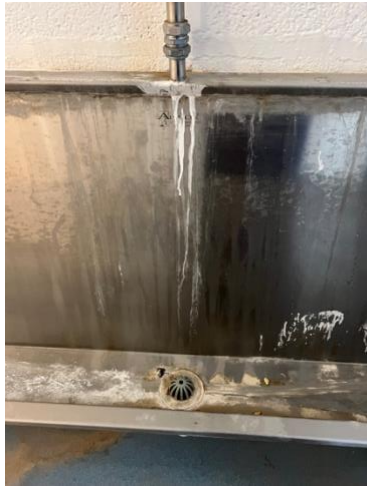
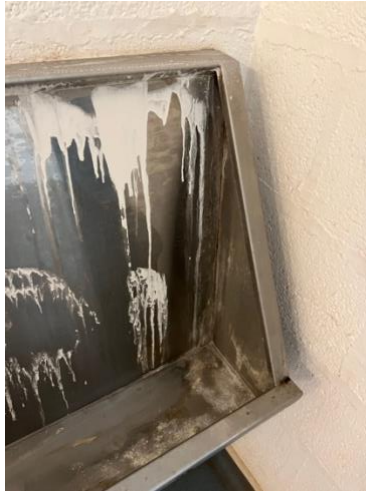
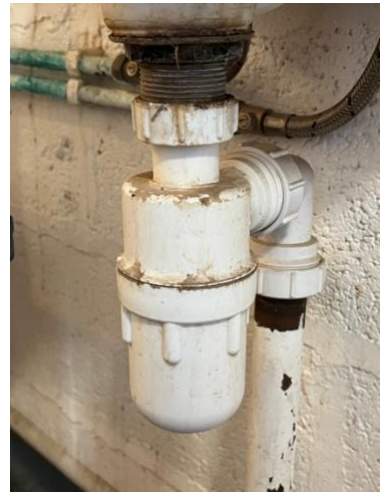
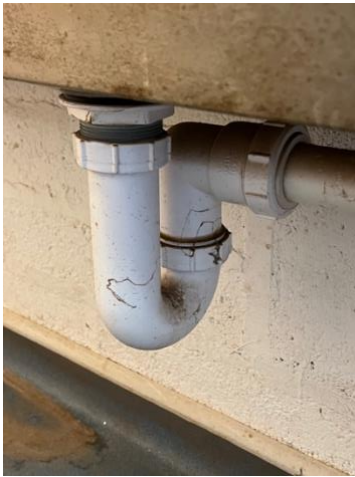
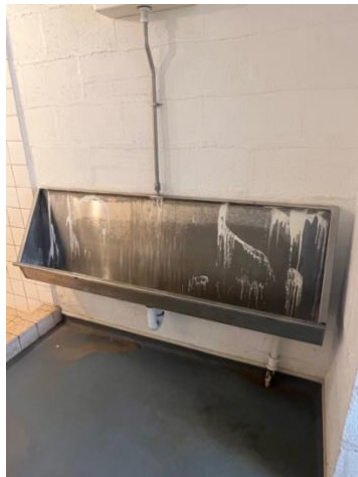
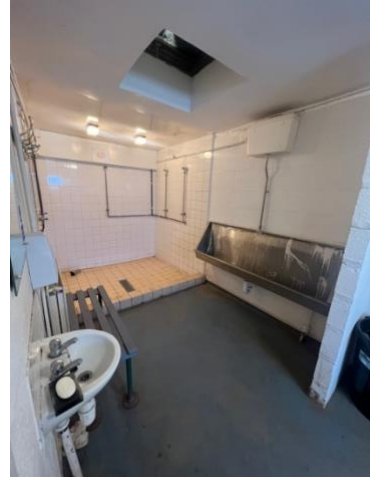
The building has both urinals and toilets which are in use. However, the condition of the sanitary conveniences, in particular the urinals, are in a poor and unhygienic condition.

The urinals in particular are showing evidence of leaking fittings, rusted and weak fixings and limescale build up. The silicone sealant is also perishing allowing water behind the fitting further causing the growth of bacteria.

The waste drainage system used to discharge effluent water appear to be showing evidence of deterioration due to the external condition of the pipework and staining suggesting possible minor leaks. It is also likely that given the condition of the exterior, the interior of the pipework is in a similar condition, if not worse. The deterioration of waste water pipework can cause a health and safety risk to those using the building if leaks begin to appear. It is advised that further investigations into these fittings are carried out to determine the condition of the joints, seals, etc.

There is limescale build up around the outlets and likely to also be around the seals. This can cause seals to perish contributing to leaking fittings.

The fixings securing the urinals to the walls are also rusted. Therefore, their strength is likely to be compromised. The urinals were fixed in place with no signs of movement at the time of the inspection. However, the longevity of the fixings are unknown and should be replaced taking into consideration they systems age and visible condition.

Due to the age and condition of the plumbing, fixings and urinals themselves, it would be beneficial to replace them for upgraded versions. This will help to improve the hygiene of the bathrooms and make the space safer for people to use. The waste plumbing should also be replaced alongside to ensure the system is functioning correctly throughout and preventing inconsistencies with the installations that could cause further repairs.
