Independent Thatching Consultant & Vernacular Buildings Adviser

Condition survey of roof

Plume of Feathers Crondall, Hampshire

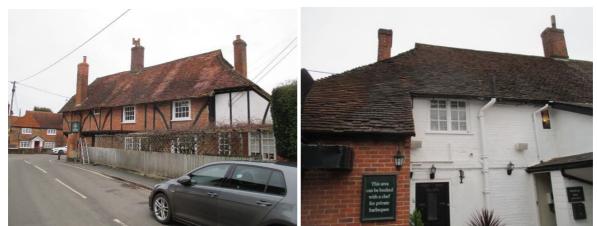
West Elevation (Church Street).

The clay tiles on the western elevation (Church Street) were found to be suffering from delamination and nail fatigue.

Externally there are large areas of unstable and failing tiles on the western elevation (Church Street). The remaining tiled sections of roof only require minor spot repairs.

Strip and retile using all salvageable old tiles and making up any shortfall with matching materials. Service all rainwater goods as required.

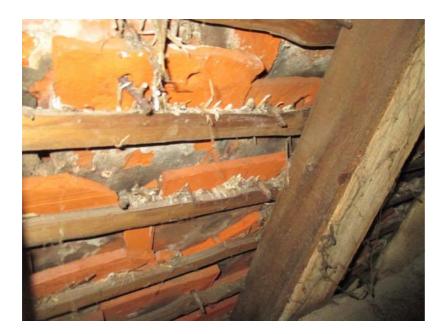
The exposed section of roof frame in the first two bays are predominantly over fixed with thin riven oak tile battens. A small section of the eastern slope has been re tiled in more recent years and has modern tile battens and bitumen sarking.

Small section or c21 retiling (right of image)
