#REP07012023-13901

FAO: ROS WHITLEY
C/o: 139 Marine Parade, East
Clacton-On-Sea
CO15 5AD
07918 163745

Sunday, 08 January 2023

PWASS – REPORT OF PROPERTY CONDITION PRE WORKS-ASSESSMENT

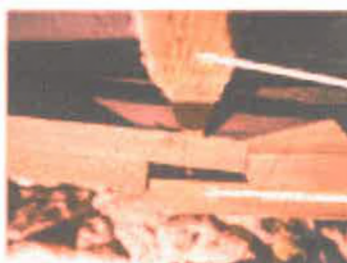
Noticeable from the outside of the property there is a considerable drop/dip in the centre of the roof that faces North East. Upon inspection in the loft area, it is evident that the purlins that brace the rafters have failed at the half lap joint. This has caused the roof to drop/dip in this area. This is also the same for the opposite side of the roof. Possible relation to section 2.1.

Rafter
Purling

A Structural engineer would give the best solution to follow as they can calculate the loads on the roof upon inspection. We have dealt with this before, but each property is different and we can not at this stage recommend a solution without the approval of a qualified structural engineer.

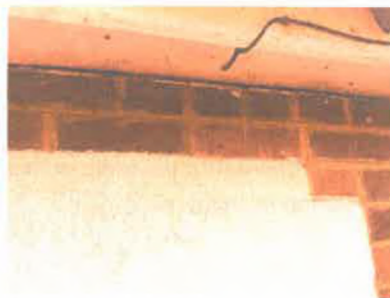
Noticeable cracks have appeared in various locations throughout the property on the internal skin (as shown through the plasters). The external skin has also shown signs of subsidence in two corners of the property that we can see.

Again, this would require a structural engineers report to ascertain the best course of action. As stated before, we have dealt with properties with structural issues in the past and each property is different when taking into consideration soil types, footing depth etc. We can ascertain this information at the request of a structural engineer to aid their conclusion if required. This will have to be booked if this is the case.

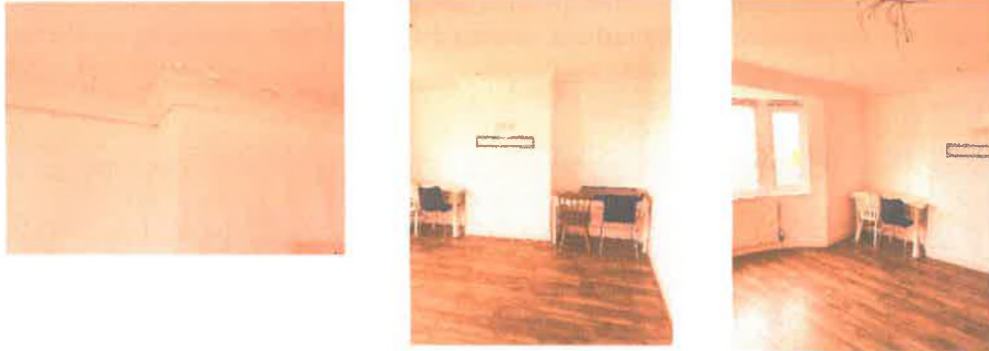
In the lounge area there are considerable signs of damp that have appeared leading down to the sockets on the chimney breast. The chimney breast itself looks as if it has shifted slightly (again, possible relation to section 2.1). Without means of safe access to the roof (IE Tower) to undertake an inspection, we can only assume the lead has failed either due to movement or damage around the chimney. There is also the possibility of broken tiles and/or mortar failure between the tiles and under-cloak.

It would be best to ascertain if this is covered under the building insurance, especially if related to section 2.1 covered above. There would need to be further investigation to identify the main cause of the water ingress and a plan can be put into action once details have been agreed.

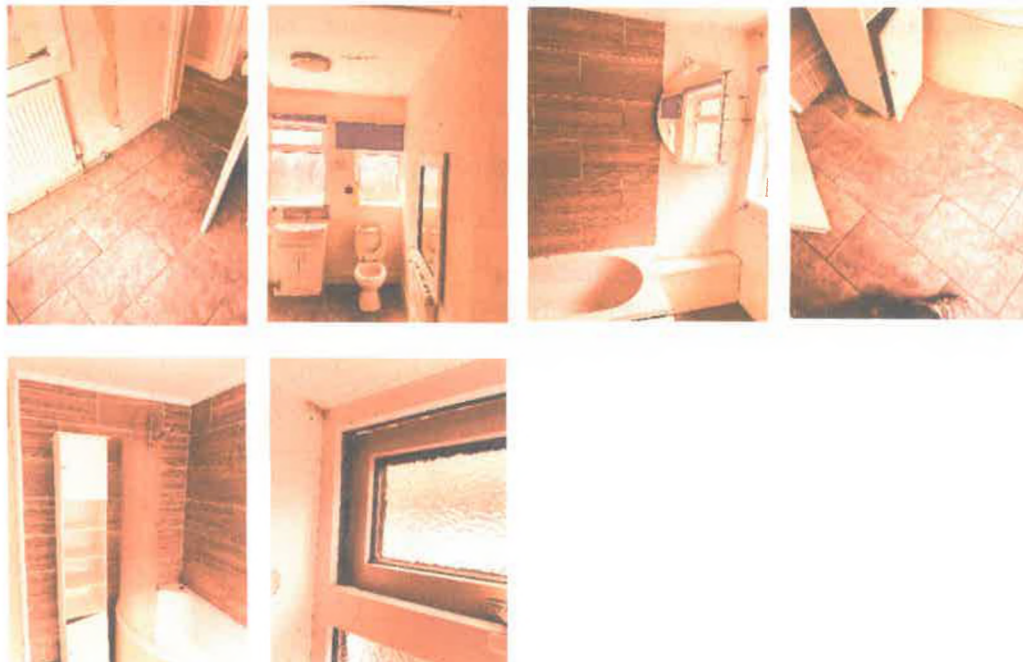
The bathroom has endured some wear and tear over the years it has been installed. Broken tiles to the flooring area, grout missing in places that are tiled on the walls, mould in various locations and windows that no longer operate are but a few of the issues highlighted within the bathroom area.

It would be advised to completely upgrade the bathroom given the state it is currently in. This would prevent future damp issues on walls and floors where tiles have failed. The yellowing of the plastic on the bath also suggests it has been cleaned with bleach and/or exposed to prolonged sunlight causing the panel to become brittle. Again, in conclusion it would be advised to go down the route of a complete bathroom upgrade. This includes the W/C next to the bathroom.

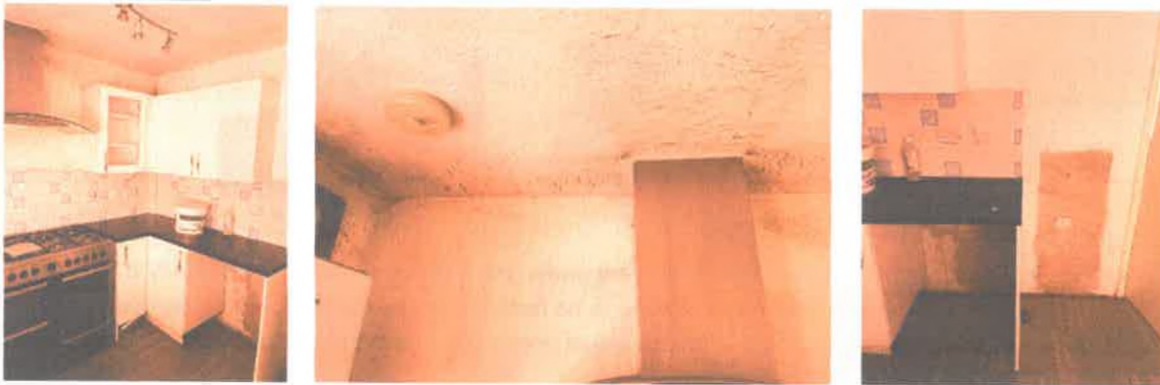
Much like the bathroom, the kitchen has suffered the same fate over the years since installation. Mould along the ceiling that follow crack lines throughout, damaged units and other aspects of the kitchen state that it needs replacing.

Install new kitchen to clients specification to update and modernise the area.

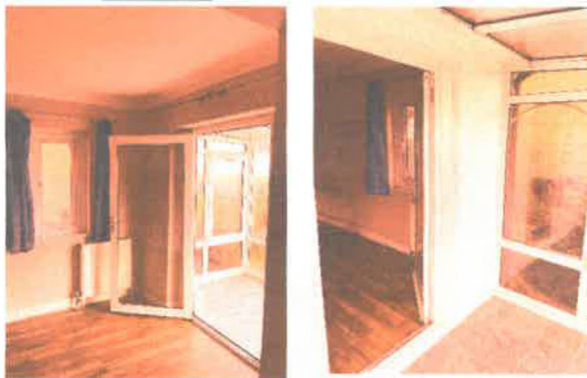
Multiple windows around the property have damage to their friction hinges causing the windows to not run as designed. The lack of trickle vents throughout also have not helped with the airflow within the property adding to the damp issue as the air inside (especially during the winter months and the properties location) can be very moist. The main door to the front of the property (sea facing) leads out to a conservatory area. The crack above the door indicates movement that may have twisted the frame to impair the hinge operation of the door. This, as result, has made the door difficult to open and shut.

To ascertain if this is covered withing the buildings insurance. Possible relation to section 2.1.

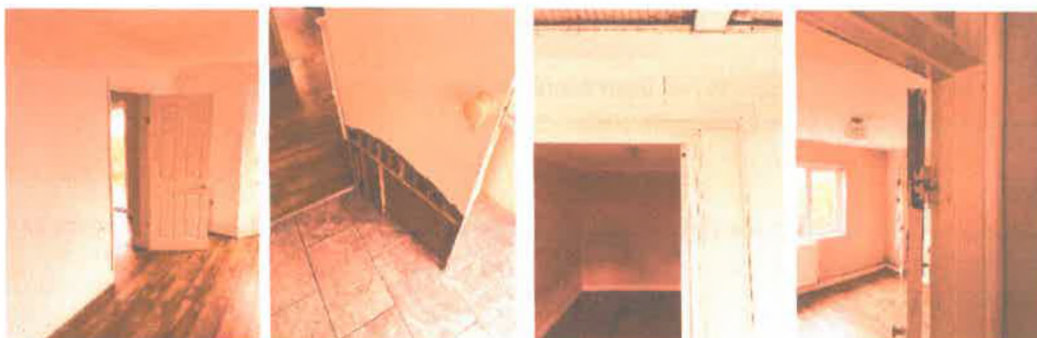
Damage to the frames, doors and ironmongery (if not all) within the property.

To replace all internal doors dependant on the properties intended use (IE FD30 or FD60 doors for regulatory purposes where required).

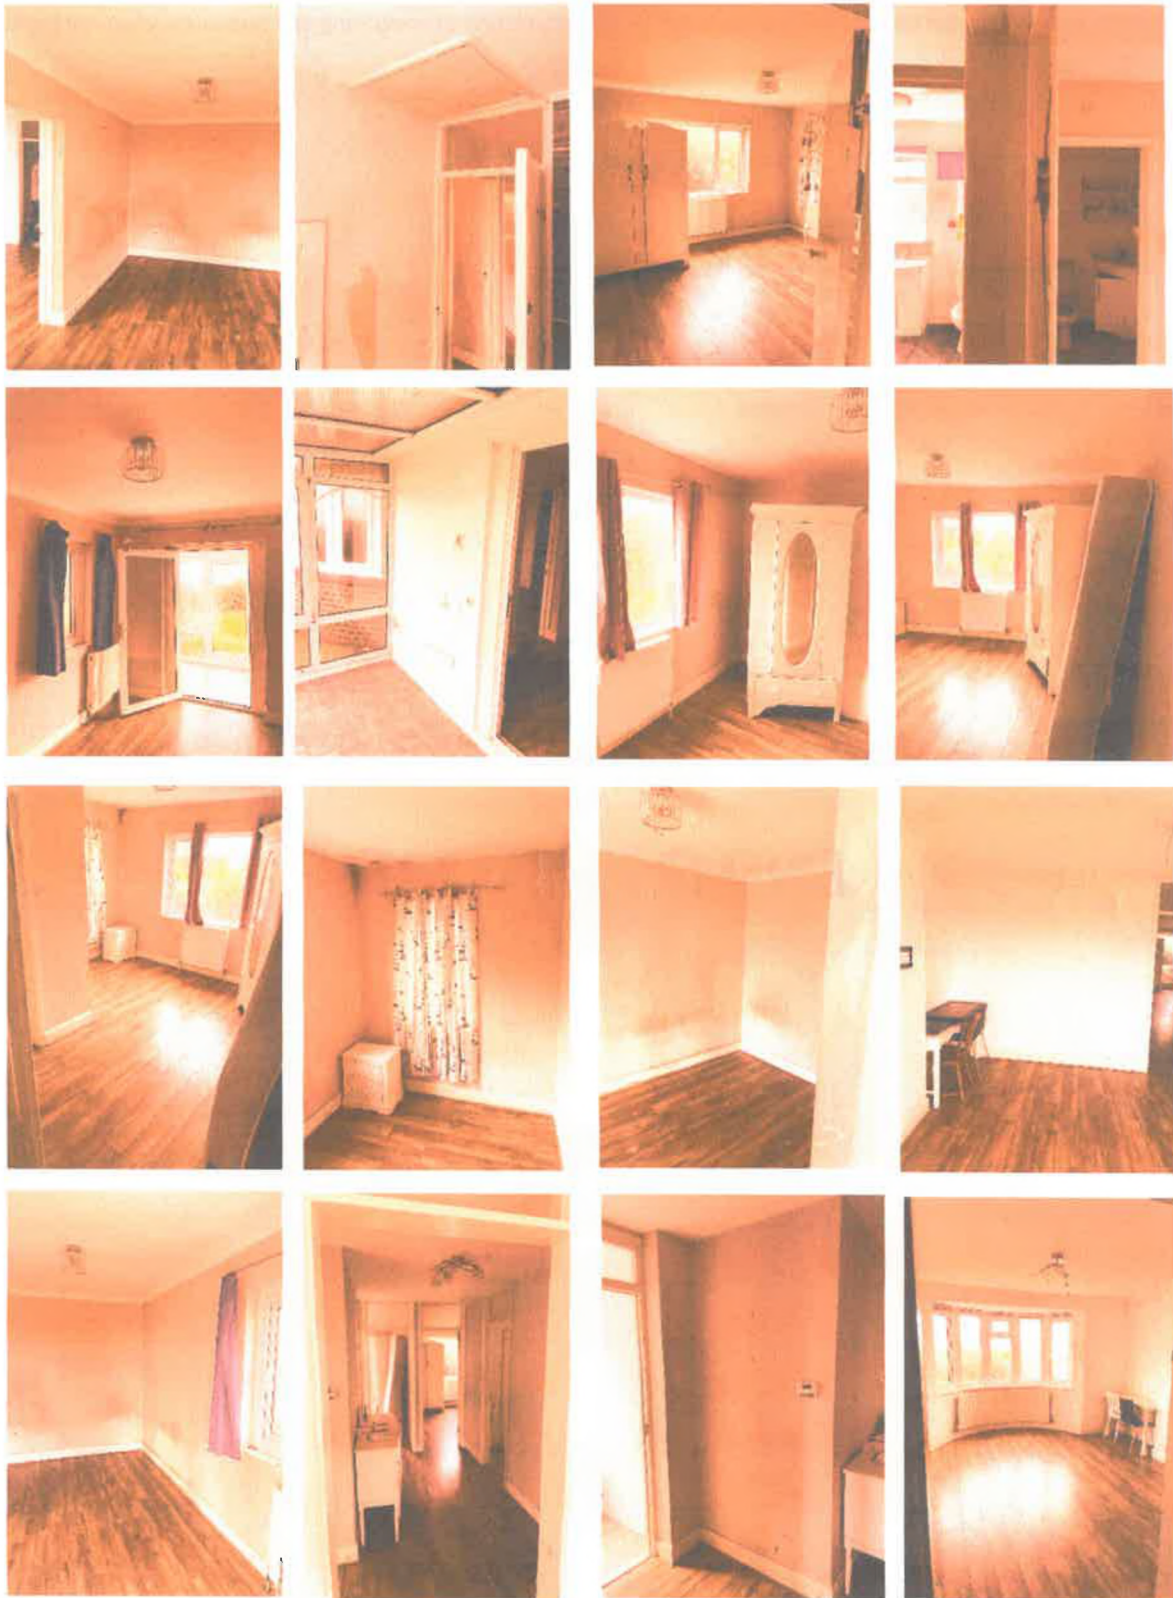
Additional supporting photos

Mould in various locations throughout the property.

The flooring throughout the property has been damaged in various locations. This is mainly wear and tear but evidence of water damage to some areas.

Mould treatment to areas that have not been resolved by steps above.

Remove and replace flooring and skirting throughout to give professional finish.
