Bat Survey Report

**For Proposed Replacement Dwelling at
Meadow View
Sherfield Road
Bramley
RG26 5AG.**

November 2023

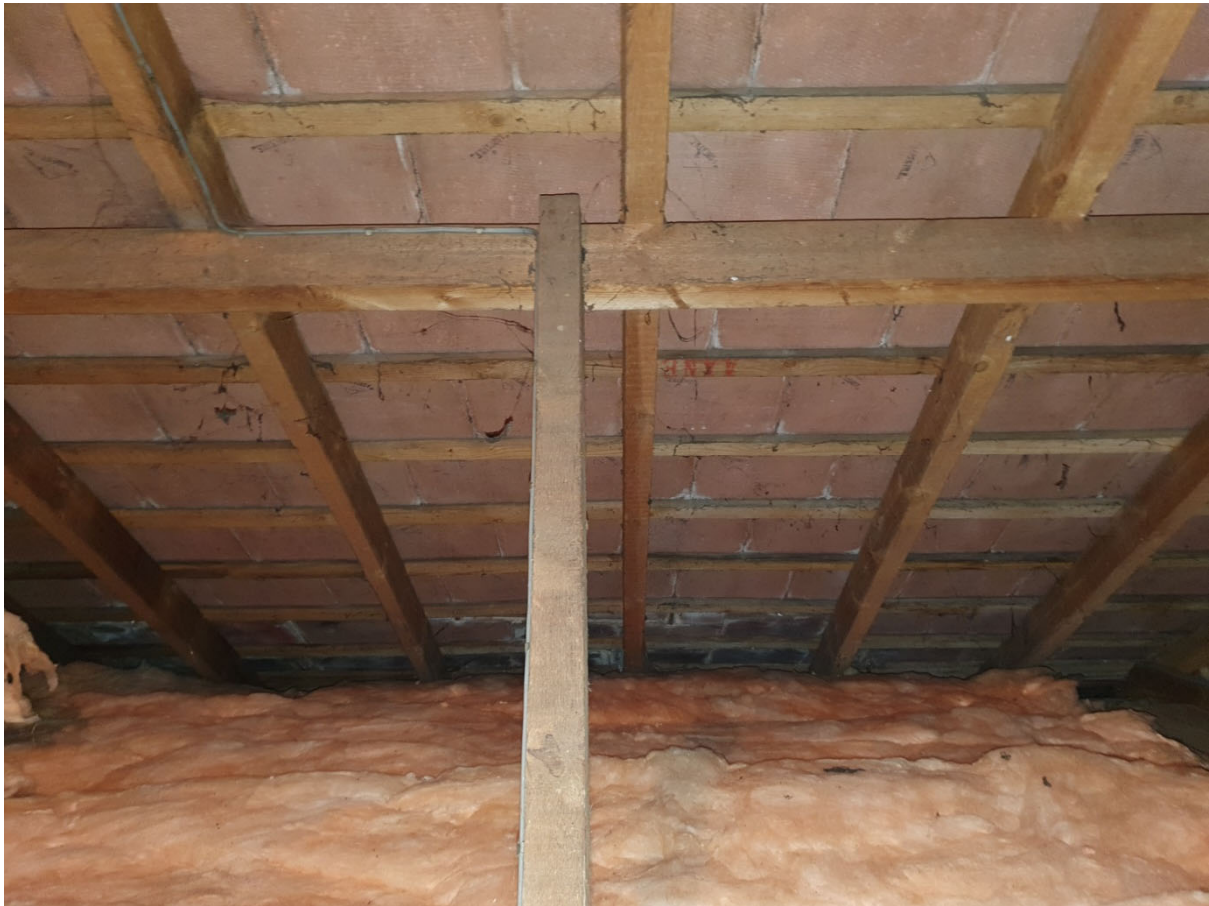
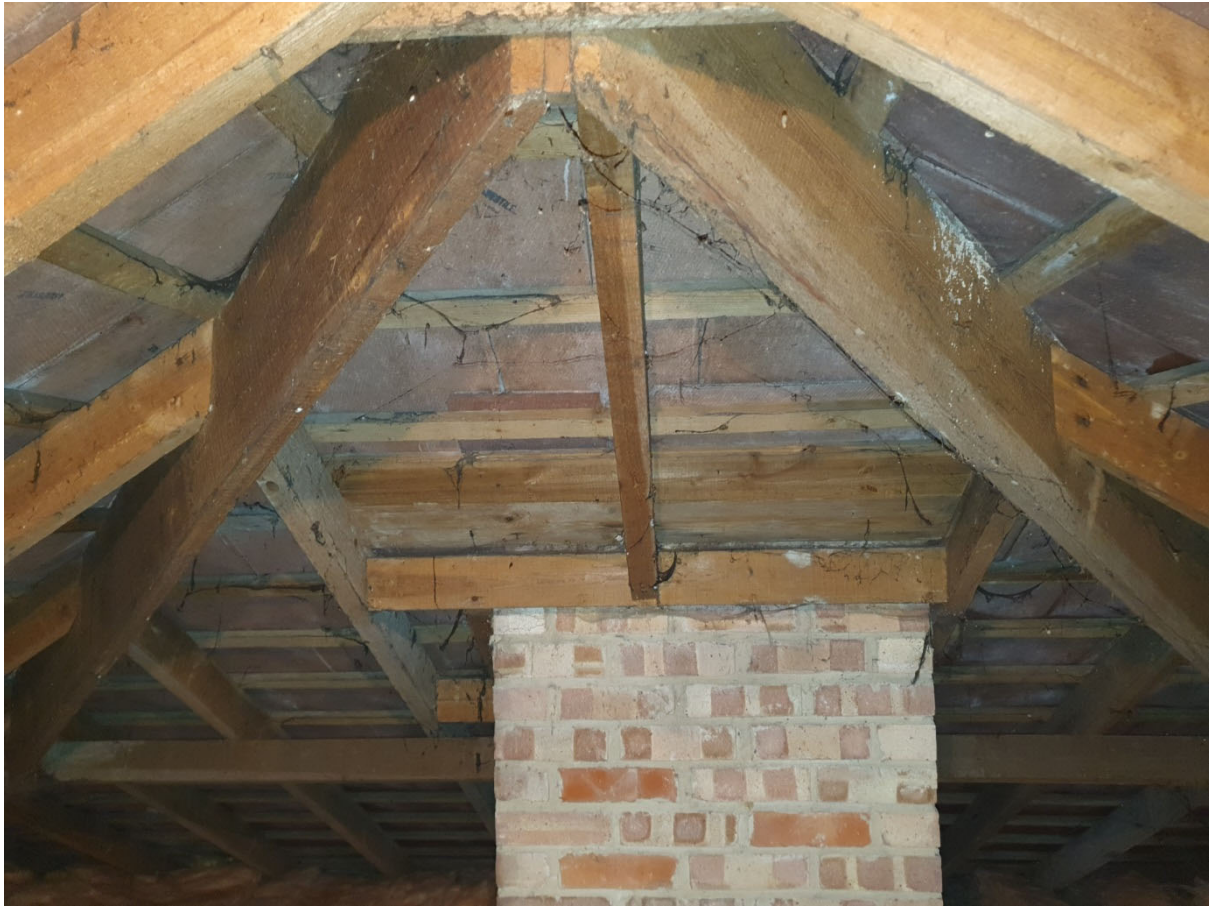
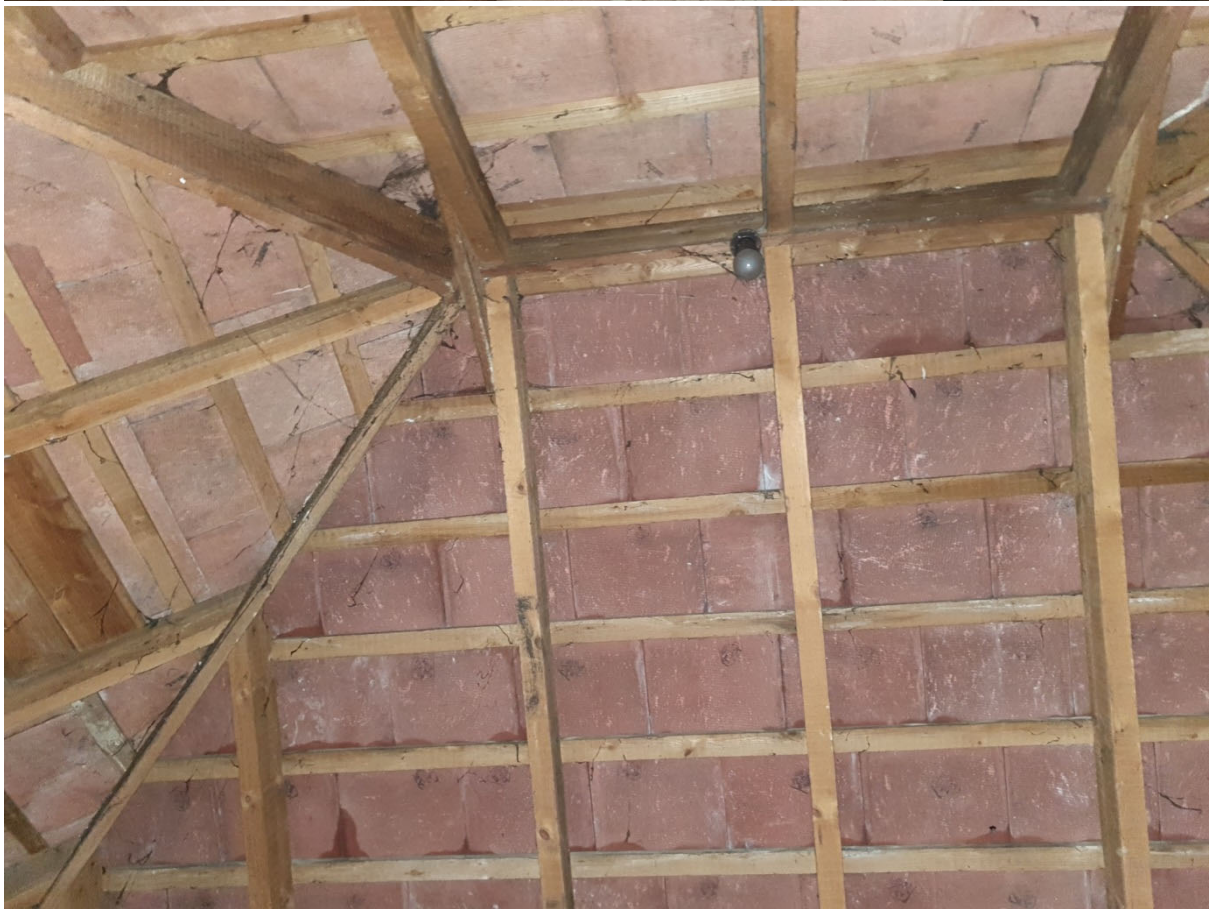
Internal bungalow images

The roof space has been inspected (access into the void was via a standard roof hatch) and there is no evidence of Bats or Birds entering the enclosed roof space either currently or in the past. The lack of underfelt has made it straightforward to carry out a thorough inspection of the roof space and there is no evidence of droppings or other detritus on the existing loft insulation that would indicate an existing or historical roost. It was noted that internally the roof void was thick with cobwebs, which is a good indication that bats have not been using the roof space.

I can confirm that none of the above were found in the internal loft space.

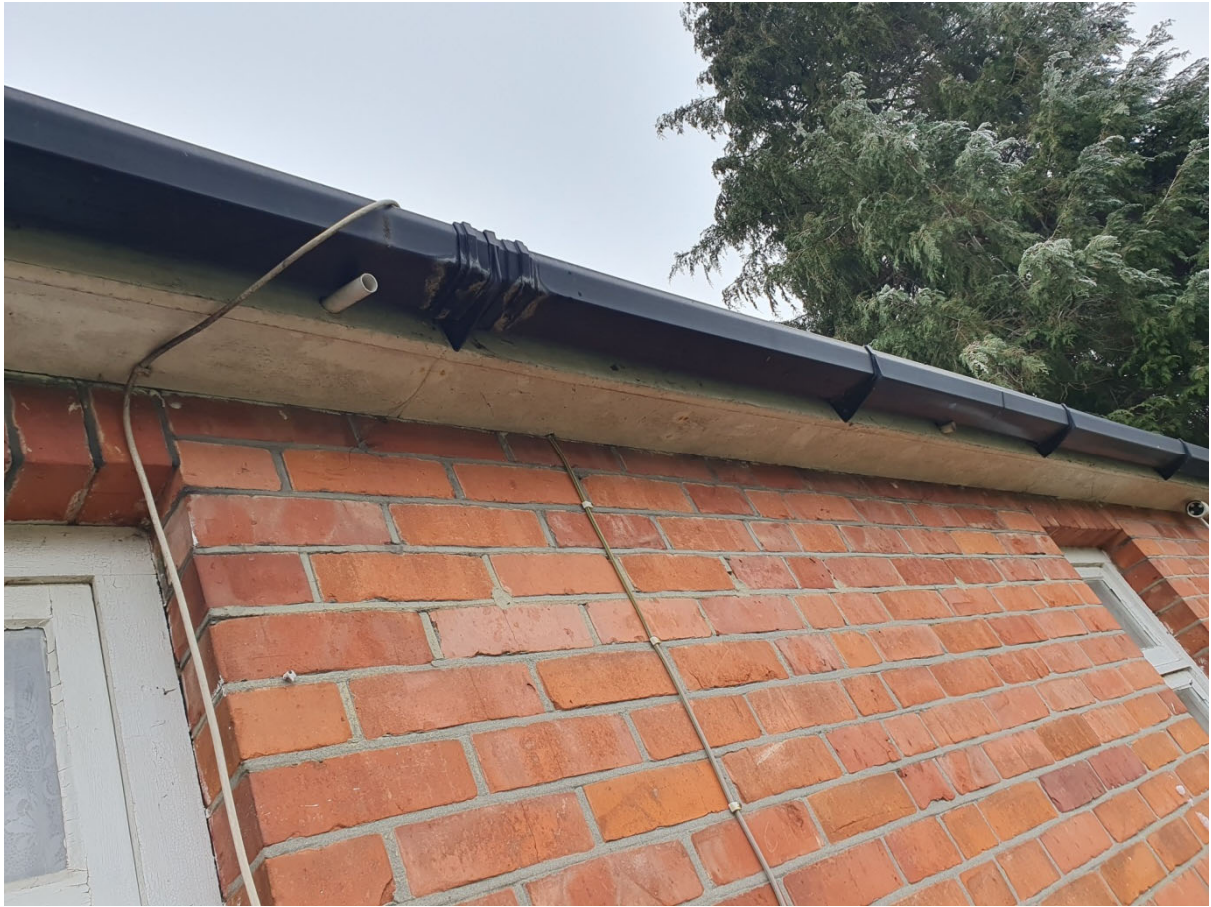
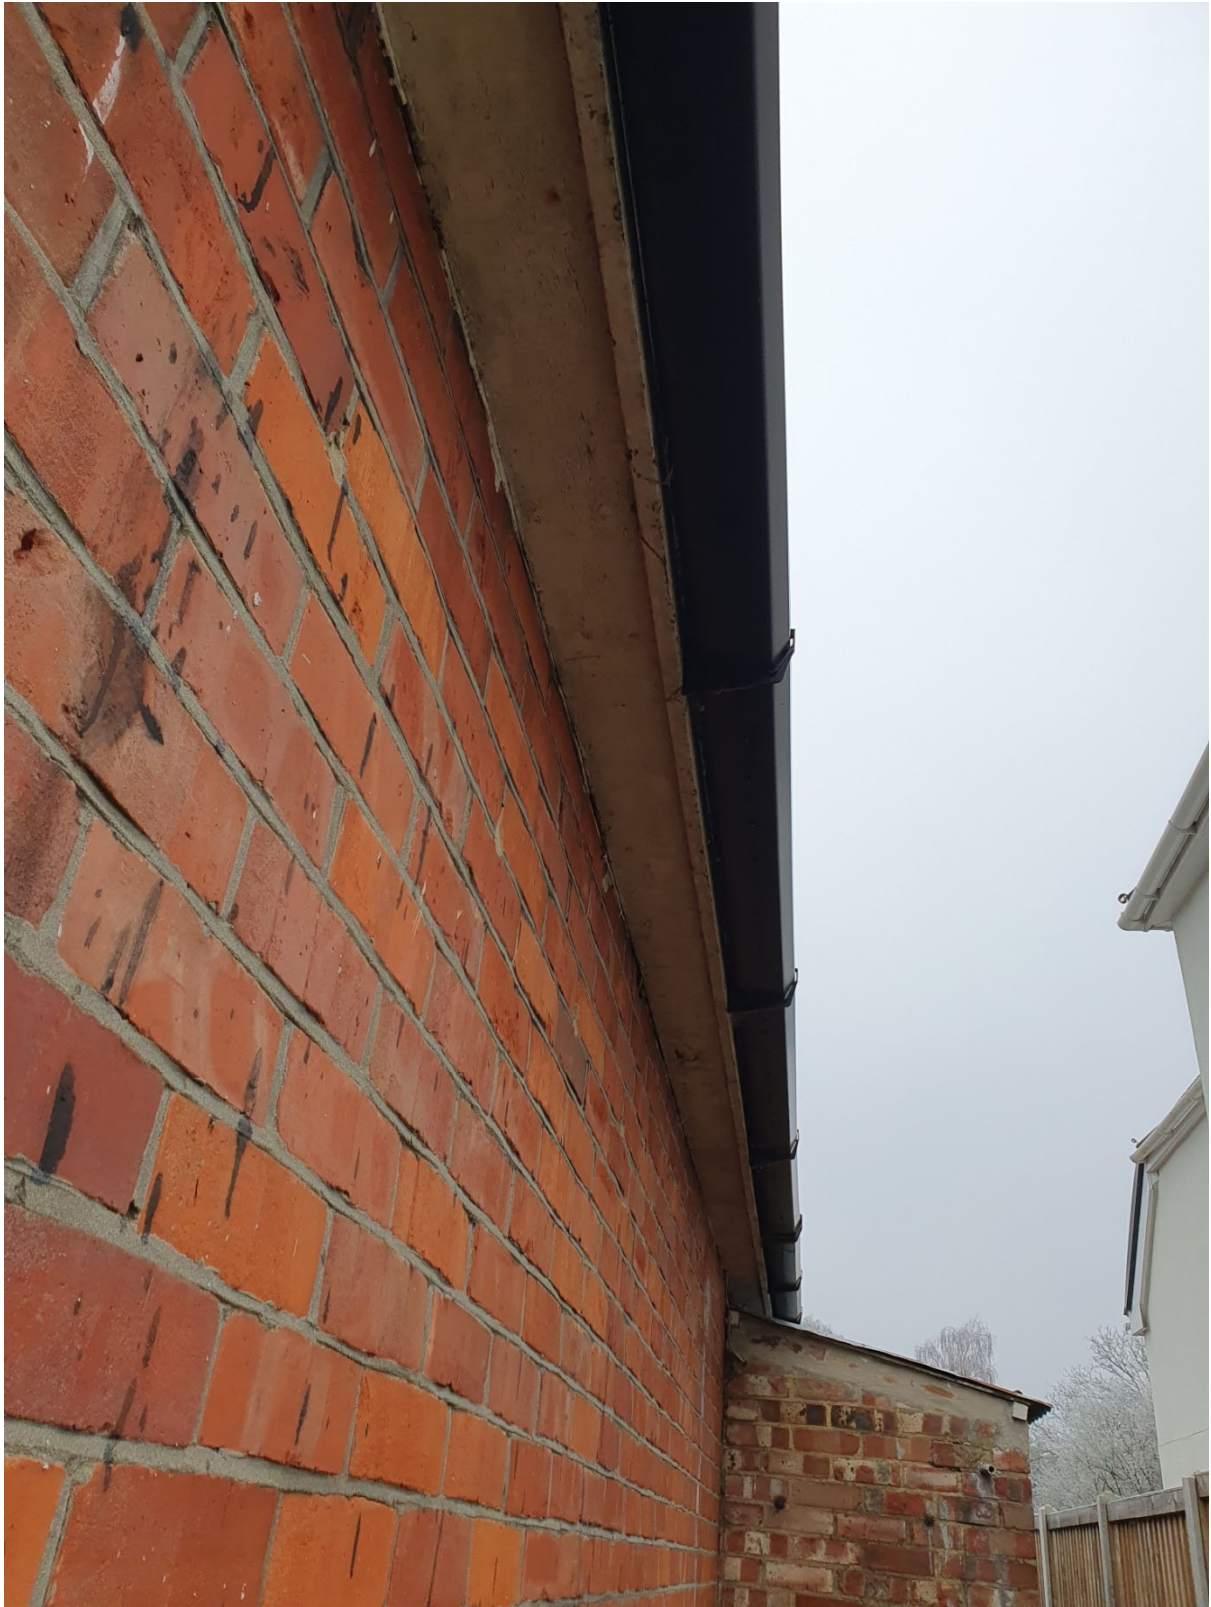
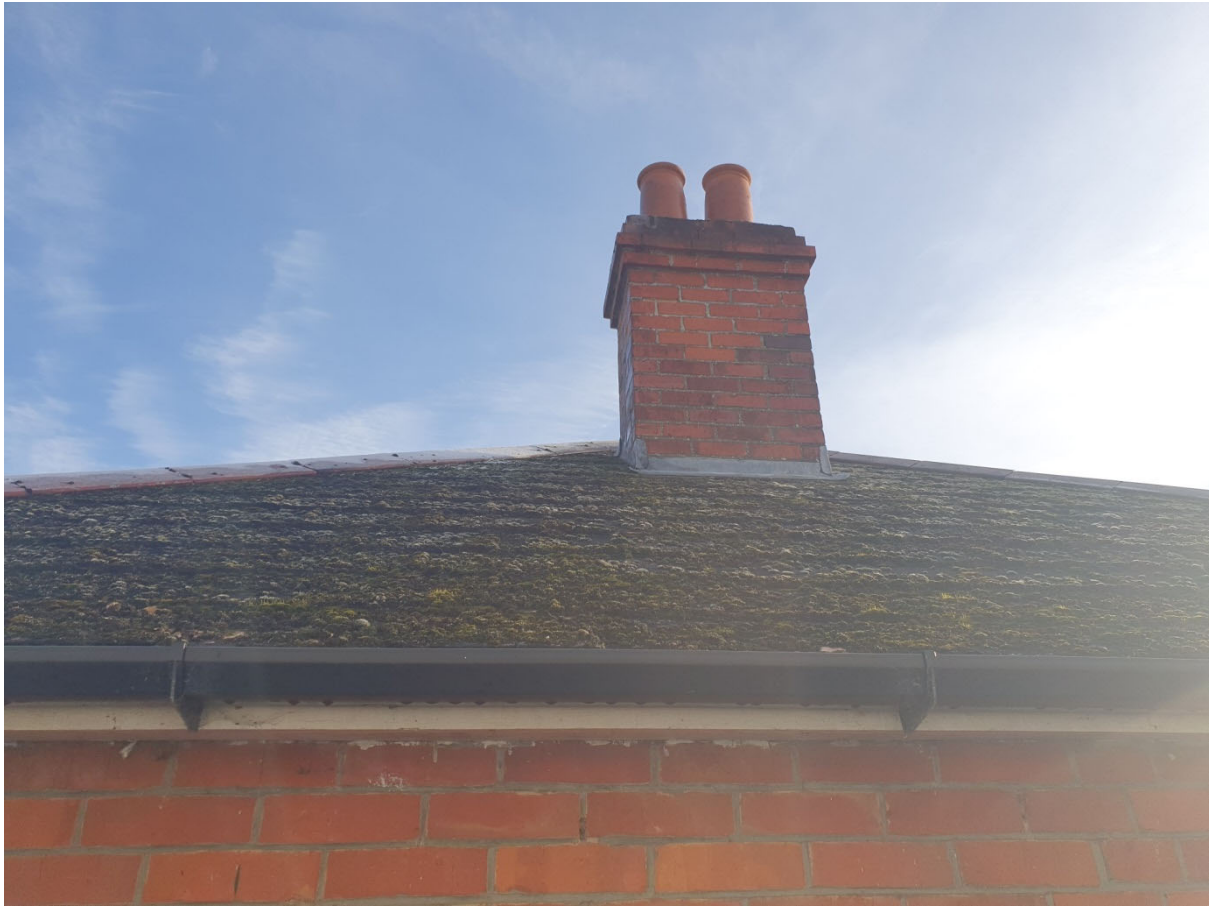
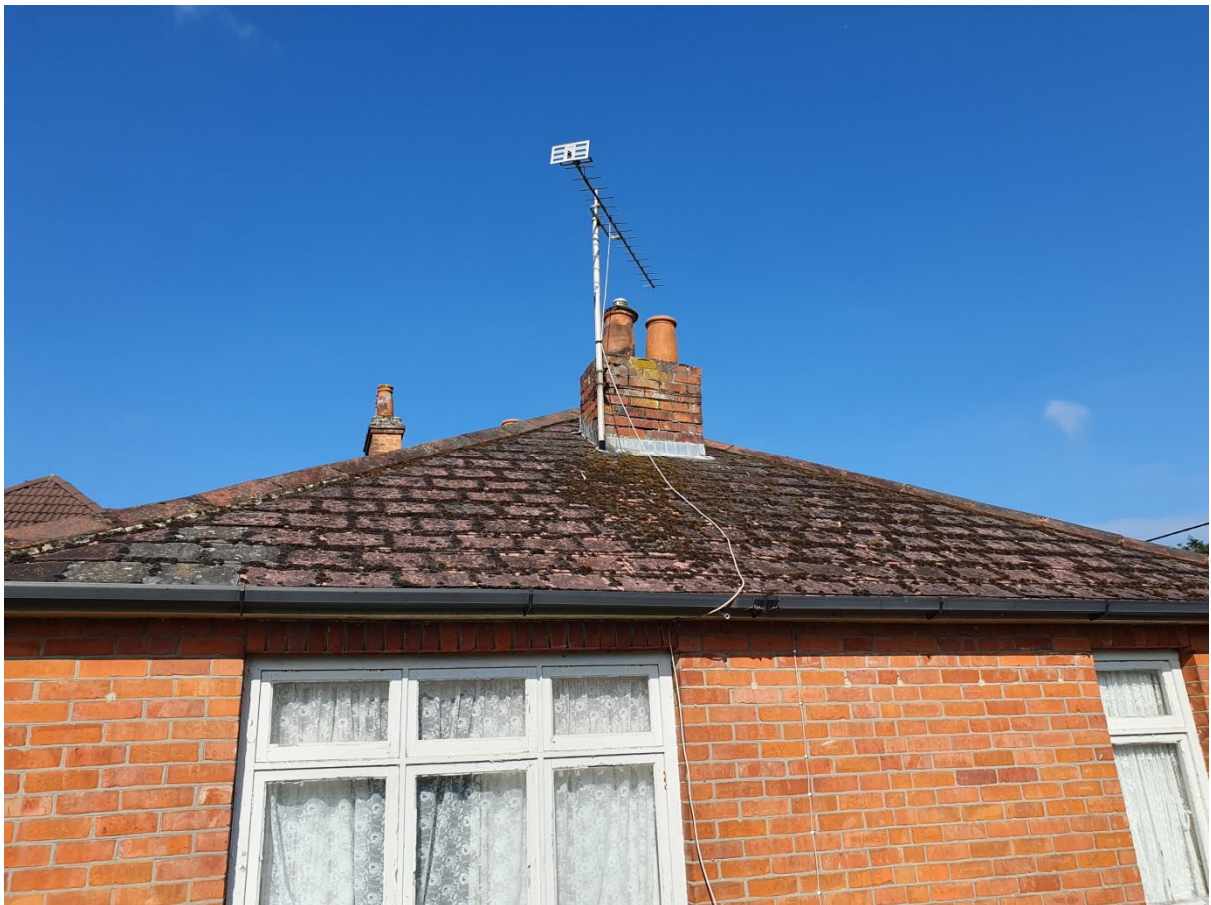
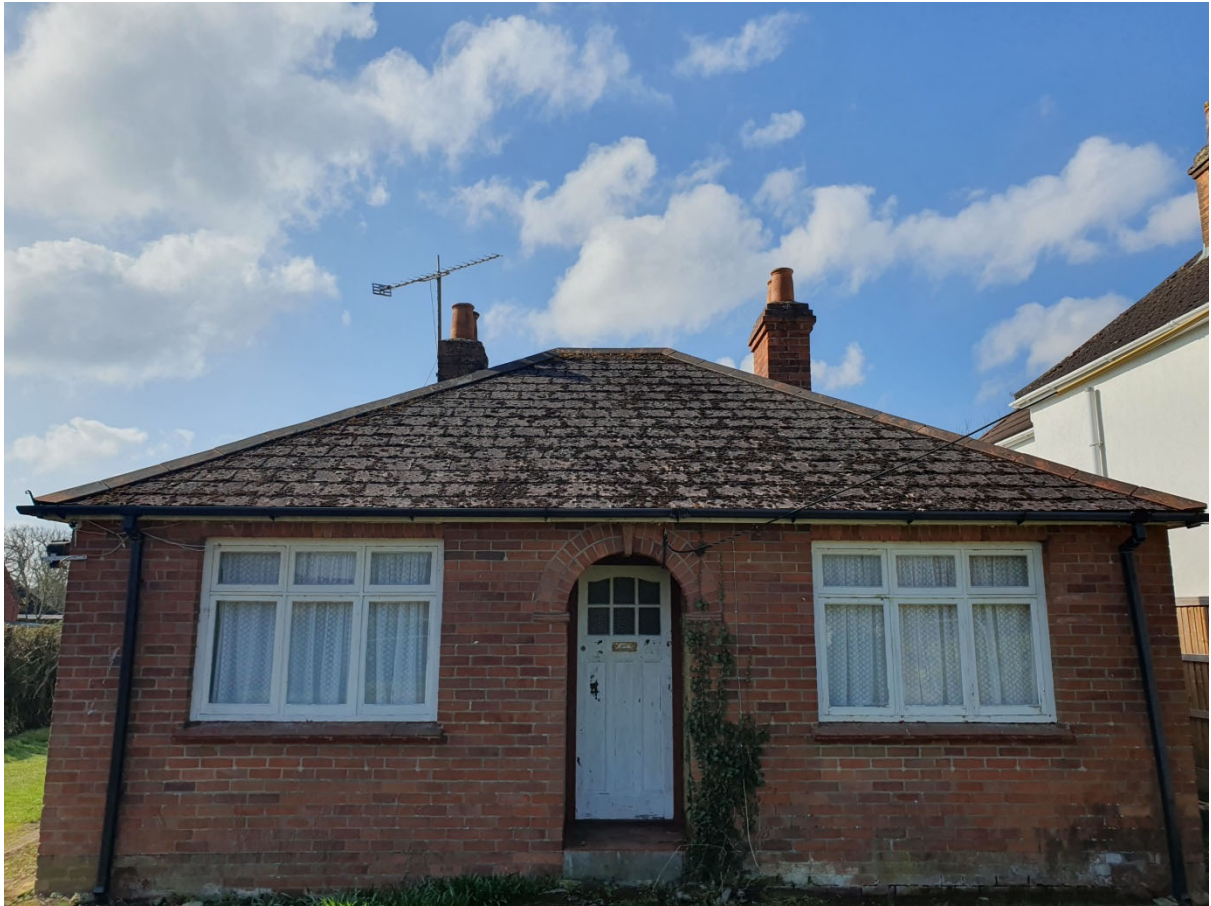
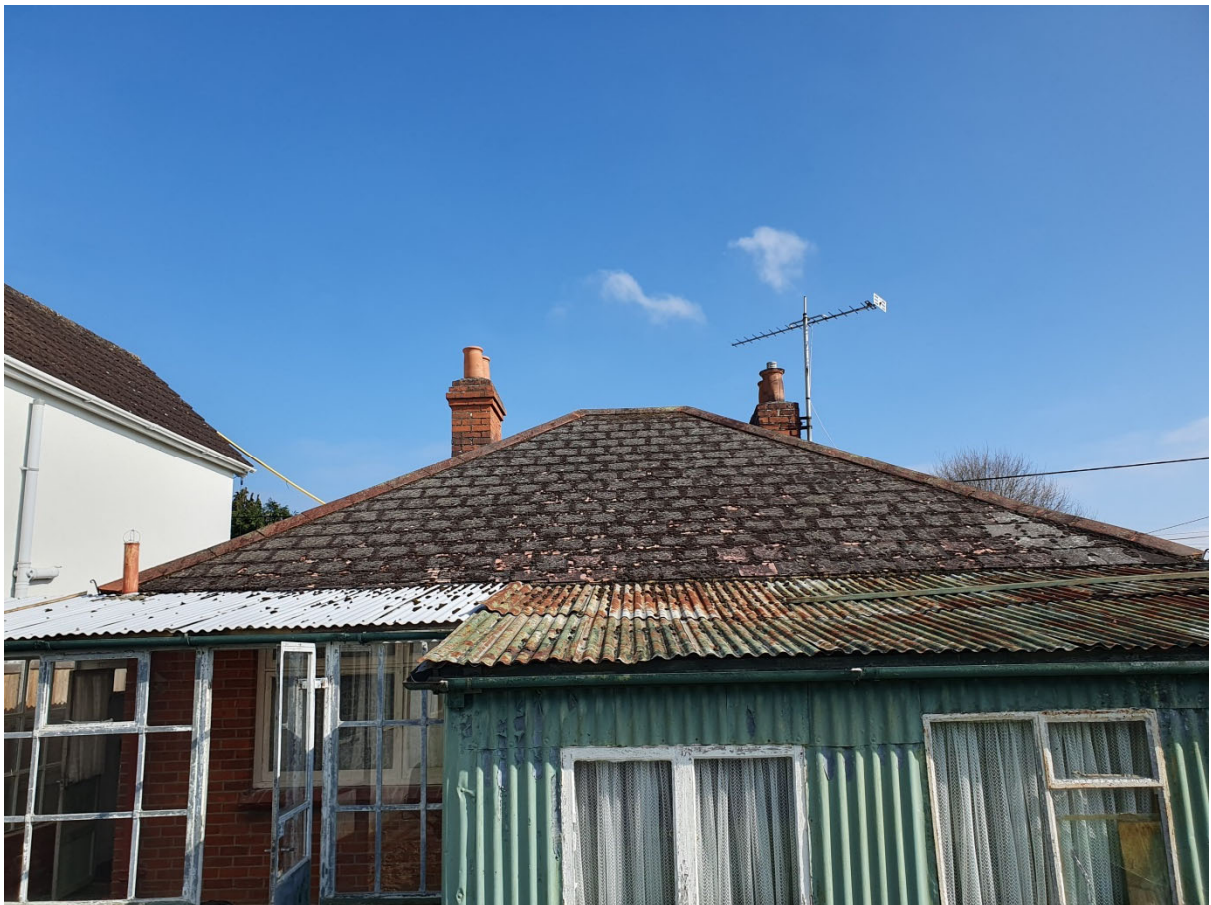
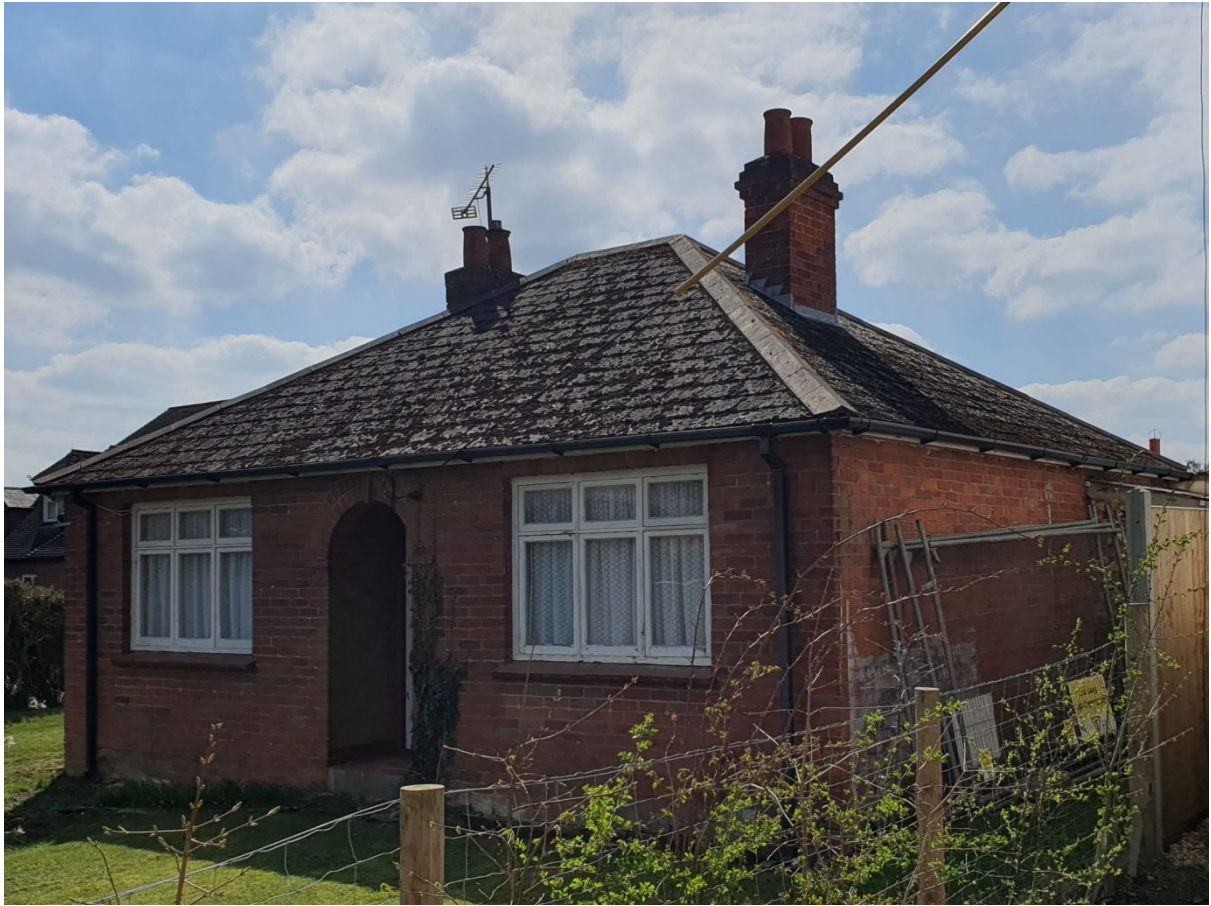
External bungalow images

The existing detached bungalow which is to be demolished consists of a pitched roof with tiles fixed on battens. There is no underfelt. The existing roof tiles and ridge treatments are in good condition with no missing/cracked or loose fitments. The eaves and roof treatments (soffits, fascias and chimney flashings) are fully sealed with no gaps or crevices which effectively prevent access to roosting species (Bats) from entering the roof space. The loft has been used as ancillary household storage.
