Tree Inspection Report

Site: Elm Court, Truro

4 March, 2018

Colin Hawke, BSc, MICFor, FArborA

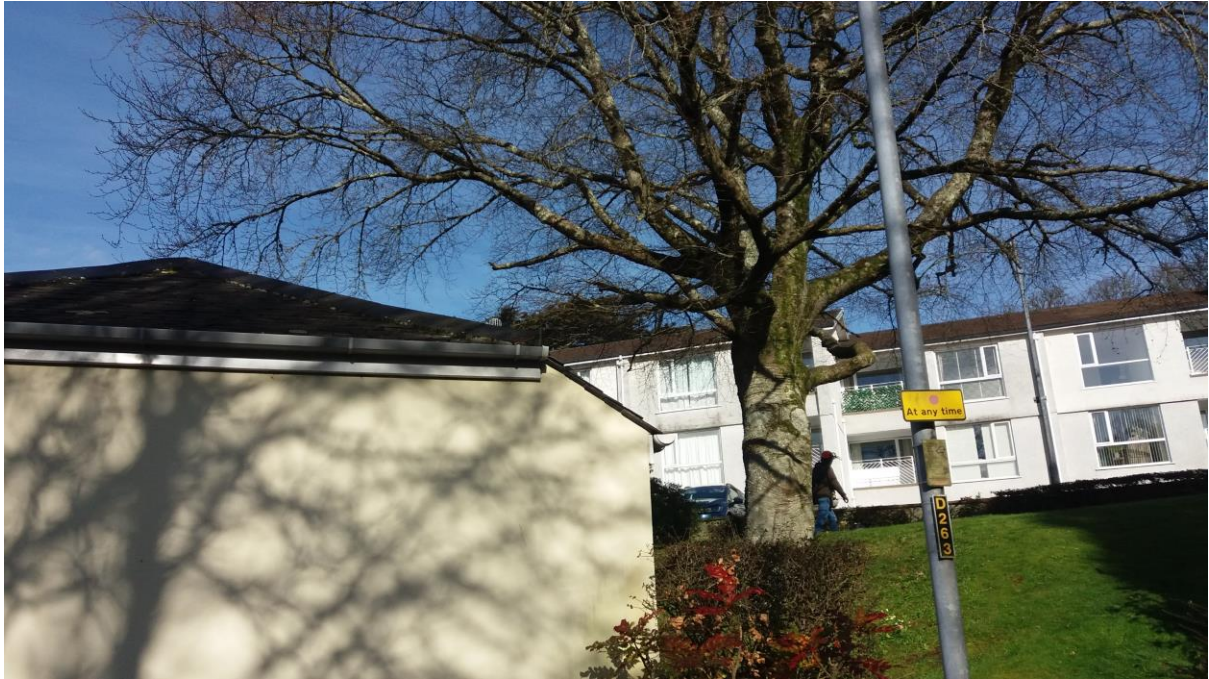
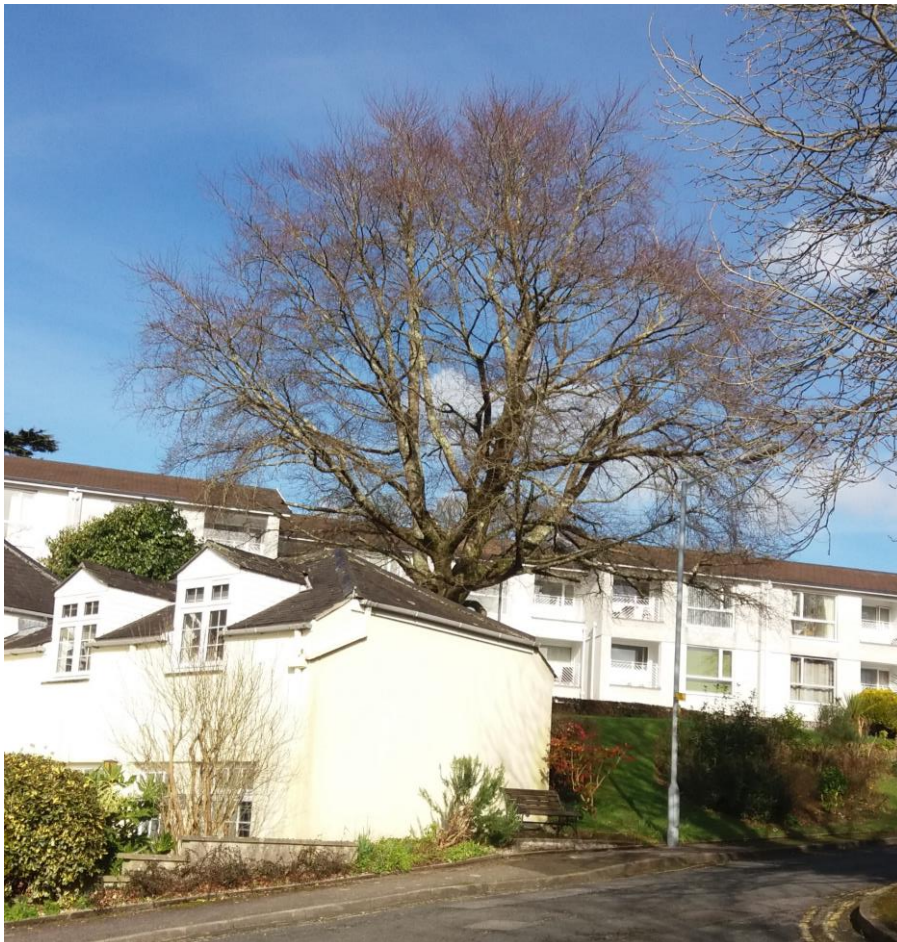
Photo 1

Photos 1 & 2 – T1 showing overhang and context

Ref	Species	Age Range	Height Range (m)	Stem Dia. Range (cm)	Vitality	Observations	Recommendations	Priority
T1	Copper Beech	M	17-18	>100	G	<p>Close to and overhanging building below.</p> <p>Crown breaks at ~3m. Some bark inclusion in major fork but doesn't appear to be structurally significant.</p> <p>Has been pruned historically to clear roof and street light. Crown spread 6-7m.</p> <p>Some bark bleeding at base of trunk on NE quarter. Currently of minor significance but may signify onset of Honey fungus decay.</p>	<p>Light prune to give 2m clearance of light, pruning branches at point of origin.</p> <p>Remove in entirety 1 limb over roof. Will leave larger wound than desirable but should negate need for repeated pruning.</p> <p>Monitor basal decay</p>	<p>Man1</p> <p>Man1</p> <p>Man2</p>
G1	3 Beech	EM	3-5	20-30	?	Heavily lopped. 2 should recover but 1 may not	Consider supplementary planting to create a screen for the wall or install a framework against the wall and train the Wisteria to cover wall	Man3

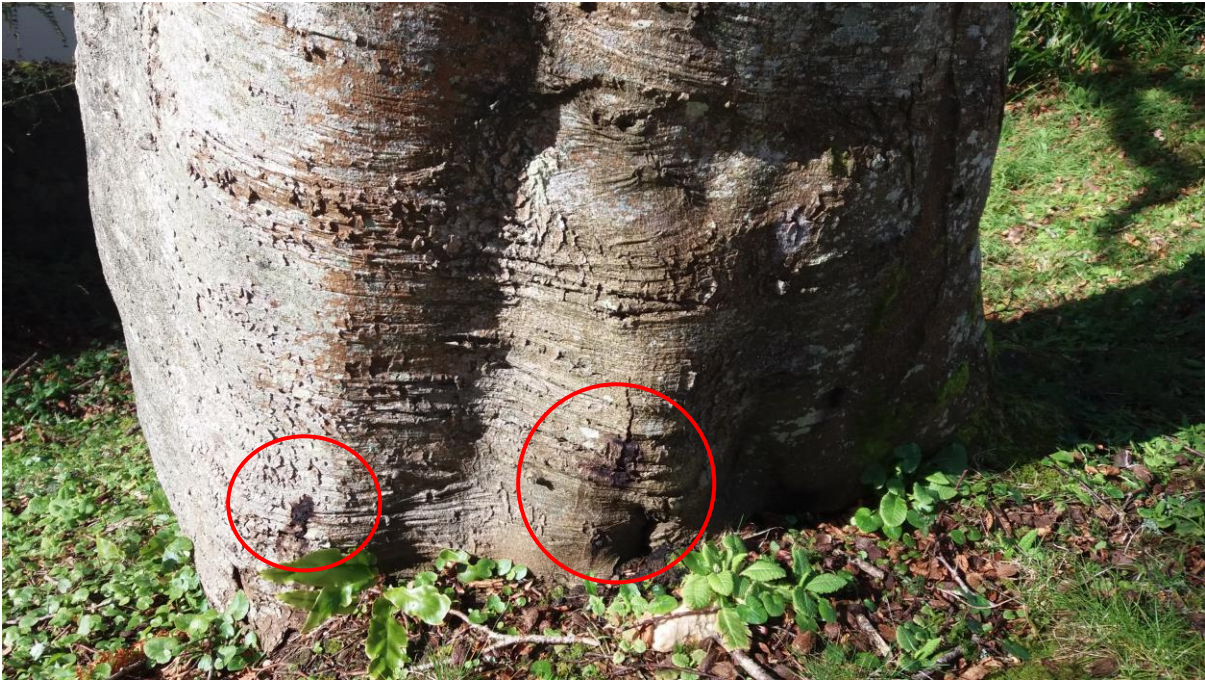
Photo 3

Photos 3 – T1 showing bark bleeding on NE quarter

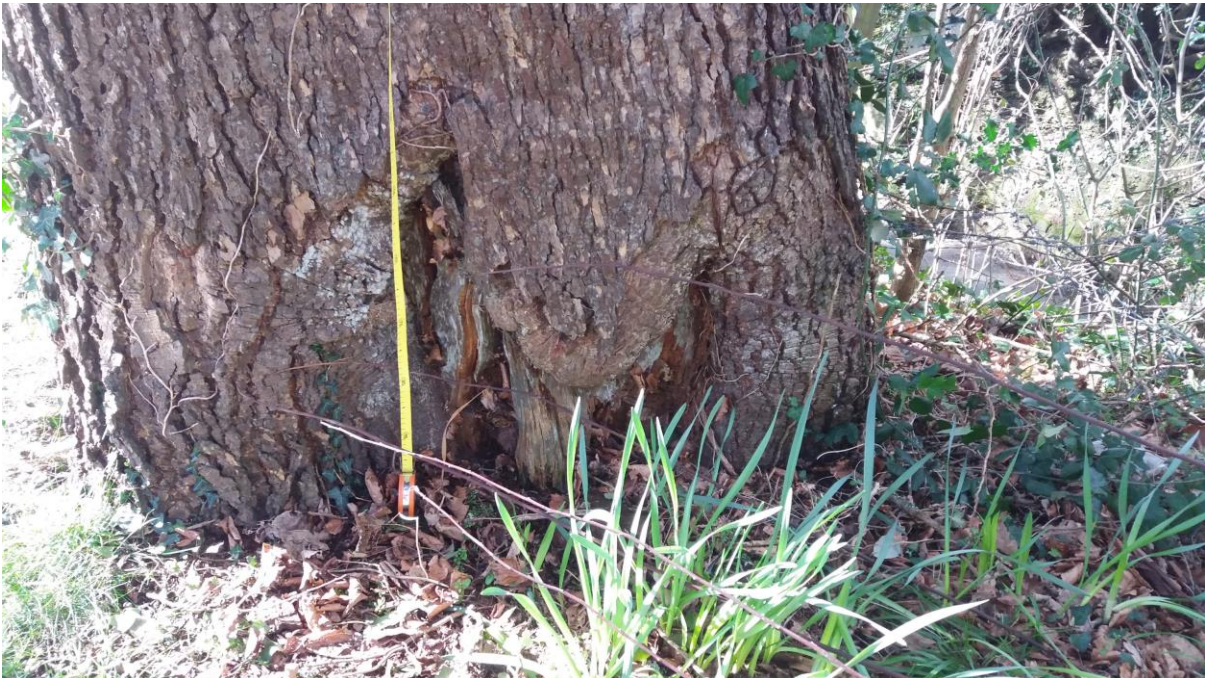
Photo 4 – T4 showing extent of basal decay and reaction wood

T3	Beech	M	10-12	30-40	G	Has been pruned over lawn	No action	
T4	Cedar	M	~20m	111	G	Basal decay on north side 30-40cm wide x 40cm high. Buttressing either side is good. Decay appears to be isolated and not structurally significant. The trunk in this quarter is significantly flattened suggesting that the decay has been present for a considerable time.	No action. <u>Advisory</u> : Retain deadwood. This is a low risk and helps to dampen branch movement. Removal of significant amounts of deadwood can increase risk of branch failure. Fell the small sycamore (not protected) by the road sign behind this tree.	Man2

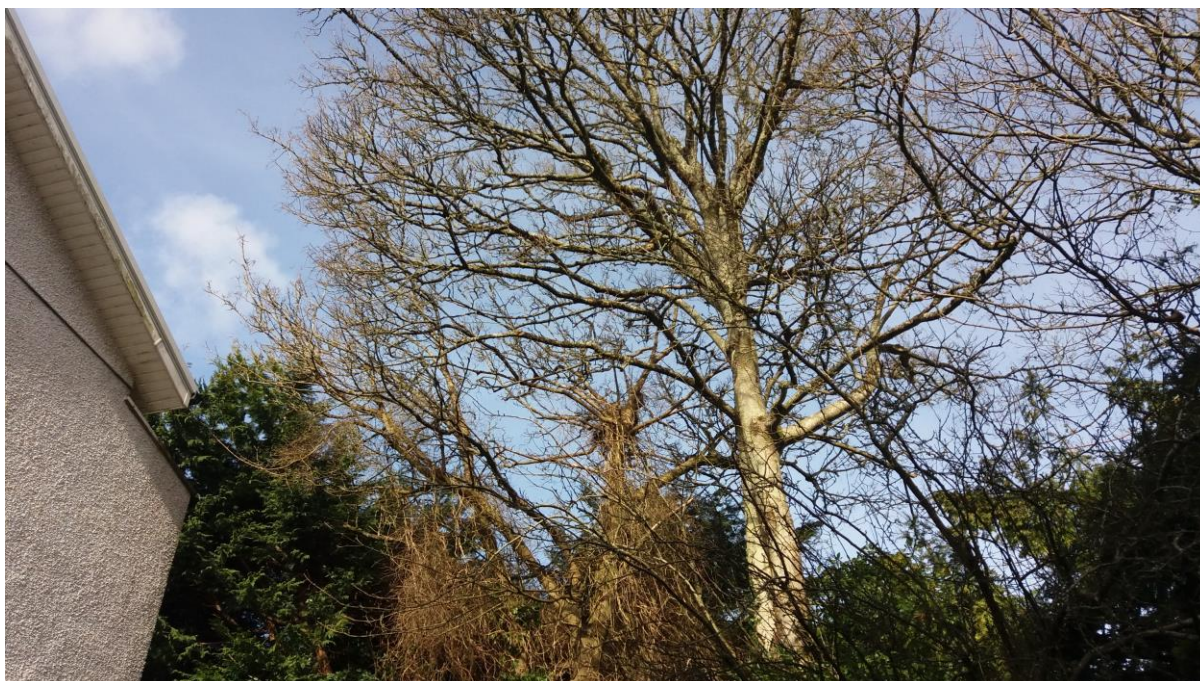
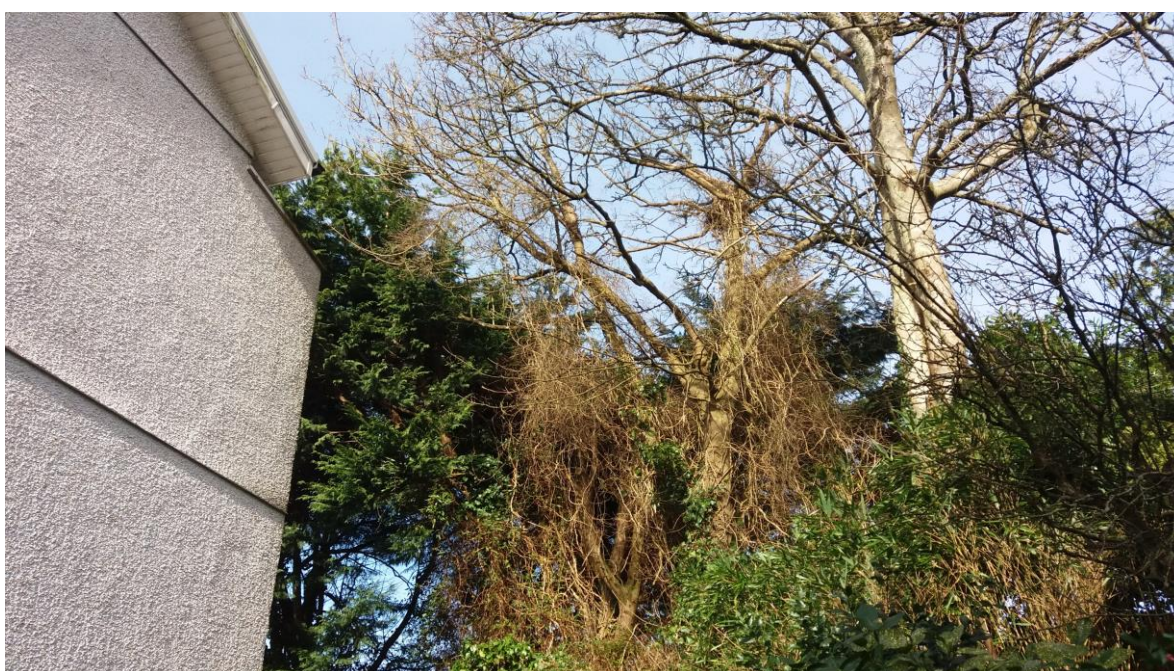
Photo 5

Photos 5 & 6 G8 showing proximity to building

G8	LEYLANDII	M	10-15			Appears to be on neighbour's property but overhangs grounds. Have been pruned. Clematis growing profusely in some stems	Discuss management with neighbour. Some reduction desirable (up to 3m) within 5 years.	Man1 Man3

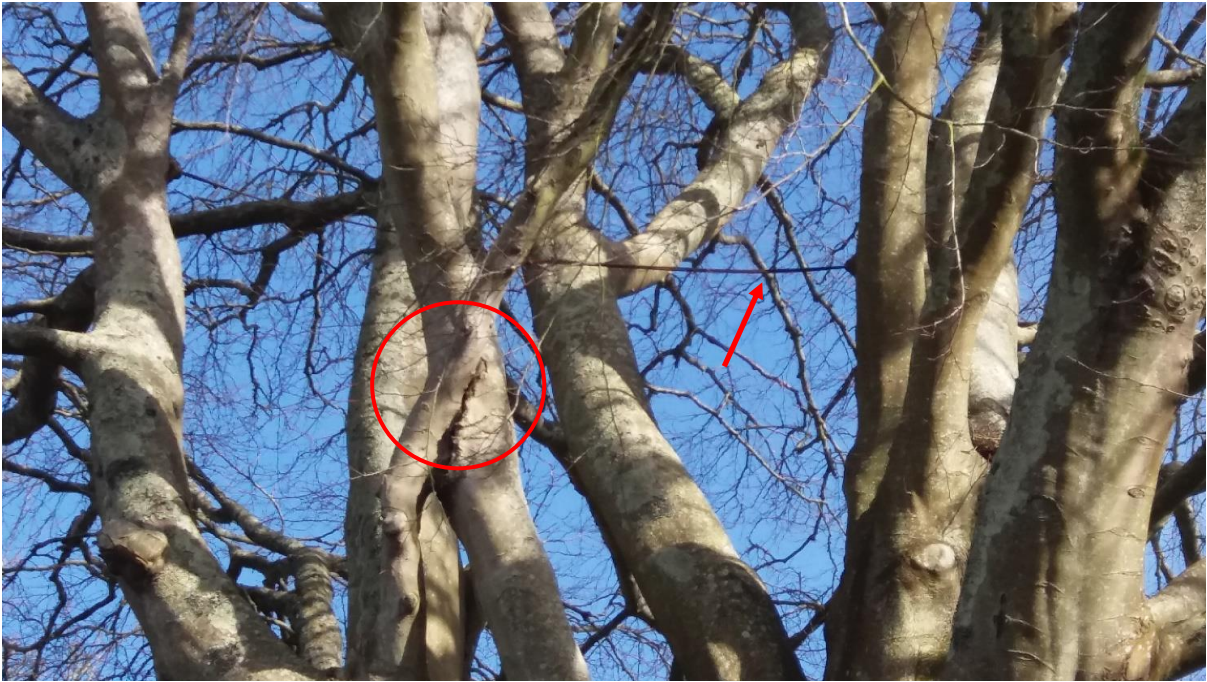
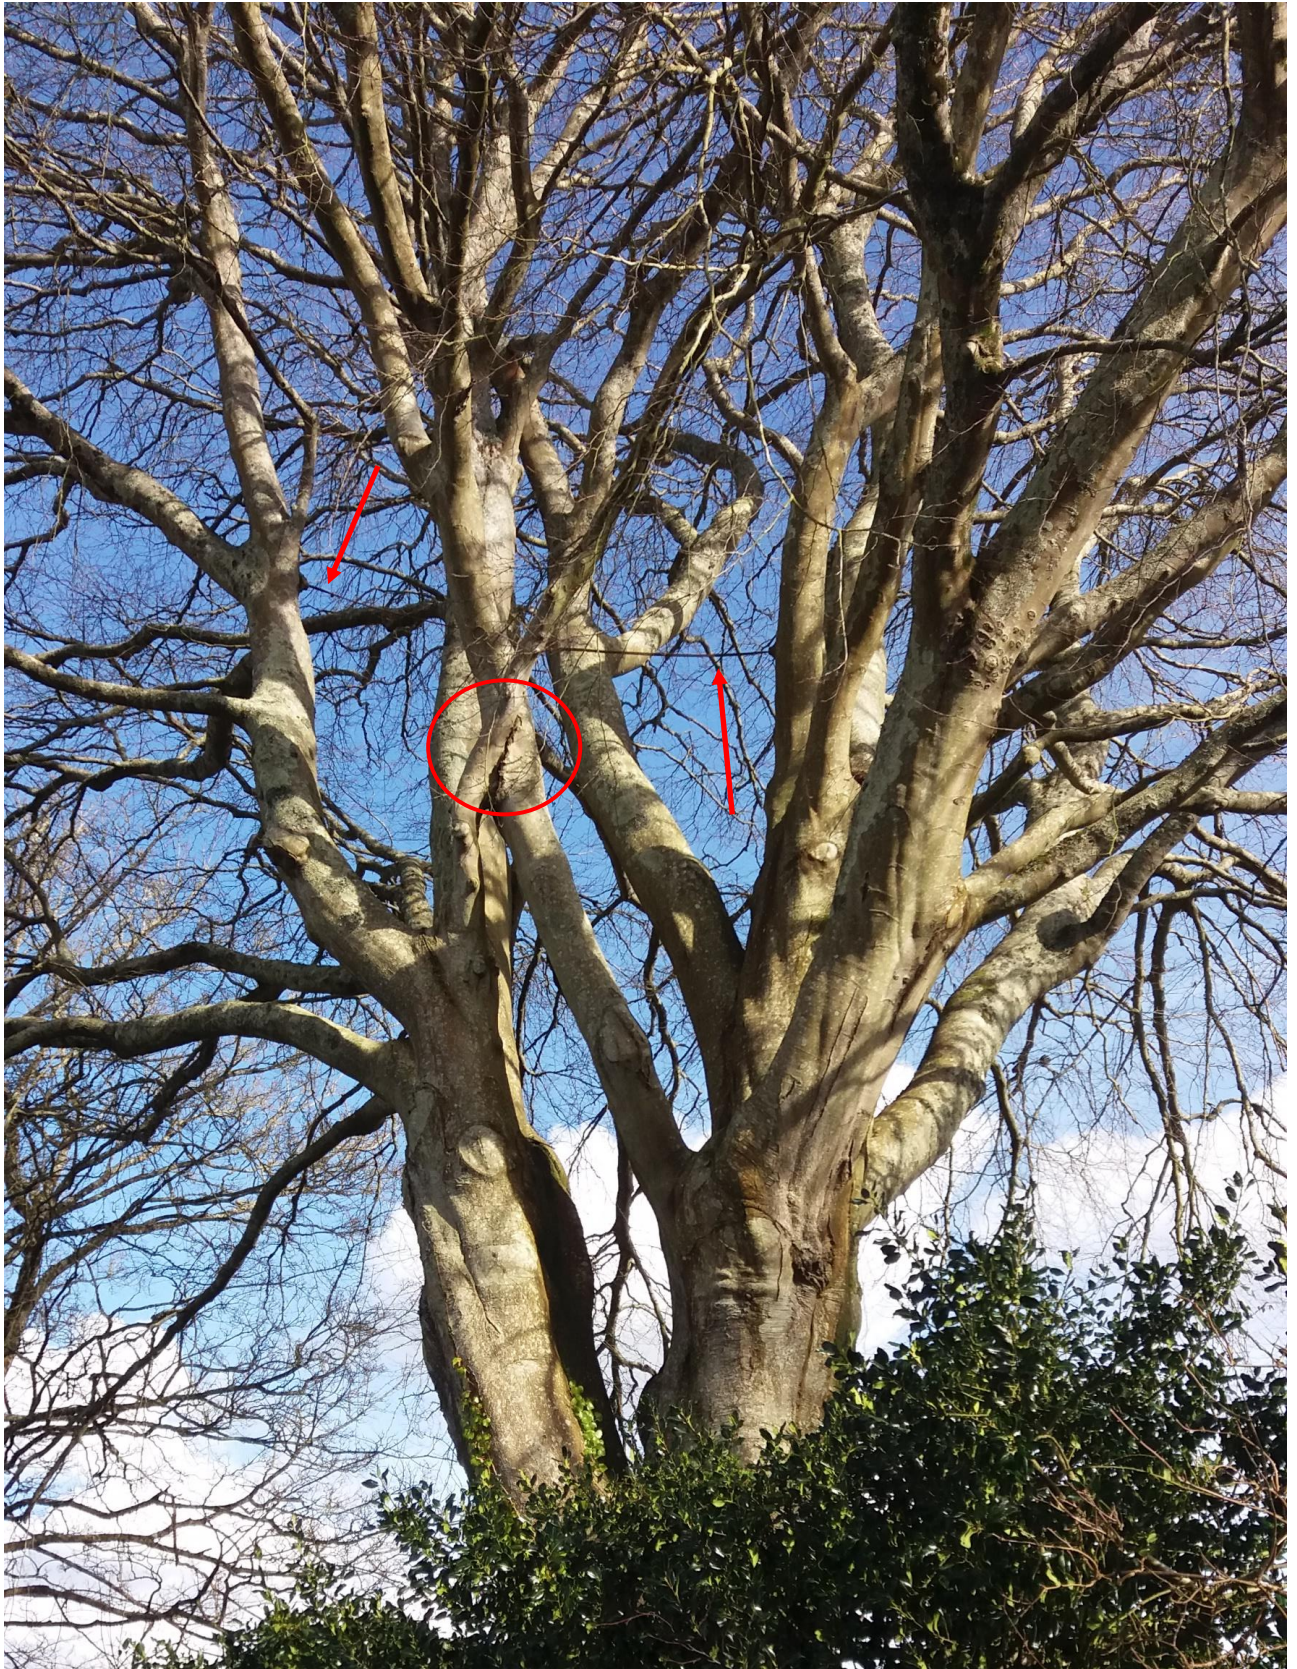
Photo 7

Photos 7 & 8- Tree T11 showing natural graft and cable brace.

Ref	Species	Age Range	Height Range (m)	Stem Dia. Range (cm)	Vitality	Observations	Recommendations	Priority
						<p>Tree forks @ 5m into 2 major stems.</p> <p>Crown has historically been cable braced – presumably to support the major fork. It was not possible to view the condition of the fork fully.</p> <p>1 cable has failed completely and the other is rusty and slack. It is unlikely that this cable would be effective as a brace. However there is a natural brace below the cable plus others above. I do not suspect this tree to be a significant risk of serious harm from my limited access to inspect</p>		
T12	Sycamore	M	10-15	40-50	G	<p>On neighbouring ground. Twin stemmed. Some decay in fork. Crown overhangs roof.</p>	<p>Advise owner to investigate fork.</p> <p>With owner’s and TPO consent remove 1 small branch over the roof at point of origin or at boundary if owner’s consent not forthcoming</p>	<p>Man1</p> <p>Man3</p>
