**Project:** Save The Children Refit, Lymington  
**Prepared By:** JB  
**Present:** JB

**Project No:** 03134  
**Date:** 17<sup>th</sup> March 2023  
**Weather:** Sunny and dry

1. Inspection of first floor joists during refit works due to concern raised about their poor condition.

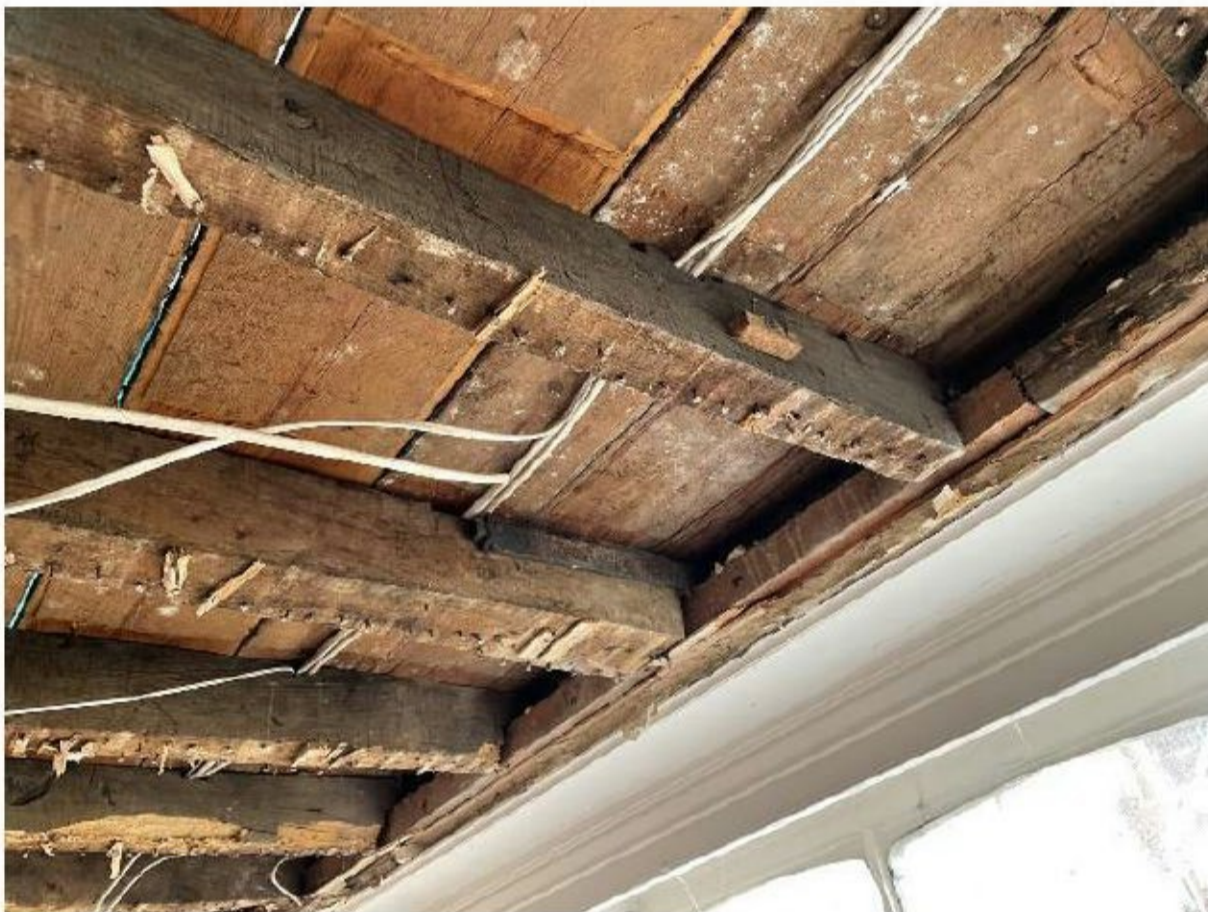
Figure 4 - View of joists a:3-7, joists notched over timber batten. Note metal strap to side of wider joist 6.

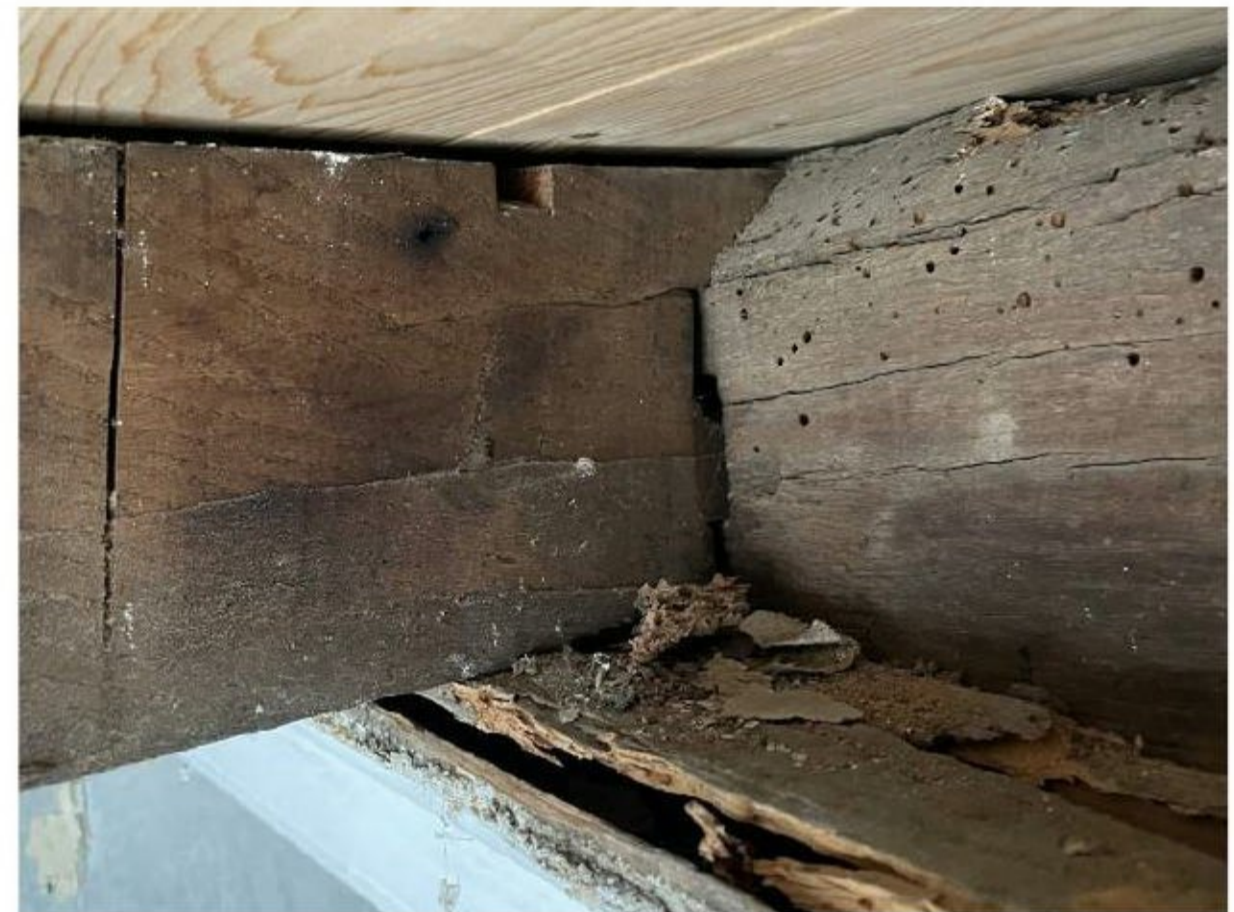
Figure 5 - Typical joist notching into primary beam A, some flight holes in side of beam

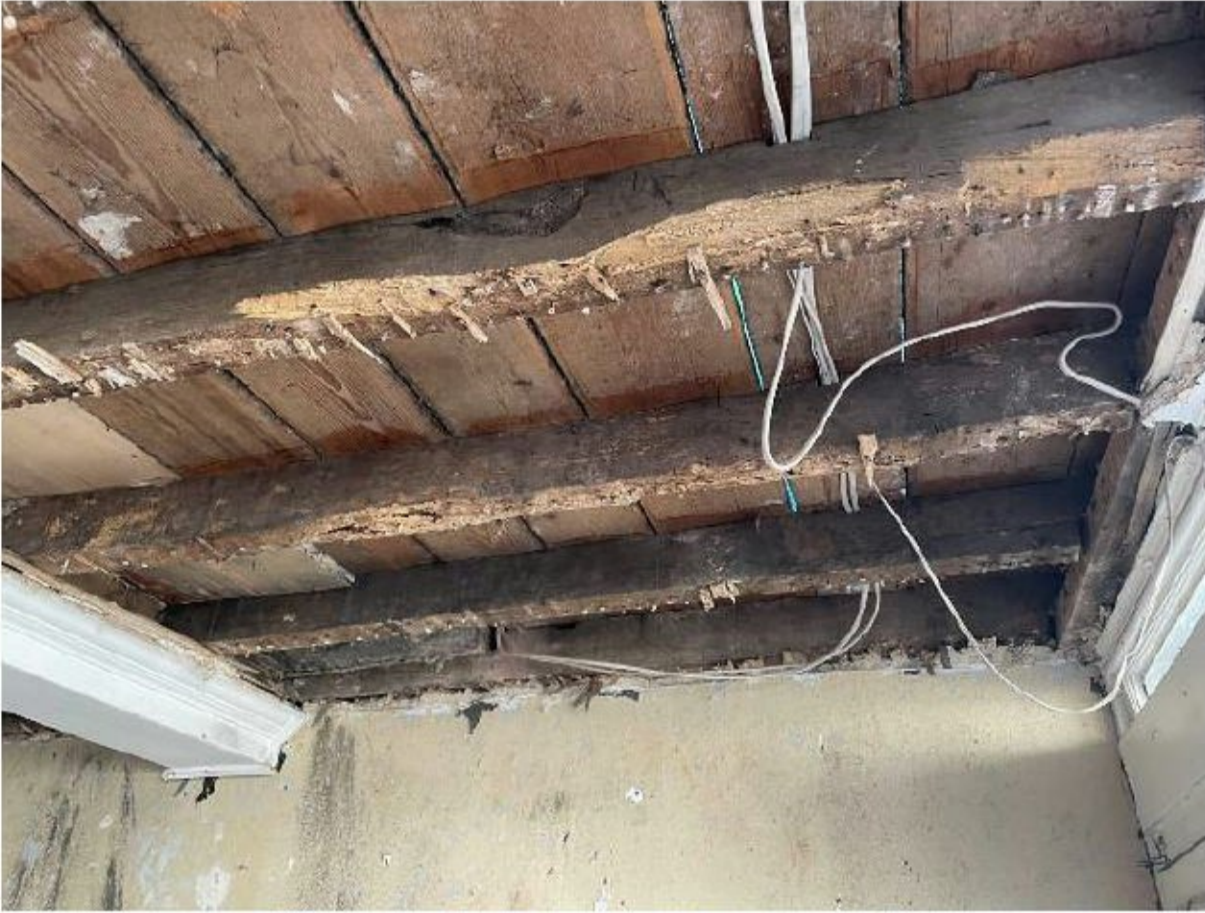
Figure 8 - View of joists a:1-4, note material loss to underside of 3 & 4

5. Where minor defects are recorded, e.g. ~5mm affected to sides or underside then these joists are considered satisfactory. Where the joists are worse affected then it is recommended that these should either be partnered or replaced. These joists are highlighted in the above table in **red**.

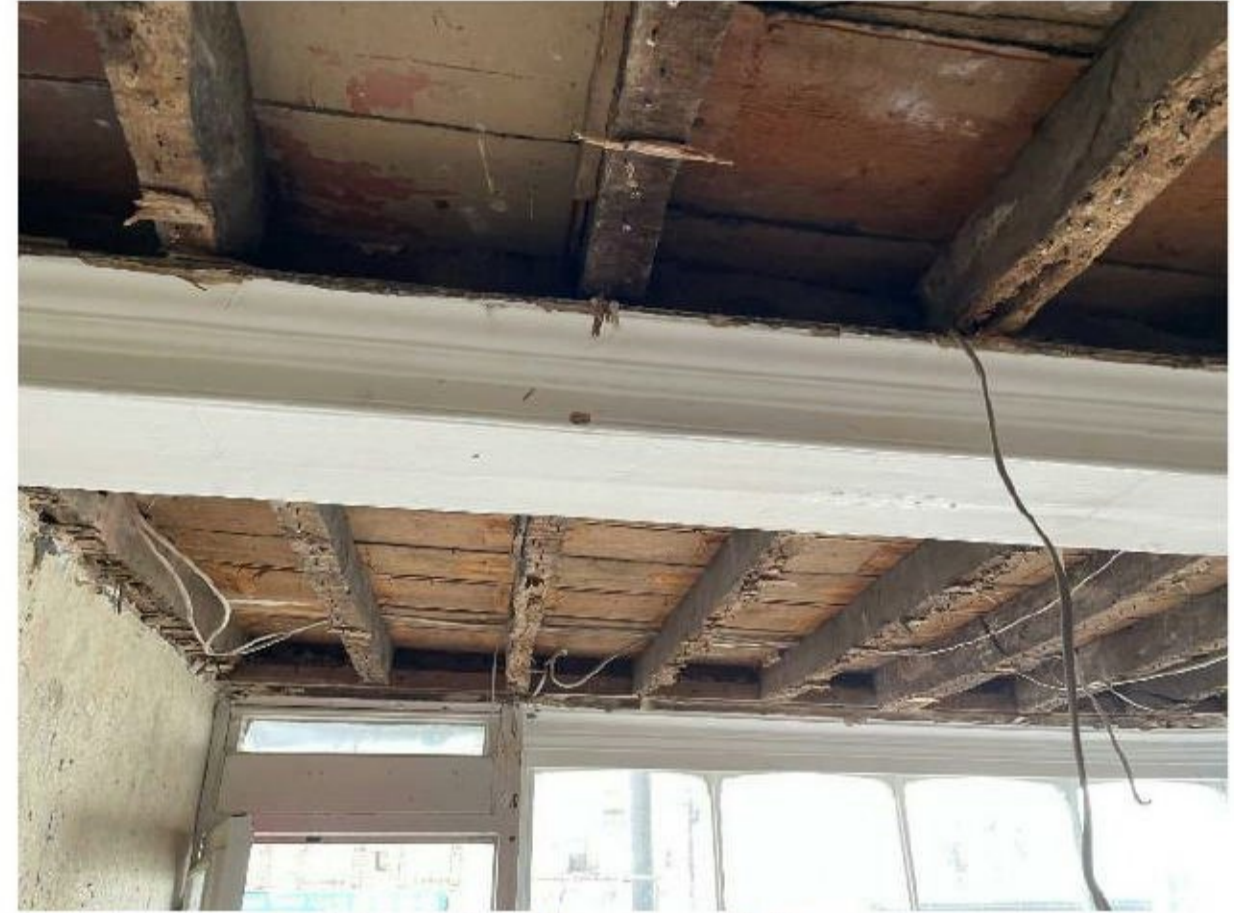
Figure 9 - View looking north from bay b to a, beam A with decorative mouldings in place.

11. The primary beams also display some evidence of beetle attack with flight holes visible above the retained mouldings. These beams feel firm but there could be further damage behind the retained finishes.

7. The existing primary beams have been checked for loading and these are slightly over deflected with the proposed loading but within limits for stresses. It was not possible to inspect the undersides of these beams due to retained finishes. These should be removed locally to ensure the beams are in satisfactory condition.

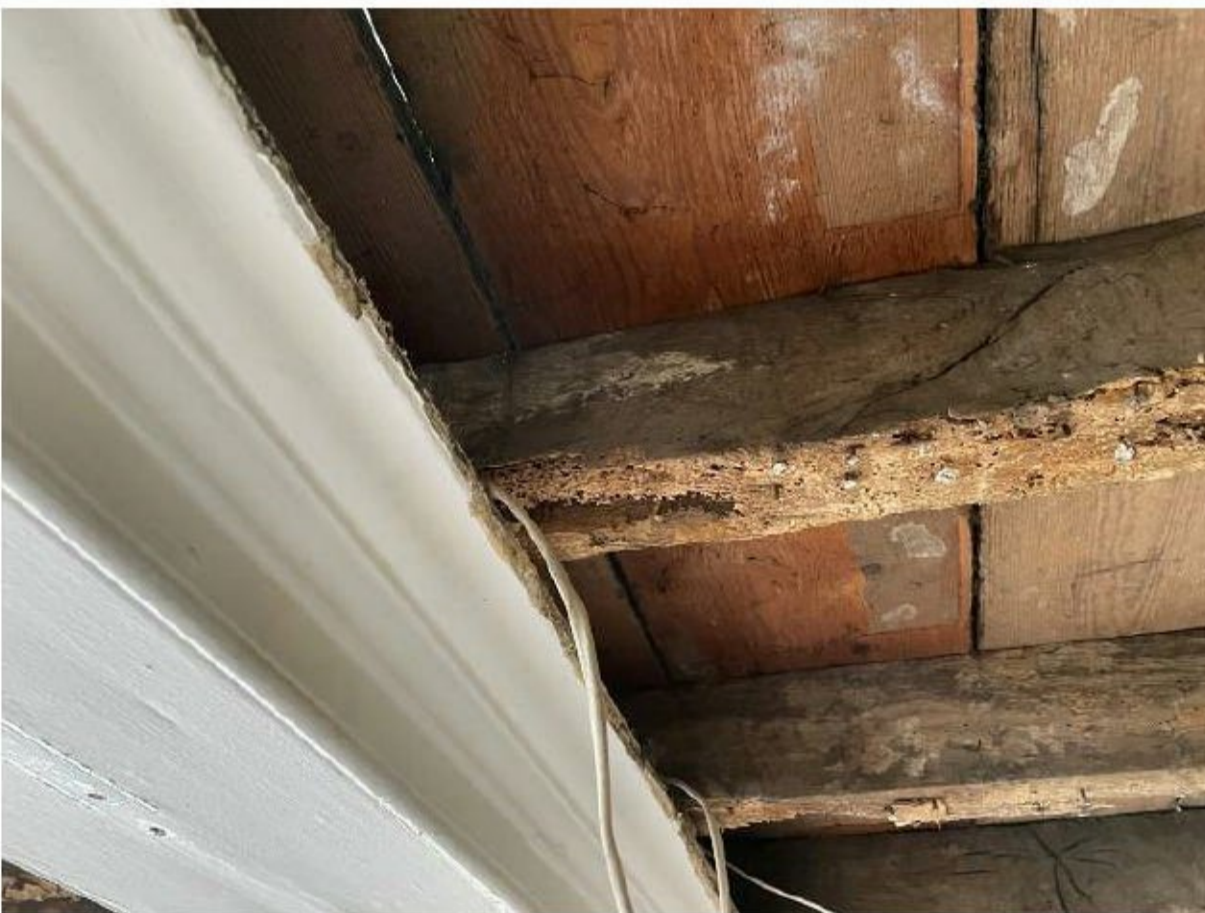
Figure 10 – Joist b 4, loss of material to  $\frac{1}{2}$  joist depth

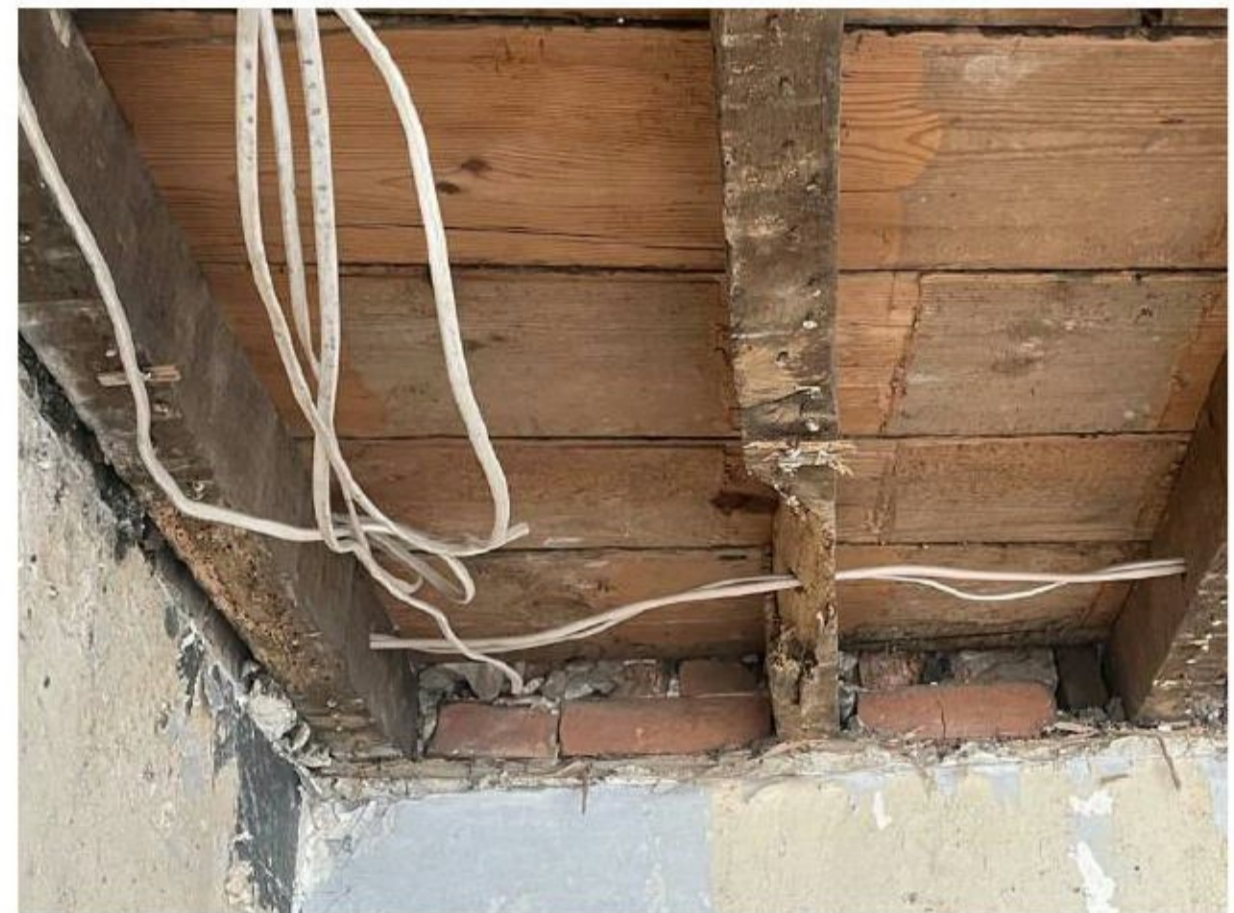
Figure 11 – Joists b 10 & 11, south bearings. Significant loss to joist 10.

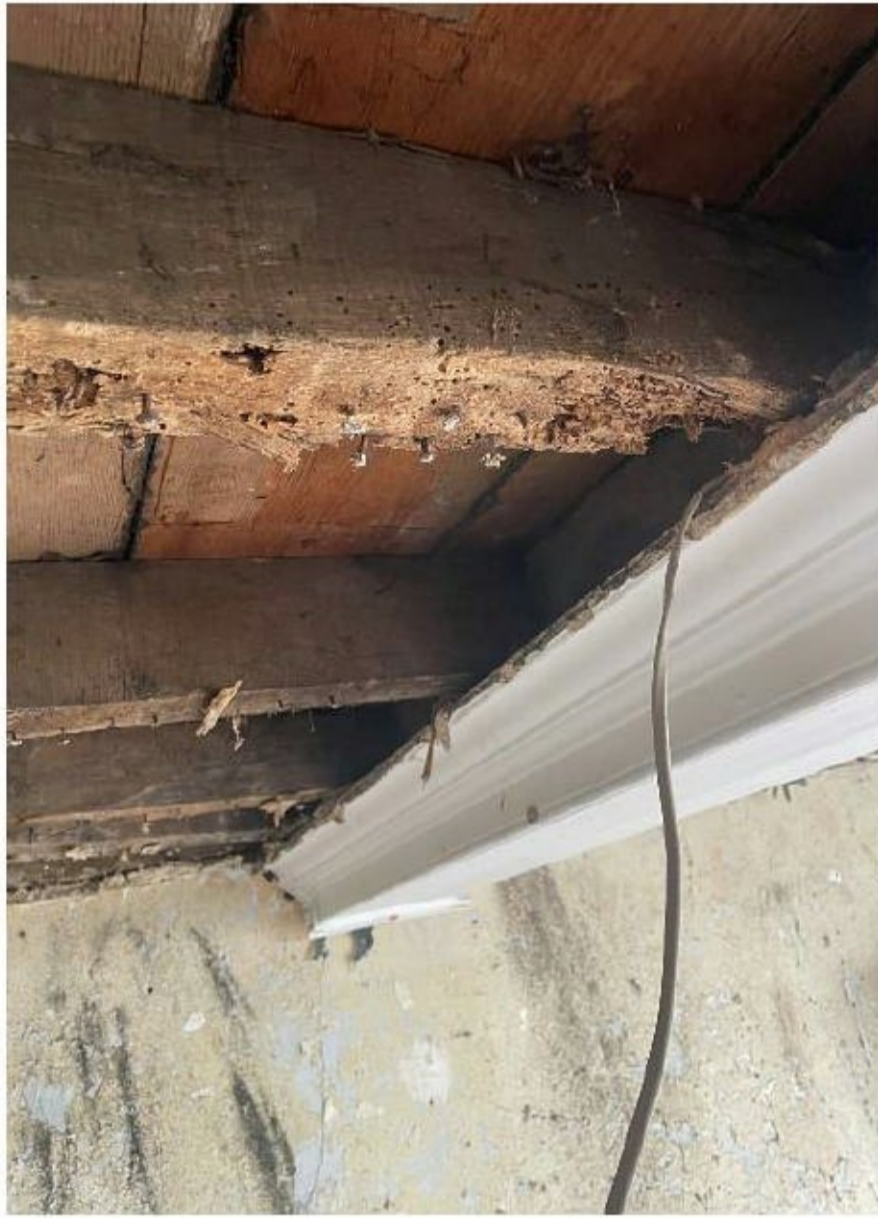
Figure 12 – Joist b 4, loss of material to ½ joist depth

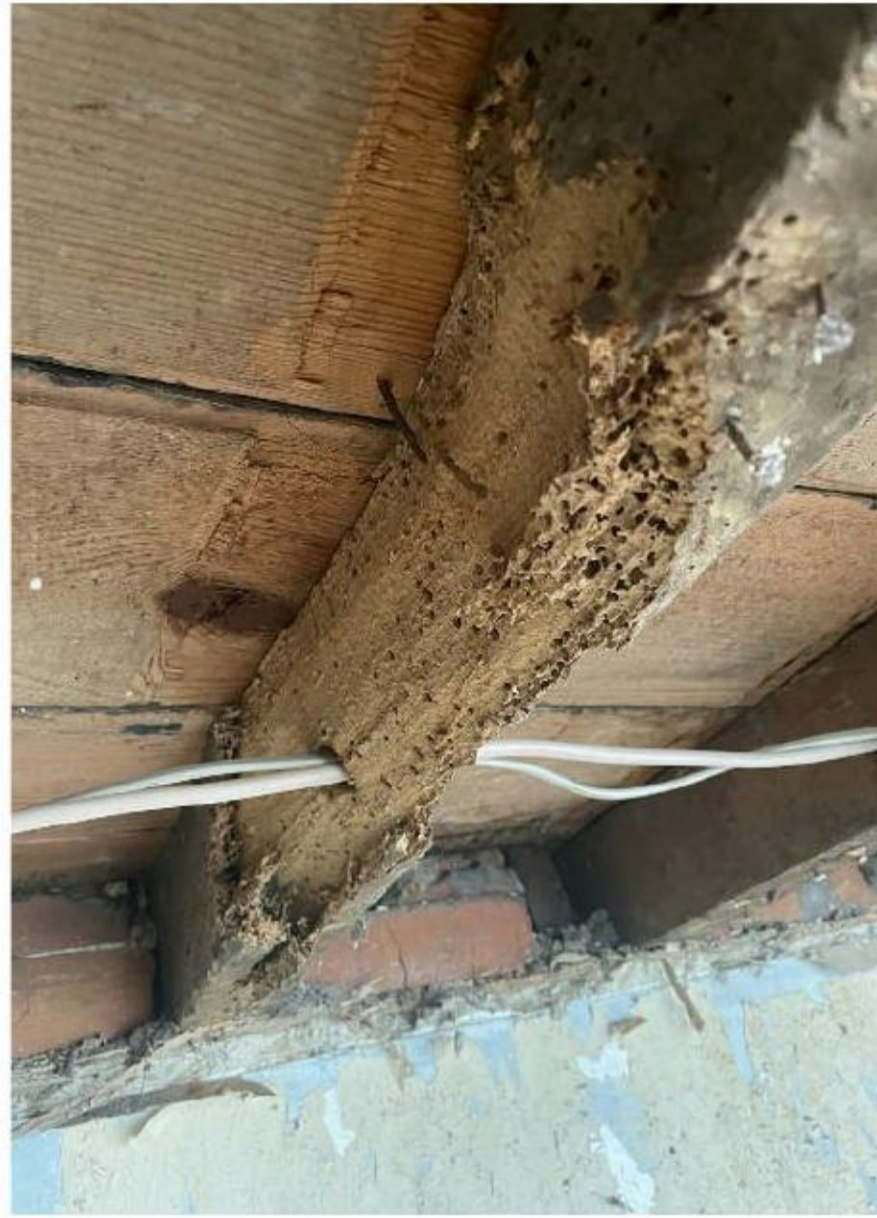
Figure 13 – Joists b 10, south bearing. Loss of sap wood.

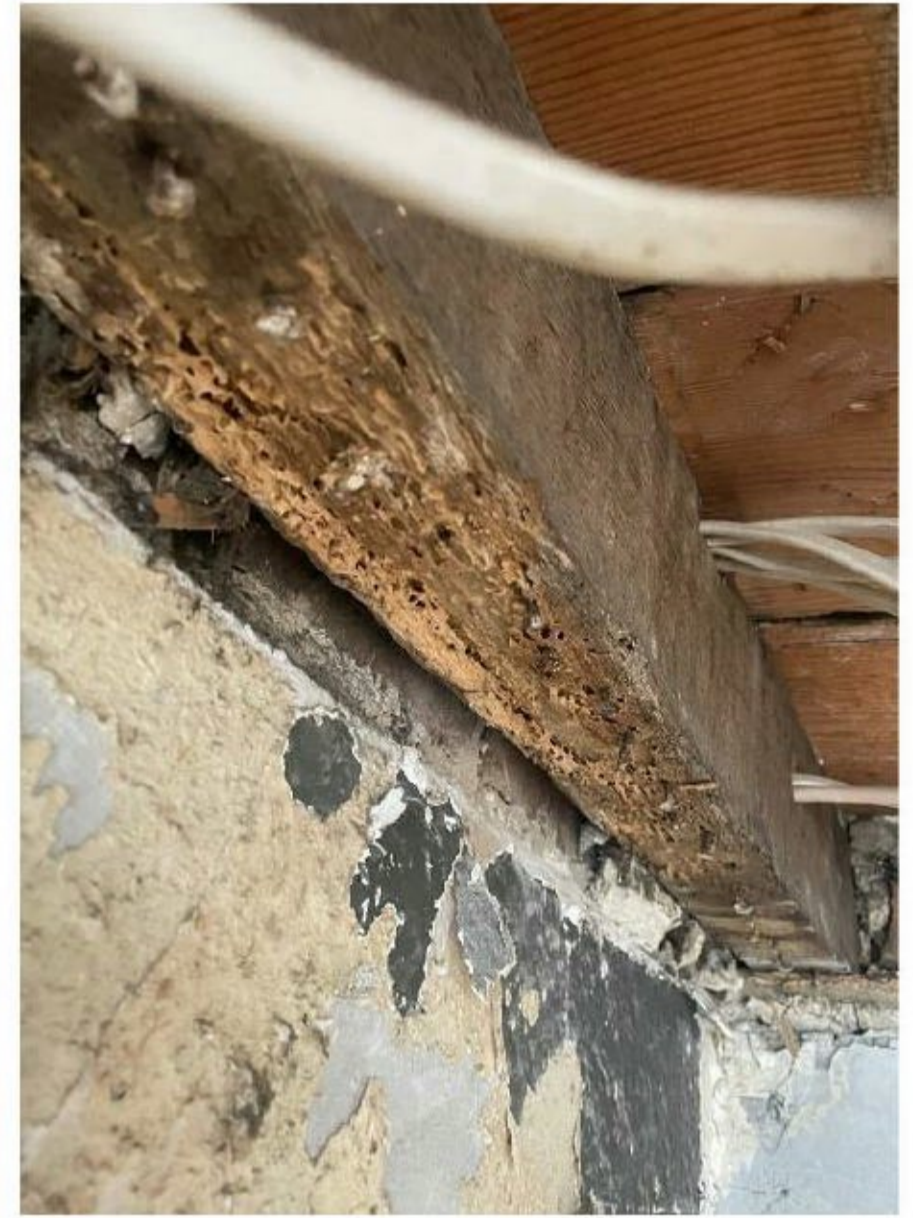
Figure 14 - Joist b 11, loss of material to underside

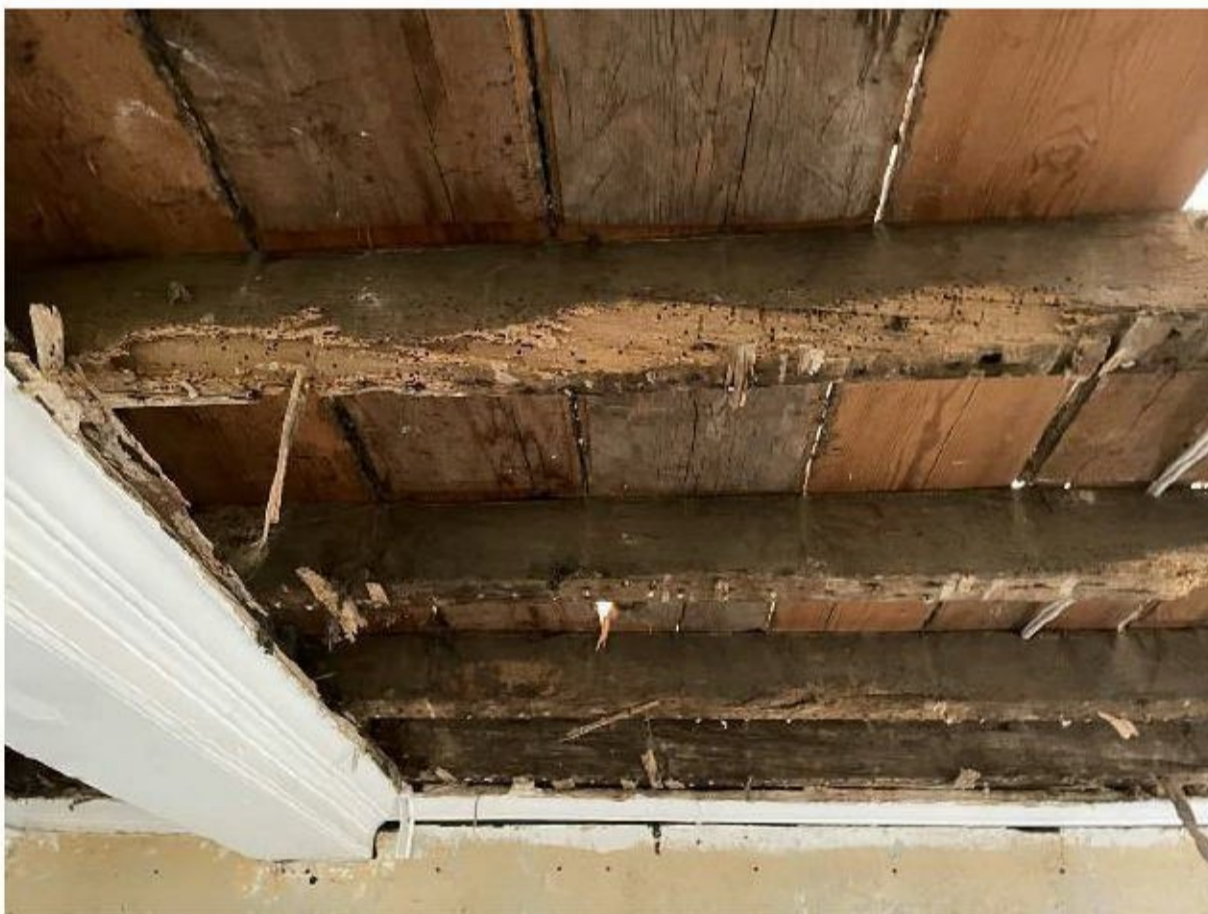
Figure 15 – Joist d 8, significant loss of material to north end west side

3	Ok, minor beetle attack to sides
	<b>4</b>	Major beetle attack to N bearing to 1/2 depth
	<b>5</b>	Major beetle attack to N bearing to 1/2 depth
	6	Minor beetle attack to u/s, ~5mm
7	Ok, surface holes	
8	Ok	
9	Ok	
<b>10</b>	Major beetle attack to S end, u/s and E face	
<b>11</b>	Major beetle attack to S bearing E side, depth to 1/4	
<b>c</b>	1	Ok
	2	Ok
	<b>3</b>	Beetle attack to u/s to 1/3 depth
	4	Minor beetle attack to u/s and side ~5mm
	5	Minor beetle attack to u/s and side ~5mm
	6	Ok
	<b>7</b>	Beetle attack to W side and u/s, and N bearing
	8	Ok
	9	Ok
	10	Ok
	11	Ok
<b>d</b>	2	Ok
	3	Ok
	4	Minor beetle attack to N bearing ~5mm
	5	Ok
	<b>6</b>	Ok, some beetle attack E side, S bearing up to 1/4 depth
	7	Ok
	<b>8</b>	Major beetle attack to NW side with loss of bottom corner

6. Depending on the view of the conservation officer, partnering could be achieved with modern C24 softwood timbers (120mm deep x 50mm wide) either bolted alongside the existing with M10 at 300mm c/c, or otherwise spanning new joists in between the existing and fixings to the supports with face fix joist hangers. If joists are to be replaced then these should be like for like with connections matching the existing.

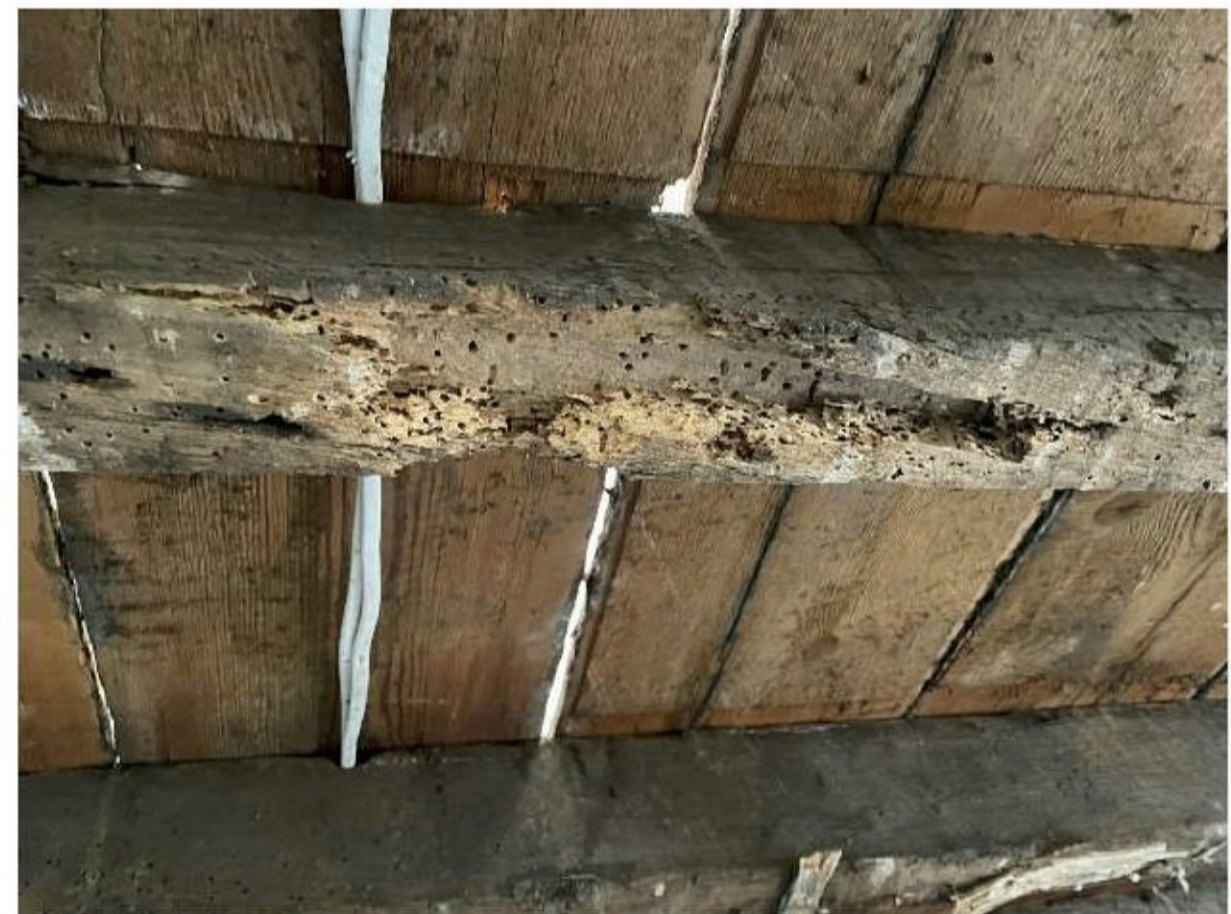
Figure 16 – Joist d 9, significant loss to central underside to 1/3 depth

<b>9</b>	Major beetle attack to central u/s to 1/3 depth
	<b>10</b>	Major beetle attack to central u/s to 1/4 depth
	11	Minor beetle attack to W side ~5mm

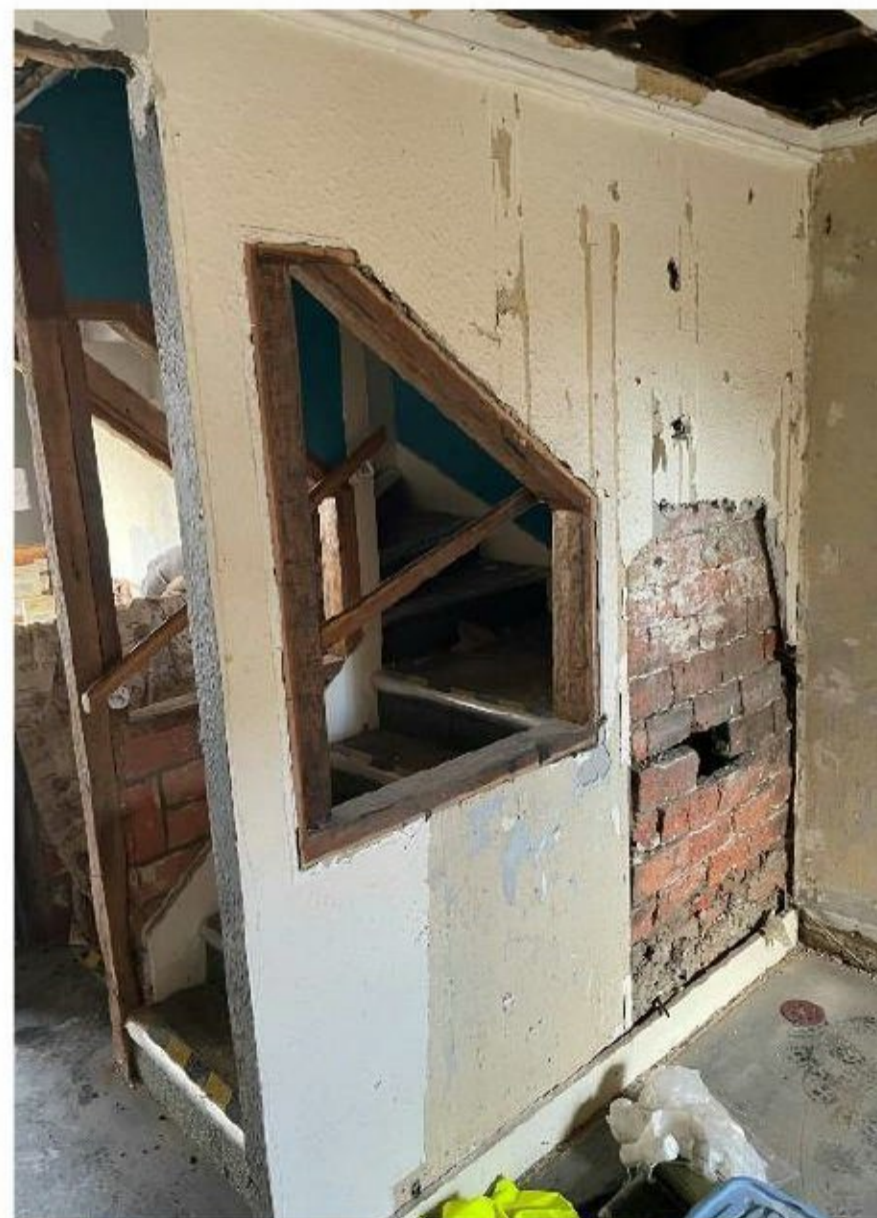
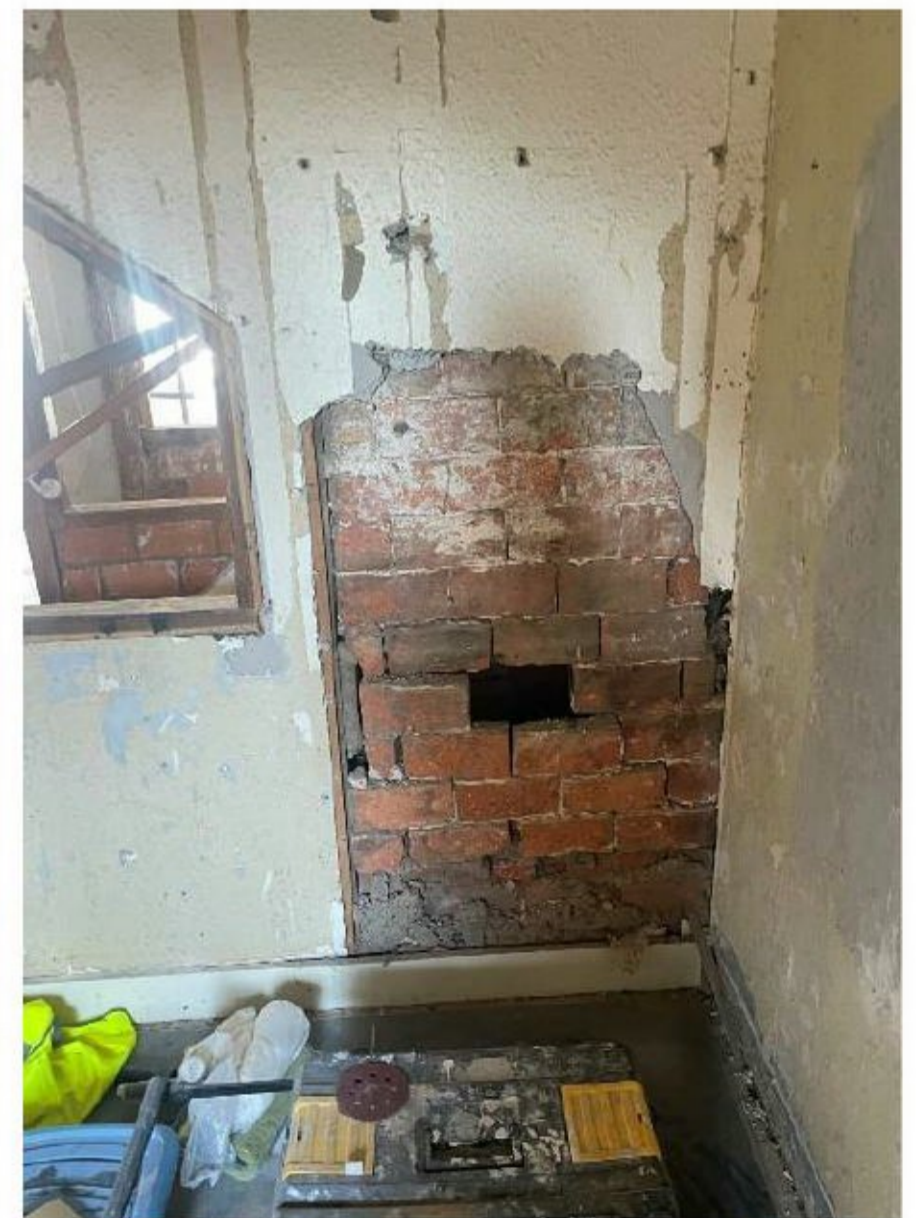
12. The internal walls adjacent to the staircase appear to be timber framed construction with infill of bricks laid on their side. The bricks measure 110mm high x 60 thick x 230 long. The southern wall below the quarter landing has suffered some collapse and will need to be repaired.

Figure 18 – Southern wall with unstable masonry panel

Figure 19 - Southern wall with unstable masonry panel
