CONAULT DESIGN

www.conaultdesign.co.uk

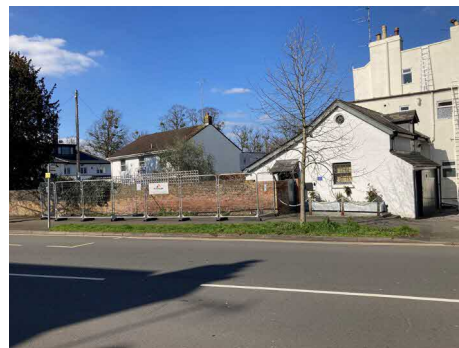
Reconstruction of Boundary Wall
And Replacement of Rope Boundary Detail with
Traditional Railings

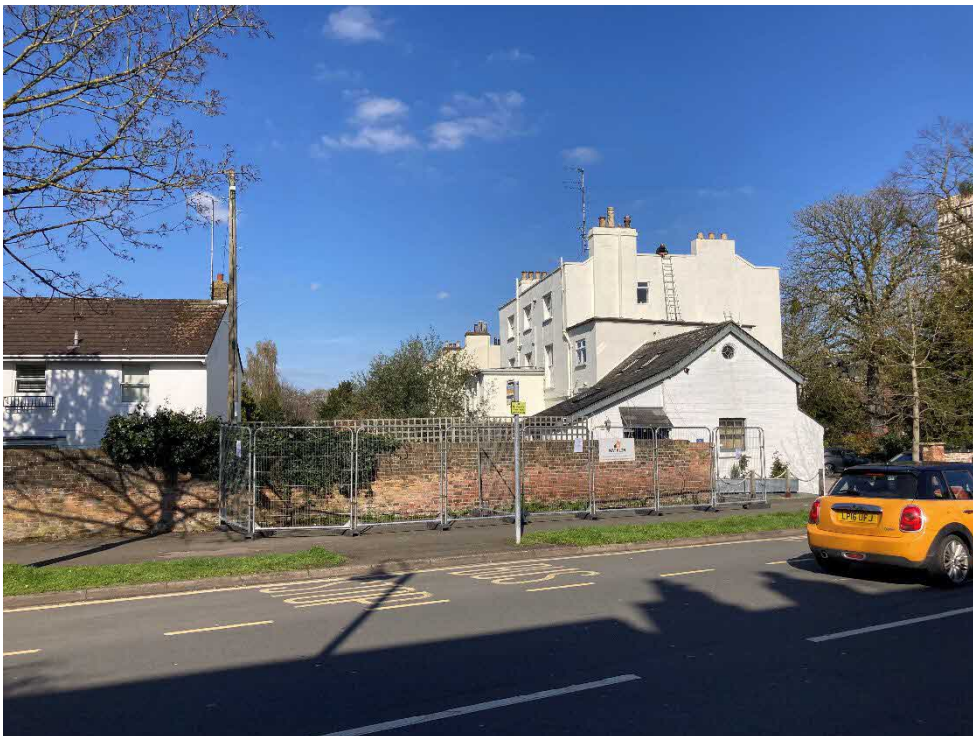
ii. Location of unsafe wall

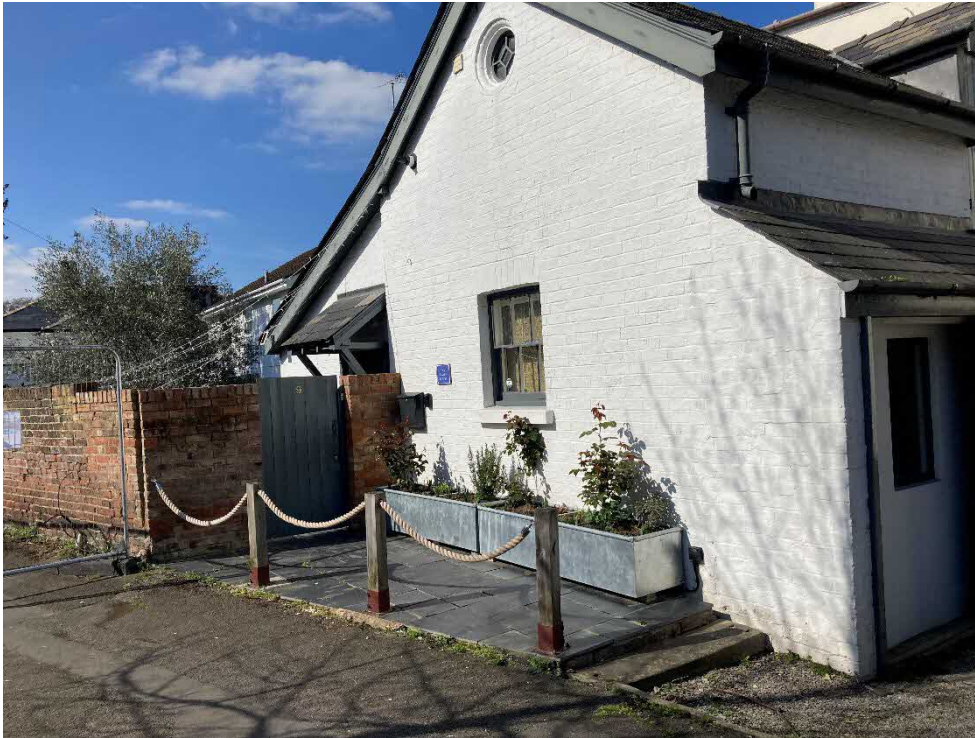
III. Rope boundary treatment which is proposed to be replaced by railings.

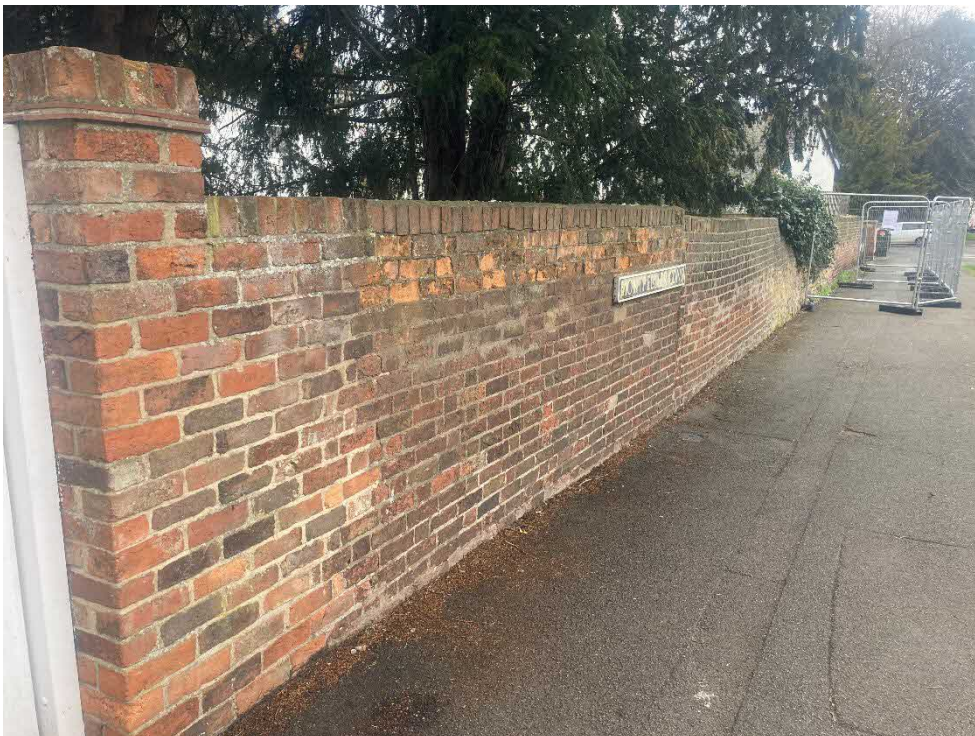
IV. Section of wall 3 Montpellier Gardens understood not to be listed as the plot was separated from the main house pre listing.

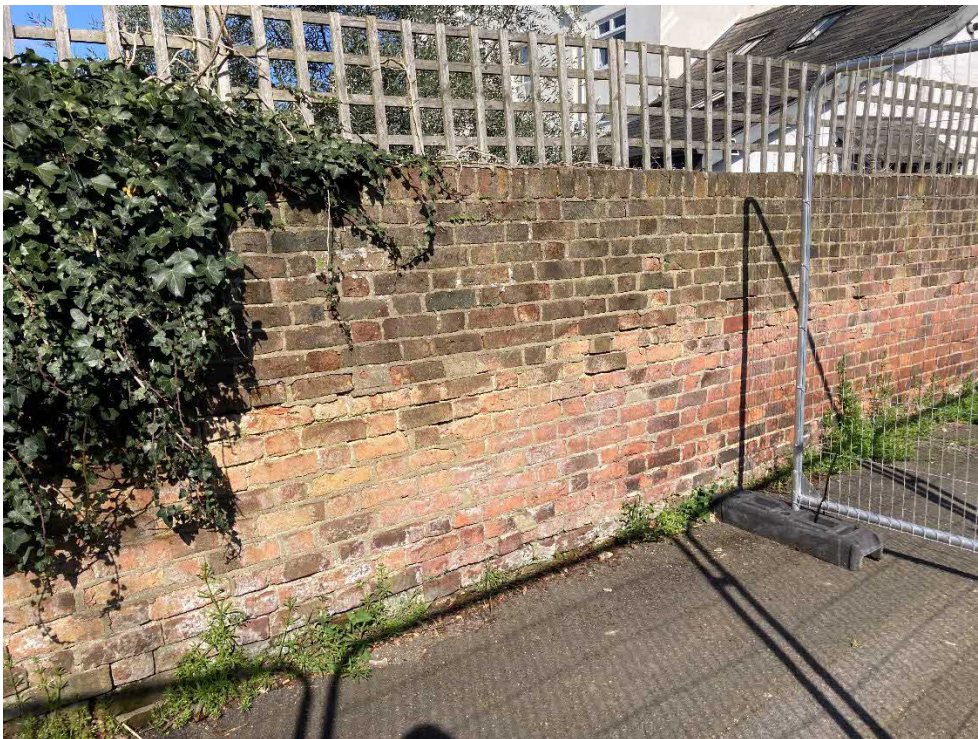
VIII. Different colouration in lower wall suggest frost/damp damage.

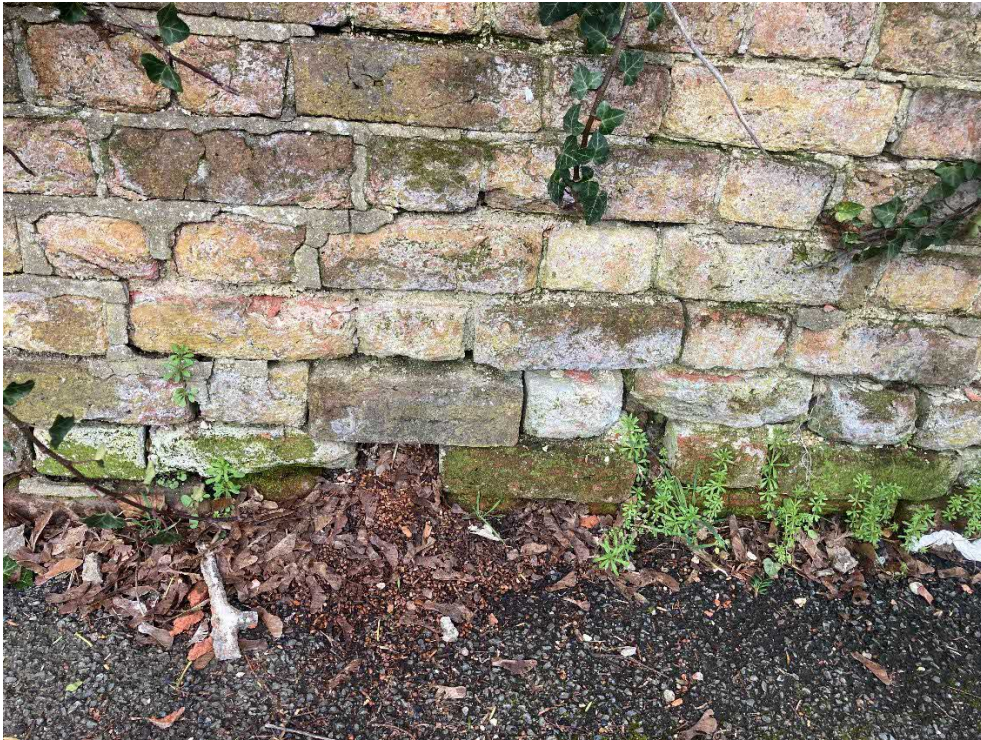
IX. Deterioration of brick at ground level

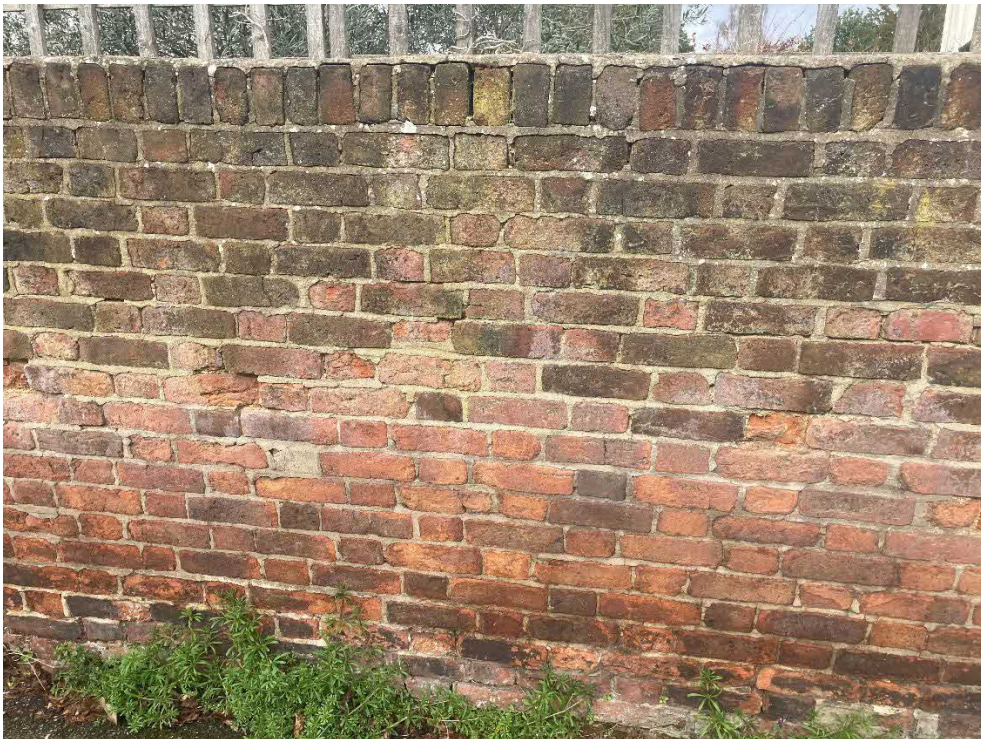
X. Right of Heras fencing

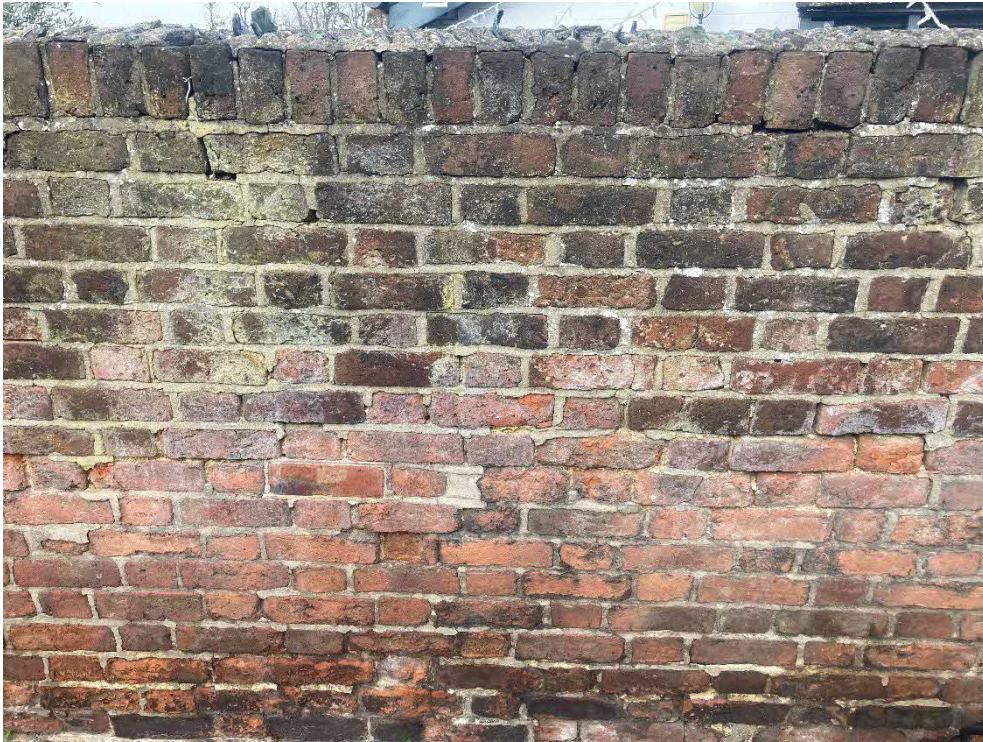
XI. Right of photo above not broken glass and cement capping.

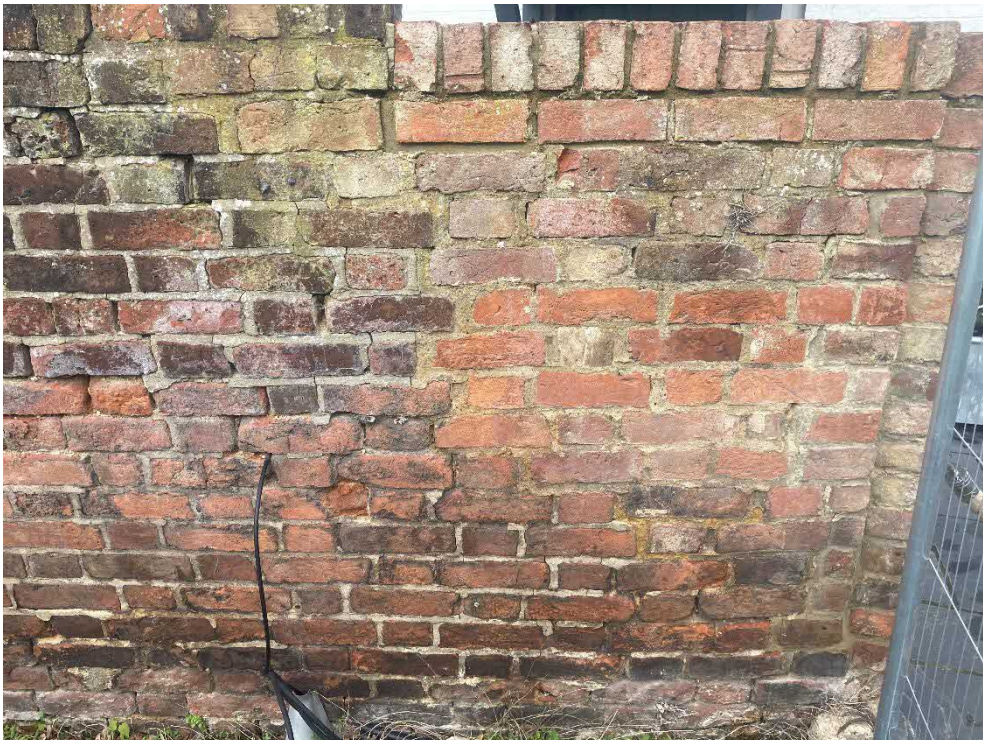
XII. Open cracks running through centre of bricks

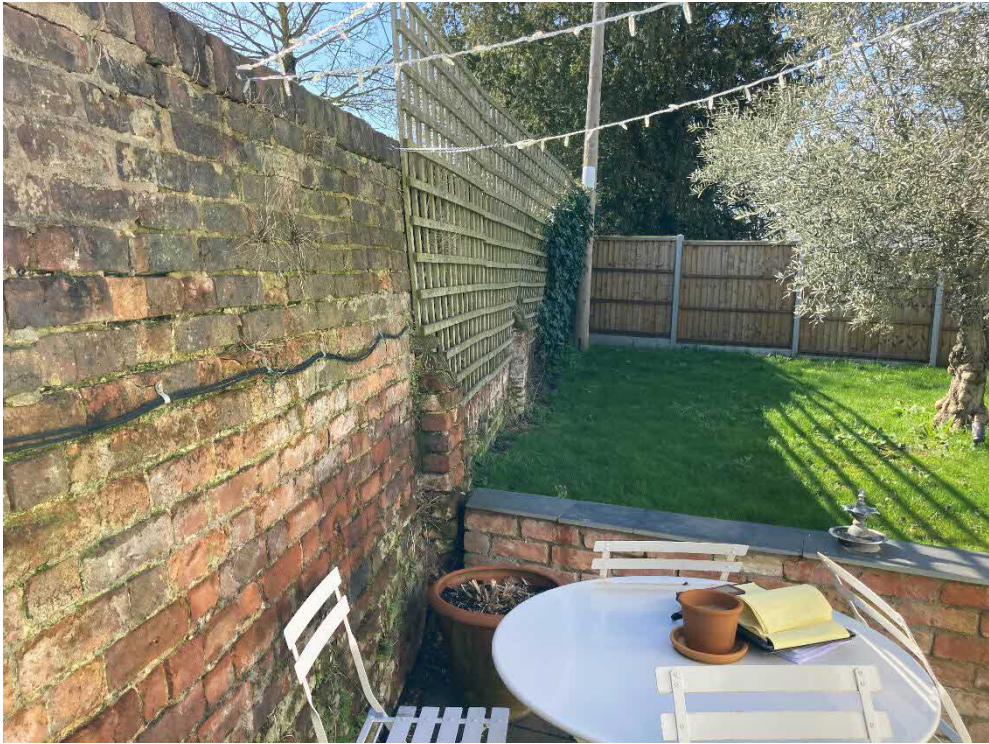
XIII. Garden side of wall

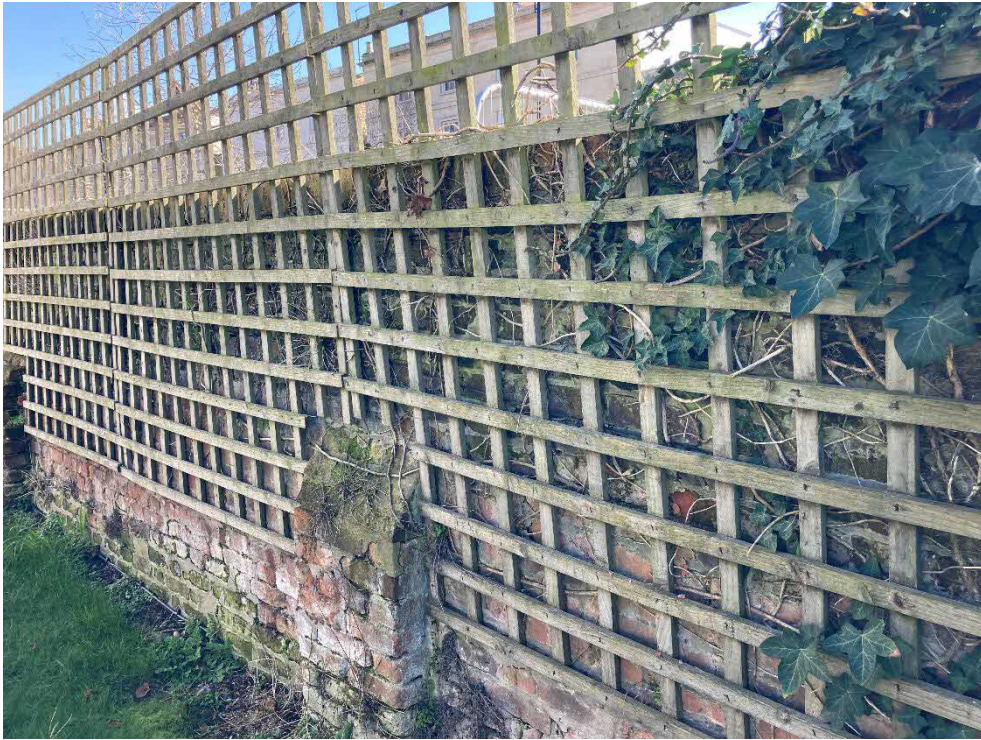
XIX. Crack running vertically through buttress.
XX.

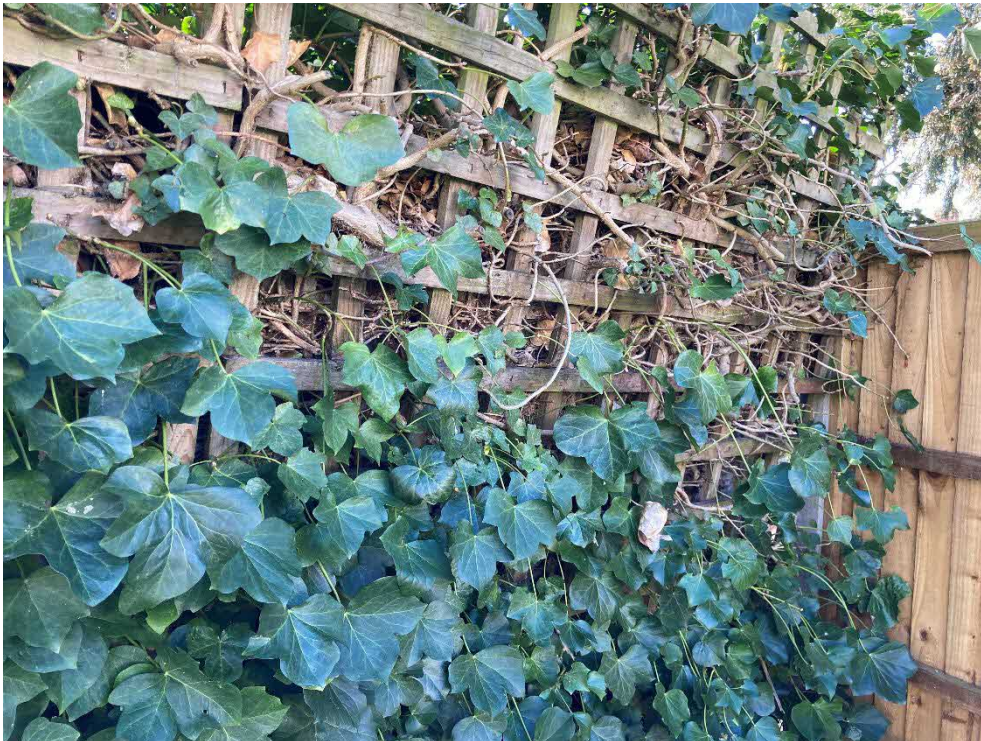
XXI. Trellis and ivy holding wall up
