BS5837:2012 Tree Survey  
 Land adjacent to Lutterworth Road  
 Blaby  
 Leicestershire  
 NGR SP56568 96629

Report prepared by: C Barker	Date Issued: 19 July 2021
	Reviewed by: KLB	Report Version: V1
	Report ref: <b>P2129 /0721 /01</b>	C B E Consulting Highbank, 5 Grantham Road, Navenby Lincoln. LN5 0JJ. Telephone (01522) 810086. <a href="http://www.cbeconsulting.co.uk">www.cbeconsulting.co.uk</a>

# BS5837 Tree Survey, Land adjacent to Lutterworth Road, Blaby

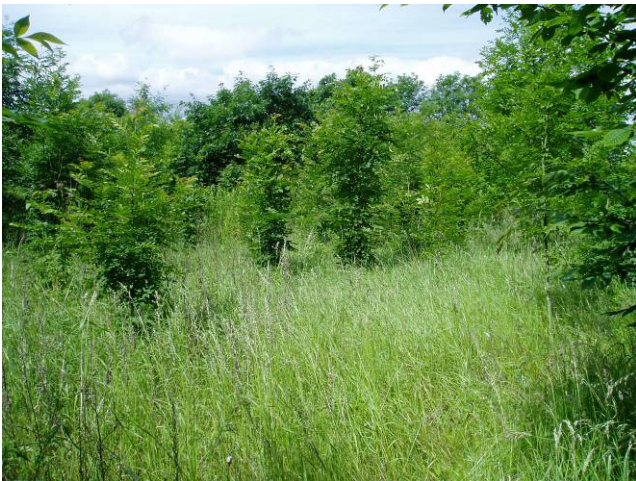
Group G6

Within the Golf Course area there is a dense canopy of young trees in the western corner of the site (Group G6) within which there are a number of individual mature trees of high quality. Some of these face Lutterworth Road (Group G30 and T33 and T34) with a significant number closer to the golf course (T9, T10, T11, T35 –T39). The majority of trees in this area of the site are of poor quality, crowded young and semi-mature trees with little space for development.

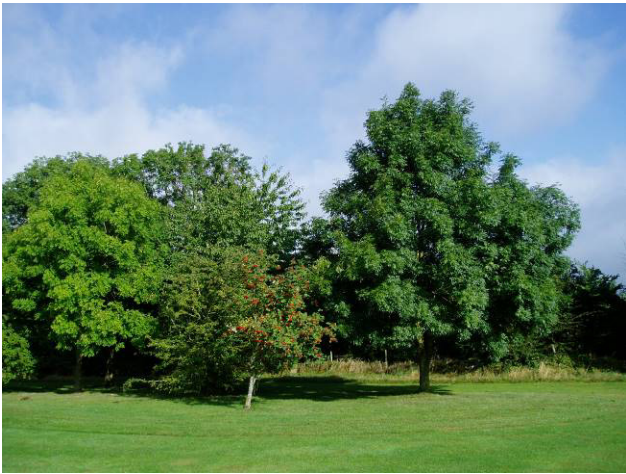
Within the Golf Course the majority of the trees are young specimens planted to divide and screen the fairway areas. There are a small number of larger trees (Willow T24 and T28) but the majority are quite small specimens of limited landscape value. These trees are visible from the nearby public footpath but not from elsewhere outside of the golf course. There is also a dense line of trees on the eastern boundary of the golf course where the footpath turns south (G29 and G45)

Trees T9 – T19 on the golf course

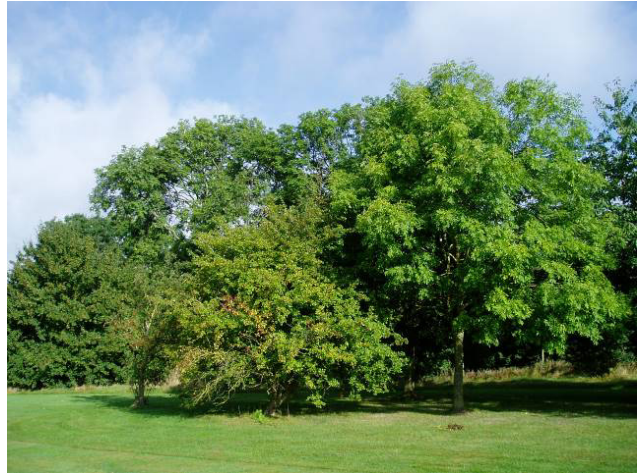
T20 – T28 on the golf course

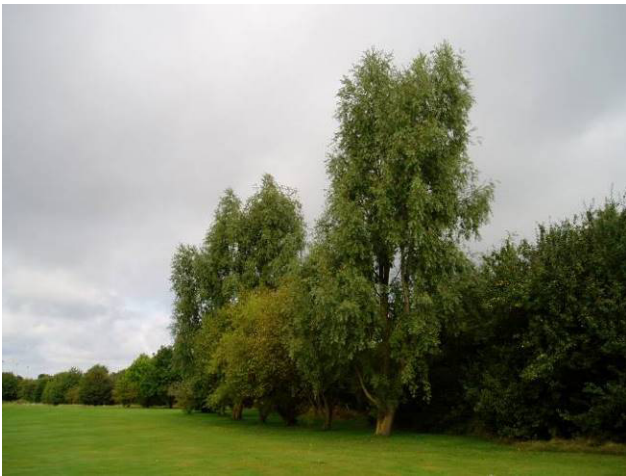
Trees T20 – T28 on the golf course.

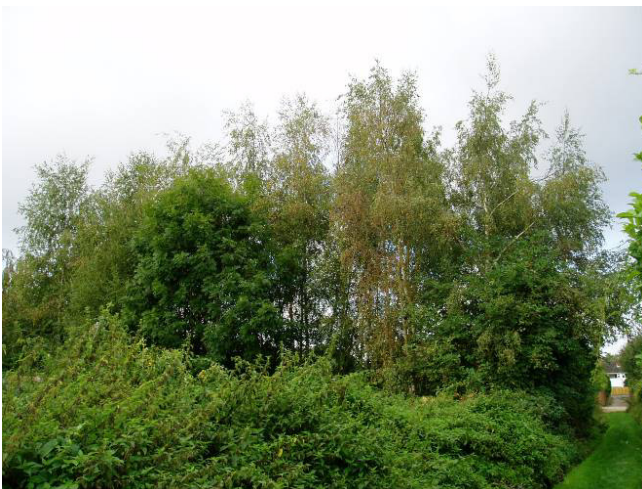
There are far fewer trees within the allotment area. At the western end of the allotments is an area of dense young and semi- mature Birch of little landscape significance but there are scattered mature Ash trees along the footpath edge (T31, T32, T41, T42 and T43) some of which are of significant stature and maturity. There are also trees along the eastern boundary of the allotments of significant size (Ash T46, Ash T47 and coppice Willow T48).

Birch at the western end of the allotments
