# Heritage Impact Assessment and Statement of Significance

Client: Narborough Congregational Church

Project: Repairs to Manse (National Heritage Listing 1074724)

Document No: 23/387 PL02

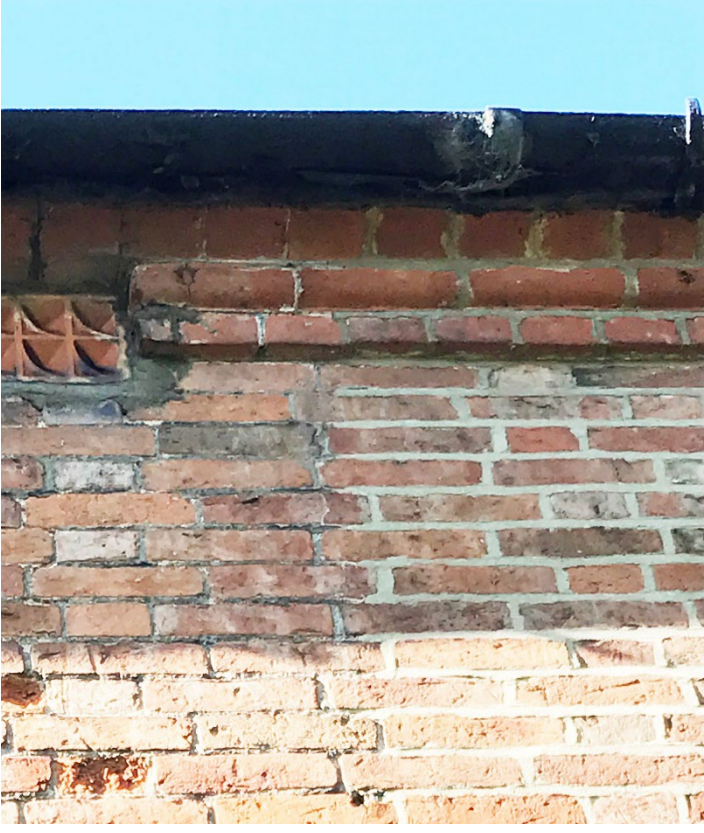
Photographic Record	Location and Description
<p data-bbox="156 259 177 293">5</p>

<p data-bbox="906 259 1433 293"><u>Manse elevation k (drawing 23/387 P03)</u></p> <p data-bbox="906 304 1433 450"><u>Repair of cast iron guttering</u> Seals broken in cast iron guttering causing leaks, as to be expected in historic rainwater goods if they are not regularly cleared out.</p> <p data-bbox="906 495 1433 1144">Paintwork and rust to be carefully removed with hand held electric wire wheel brush (colour to be recorded in order to restore guttering back to its original colour). Where seals/bolts have perished, remove and replace with low modulus <u>or</u> EP1 silicone sealant spread evenly within gutter socket and bolt together with stainless steel or zinc plated screws and allow to dry thoroughly. Apply 2no. coats Hammerite Ultima Smooth, (colour to match existing) to all gutters, downpipes and hoppers for continuity. If any areas of guttering are found to be beyond repair, the damaged section is to be removed and replaced with an exact match which will be to the approval of LPA Planning Officer and Conservation Officer.</p>
