SIGNAGE REPORT

The Onslow Arms
The Street, Guildford
West Clandon, GU4 7TE

Young & Co.'s Brewery PLC Riverside House 26 Osiers Road, Wandsworth London, SW18 1NH

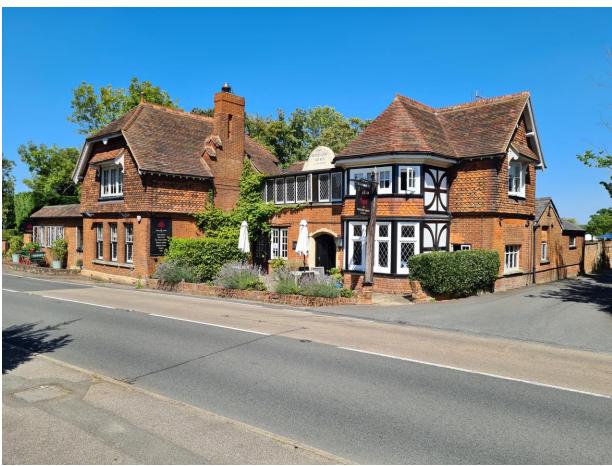
Photo A - West facing front elevation. Roof level bow headed rendered sign approx. H500mm, W500mm. Tallest font H80mm.

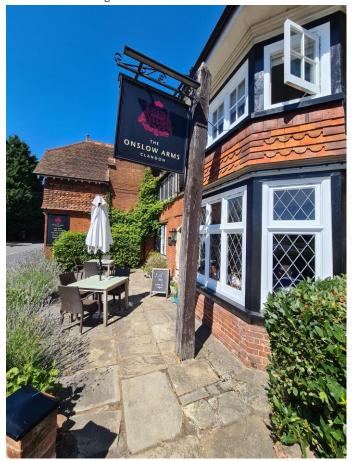
Photo B - Post swing sign to RHS of entrance. Timber post with signs of decay and suggest temperory support. Swing sign approx H1300mm, W1200mm. 2 x trough light illumination.

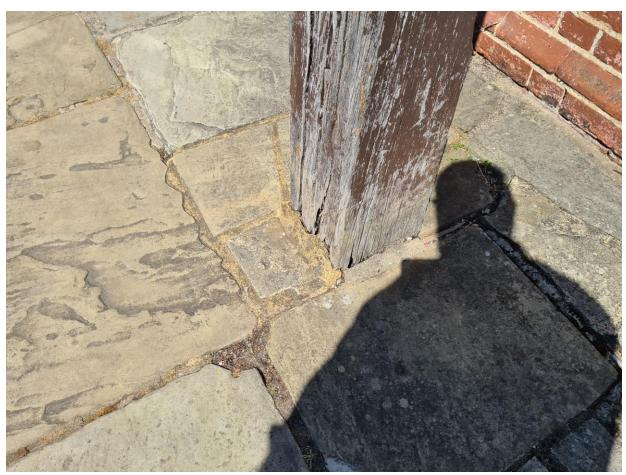
Photo C – Post base for swing sign showing signs of decay, recommend changing.

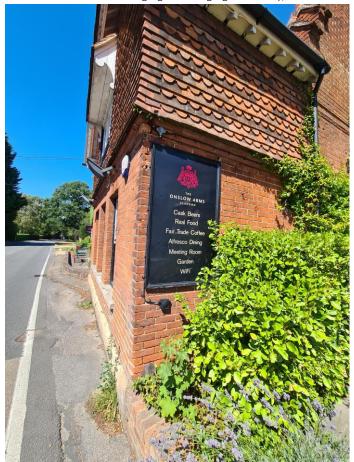
Photo D - Wall sign to flank wall approx. H1650mm, W820mm.

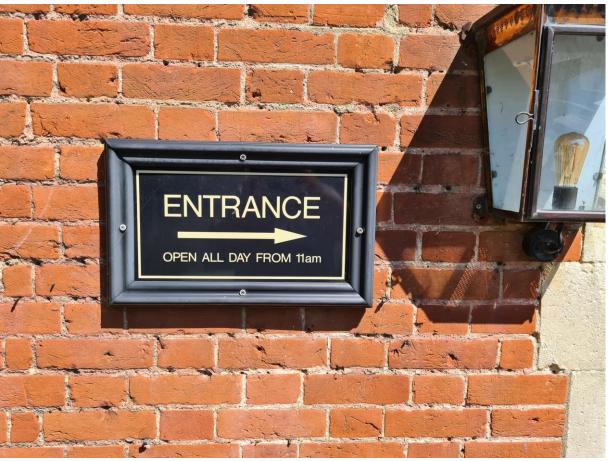
Photo E – Wall sign to LHS of entrance H320mm, W520mm.

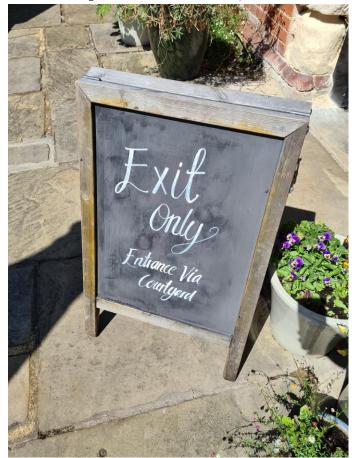
Photo F – A board sign outside front entrance

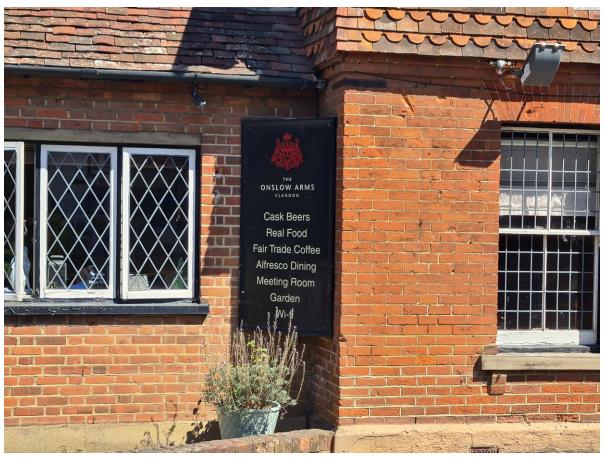
Photo G - Wall sign fitted between original building and single storey extension approx. H1650mm, W820mm. Spotlight illumination.

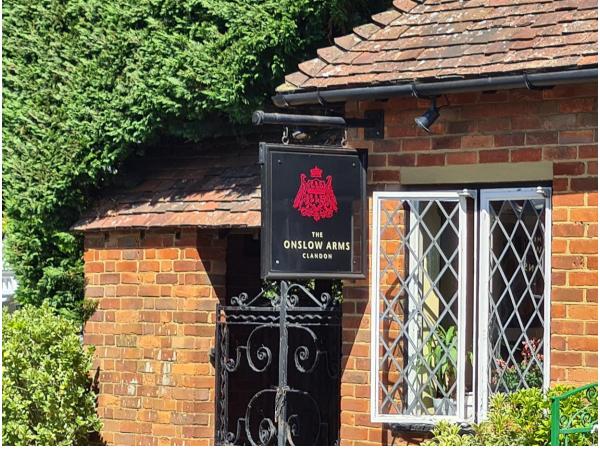
Photo H – Projection hanging sign on single storey extension. Approx. H700mm, Projection from wall 700mm. Spotlight illumination.

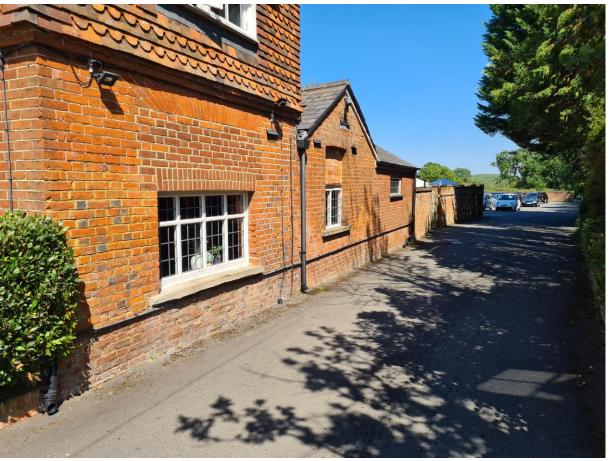
Photo I – South facing side elevation, with driveway leading to car parking areas.

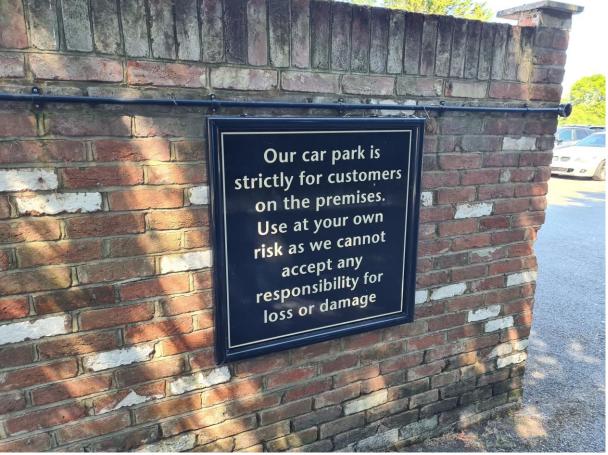
Photo J - Secondary signage adjacent to garden wall. H1200mm, W1200mm. No illumination but has electrical supply in the vicinity.

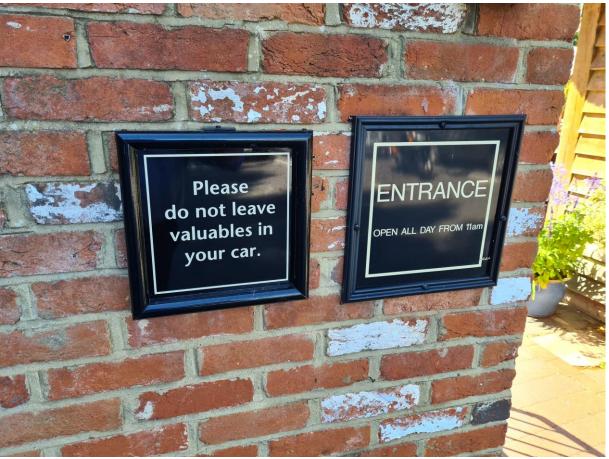
Photo K - Secondary signage to rear garden entrance. "Please do not leave...." H300mm, W300mm, D40mm. "Entrance..." H340mm, W340mm, D40mm

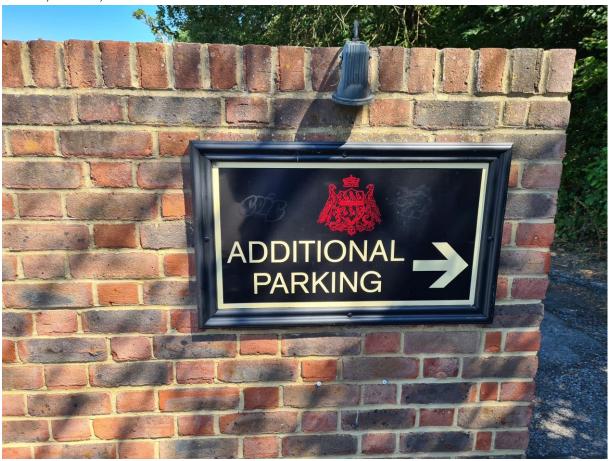
Photo L - Wall signage to overflow car park wall H490mm, W780mm spotlight illuminated.

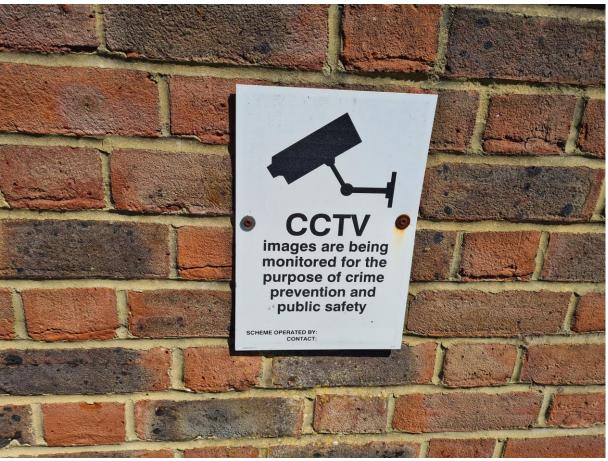
Photo M - Disclaimer sign to car park wall H300mm, W120mm.

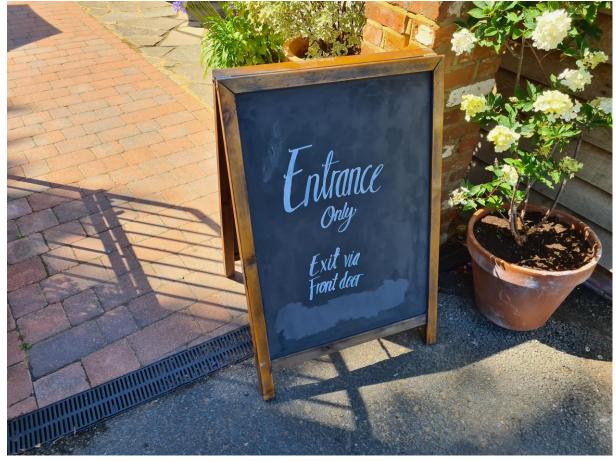
Photo N - A board to garden entrance. Additional two A boards located within the garden area.

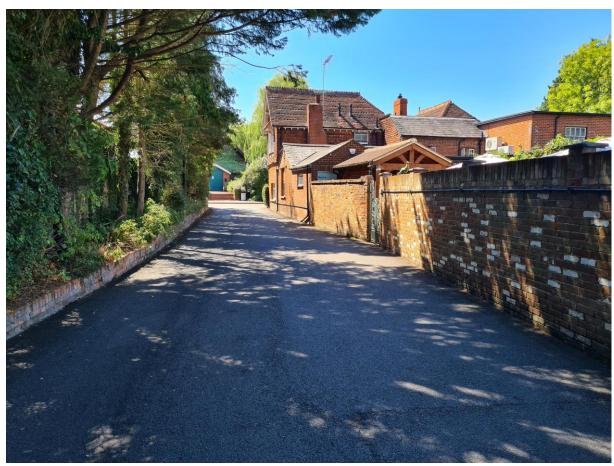
Photo O – South facing side elevation (opposite direction).

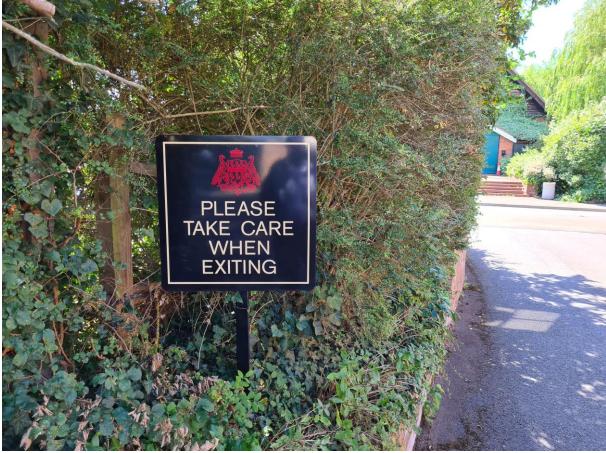
Photo P – Post sign close to driveway exit. Sign H610mm, W610mm. Post and sign H1200mm.

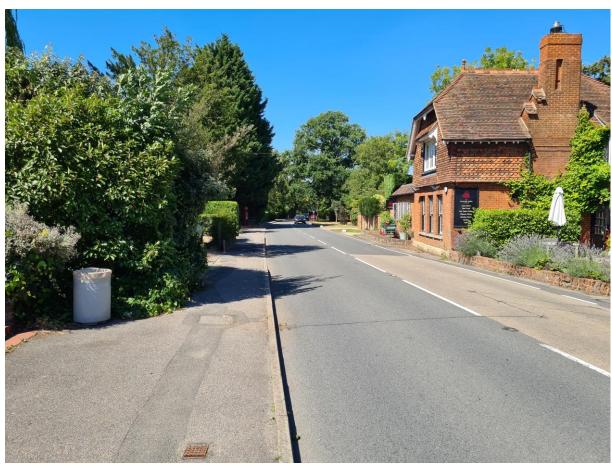
Photo Q – North facing street view (The Street)

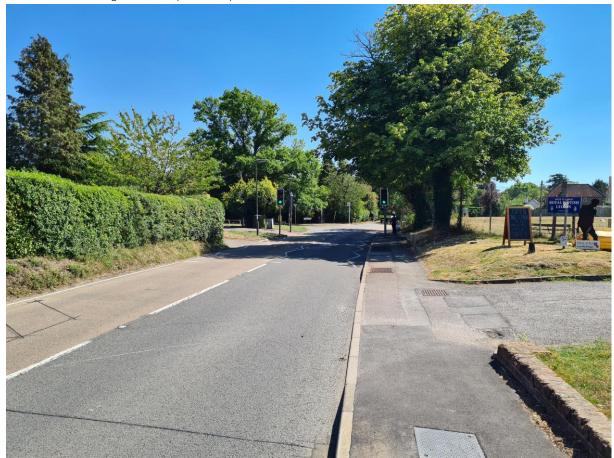
Photo R - South facing street view (The Street)
