Your survey report

45-47 Main Street, Greetham, Oakham, Rutland, LE15
7NJ

24th April 2023

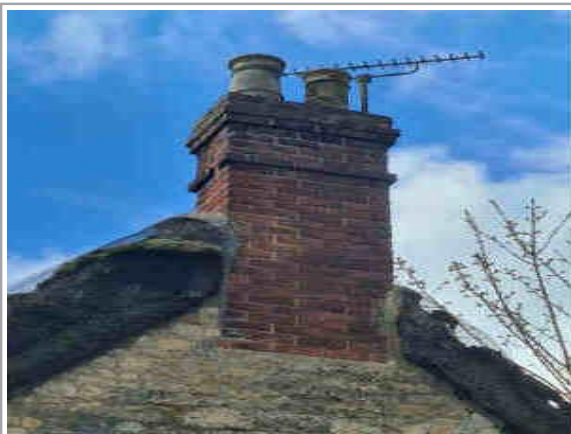
North stack

A scheme of repair is required to each stack, including cutting back and renewing defective brickwork to the north stack, with repointing of the mortar joints necessary at the same time. Repointing of the central stack should also be carried out using a traditional lime mortar, whilst repair to the upper courses of masonry to the south stack should also be undertaken to reduce potential damp penetration.

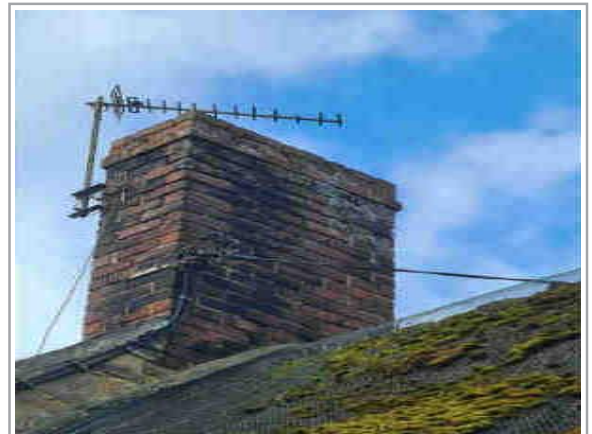
Central stack

TV aerials are fixed to the central and west stack and appear secure.

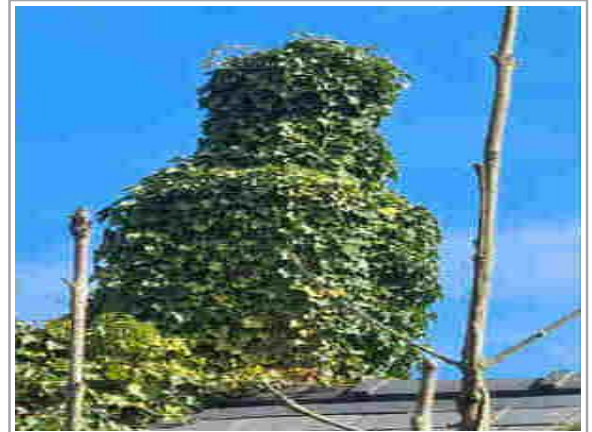
West stack

The west stack is obscured due to extensive ivy growth. It must be anticipated that deterioration will become evident when the ivy is removed, with the approved plans indicating that this stack is to be removed. This should be confirmed prior to undertaking the removal works.

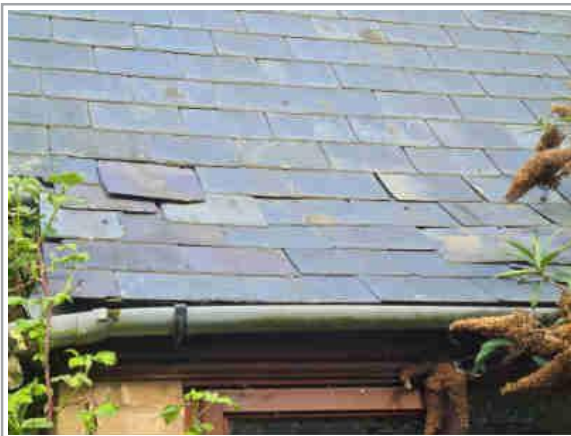
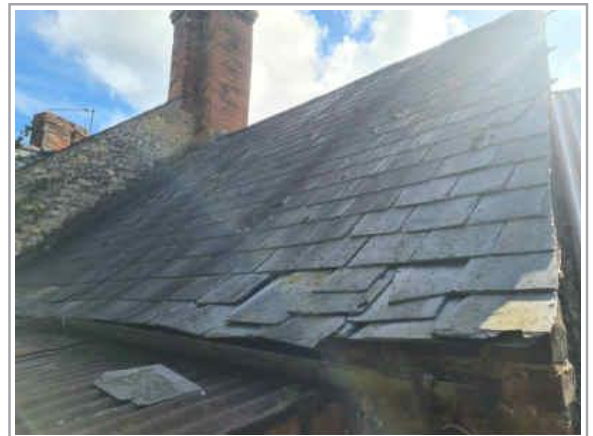
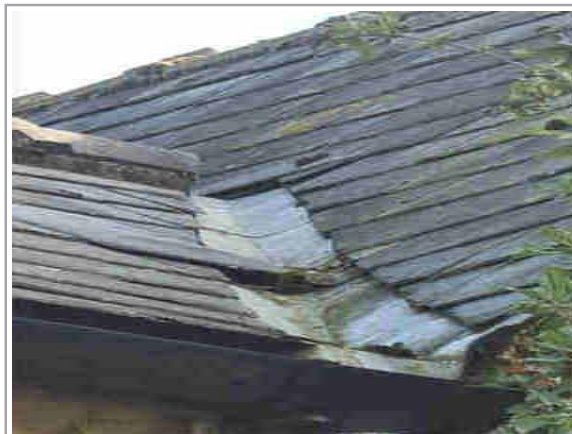
The covering to the single storey section has been renewed in recent decades, at which time the nail fixings and timber battens will also have been replaced. Despite this, there are slipped slates evident. Additionally, no underfelt or membrane has been included beneath to provide a secondary defence against weather ingress. Accordingly, you should budget for stripping and re-laying the slates, with a suitable underfelt included at that time.

There is a further pitched slate covering over the west projection which has also been renewed in recent decades. Further slipped slates are noted in this area and you should budget for stripping and re-laying the covering.

Slipped slates

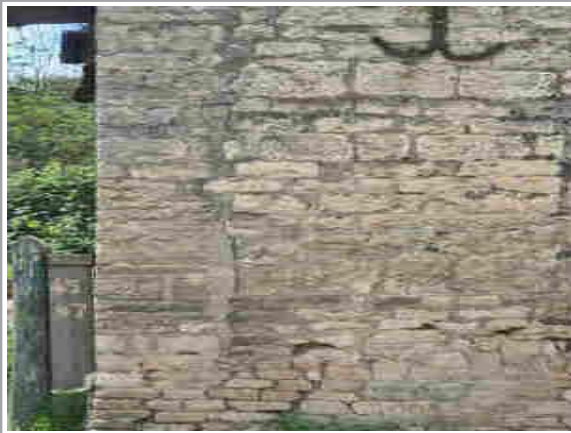
Two long standing tie bars are evident between ground and first floor on the north gable and will have been installed to arrest past movement and provide restraint to the gable. Despite this, there is a crack and a noticeable bulge to the masonry beneath the east tie bar. In part, this will be a result of thermal cracking following repointing with a stronger cement mortar. Traditionally, old stone walls contain inner and outer leaves of stonework with a loose infill of rubble. The outer leaf may not be well bonded to the interior and therefore it can suffer from movement, depending to some extent on the quality of original workmanship and subsequent maintenance. The external stonework may gradually loosen, resulting in visible external deflection and if this occurs, it will be necessary to employ an experienced stonemason to cut out and re-stitch the affected stones into position. You should consult a structural engineer regarding the cracking to assess whether any further remedial work or strengthening is required as part of the renovation work.

Cracking to north gable

A structural engineer should be employed to review cracking toward the east side of the north gable.

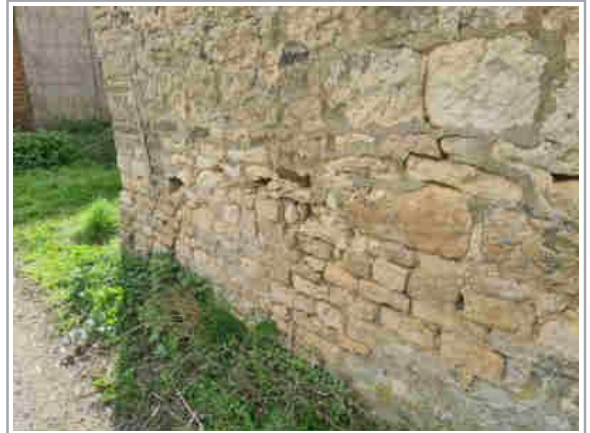
There is weathering evident to the masonry at low level to the north gable, which will have been accelerated due to splash back from the roadside position and associated salts. This area will be at risk of increased deterioration and, as part of renovation works, a scheme of repair will be required including repointing and the potential application of a render to provide a first line of defence against reoccurrence.

Weathered stonework

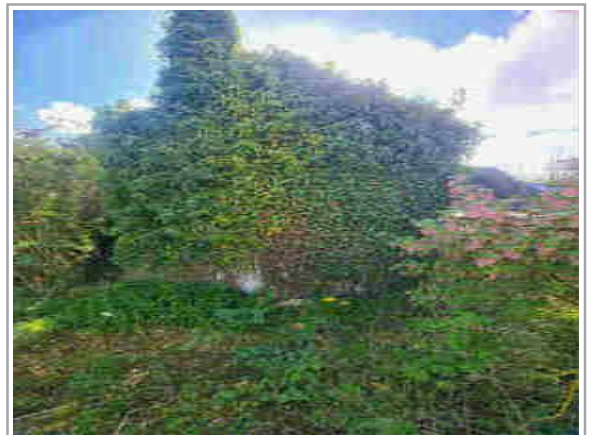
West projection

Masonry paint has been applied to the brick built west projection. Where applied, this can further restrict breathability and evaporation of moisture from the masonry. As part of the planning consent, it is proposed that this area will have a render coating applied. A suitable breathable render should be applied to assist with evaporation of moisture and reduce potential damp related issues. Again, ivy growth in this area should be removed.

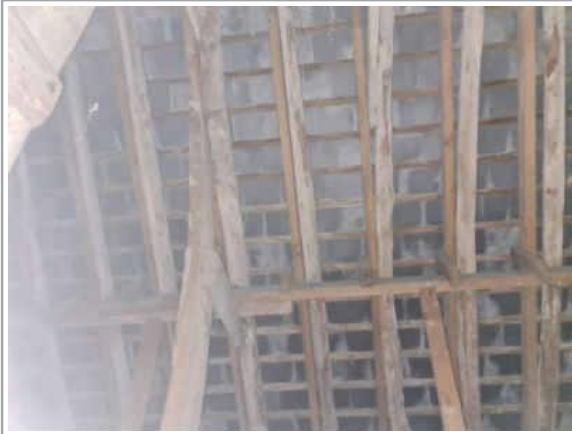
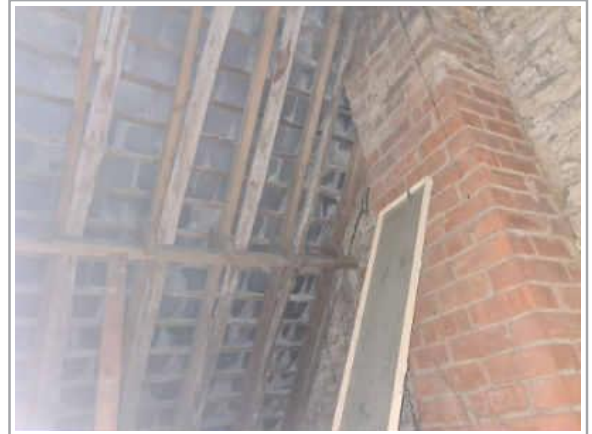
Single storey roof structure

There is evidence of additional rafters having been fitted when the roof covering has been stripped and re-laid, with no significant stress or distortion noted to indicate a weakness in the supporting structure.

There is widespread evidence of timber beetle activity in this area and you should anticipate and budget for treatment of the timbers as part of renovation works. As noted earlier, there is no underfelt included beneath the covering to this area and, therefore, stripping and re-laying of the covering is recommended to include an underfelt or breathable membrane.

Insulation should also be renewed to current recommended levels of 270mm, whilst ensuring it is pulled back from the eaves to reduce potential cold bridging from the underside of the covering.

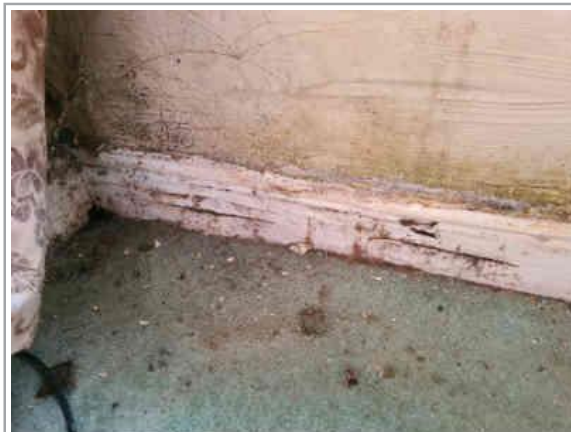
The suspended timber floors in these areas show signs of rot and decay, with damp penetration at the rear of the east kitchen and significant rot around the bay window in the bedroom. In addition, there is cuboidal cracking to the skirting board in this area which is typically indicative of dry rot, requiring extensive repair, with further advice required from a Property Care Association approved timber contractor. The affected timbers will require cutting back and replacement as part of renovation works. Alternatively, the timber floors could be removed and replacement solid floors fitted in their place to incorporate insulation and a damp-proof membrane as a more long lasting alteration.

Potential dry rot

As noted earlier, there is evidence of apparent dry rot in the ground floor bedroom requiring attention from a Property Care Association approved timber contractor in conjunction with renovation works.

A Property Care Association approved timber contractor should inspect the ground floor timbers due to evidence of apparent dry rot.

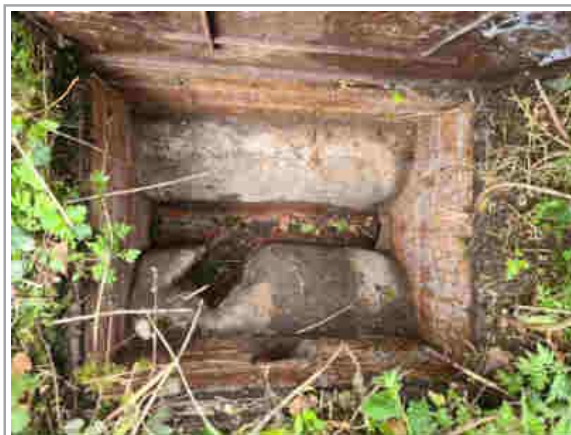
Drainage run

A single inspection chamber cover was noted outside the west of the two storey projection. This was lifted to reveal a clay drainage run. No further covers were noted within the boundaries. No significant blockages were noted within the chamber, however, you must be aware of the risk of concealed defects. The redevelopment and creation of the access drive over this area provides an ideal opportunity to renew the drains with modern PVC equivalents, as part of extending the drainage run to the new dwelling.

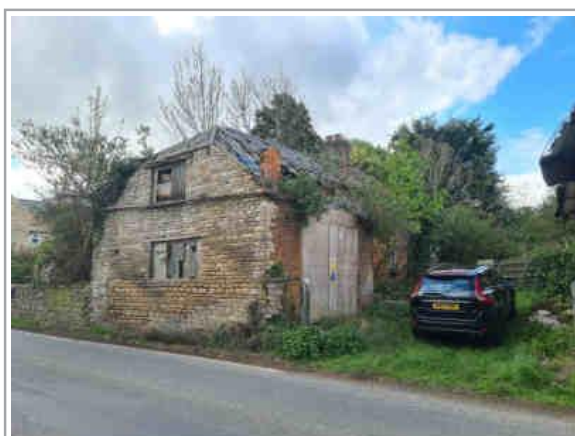
Outbuilding

Your attention is drawn to sections of corrugated asbestos panelling, which should be removed at the same time.

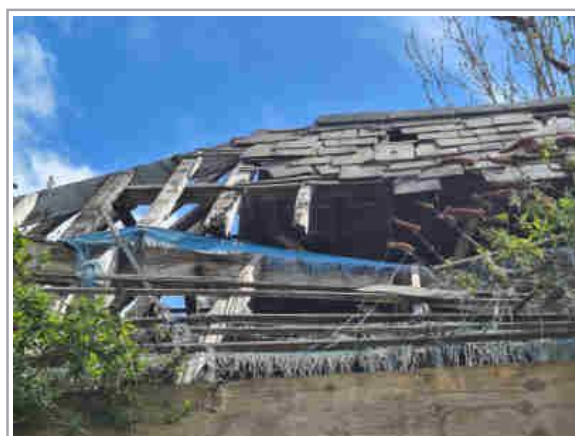
Missing roof covering

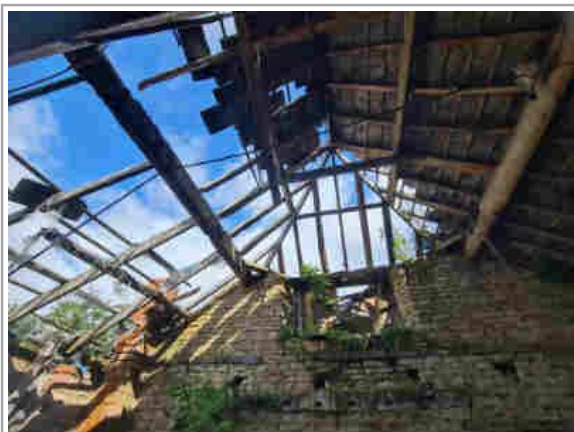
Damaged roof structure

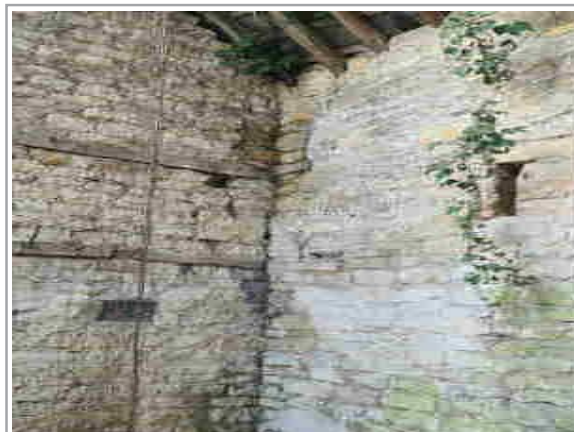
Cracking to north east corner
