GEOTECHNICAL

for Subsidence Management Services

**Woodstock, COTTESMORE ROAD, ASHWELL, Oakham, RUTLAND,
LEICESTERSHIRE, LE15 7LJ**

Client: Subsidence Management Services
Client Contact: Fyaz Jan
Client Ref: IFS-PRE-SUB-22-0104778
Policy Holder: Mrs Yvonne Olive Walters
Report Date: 20 March 2023
Our Ref: C69569G31839

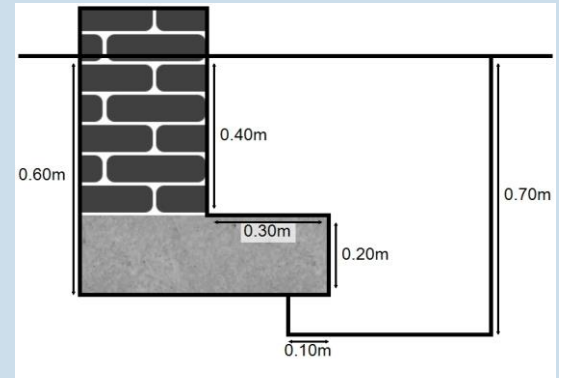
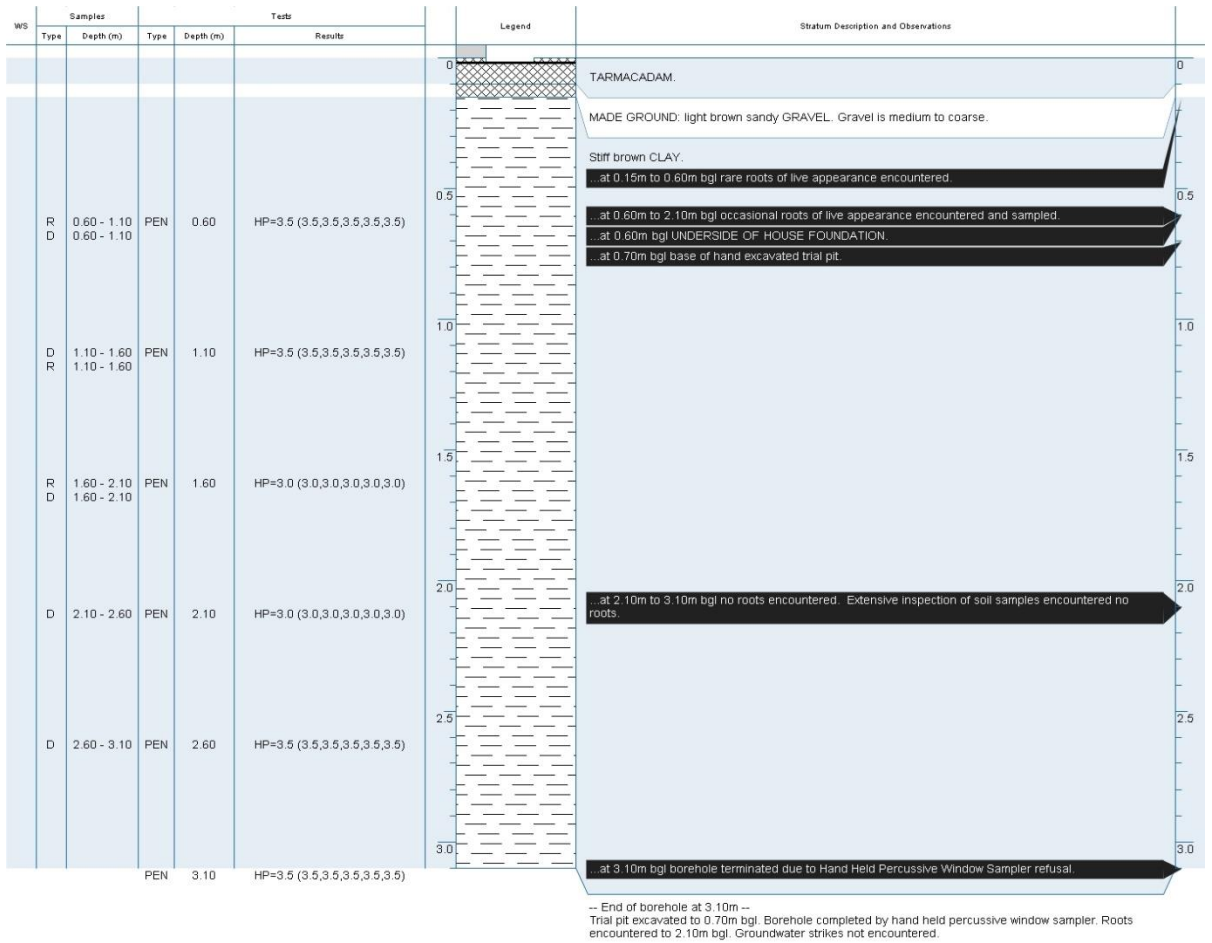
TP/BH1 Foundation Detail and Borehole Log

House foundation comprised of brick wall to 400mm bgl, bearing on concrete to 600mm bgl, with a total projection of 300mm from the elevation. Underside of foundation (USF) was exposed to 100mm back from the face of the foundation and probed 350mm back from the face of the foundation.

House foundation was exposed and the underside of foundation (USF) recorded to be 0.60m bgl (TP/BH 1).

Hand Held Percussive Window Sampler refusal at 3.10m and 3.60m bgl due to granular content within the clay (TP/BH 1 and BH 2). Borehole terminated. No further works undertaken.

Roots encountered to 2.10m bgl (TP/BH 1).

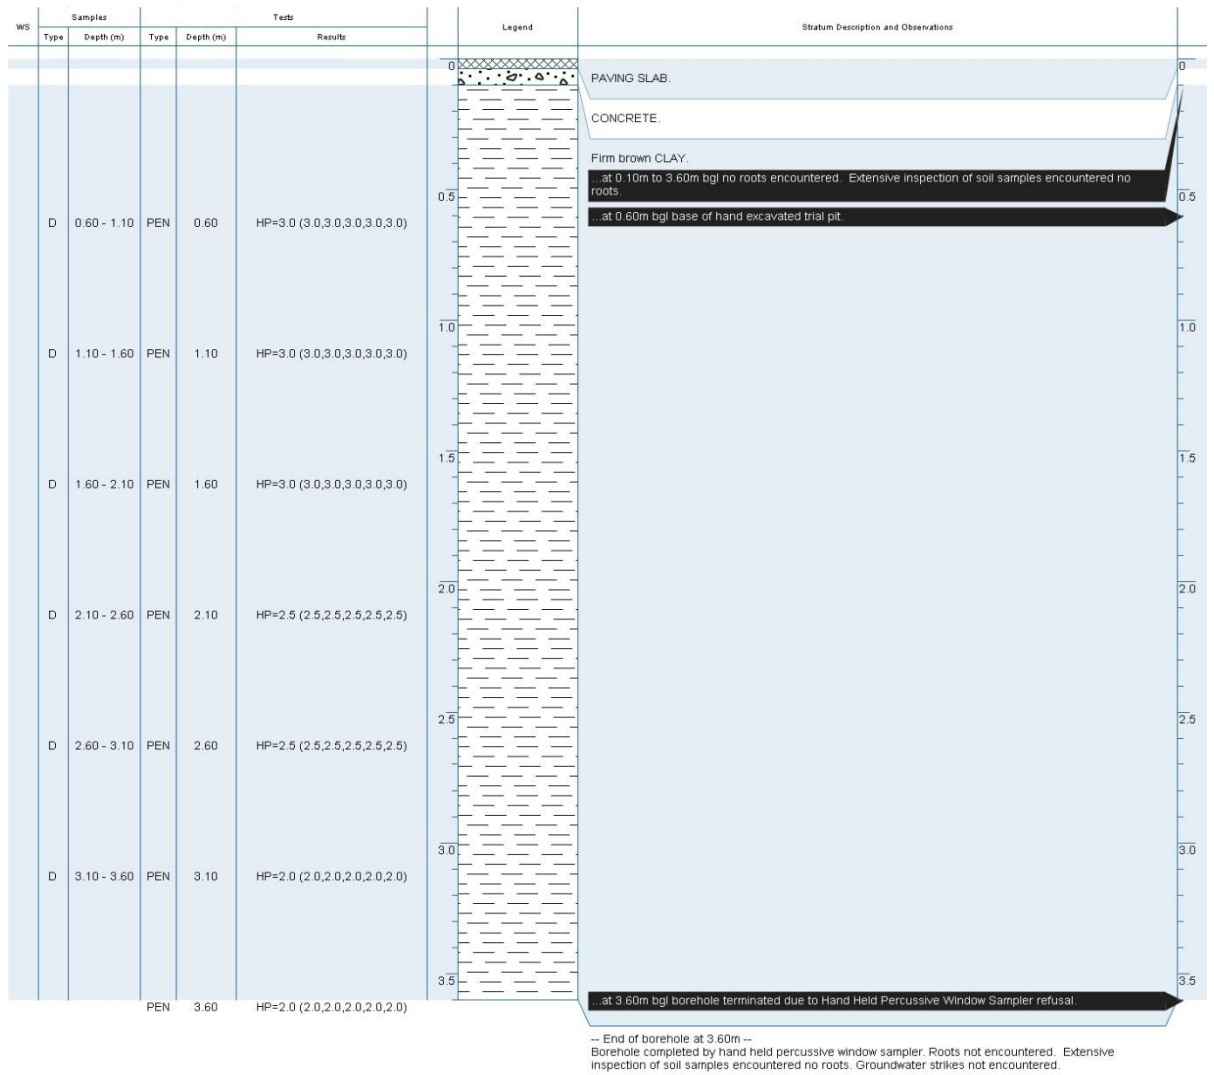
BH2 Borehole Log

Roots not encountered from 0.10m bgl to 3.60m bgl (BH 2). Extensive inspection of soil samples encountered no roots.

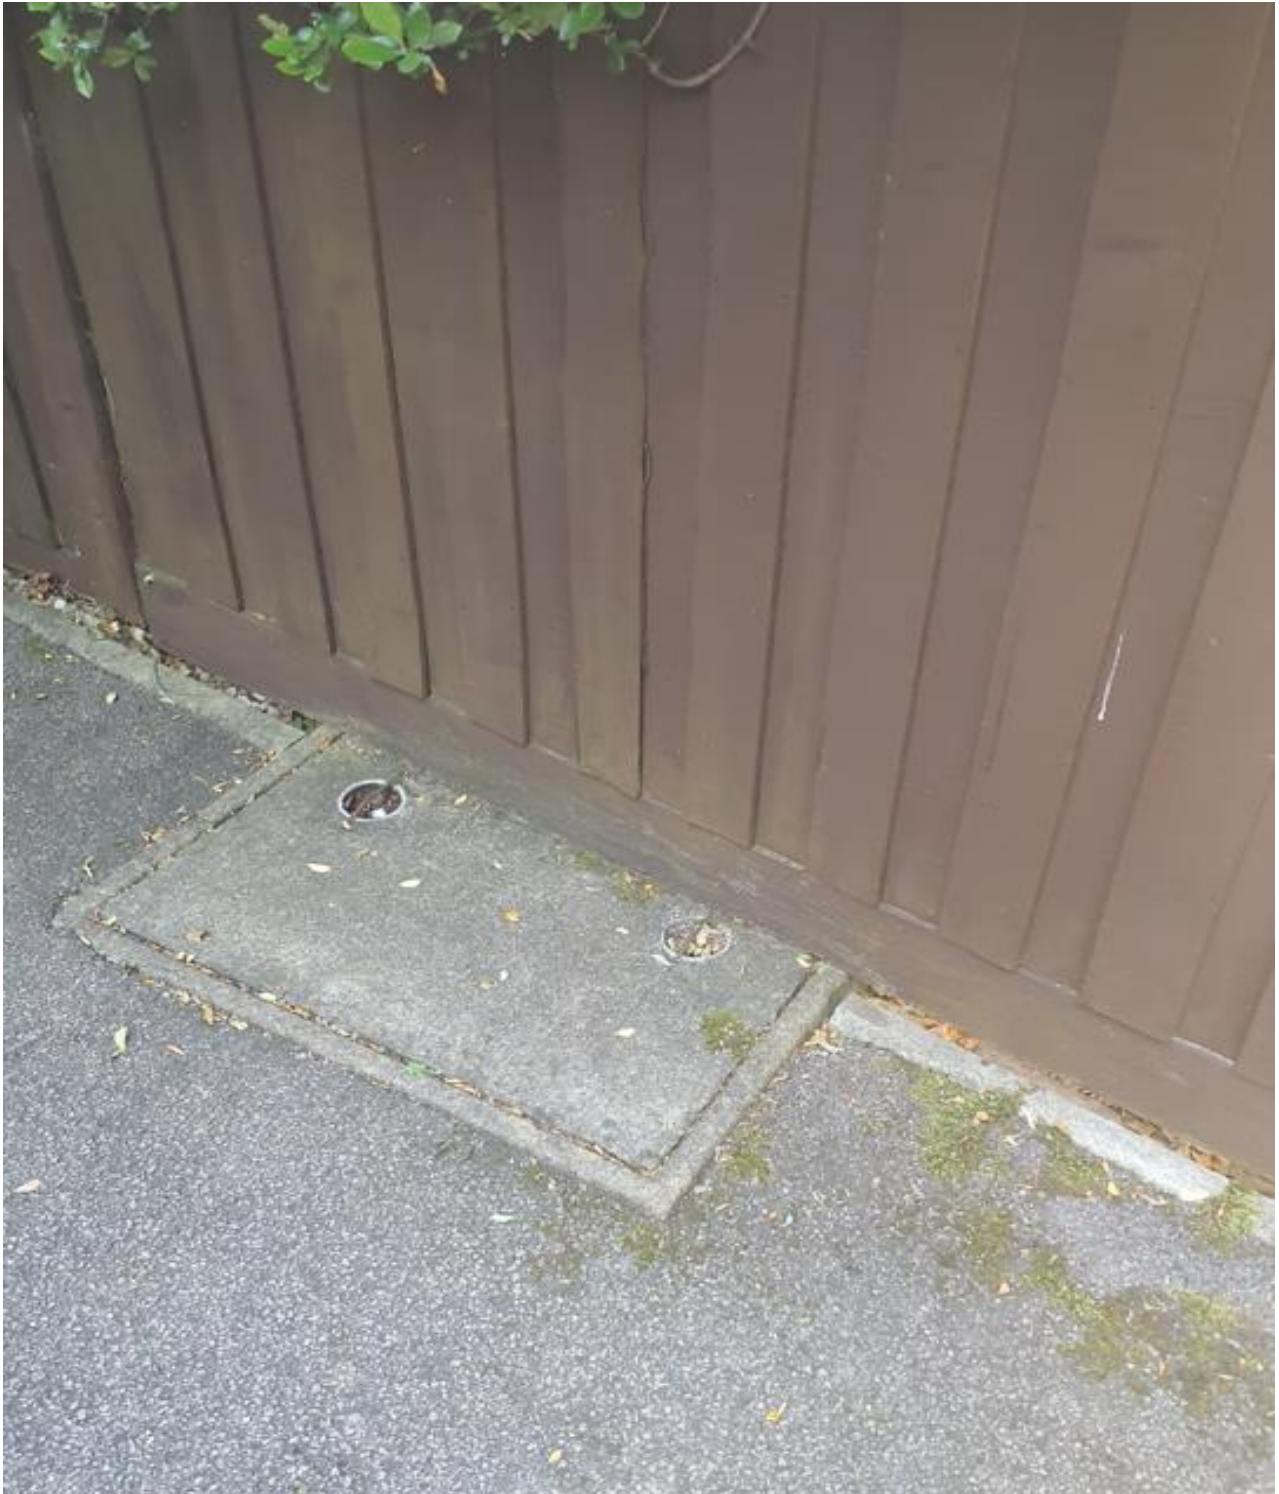
We were unable to complete the CCTV survey as we were unable to lift FMH3 cover as its currently sitting underneath a fence. The home owner is aware that this needs to be lifted but we would require permission from next door to do this as its their fence.

We were unable to lift out the rainwater downpipes at RWP's 1, 2 and 3 due to the brackets being so low to ground level. The downpipes run underneath the hard standing surface also and therefore require excavation for access or cut-ins.

Once we have lifted it, we would require the following works as there was debris building up between MH2 and FMH3:

- 1) Carry out extensive high pressure water jetting
- 2) Lift FMH3 frame and cover for access
- 3) Carry out a further CCTV survey of all laterals into FMH3 and report findings.
- 4) Perform 3x cut-ins to RWP's 1, 2 and 3 for access.
- 5) Carry out a further CCTV survey downstream of the RWP's and report findings.

Enabling contractor require dto lift up / take out boundary fence (see photographs page). This will need to be reinstated by the contractors upon completion of our works / further investigations.

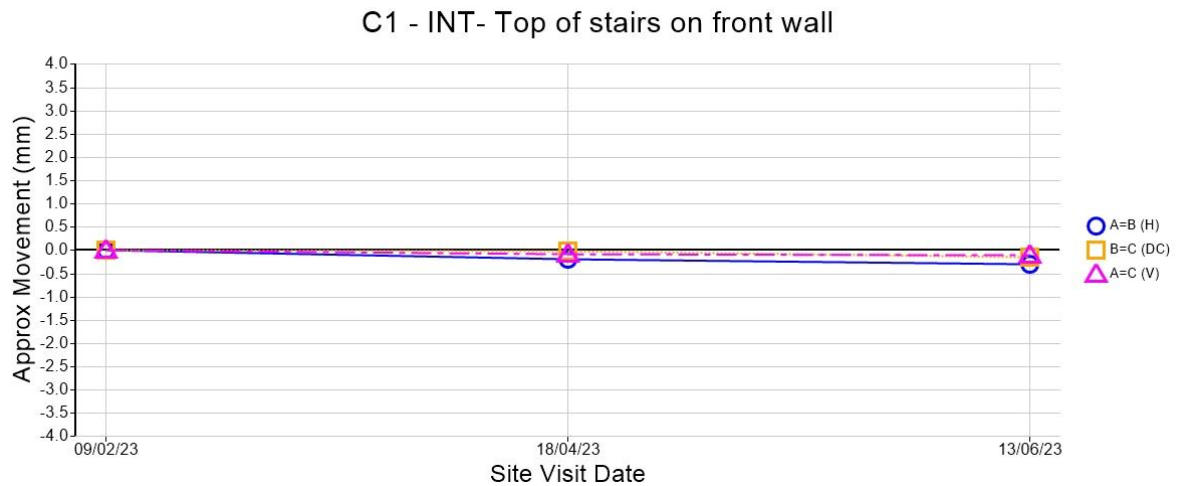
Crack Monitoring Difference Graphs

Date	A=B (H)	B=C (D)(C)	A=C (V)	Crack Width
C1 - INT- Top of stairs on front wall				
9 February 2023	101.30	127.27	83.19	0.30 - 0.40
18 April 2023	101.12	127.25	83.12	
13 June 2023	101.00	127.12	83.10

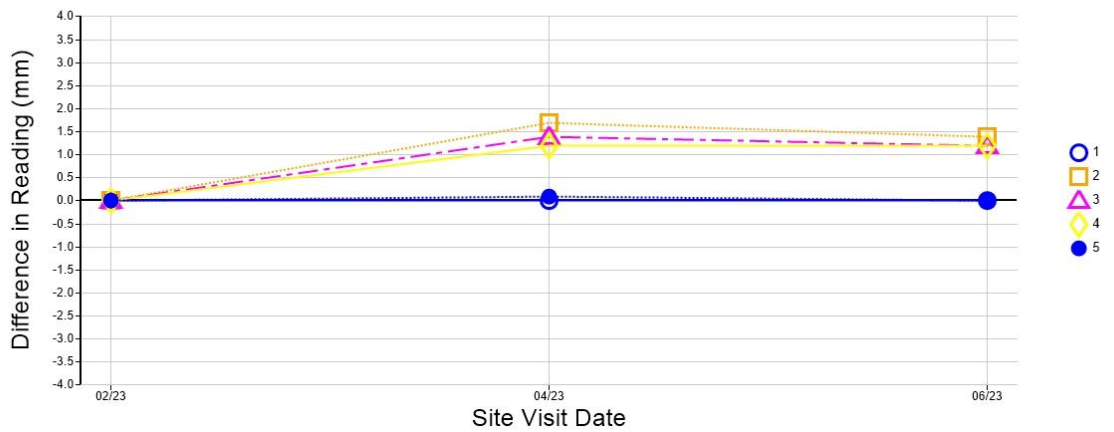
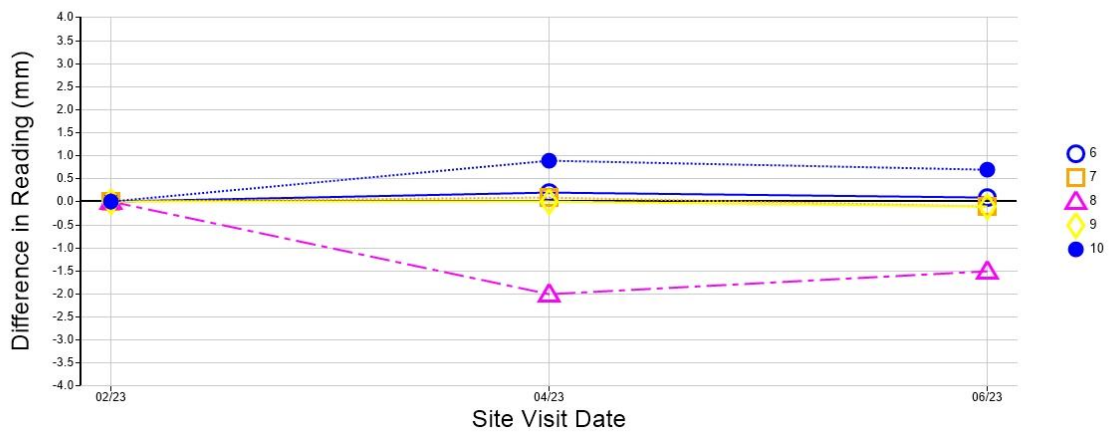
Level Monitoring Difference Graphs

Date	1	2	3	4	5	6	7	8	9	10
09/02/2023	10.0000	10.0604	9.9769	9.9927	9.9895	9.9918	9.9931	9.9884	9.9745	9.9730
18/04/2023	10.0000	10.0621	9.9783	9.9939	9.9896	9.9920	9.9932	9.9864	9.9745	9.9739
13/06/2023	10.0000	10.0618	9.9781	9.9939	9.9895	9.9919	9.9930	9.9869	9.9744	9.9737

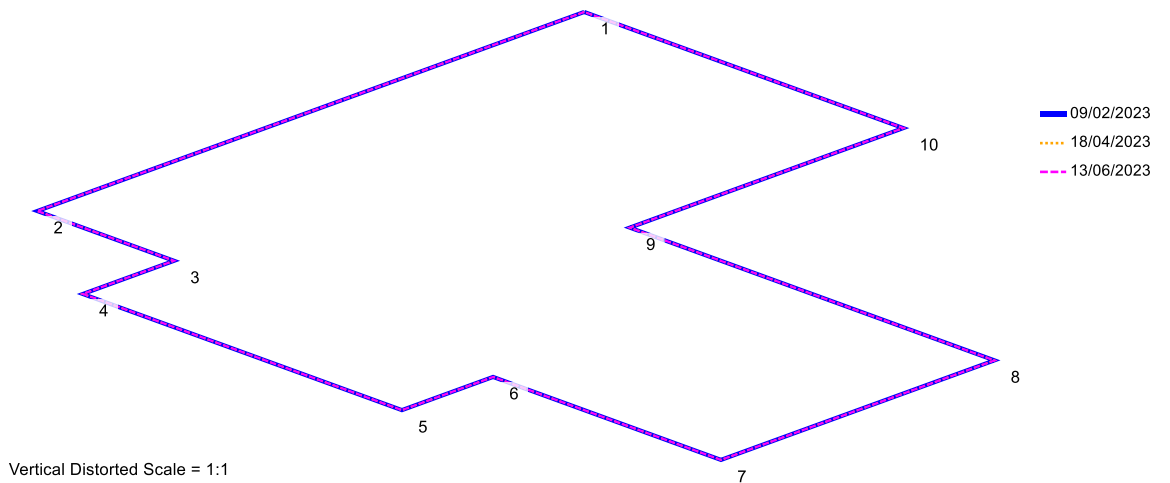
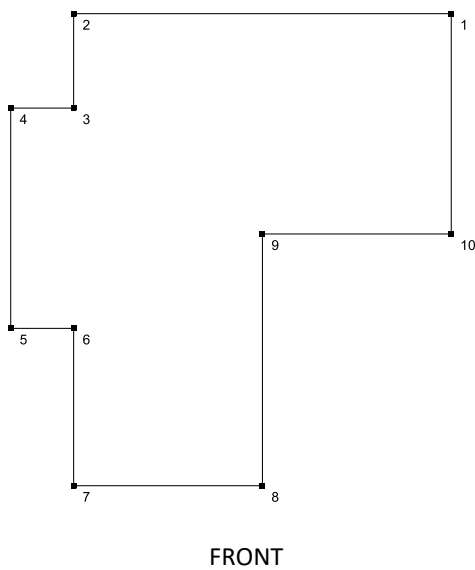
Level Monitoring Displacement Map

Datum is relative to point 1 away from damage. It has an assumed value of 10.0000m. There is no suitable secondary TBM available. If this is not suitable, a deep datum is recommended.
