Ground Investigation Factual Report

Site Address: Silverton Lodge, 118 Church Road, London, SE19 2UE

Project No.: HH/23/70502

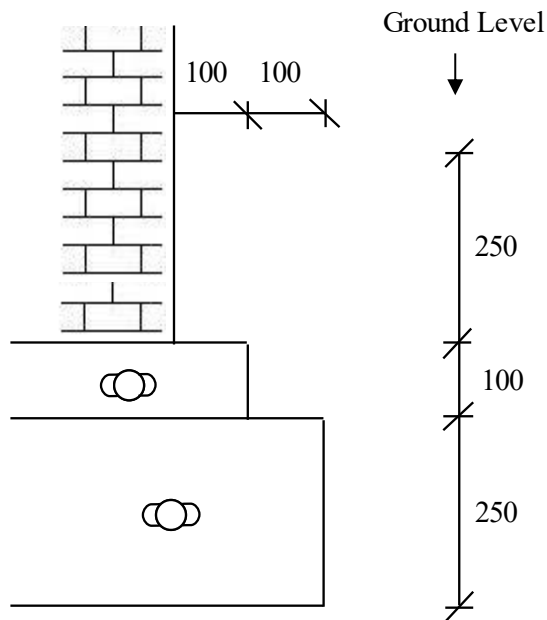
TP/BH1 Foundation Detail

For strata information, please refer to borehole log TPBH1.

(0.20) 0.20	MADE GROUND topsoil.				
						(0.40) 0.60	MADE GROUND light brown slightly gravelly clay. Gravel is of brick and concrete.				
0.60-2.30	ROOTS						BASE OF FOUNDATION AT 0.6m Stiff becoming very stiff with depth light brown slightly sandy CLAY with many roots.
