Arboricultural Appraisal Report

Subsidence Damage Investigation at:

Silverton Lodge
118 Church Road
London
SE19 2UE

CLIENT:	QuestGates
CLIENT REF:	QG1S1141035
MWA REF:	SUB230911-14214
MWA CONSULTANT:	Mark Bisley (BSc Hons)
REPORT DATE:	25/10/2023

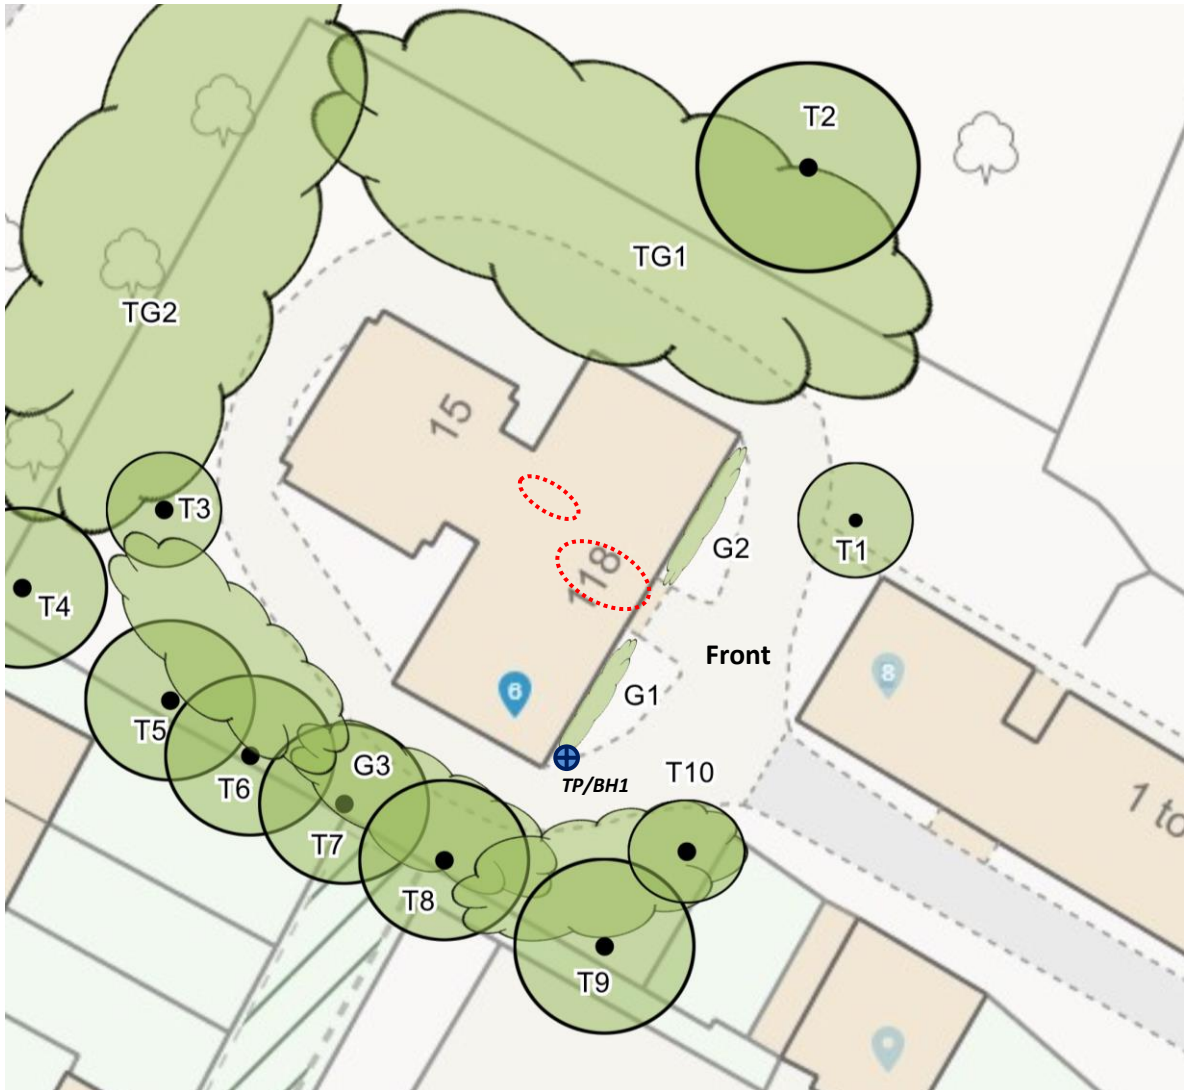
Site Plan

Approximate areas of damage

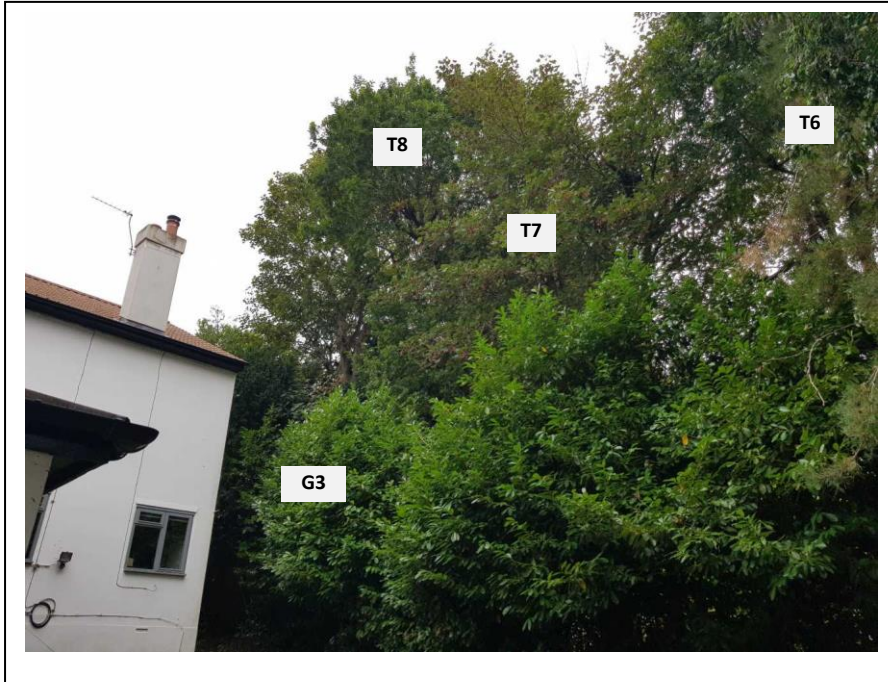
Roots were observed to a depth of 2300mm bgl in TP/BH1 and recovered samples have been positively identified (using anatomical analysis) as *Acer spp.* and either *Quercus sp.* or *Castanea spp.*, the origin of which will be T8 and T9 respectively, confirming their influence on the soils below the foundations.

Based on the technical reports currently available, engineering opinion and our own site assessment we conclude the damage is consistent with shrinkage of the clay subsoil related to moisture abstraction by vegetation. Having considered the information currently available, it is our opinion that T8 and T9 are the principal cause of or are materially contributing to the current subsidence damage.

View of T7 and T8 from rear

If an arboricultural solution is to be implemented to mitigate the influence of the implicated trees/vegetation we recommend that T8 and T9 are removed. Other vegetation recorded presents a potential future risk to building stability and management is therefore recommended.

Tree No.	Species	Ht. (m)	Dia. (mm)	Crown Spread (m)	Dist. to building (m)	Age Classification	Ownership
T8	Sycamore	21 *	700 *	15 *	7	Younger than Property	Policy Holder
Management history		Subject to periodic reduction as part of an ongoing management regime.					
Recommendation		Remove (fell) to near ground level. Owner to physically remove any regrowth (no chemical treatment due to translocation risk).					
T9	Oak	15 *	700	17 *	10	Younger than Property	Policy Holder
Management history		Subject to periodic reduction as part of an ongoing management regime.					
Recommendation		Remove (fell) to near ground level. Owner to physically remove any regrowth (no chemical treatment due to translocation risk).

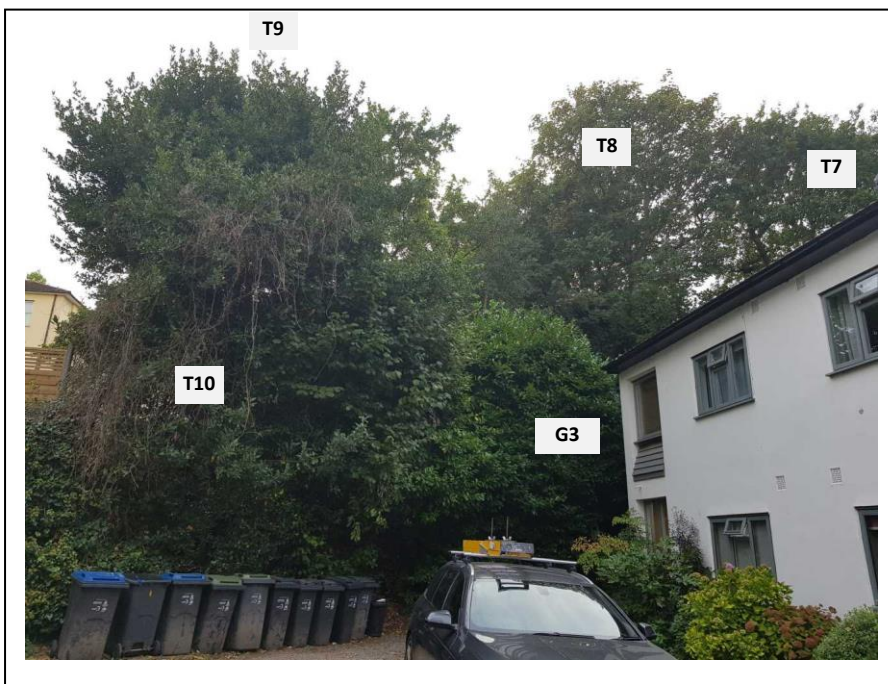
The current damage affects the front left corner of the block. Other damage to the interior stairwells has not been attributed to subsidence.

At the time of the engineer's inspection the damage was assessed as being the result of clay shrinkage subsidence due to moisture abstraction by vegetation and was found to fall within Category 2 - 3 (slight – moderate) of Table 1 of BRE Digest 251.

View of front left corner of block

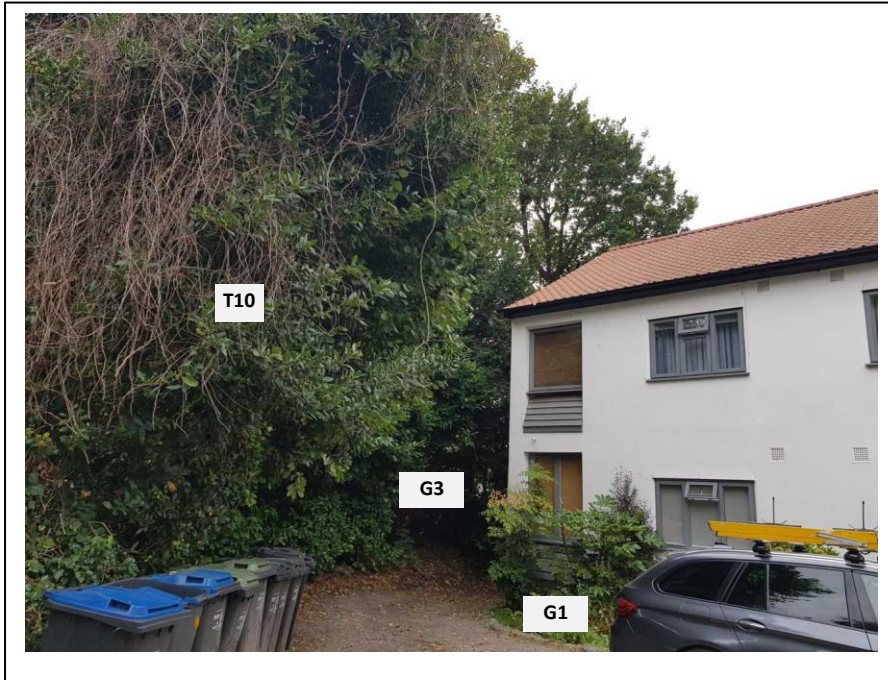
View of G1

Tree No.	Species	Ht. (m)	Dia. (mm)	Crown Spread (m)	Dist. to building (m)	Age Classification	Owership
G1	Includes Pittosporum, Hydrangea, Fatsia	2	25 Ms *	2	0	Younger than Property	Policy Holder
Management history		Subject to past management/pruning - appears regularly pruned.					
Recommendation		Do not allow to exceed current dimensions.					
G2	Includes Cotoneaster, Hydrangea	1	3 Ms *	2	0	Younger than Property	Policy Holder
Management history		Subject to past management/pruning - appears regularly pruned.					
Recommendation		Do not allow to exceed current dimensions.					
G3	Cherry-laurel, Yew, Holly, Lime	5.5	220 Ms	7 *	8	Similar Age to Property	Policy Holder
Management history		Subject to periodic reduction as part of an ongoing management regime.					
Recommendation		Do not allow to exceed current dimensions (subject to review if movement persists).
