Mike Wilford Associates

Structural Engineer's Report for Basement Works

165 Thatched Cottage, Bampton

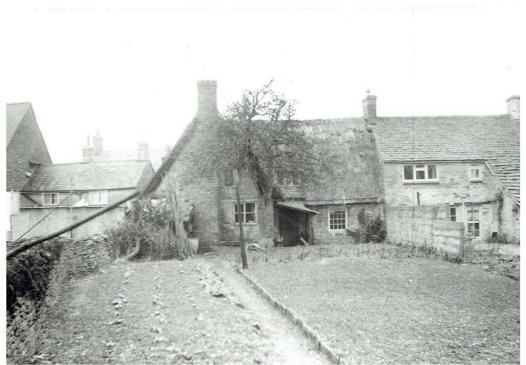
Figure 2 – Rear of the building in 1963. The basement is below this rear outshot

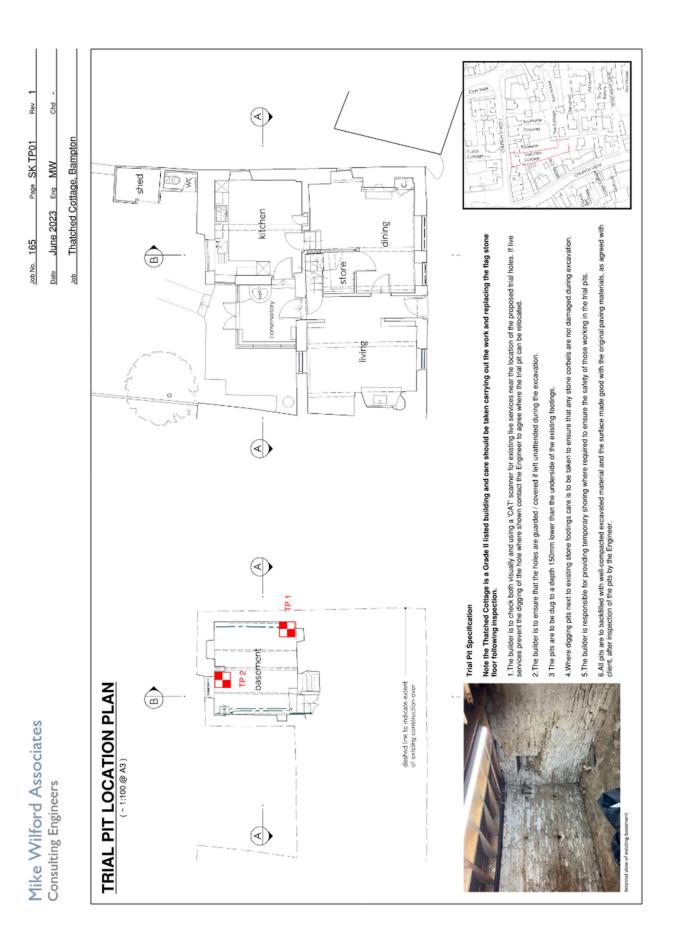
Appendix A: Trial Pit Records

The perimeter walls were founded at shallow level some 75-100mm below the top of the existing basement floor. There was no corbel to the base of the footings. The base of the stone walls coincided with the underside of the stone flag floor.

The ground in both pits was a sand and gravel, typical of the Summertown-radley Sand and Gravel Member. No ground water was encountered during the investigation.

Mike Wilford Associates	Job No. 165	Pa	ge SK TP02	Rev 1
Consulting Engineers	Date Sep 2	2023 Er	ng MW	Chd -
	Job Thate	ched Cotta	ge, Bampton	
Results of Trial P	it Invest	ligatio	n 23rd J	une 2023
Results of trial pits TP01 and TP02 similar.	(~1:10@	⊉ A4)		
			Coursed lime rubble wall	estone
Ľ,	1	/	Depth of wal between 75 both trial pits	100mm in
tes	5		75 - 100mm laid directly o	stone flags on ground
	J I	J.	SIT	
	T			
			and Gravel	n-radley Sand
Photograph of TP01 Note shallow footing and		Photograph of TP02 Note shallow footing and

orange sands and gravels.

The slab will be cast in 1.0m wide strips and will be cast under the walls, in an underpinning type sequence. A 75mm gap between concrete and base of wall will allow drypack to be rammed in tight to the underside of the wall to the full depth of the wall.

It is proposed to tank and insulated the walls and floor of the basement and install a new ground bearing concrete slab. The slab would be installed in an underpinning type method sequence ensuring the historic fabric remains supported throughout the work using known techniques to limit effect on the listed structure.
