# BNTW – SCOTLAND

**Tree Report - Fife Housing Group  
7 Pitreavie Court  
Pitreavie Business Park  
Dunfermline  
Fife KY11 8UU  
United Kingdom  
robert.brown@fifehg.org.uk**

**BNTW- SCOTLAND on 13th November 2023 on One tree in the  
public courtyard of 23 High Street, Dysart, KY12YU**

Tree T1 - Sycamore tree.

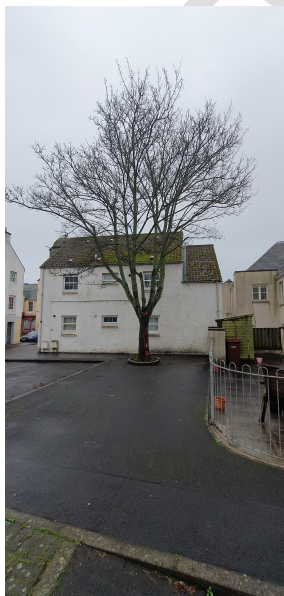
Tree is outgrowing its location and original context. It should be noted that this tree has a number of stem impacts that have resulted in bark death, which if continues will ring bark the tree.

**Picture showing tree location in courtyard**

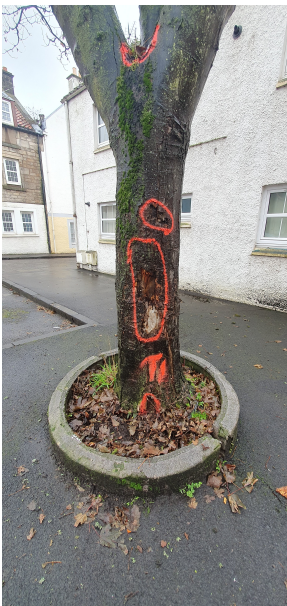
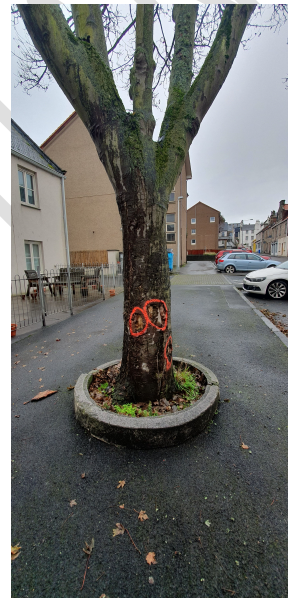
**Ref Photographs below:**

Sycamore tree - It consists of a single stem forking at 2.3m, with water pocket. Old impact wounds with deadwood/exposed heartwood. Possible basal decay. Restricted rooting. Limited life expectancy

Large spreading crown with horizontal elongated branches dominating the courtyard area.

Pics, showing tree with old pruning wounds.
