Arboricultural Consultancy for Esure

1. Case Details

Client: Subsidence Management Services
Client Contact: Michael Yuill
Client Ref: IFS-ESU-SUB-18-0078349
Policy Holder: Mr Mark Christie
Report Date: 9 December 2019
Our Ref: C47078G23510

Client: Subsidence Management Services
Client Contact: Michael Yuill
Claim Number: 4004419529
Client Reference: IFS-ESU-SUB-18-0078349
Policy Holder: Mr Mark Christie
Report Date: 21 November 2019
Our Ref: R34064

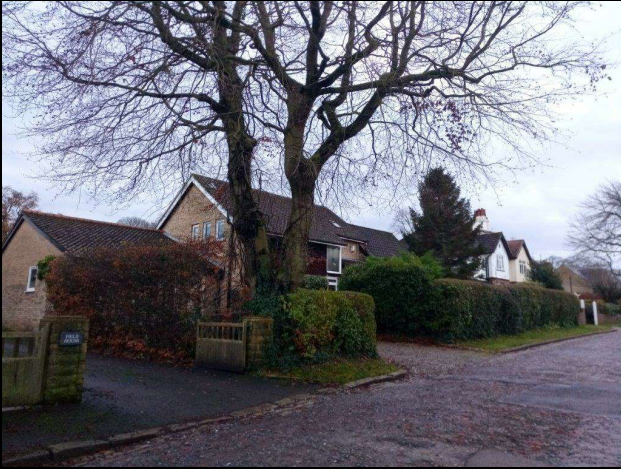
However, whilst not positively implicated by root analysis, the Beech (T1) is considered the dominant feature proximate to the area of movement and accordingly we have identified it as the primary cause of the subsidence damage.

H1 left & T1 centre

Consequently, complete removal of T1 will offer the most certain arboricultural solution likely to restore long-term stability.

Tree No.	Species	Age Cat	Approx. Height (m)	Distance to Building (m) *	Ownership	Action	Requirement
T1	Beech	3	12.5	8	C - Insured	Remove	Remove close to ground level.

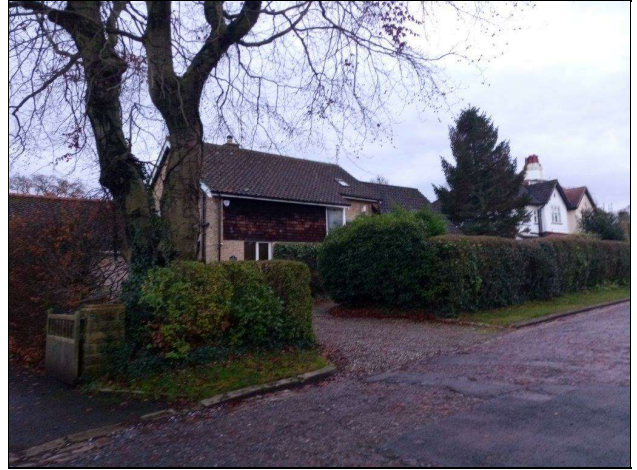
H2 right, T2 right background, SG1 & SG2 centre

T2	Spruce (Norway)	2	12	5	A - Third Party	Action to avoid future risk	Remove close to ground level.
TG1	Mixed Species Group: Includes Apple and Rowan	2	7	3	C - Insured	Action to avoid future risk	Maintain at current dimensions by way of regular pruning.

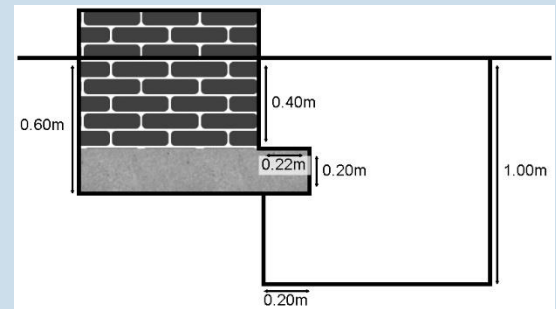
Foundation Detail

House foundation comprised of brick wall to 400mm bgl, bearing on concrete to 600mm bgl, with a total projection of 220mm from the elevation. Underside of foundation (USF) was exposed to 200mm back from the face of the foundation and probed 250mm back from the face of the foundation.

At 0.60m bgl UNDERSIDE OF HOUSE FOUNDATION in TP/BH1.

At 0.10m to 0.60m bgl numerous roots of live appearance encountered in TP/BH1.

At 0.60m to 1.60m bgl occasional roots of live appearance encountered and sampled in TP/BH1.
