Salvation Army Ayr Stone Report

Located 59 John Street, Ayr
KA8 0BS

Category B listed building
Recommended stone type - Peak Moor

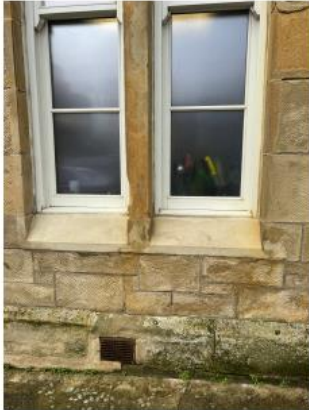
1. Bosh/failed repairs to cills required old repairs to be removed and re done using MM Repair.

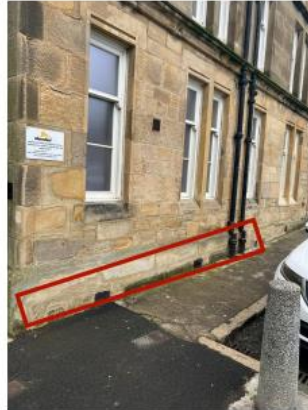
2. Bosh/failed repairs to plinth course require old repairs to be removed and re done using MM Repair.

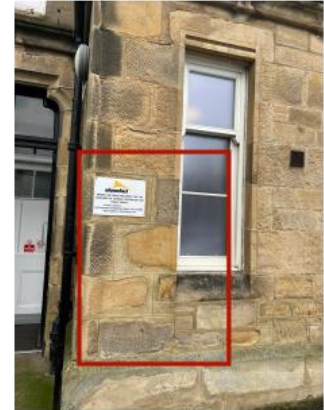
3. Bosh/failed repairs to Dressed ashlar require old repairs to be removed and re done using MM Repair.

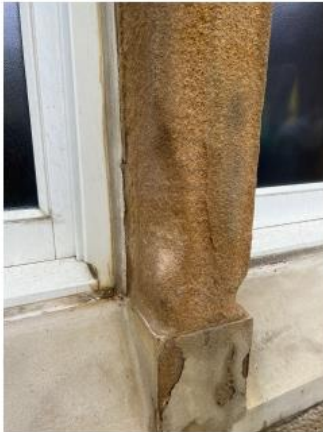
4. Base of Mullion has weathered and requires part repair using MM Repair.

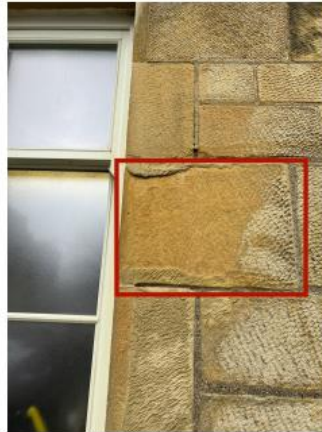
5. Bosh repairs have failed around window rybat, stone requires a redress and partial repair.

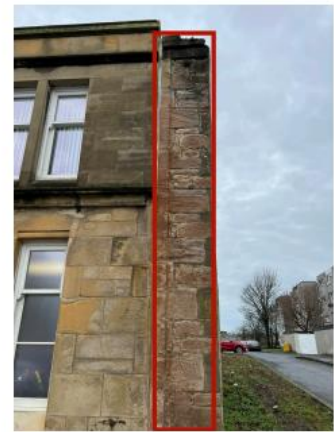
6. Cementitious old repairs to be removal and re done using MM Repair followed by isolated lime pointing to open areas.

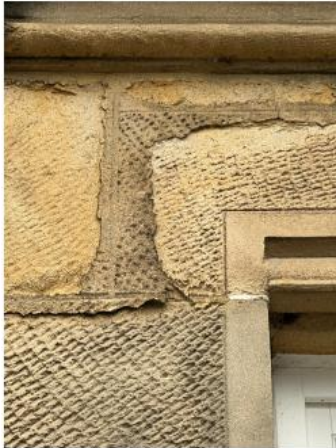
7. Bosh/failed repairs to lintels require old repairs to be removed and re done using MM Repair to 4 areas market in Section G.

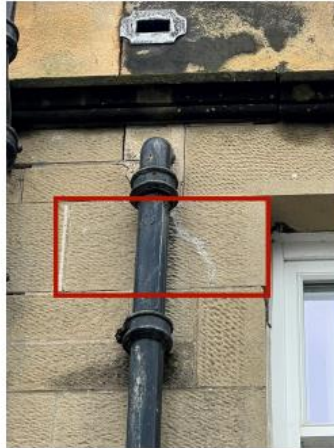
8. Resin anchor stitch repair required to window rybat.

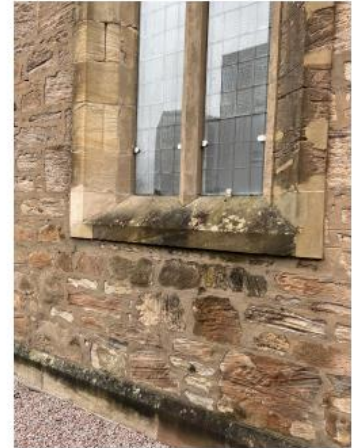
9. Bosh/failed repairs to cills require old repairs to be removed and re done using MM Repair.

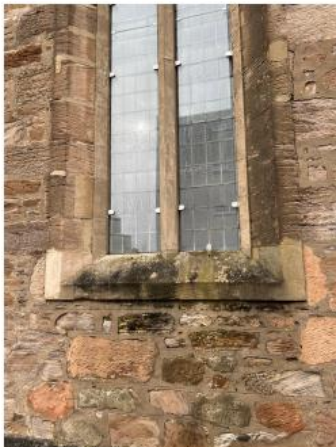
10. Bosh/failed repairs to cills require old repairs to be removed and re done using MM Repair.

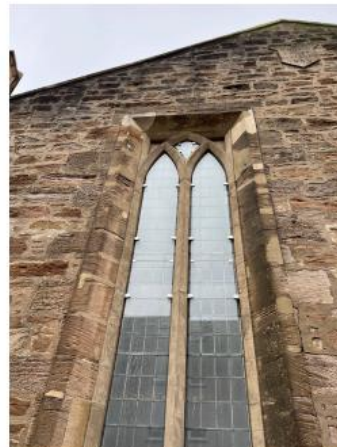
11. Bosh/failed repairs to areas around window require old repairs to be removed and re done using MM Repair.

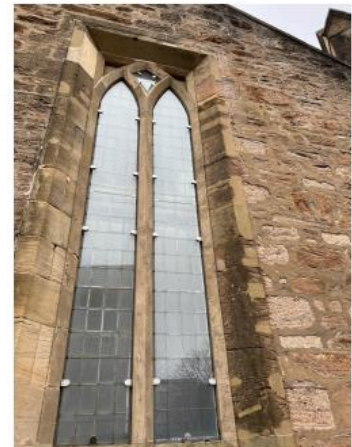
12. Bosh/failed repairs to areas around window require old repairs to be removed and re done using MM Repair.

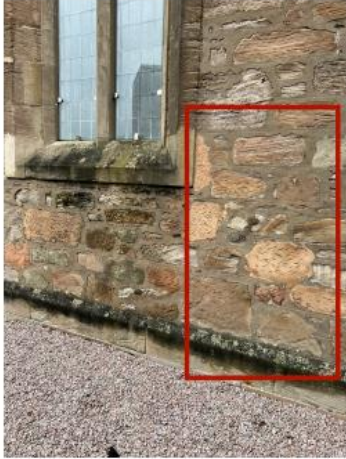
13. Bosh/failed isolated repairs to areas around base of section F require old repairs to be removed and re done using MM Repair.

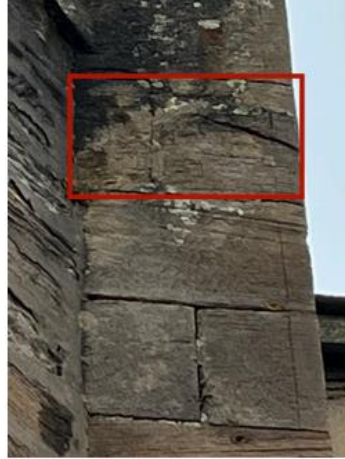
14. Stone replacement required to damaged quoin section.

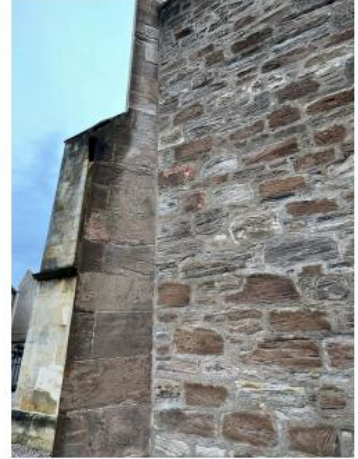
15. Isolated thin bosh repairs require redressed/removed and carborundum rub.

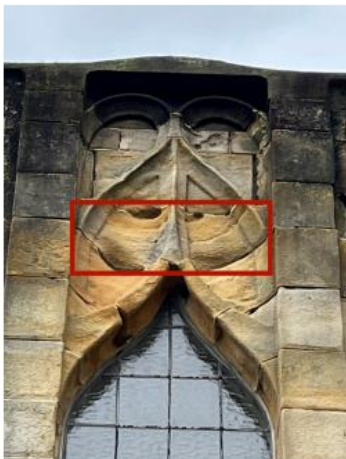
16. Eroded feature stone required replacement & repairs to surrounding stones using MM Repair.

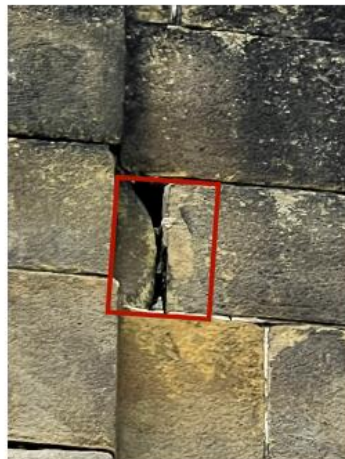
17. Stone replacement required to damaged dressed ashlar section.

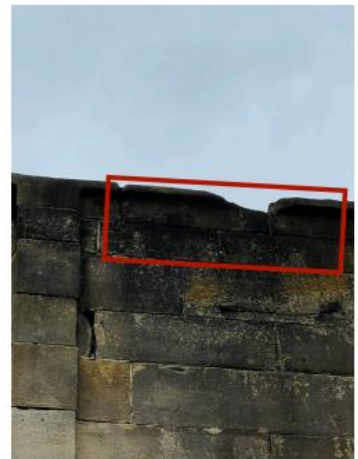
18. Stone replacement required to damaged moulded coping section.

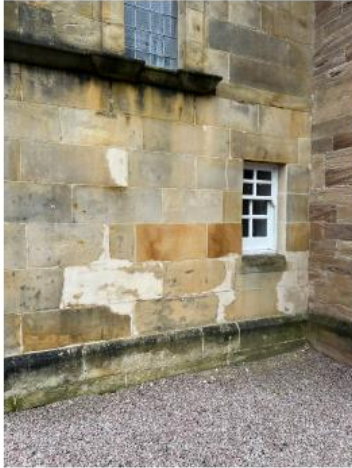
19. Bosh/failed isolated repairs to areas around base of section E require old repairs to be removed and re done using MM Repair & resin anchor stitch repair

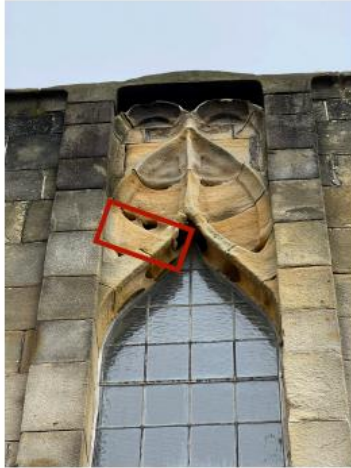
20. Eroded feature stone required replacement & repairs to surrounding stones using MM Repair.

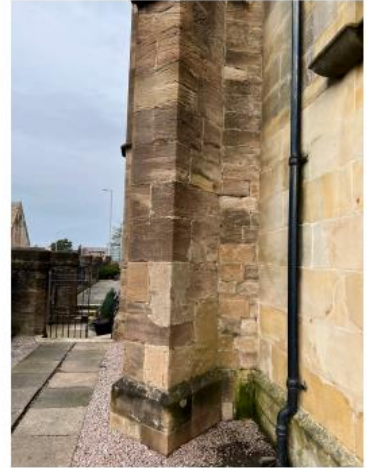
21. Cementitious old repairs to be removal and re done using MM Repair.

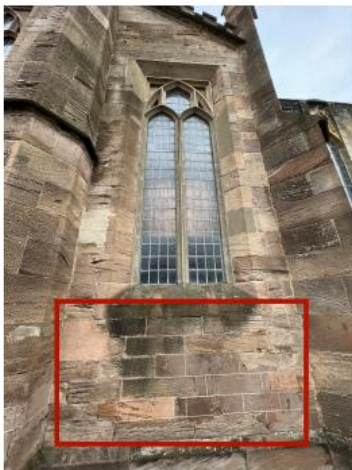
22. Bosh/failed repairs to Dressed ashlar require old repairs to be removed and re done using MM Repair.

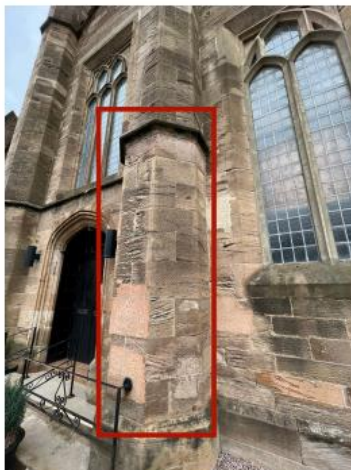
23. Bosh/failed repairs to Dressed buttress require old repairs to be removed and re done using MM Repair.

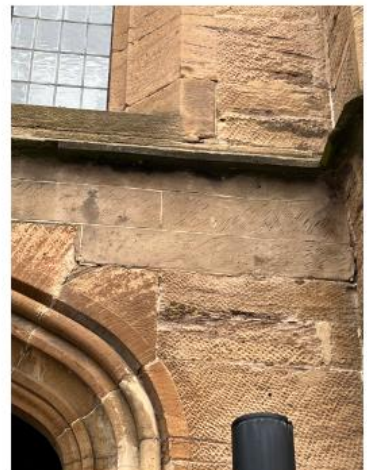
24. Bosh/failed repairs to Dressed ashlar require old repairs to be removed and re done using MM Repair.

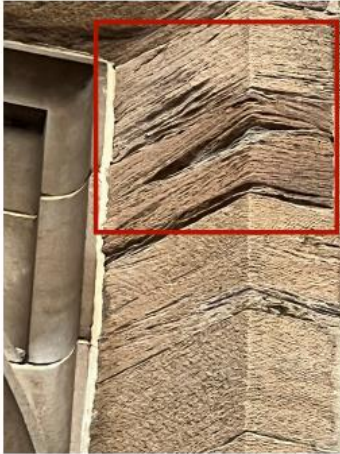
25. Isolated part repair required to window rybat to avoid water build up.

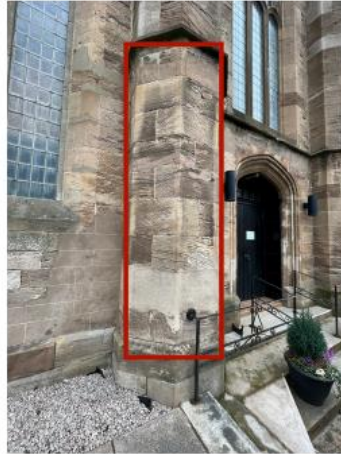
26. Bosh/failed repairs to Dressed buttress require old repairs to be removed and re done using MM Repair.

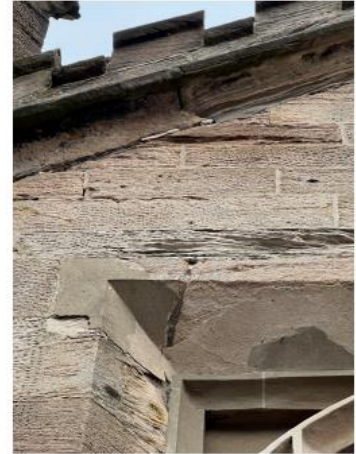
27. Damaged/cracked lintel requires resin anchor stitch repair & full lintel repair.

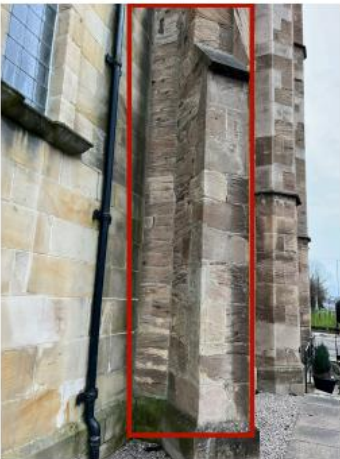
28. Bosh/failed repairs to Dressed buttress and internal wall require old repairs to be removed and re done using MM Repair.

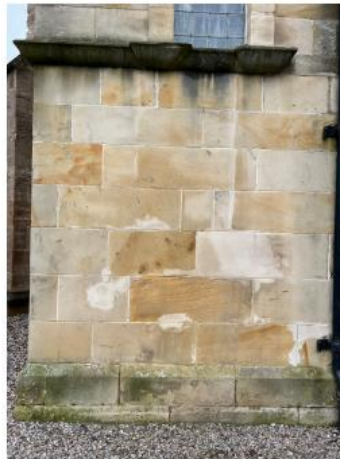
29. Bosh/failed isolated repairs to areas require old repairs to be removed and re done using MM Repair.

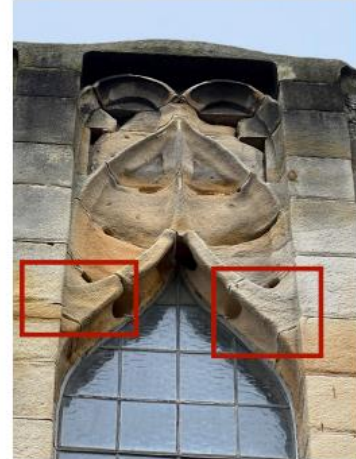
30. Eroded feature stones required replacements & repairs to surrounding stones using MM Repair.

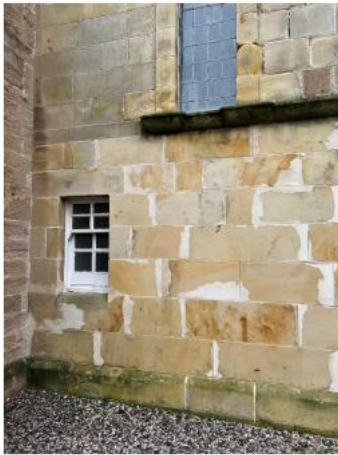
31. Bosh/failed isolated repairs to areas require old repairs to be removed and re done using MM Repair.

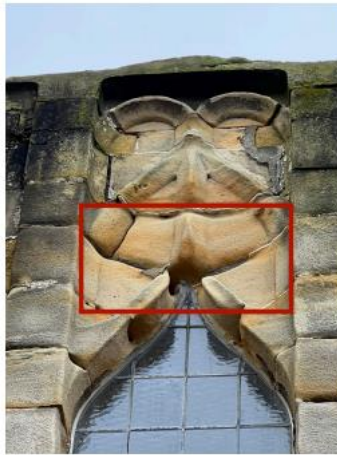
32. Eroded feature stones required replacements & repairs to surrounding stones using MM Repair.

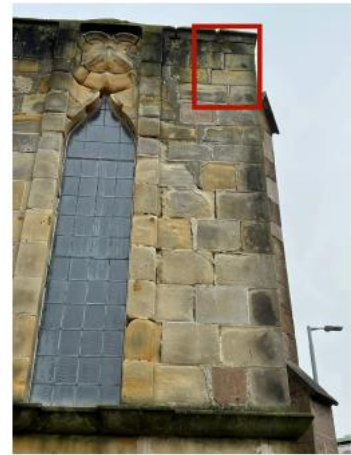
33. Top corner requires 3 courses to be striped following movement and rebuild using sufficient ties.

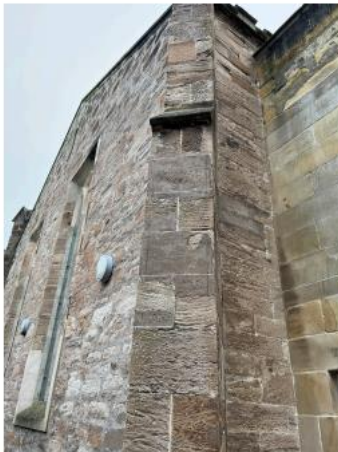
34. Bosh/failed repairs to Dressed buttress require old repairs to be removed and re done using MM Repair.

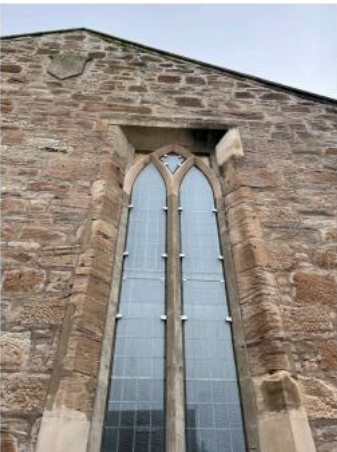
35. Bosh/failed repairs to areas around window require old repairs to be removed and re done using MM Repair.

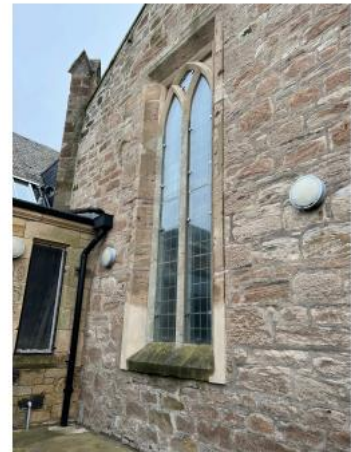
36. Bosh/failed repairs to areas around window require old repairs to be removed and re done using MM Repair.

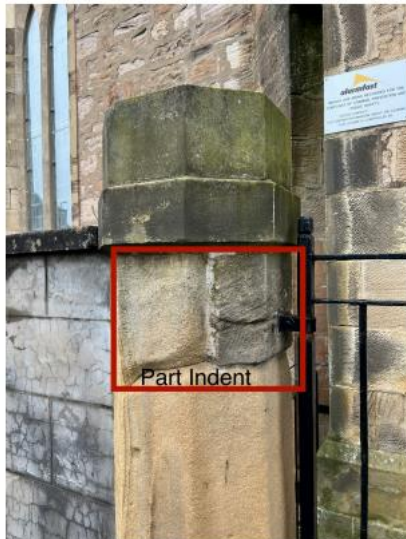
37. South Elevation Pillar has eroded through time. High level part indent should be replaced with full width part indent which will strengthen the gate.

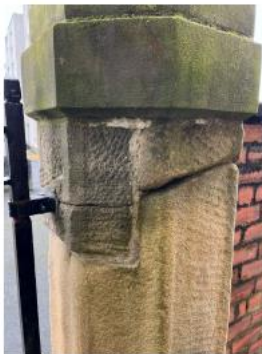
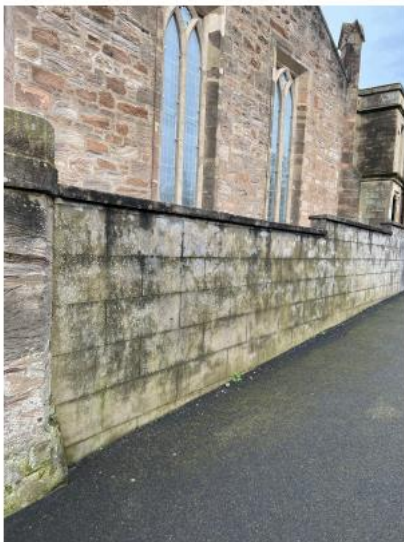
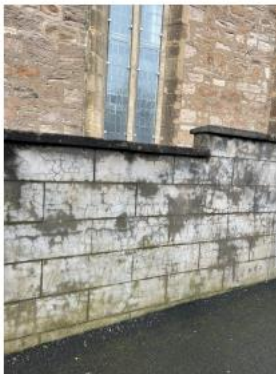
38. South Elevation cement rendered wall has become bosh in most areas, there are no signs of sections becoming loose or falling of but will in time.

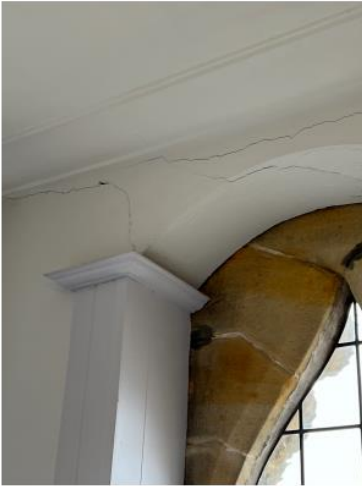
39. Internal arches above 4no windows (2 windows at each stair area) have consistent movement cracks on each arch areas. Possibly caused by movement to external corners. Investigation work will have to be carried out by opening up sections. New stone arches may be required if the internal leaf is stone or change of detail required ie concrete lintel installation on each window making up a new internal leaf.

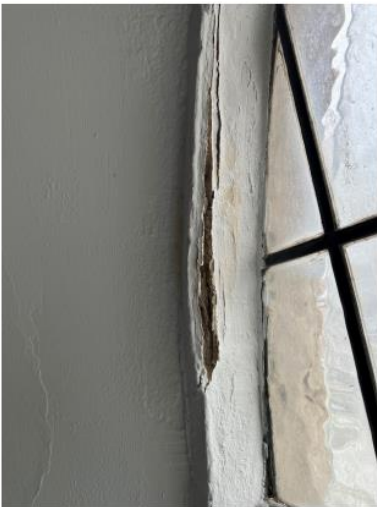
38. Due to the stone being porous, dampness is caused damage to internal finishings. I recommend areas around each window be opened up and dpc installed between stone and new finishing to avoid dampness travelling through future internal finishing.

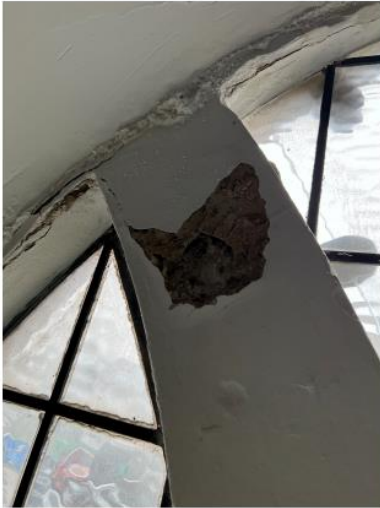
40. Paint to internal stone has bubbled and damaged the stonework to which it has been applied to. Stone must be allowed to breath or it will suffocate causing damage to the stone which is evident on this building. I recommend all paint be removed from internal stone windows, Kiem breathable paint and then be applied or the stone left without new paint.

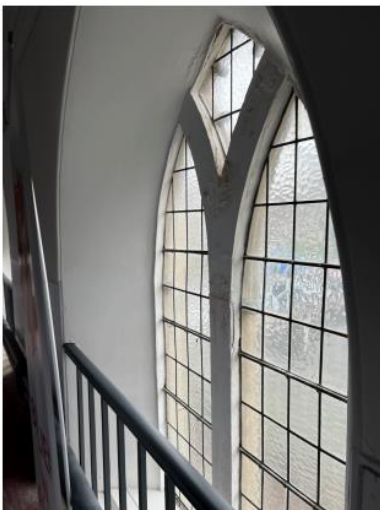
41. Internal window stonework has crack running down the inside leaf which will in time get worse. Solution would be to drill resin stainless steel ancors and repair but should the window progress with removing the paint which would be done by hand the section of stone would not withstand hand dressing and will have to be replaced.

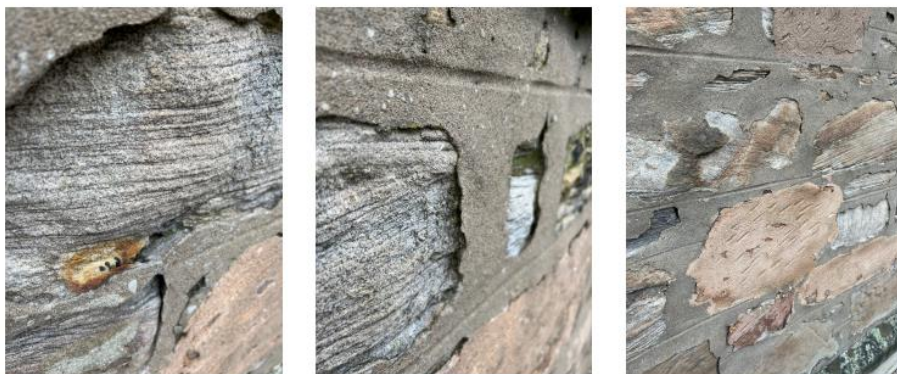
42. Lime pointing areas as per marked drawings

Area A - 60% lime pointing would be required to fill all open and defected mortar joints

Area B - 30% lime pointing would be required to fill all open and defected mortar joints.

Area C - 40% lime pointing would be required to fill all open and defected mortar joints.

Area D - 20% lime pointing would be required to fill all open and defected mortar joints.

Area E - 100% lime pointing would be required to fill all open and defected mortar joints.

Area F - 100% lime pointing would be required to fill all open and defected mortar joints.

Area G - 30% lime pointing would be required to fill all open and defected mortar joints.

Area H - 20% lime pointing would be required to fill all open and defected mortar joints.

Area I - 30% lime pointing would be required to fill all open and defected mortar joints.

Defective failed cement pointing

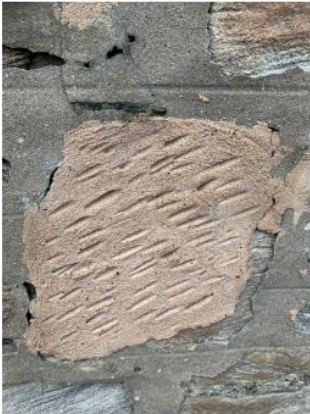
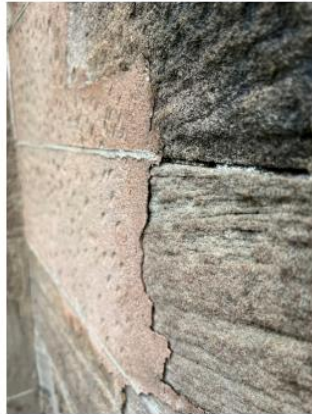
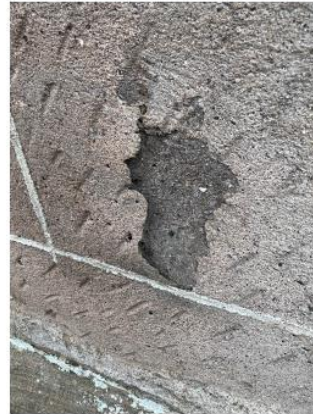
Defective/Bosh repairs
