Structural Inspection

Inspection of Timber Framed Building for Permitted Development at

West Illand Farm, Congdons Shop, Launceston, Cornwall, PL15 7LS

Reference R221130/SI/00

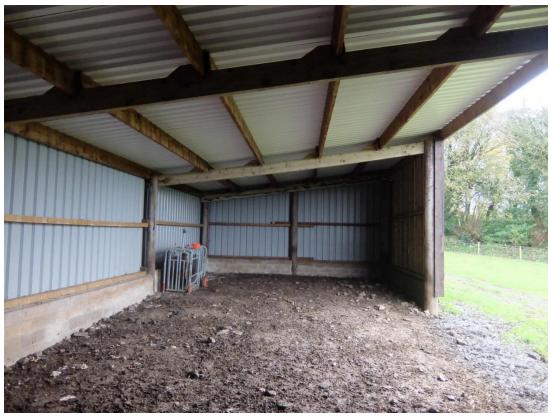
Internal view looking towards right side gable wall

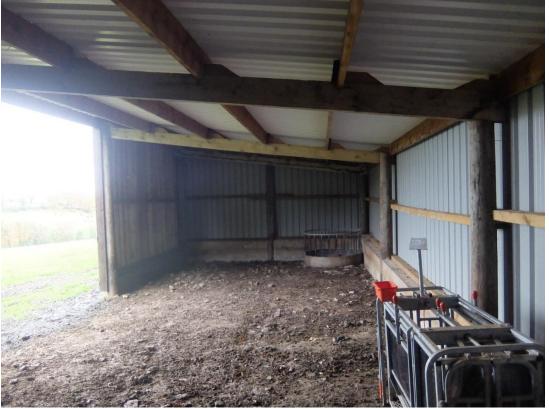
Internal view looking towards left side gable wall
