**Tree Report - 2 Lade Braes, St Andrews, KY16 9ET**

**BNTW- SCOTLAND on 17th November 2023 on One Lime tree on  
the Southern Boundary of this property adjacent to the river.**

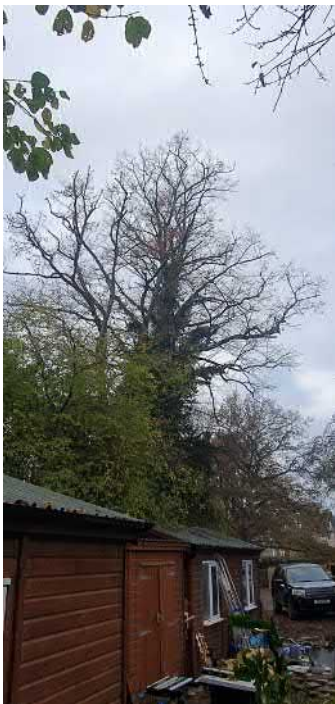
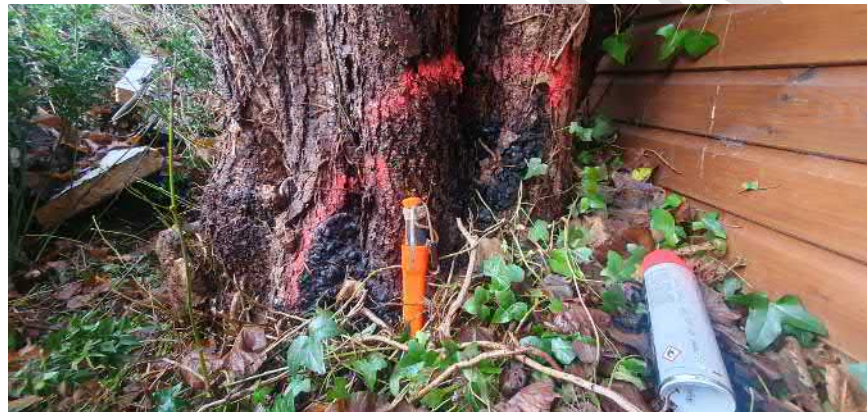
The tree - Lime tree (*Tilia spp*) is situated between a workshop building and the river. The main stem has serious defects (basal decay and fungal brackets present) that are of great concern. There is a possibility of whole tree/stem failure adjacent to workshops/storage buildings along with the potential to block the river (flood risk).

Tree has *Kretzschmaria deusta* present on main stem at ground level along with hollow soundings indicating basal decay within the stem.

Lime tree - has basal decay along with decay fungi. Rooting may be compromised and tree is in decline. Limited life expectancy

Large spreading crown with horizontal elongated branches dominating the garden area. Slightly suppressed by adjoining Lime tree. Deadwood present throughout crown. Single stem forking at 3.5m, with heavy ivy infestation (partially removed to 2.5m). Semi mature/  
Tree in decline.

Pics, showing tree with deadwood in crown/  
decline and *Kretzmaria deusta*.
