Schedule of Works
To
Gate House Cottage
Photographic Record of Conditions

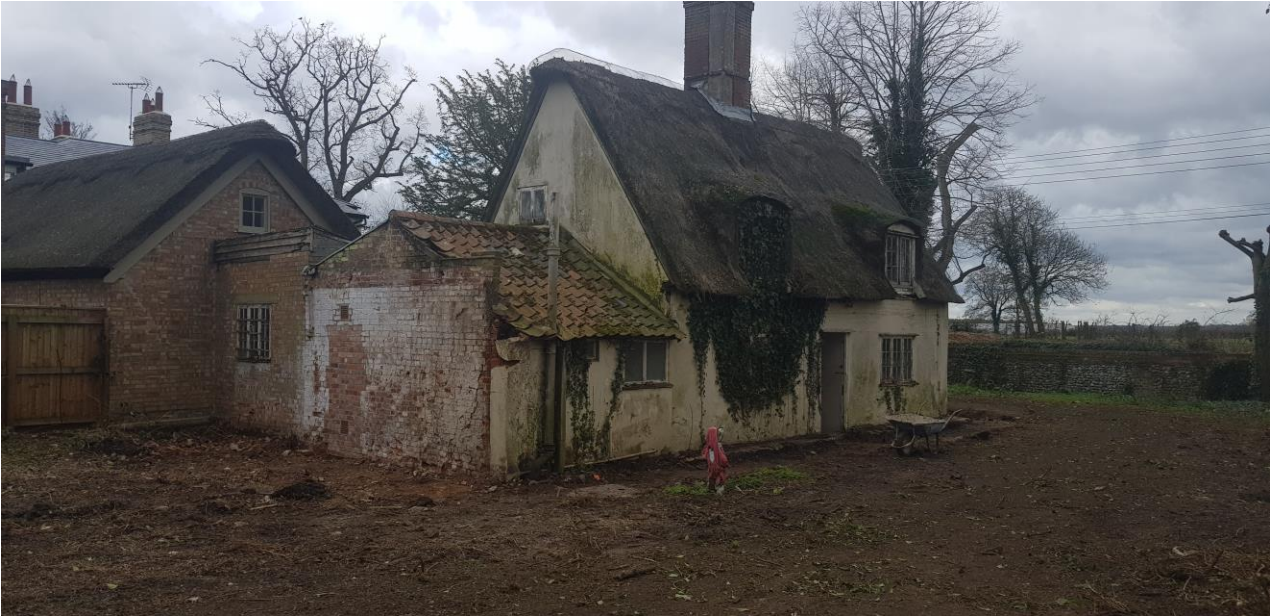
Overall View of Cottage From Garden

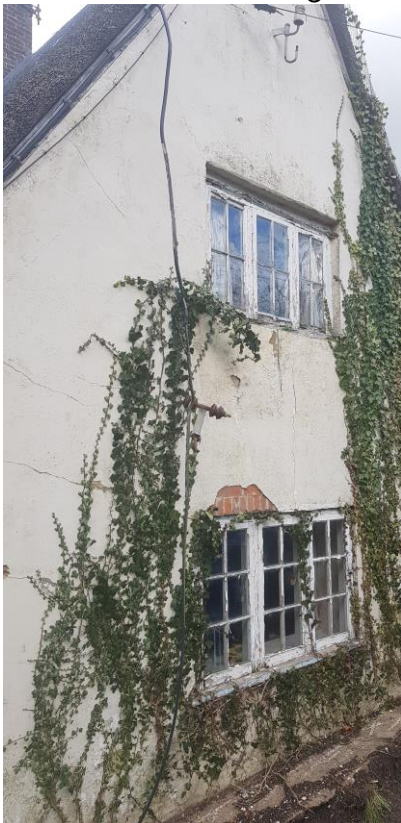
Gable to Road

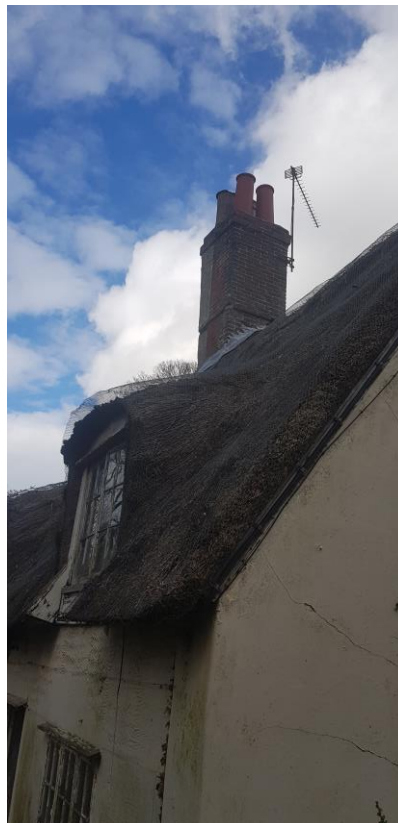
Thatched Dormer

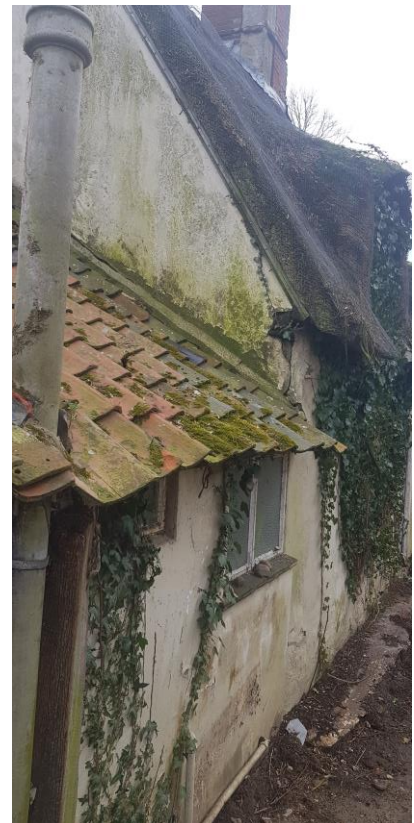
Later Extension

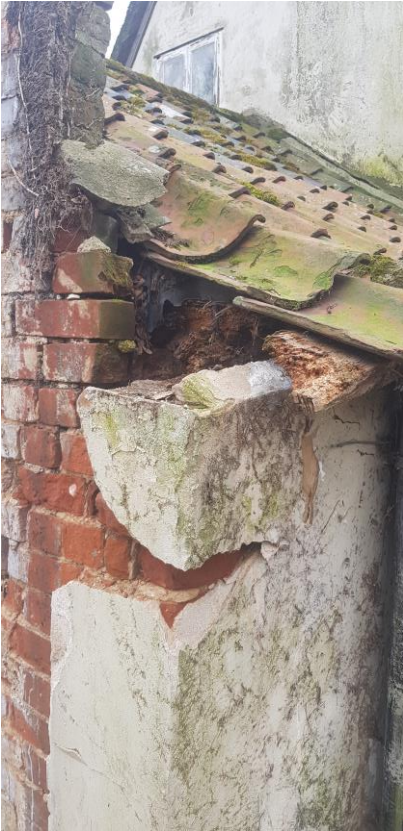
Condition of 20th C. Extension

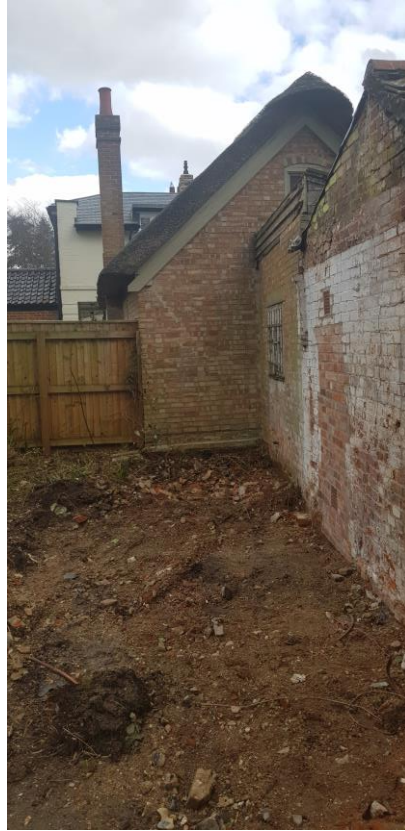
20th C. Extension

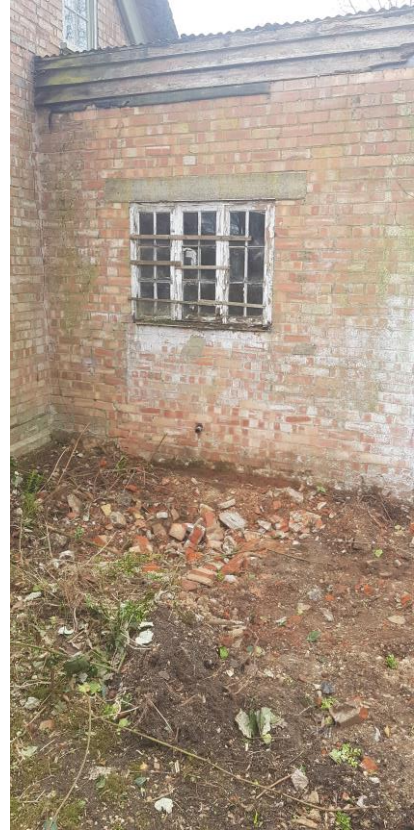
20th C. Extension

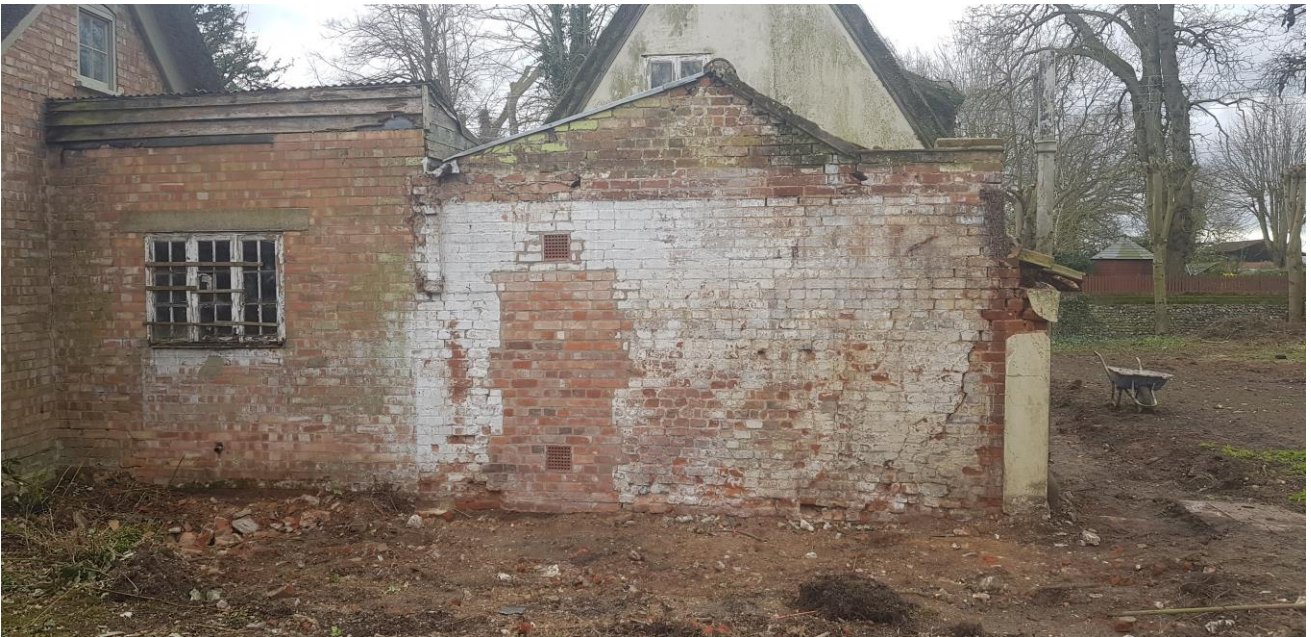
Overall Extent of 20th C. Extension to Cottage

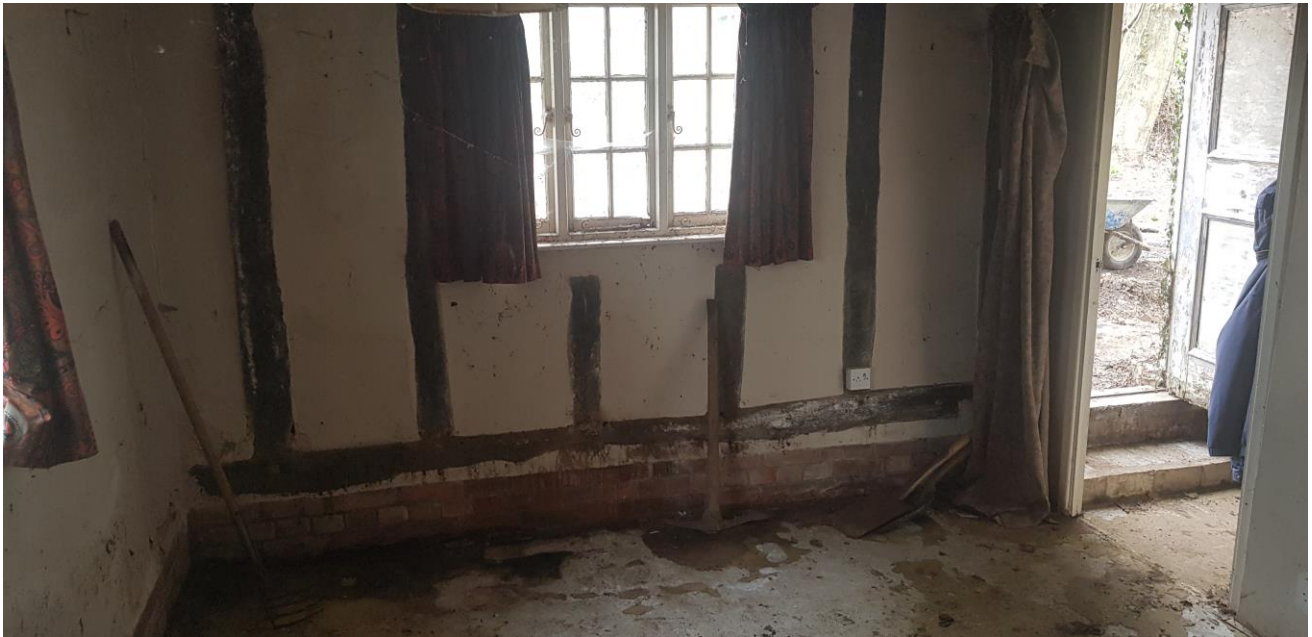
20th C. Underpinning and Slab to Living Room

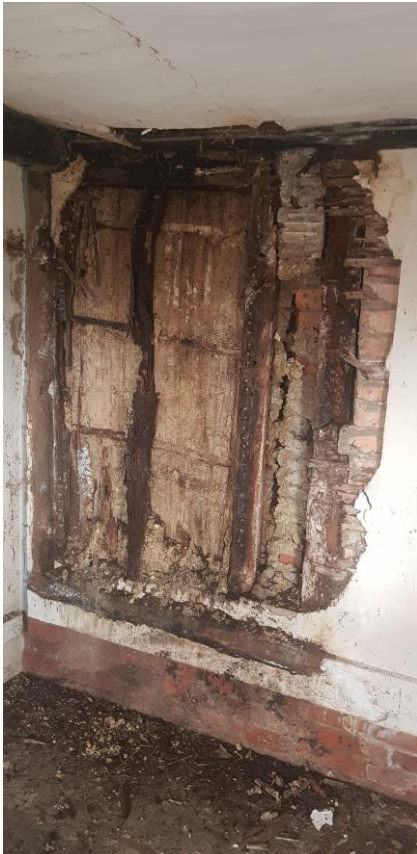
Deterioration of Wall to Living Room Where New Opening Proposed

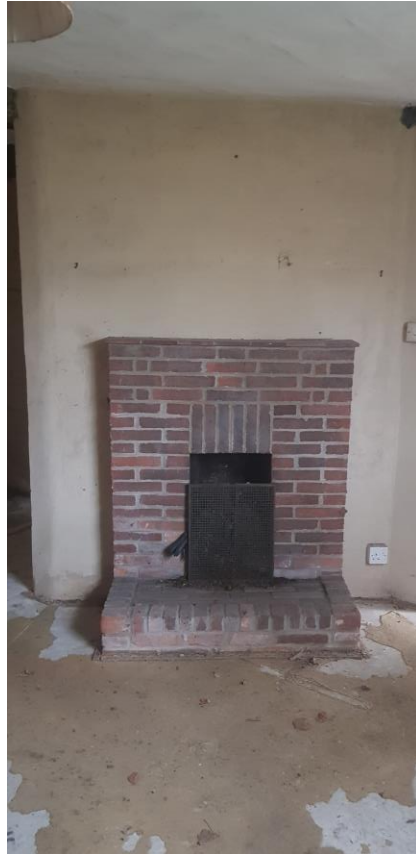
Late 20th C. Fireplace and Infill Wall in Dining Room to be Removed.

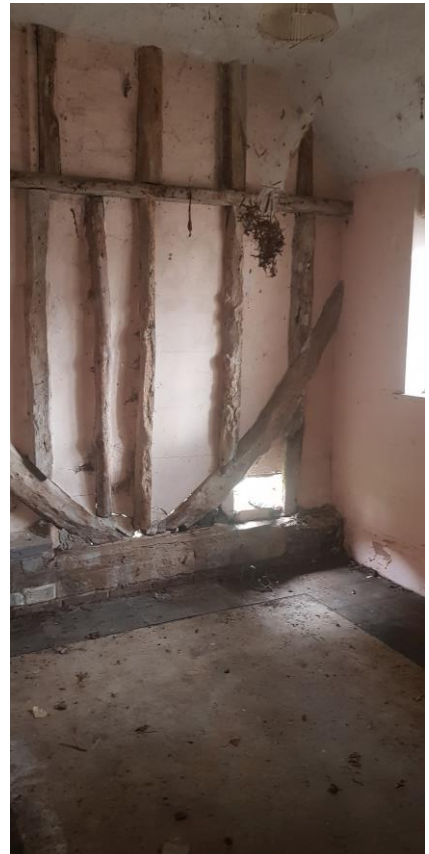
Deterioration of Wall to Rear Entrance Lobby

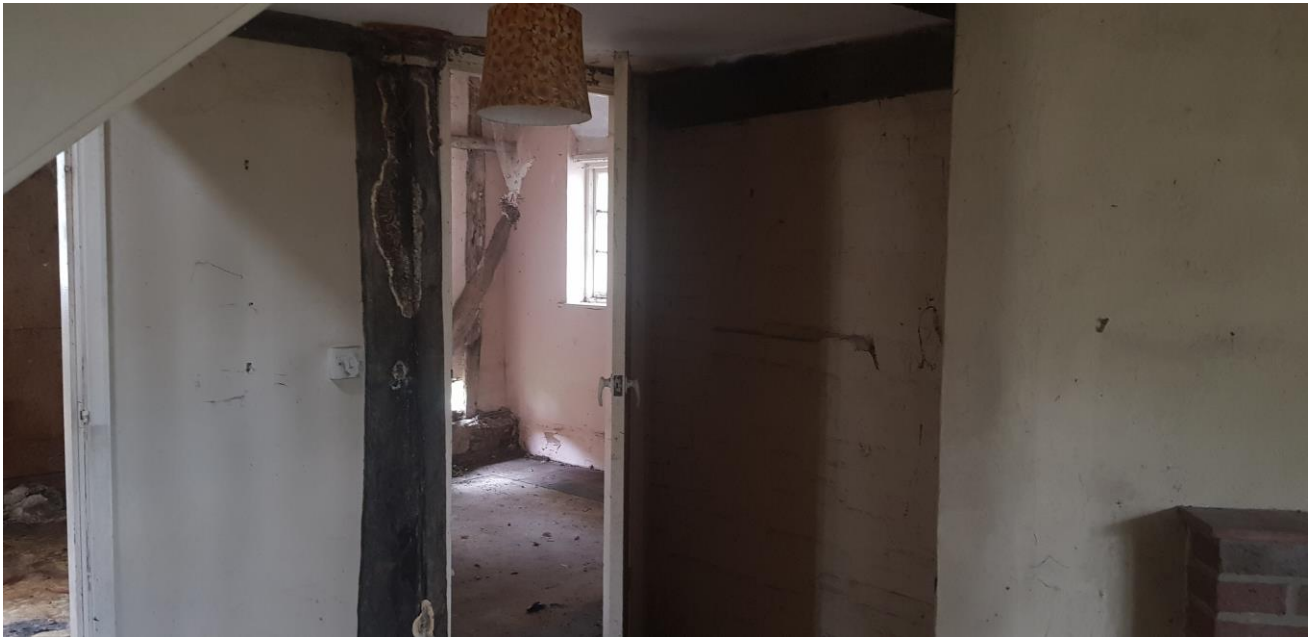
Fungal Growth on Timber Framing

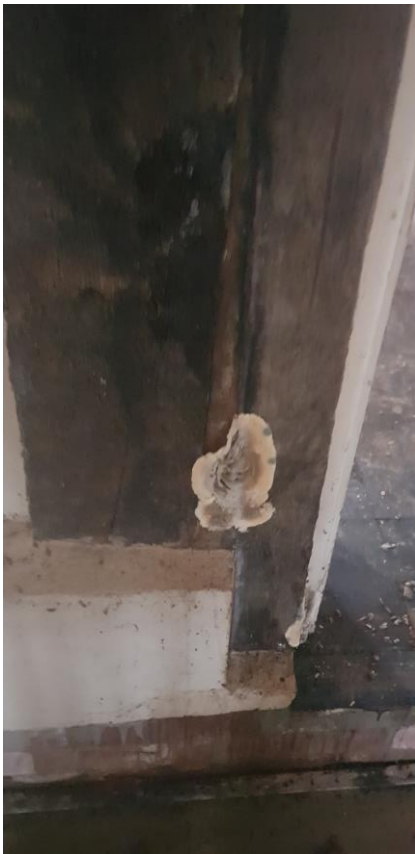
Fungal Growth on Timber Framing

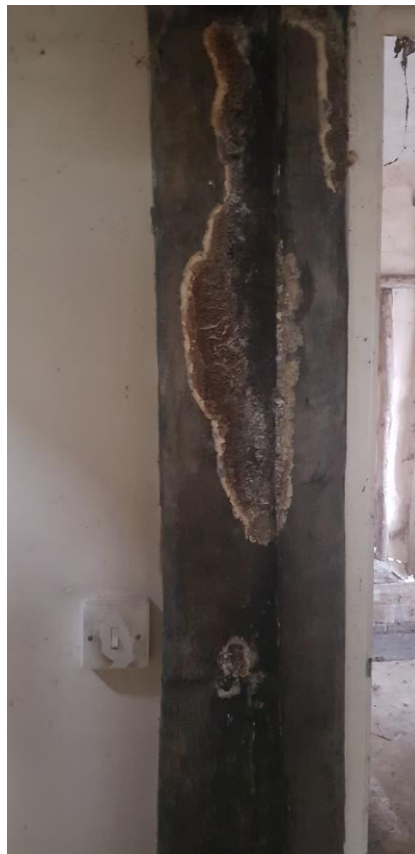
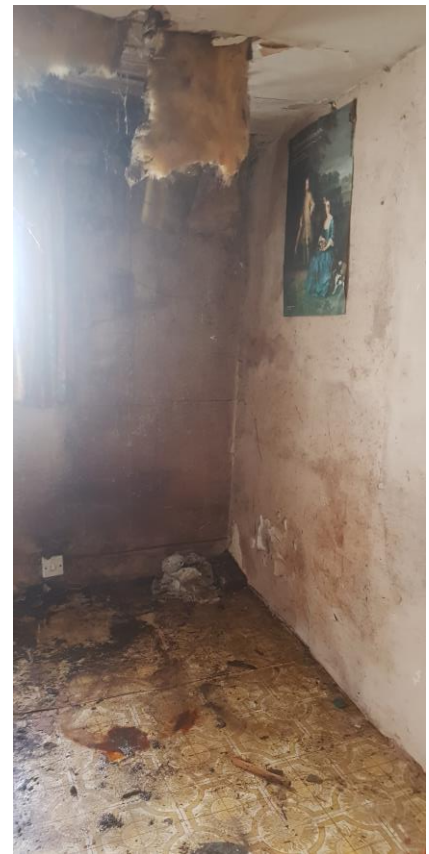
Water Damage to Ceiling
Walls and Floors

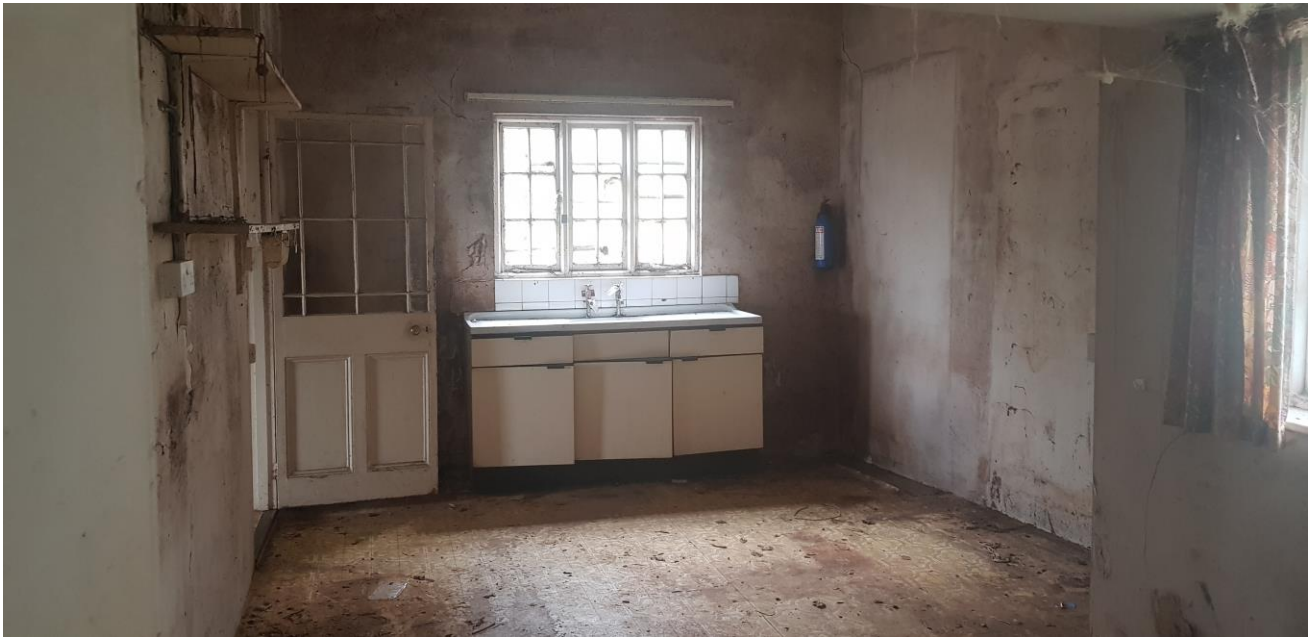
Kitchen Area with Mixture of Plaster Finishes and Damp Ingress

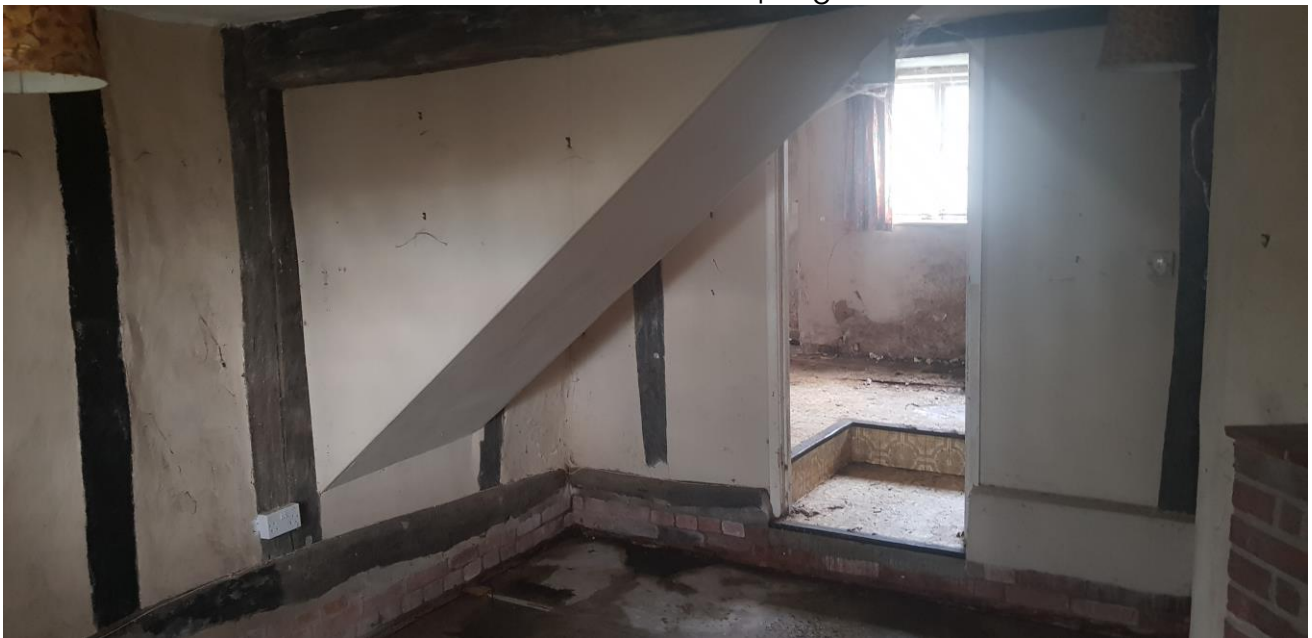
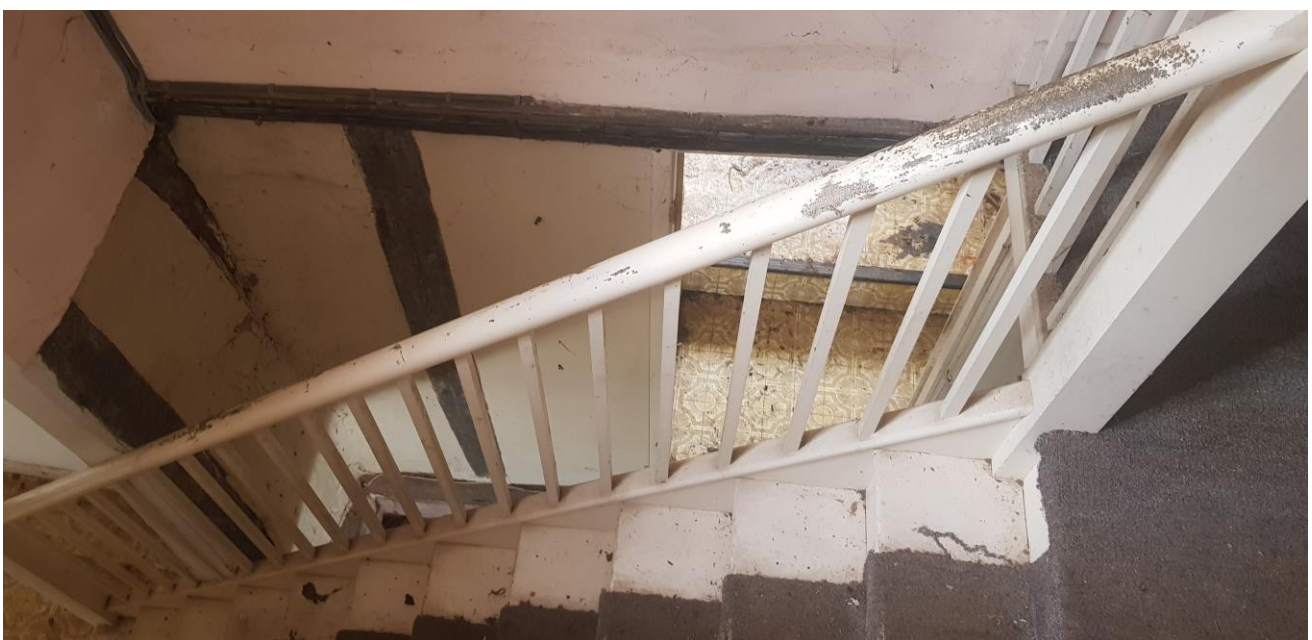
20th C. Straight Timber Stair and Plasterboard Enclosure

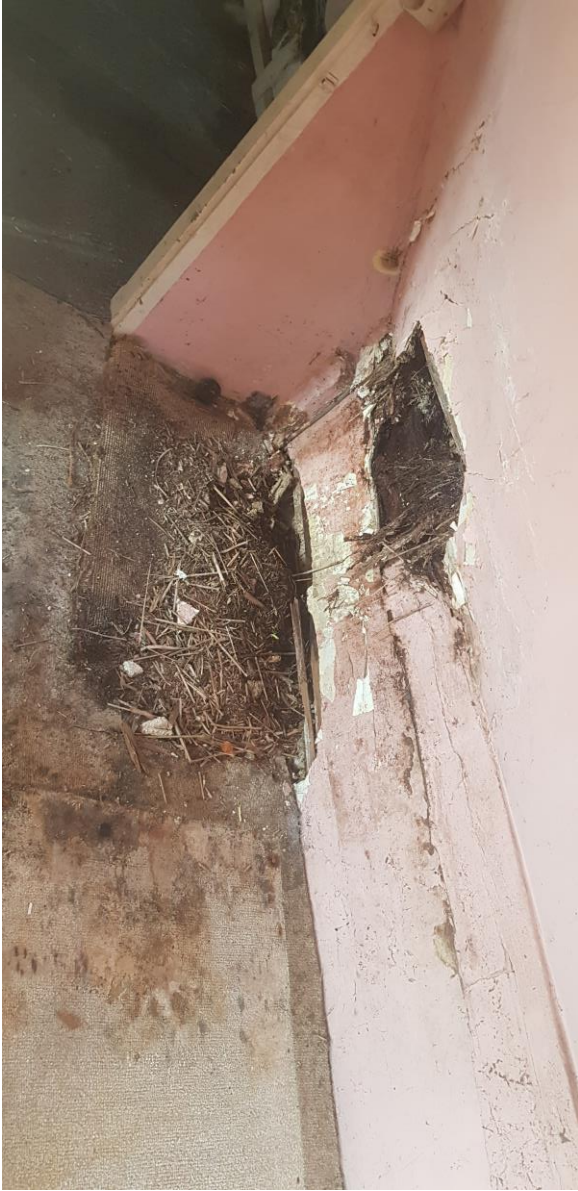
Deterioration of Plaster and Thatch

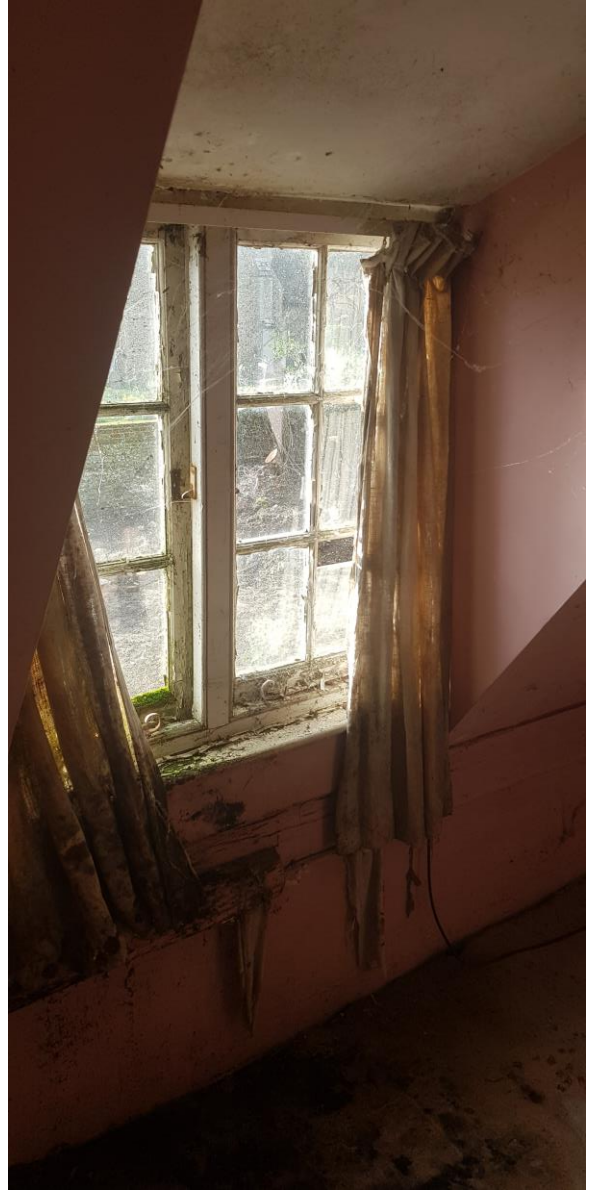
Deterioration of Windows

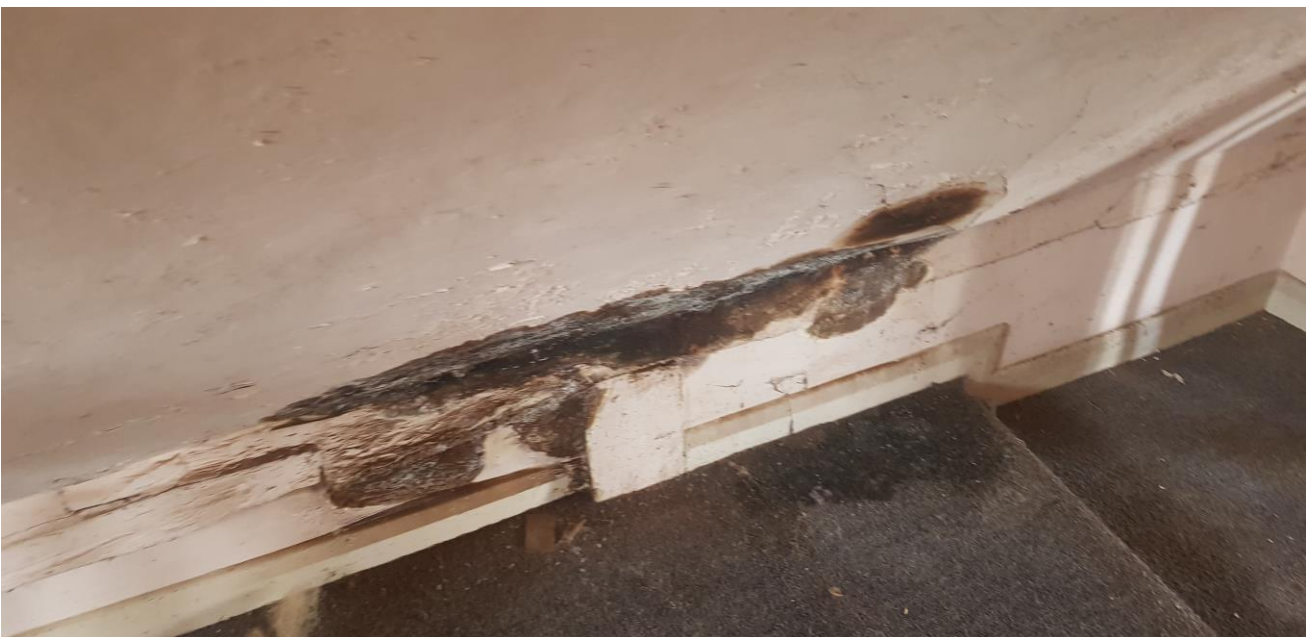
Damp and Fungus Penetration of Timber Frame
