190431: Signature Highgate

Site Inspection Report – May 2021

Location: 58 The Bishops Avenue, London, N2 0BE

Date: 27th May 2021

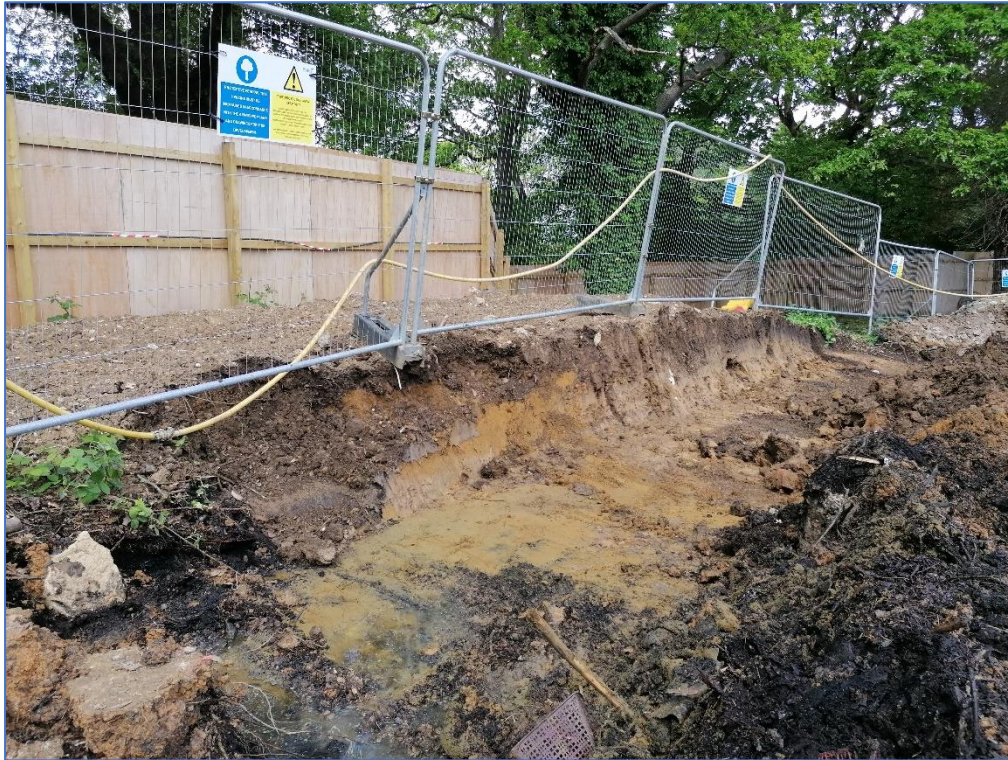
4.3	No significant tree roots were uncovered within this stretch (see photo 1). Although some roots greater than 25mm diameter were uncovered during the works, they were not deemed to be from the retained trees due to the low wood density noted during inspection. These roots were likely from shrubs removed during site clearance.

Photo 1: excavations between T33 and T37 with no significant tree roots uncovered.

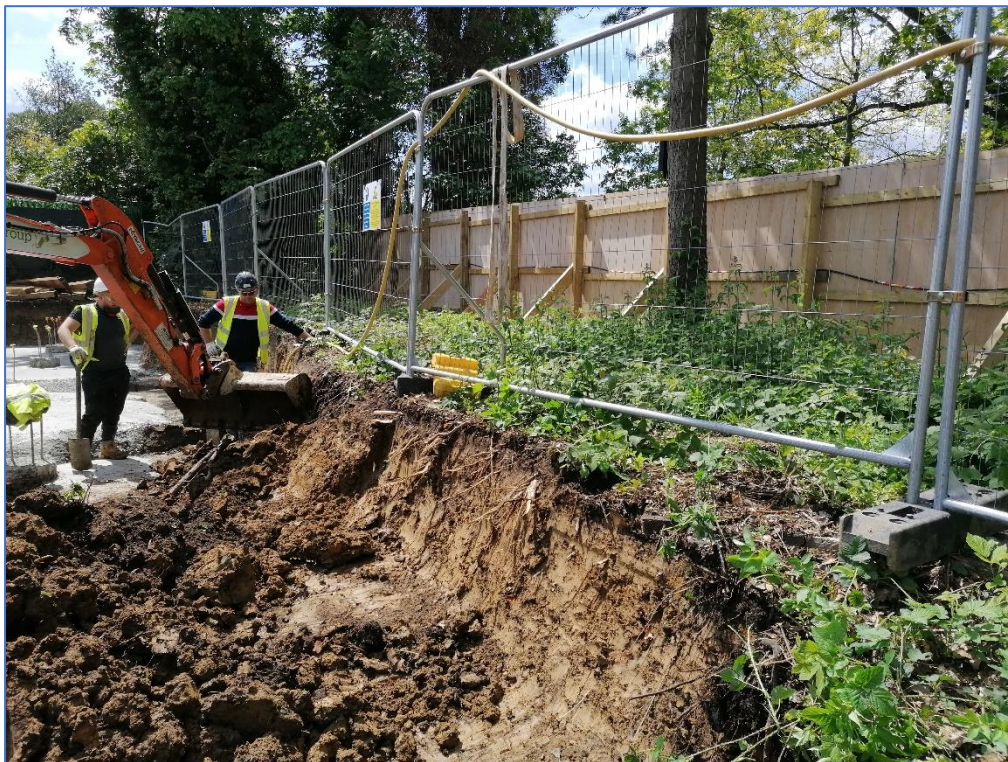
- 5 x roots at 25mm diameter, 1 x 30mm and 1 x 40mm diameter were cut back to the edge of the excavation, located 3m from the tree at its closest point.

- Given the relatively young age of the tree, abundant viable rooting area, the relatively low number of roots pruned and industry literature regarding the effects of root pruning on one side (Tree Roots and the Built Environment, 2006, 8.3.2.2); it is not considered that the physiological or structural condition of the tree has been compromised.

4.4	Satisfied that the drainage run adjacent to T33 did not contain a high number significant roots and was sufficient distance from the tree to facilitate root pruning, the drainage run was then mechanically excavated and roots cut cleanly at the edge of excavation (see photo 2).

Photo 2: excavations adjacent to T33 prior to root pruning

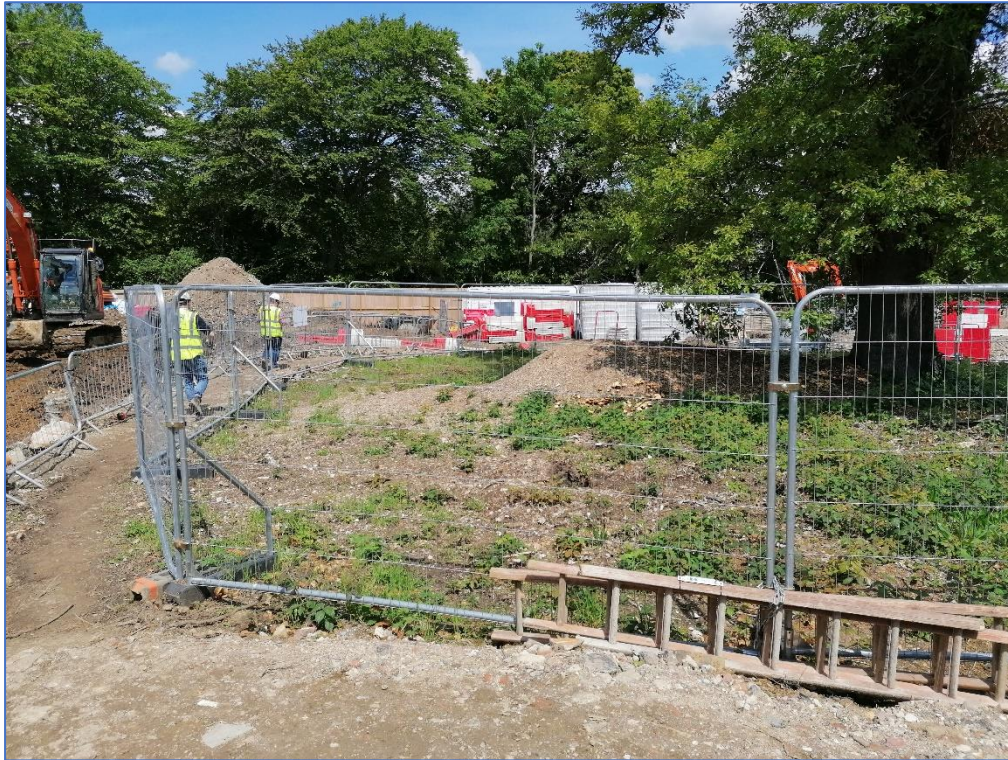
Photo 3: area of tree protection adjacent to T34 that will be replaced with ground protection.

5.3	Ground protection for plant machinery within the RPA of the central oak tree T34 was discussed and specification provided which will incorporate 150mm wood chip, 300mm reused crushed stone and track mats.
