Tree Condition Survey Report (VTA)

Site: Knights Grove Care Home, Thomas Road, North
Baddesley, Southampton, SO52 9EW

Client: Bupa

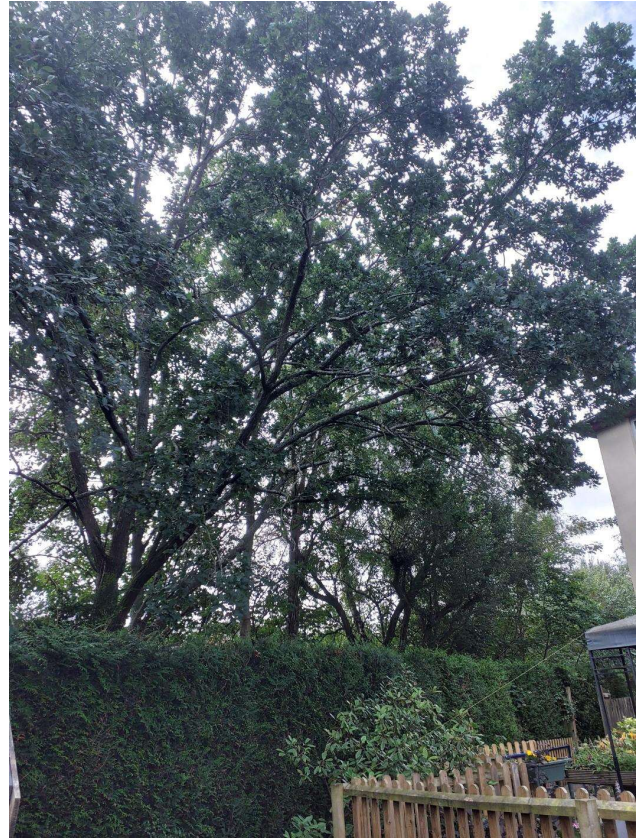
Pedunculate oak Tree ID #26605

Inspection ID:	11101
Inspected By:	MattP
Inspection Date:	03/08/2023
Inspection Notes:	
Stem Diameter [mm]:	350
Common Name:	Pedunculate oak
Scientific Name:	Quercus robur
Physiological Condition:	Good

Tree / Group ID	Common Name	Work Task	Work Priority	Description	Tag No
9	Himalayan birch 'Jacquemontii'	Prune to Clear structure/wires/buildings by 1m	Within 3 - 6 Months	Prune clear of building by reducing offending limbs by up to 1m, ensuring pruning is sufficient to maintain clearance in winds also.	N/A
10	Pedunculate oak	Prune Specific Branch/Limb	Within 3 - 6 Months	Prune back limbs overhanging garden by up to 3m to reduce end weight of limbs and strain on union with main stem.	N/A

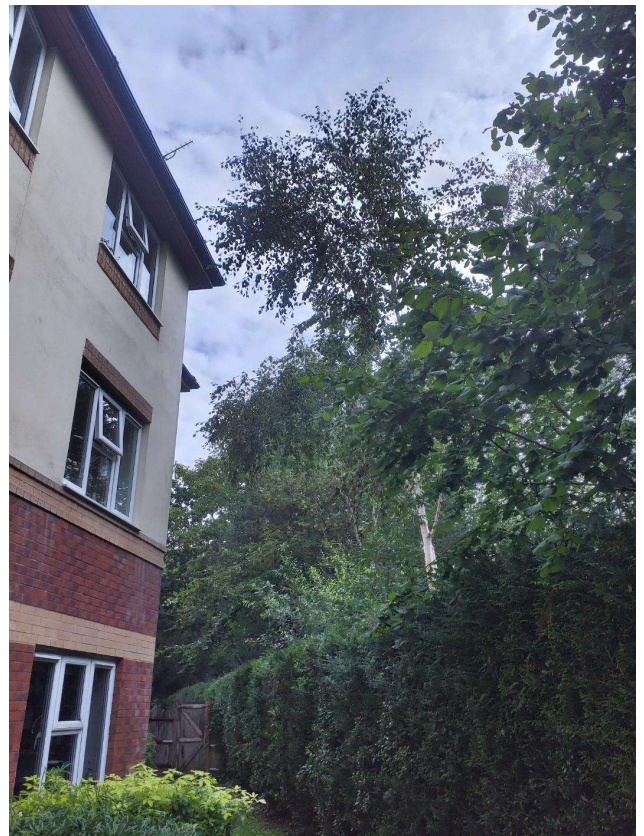
Himalayan birch 'Jacquemontii' Tree ID #26602

Inspection ID:	11107
Inspected By:	MattP
Inspection Date:	03/08/2023
Inspection Notes:	
Stem Diameter [mm]:	100
Common Name:	Himalayan birch 'Jacquemontii'
Scientific Name:	Betula utilis 'Jacquemontii'
Physiological Condition:	Good
