Condition Survey Report	Date: 17/11/2023	Client Name: Mr and Mrs Hawthorn	Address: 20 Murrayfield Avenue Edinburgh EH12 6AX

Specification:	Mould detail: Lambs tongue	Glazing notes: Proposed: 14mm (4/6/4) slim lite IGUs
Category C Listed		Timber: Redwood

Overview:
At the front, the client requests the installation of slim lite double glazing by replacing the front top sashes and returning these to the original astragal pattern, while also refurbishing the bottom sashes and installing slim lite IGUs.

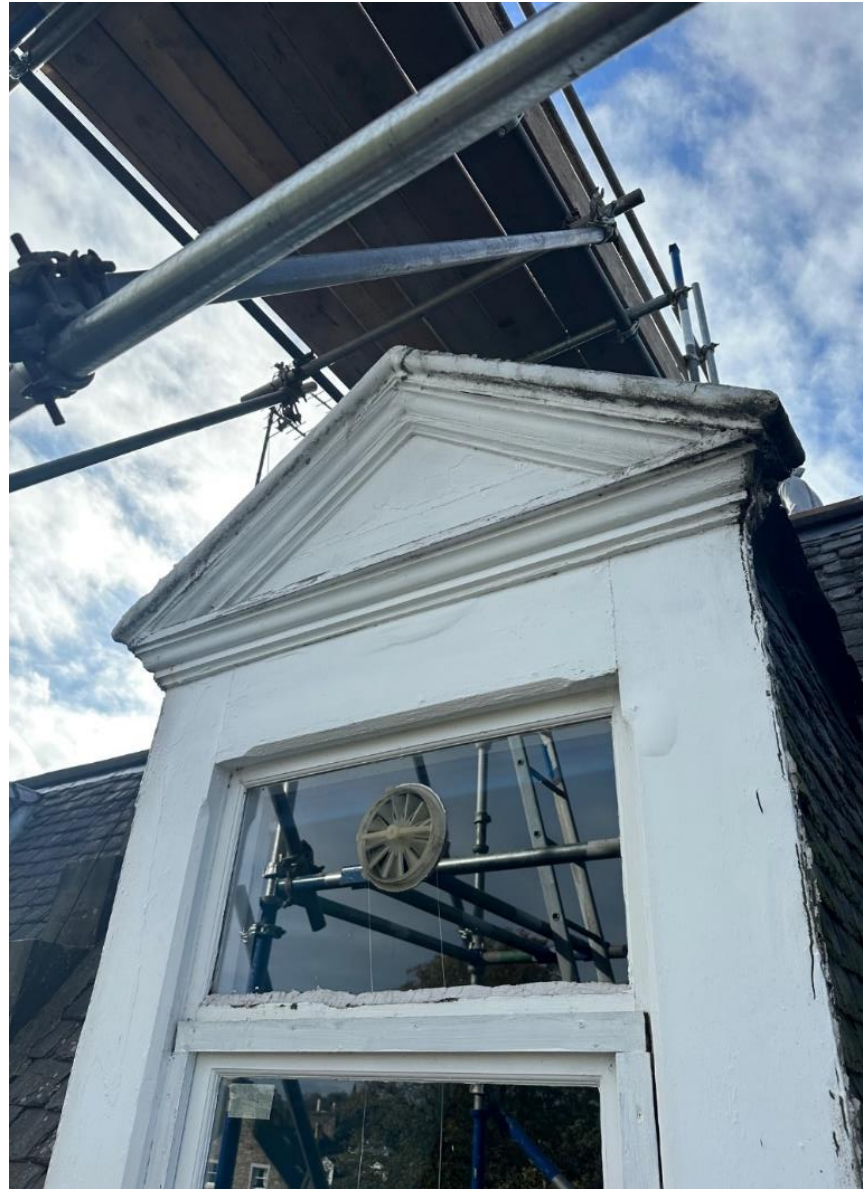
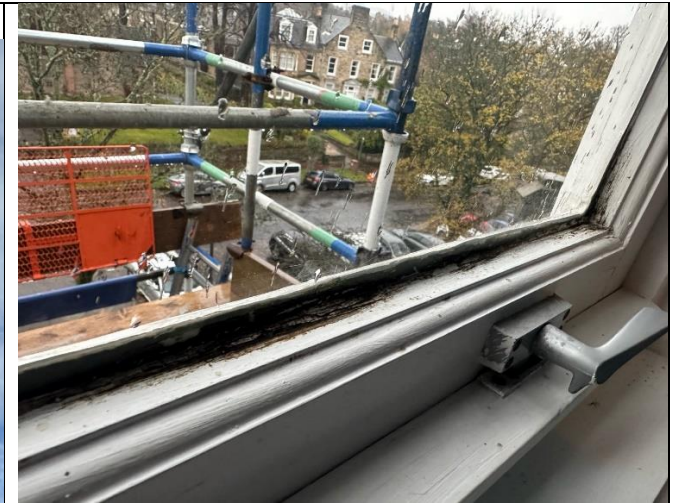
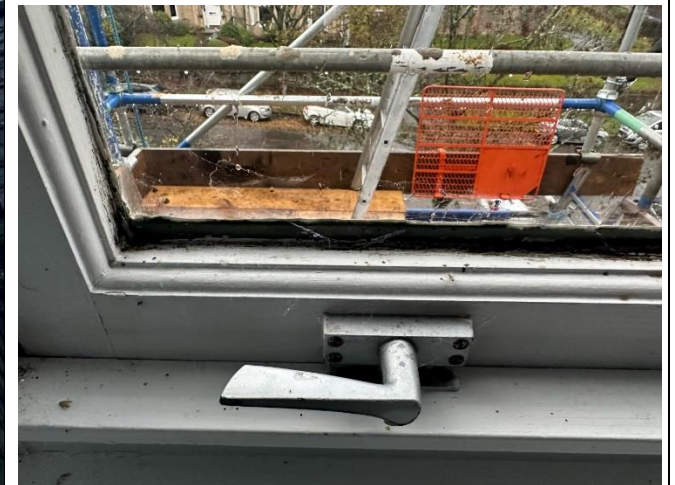
Elevation	Floor	No.	Room
Front	2nd	1	Bed1

- Non original window
- Compromised putty and paint coatings to the exterior, leading to moisture ingress and permeation of the timbers
- Heavy condensation damage to the internal timber frame
- Timber batons attached to exterior of lower window to reduce draught
- Parts of fascia board in poor condition

- 6/2 original style sash and case

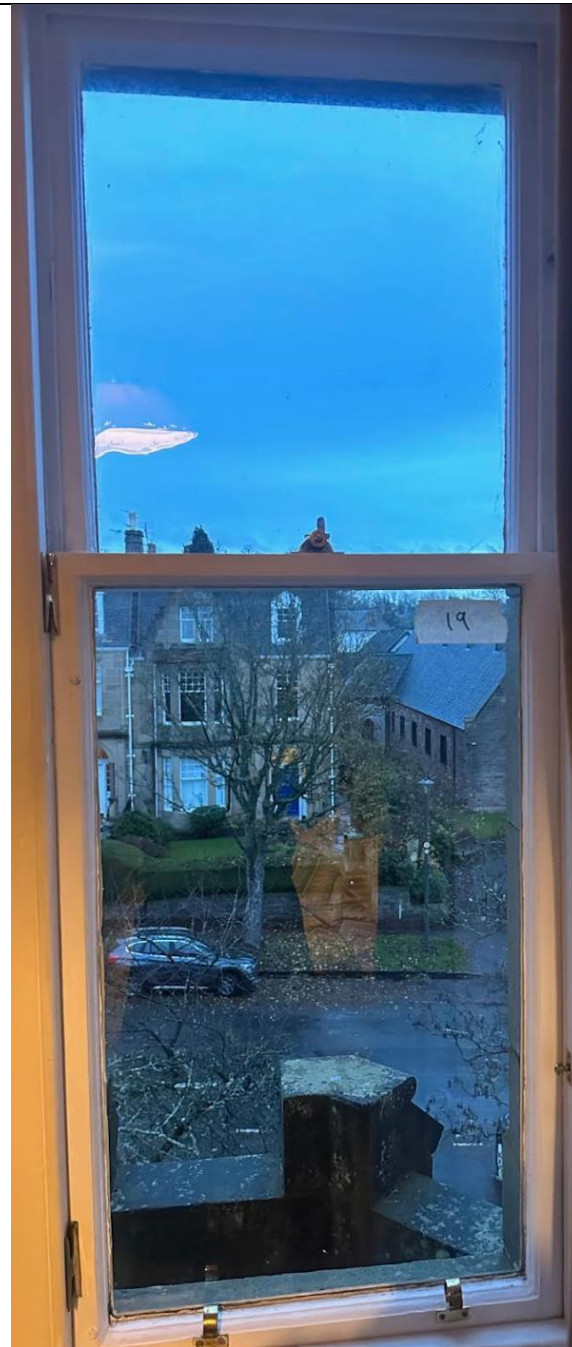
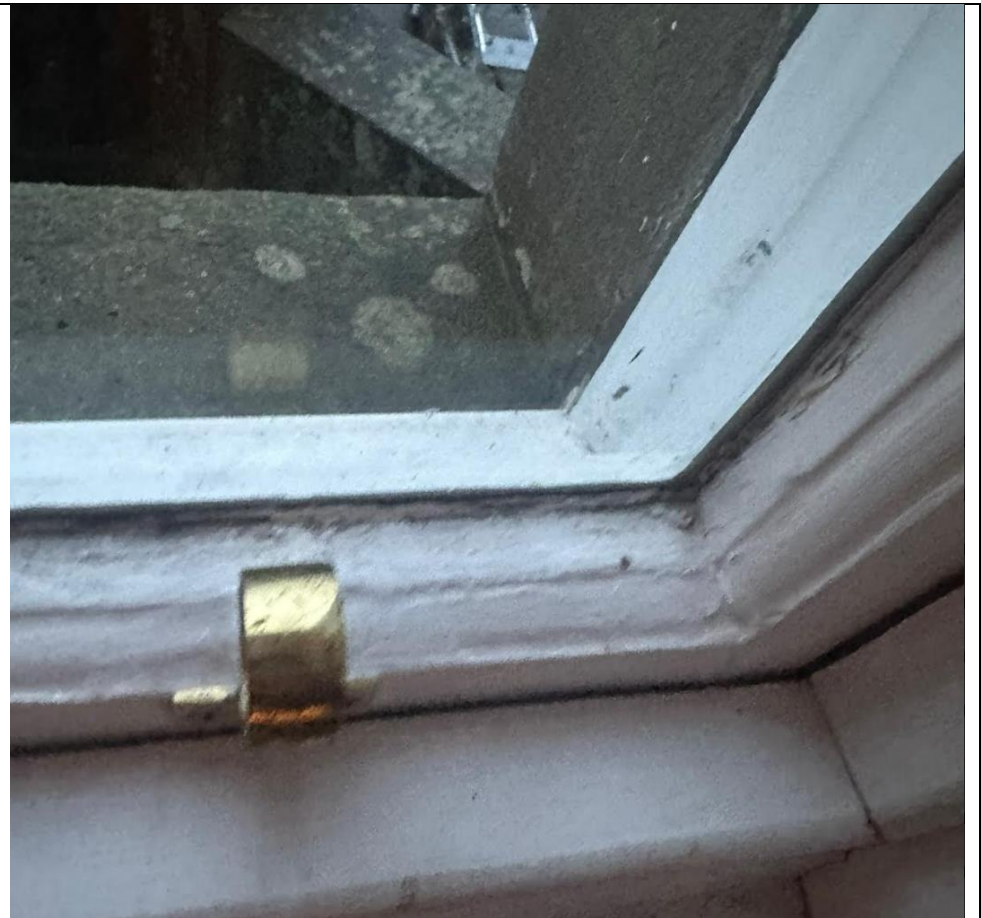
Elevation	Floor	No.	Room
Front	2nd	2	Bed2

- Non original sashes
- Evidence of some water ingress/ damage in blistered paint
- Cracking of paint along the lower rails corner joinery indicative of swelling/contraction of the timbers due to increased moisture content
- Previous repair work visible under paintwork
- Paint has been heavily overlapped onto glass panes, trapping moisture towards the timber

- 4/1 sash and case

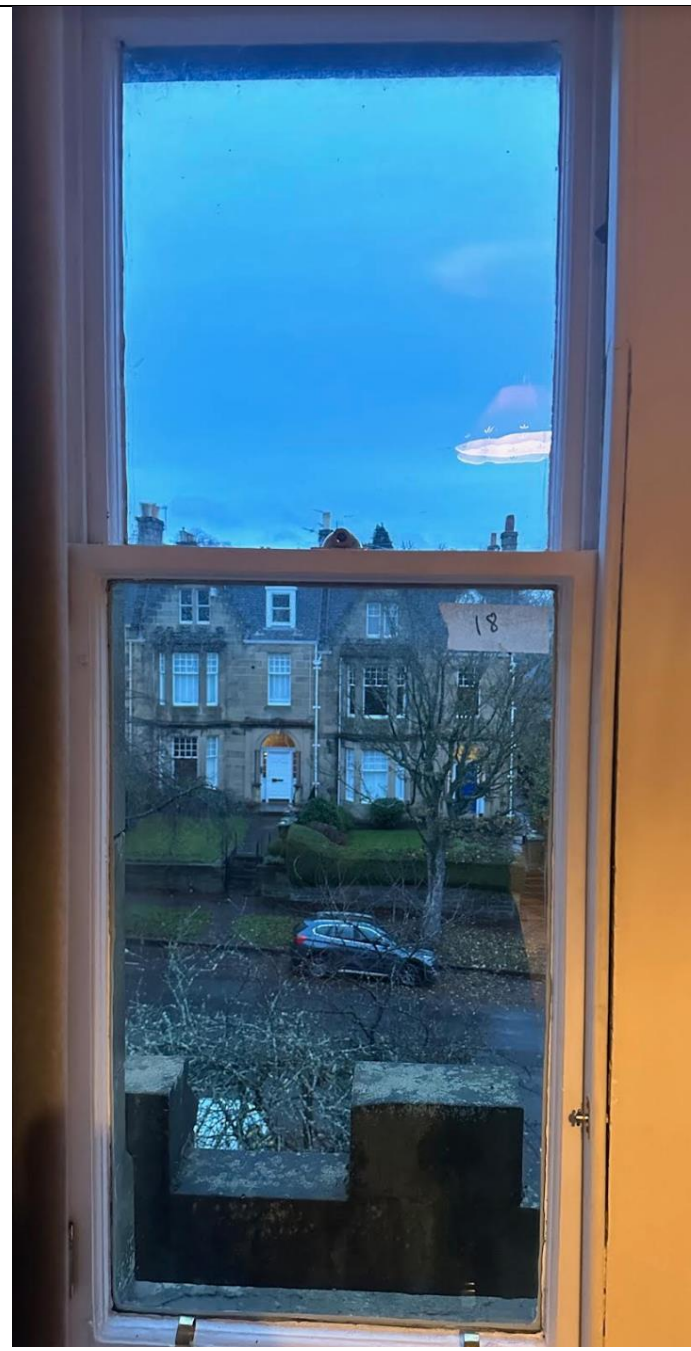
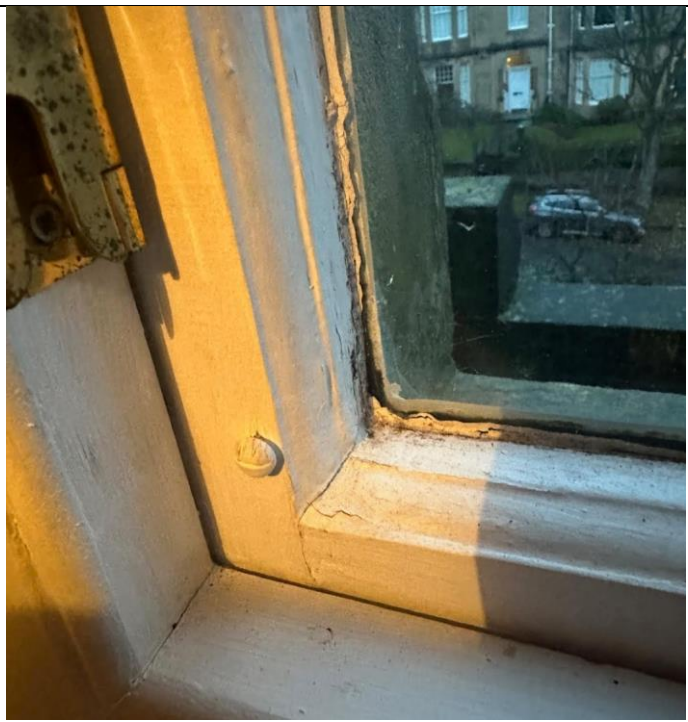
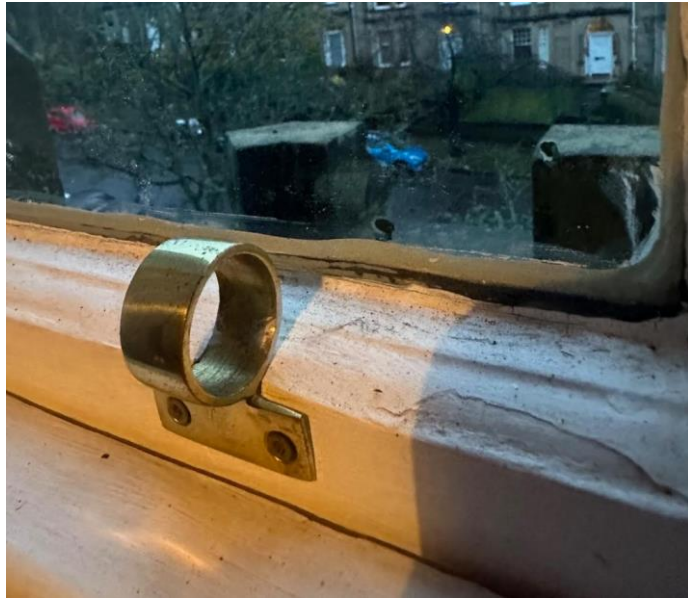
Elevation	Floor	No.	Room
Front	2nd	3	Bed2

- Assessment**
- Non original sashes
 - Evidence of some water ingress/ damage in blistered paint
 - Cracking of paint along the lower rails corner joinery indicative of swelling/contraction of the timbers due to increased moisture content
 - Previous repair work visible under paintwork
 - Paint has been heavily overlapped onto glass panes, trapping moisture towards the timber

Proposed format
4/1 sash and case

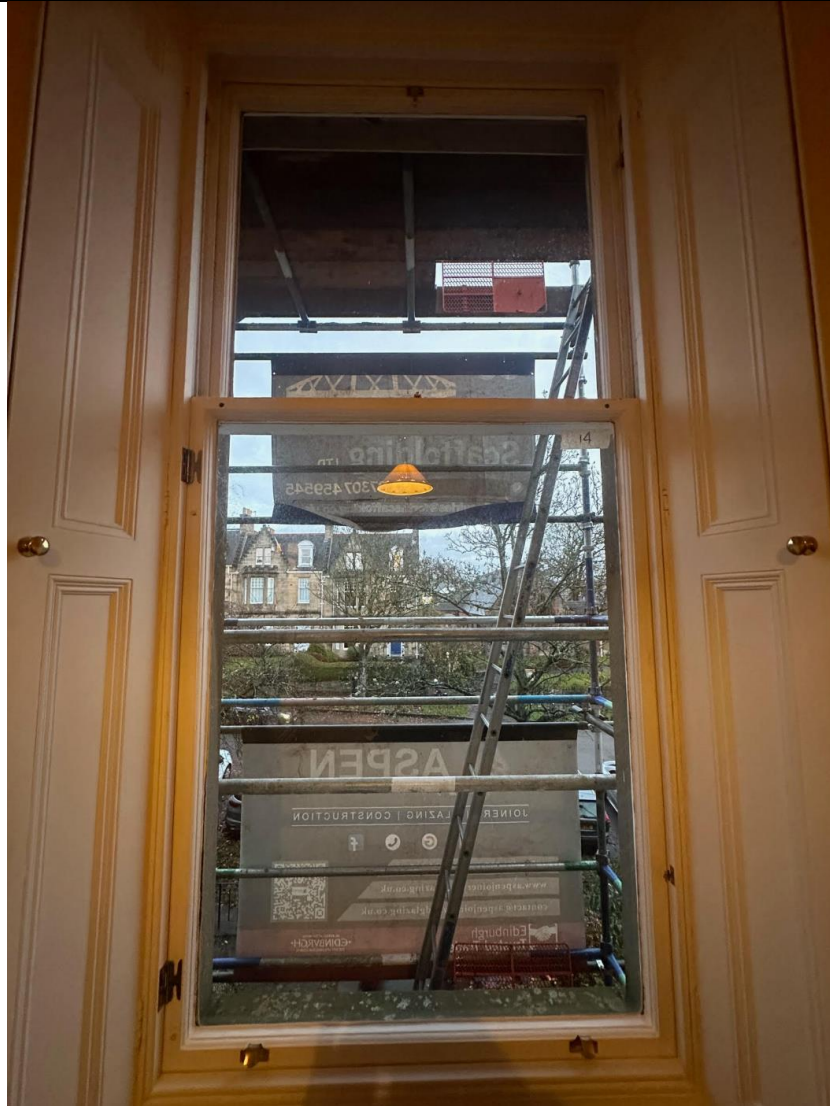
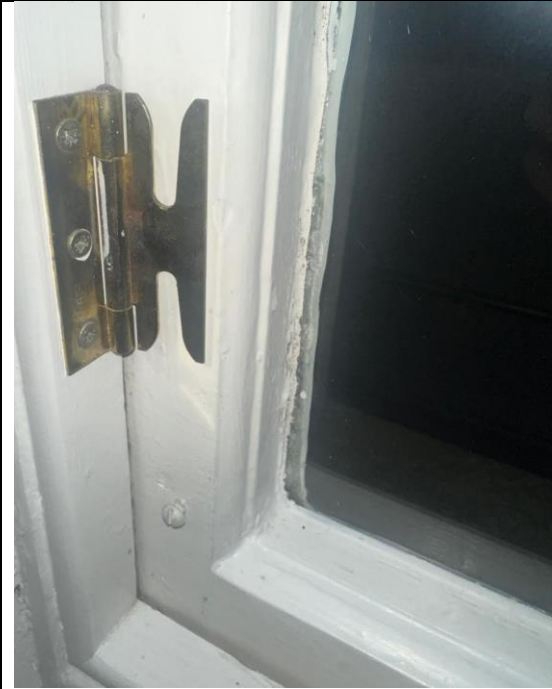
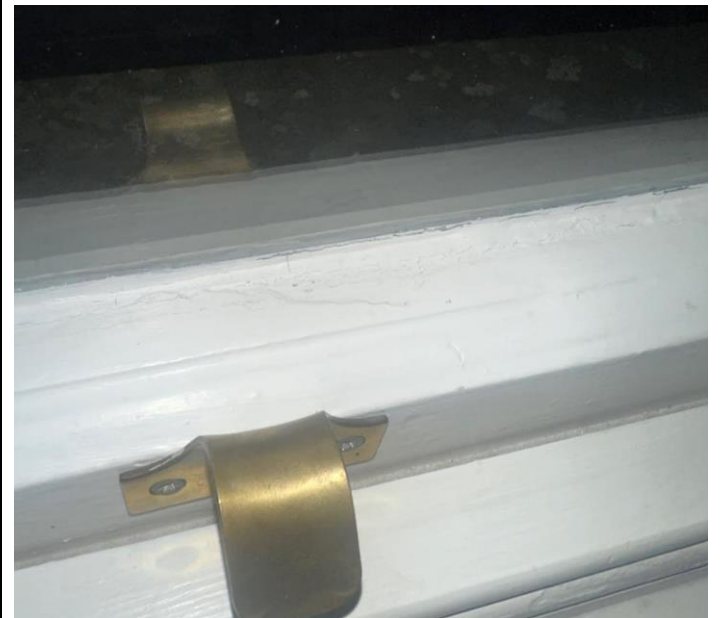
Elevation	Floor	No.	Room
Front	1st	4	Study

- Non-original top sash and lower also looks newer. Likely fitted during previous renovation
- Paint has been heavily overlapped onto glass panes, trapping moisture
- Previous repair work visible under paintwork

- 12/1 sash and case

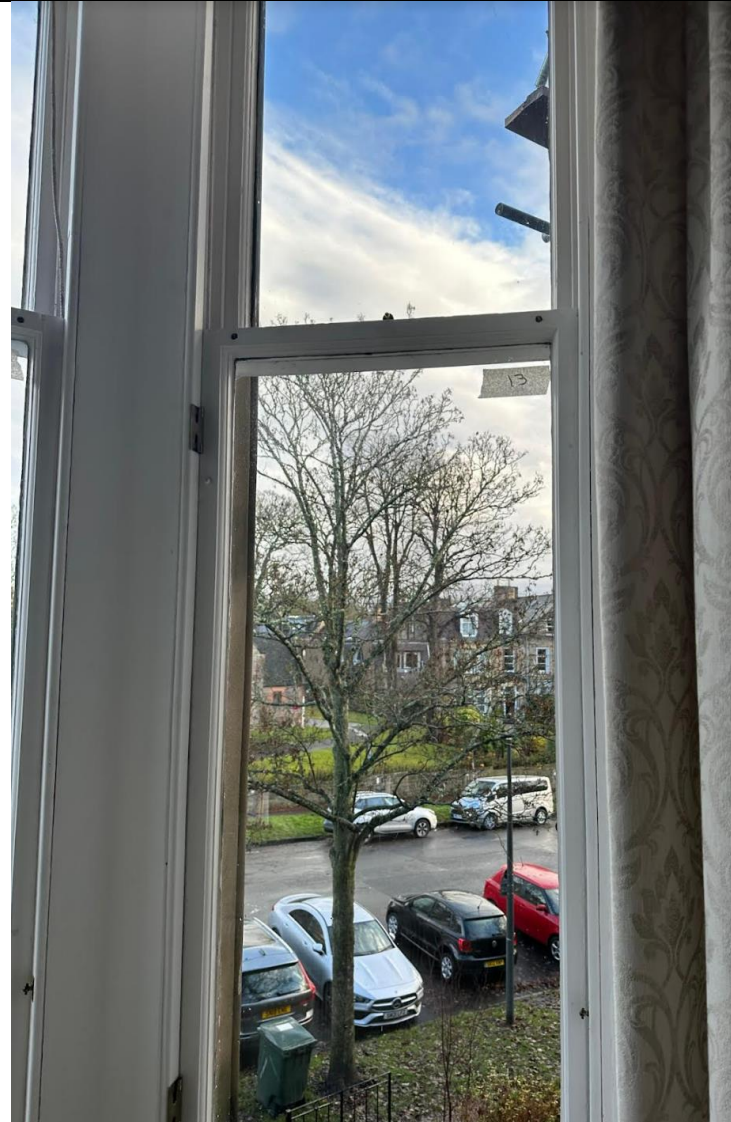
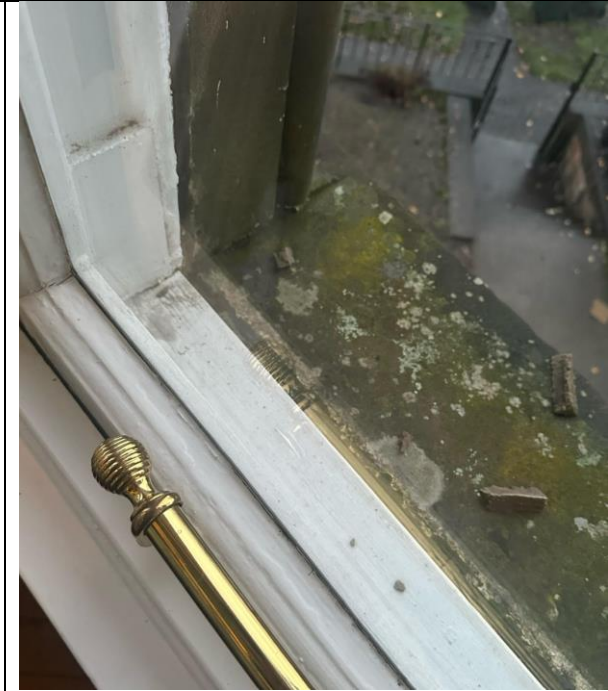
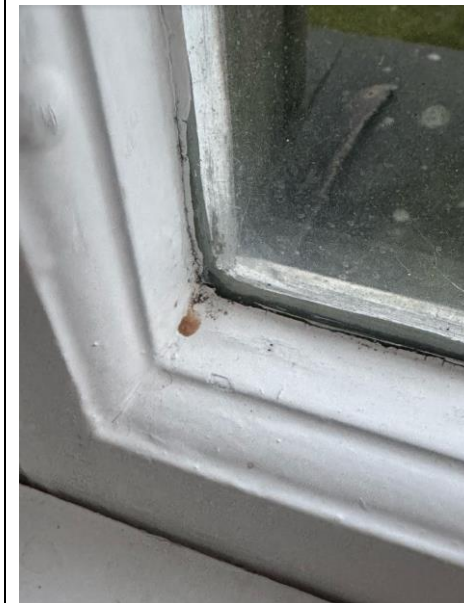
Elevation	Floor	No.	Room
Front	1st	5	Drw rm

- Non-original top sash and lower also looks newer. Likely fitted during previous renovation
- Non-original sill blocks within casement. Sill not correctly fitted
- Previous repair work visible under paintwork
- Paint has been heavily overlapped onto glass panes, trapping moisture towards the timber
- Significant damage to mastic. Likely water ingress to cases.

- 6/1 sash and case

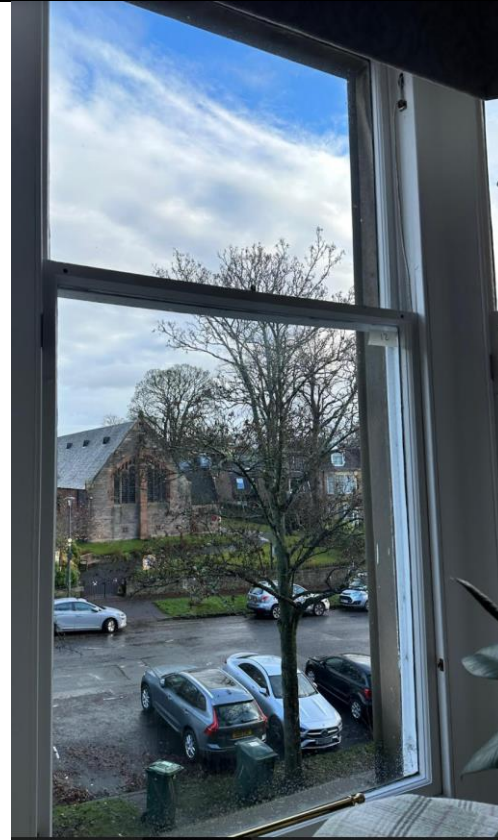
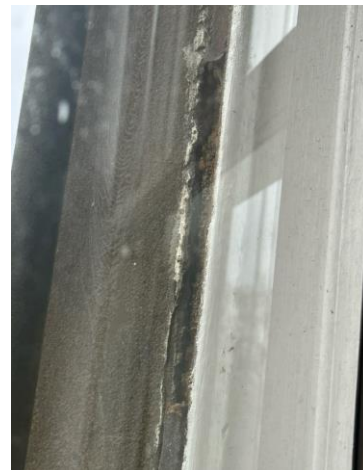
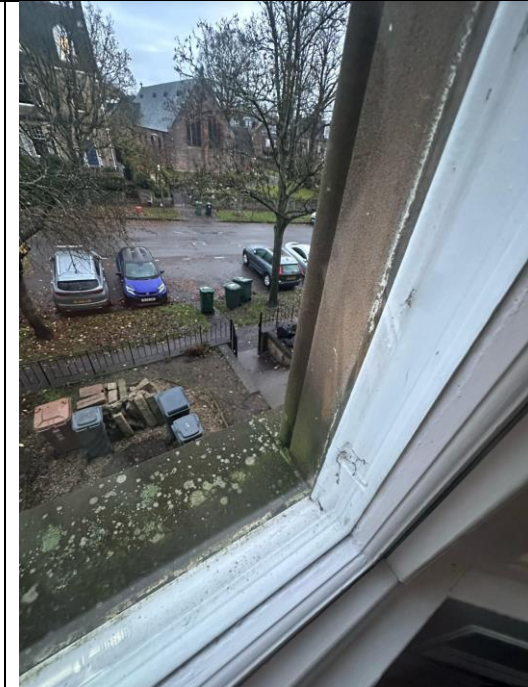
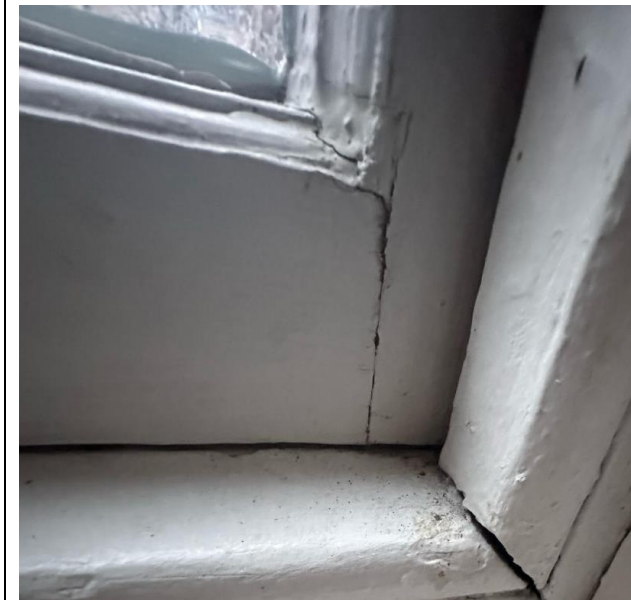
Elevation	Floor	No.	Room
Front	1st	6	Drw rm

- Non-original top sash and lower also looks newer. Likely fitted during previous renovation
- Cracking of paint along the lower rails corner joinery indicative of swelling/contraction of the timbers due to increased moisture content
- Non-original sill blocks within casement. Sill not correctly fitted
- Paint has been heavily overlapped onto glass panes, trapping moisture towards the timber
- Significant damage to mastic. Likely water ingress to cases

- 12/1 sash and case

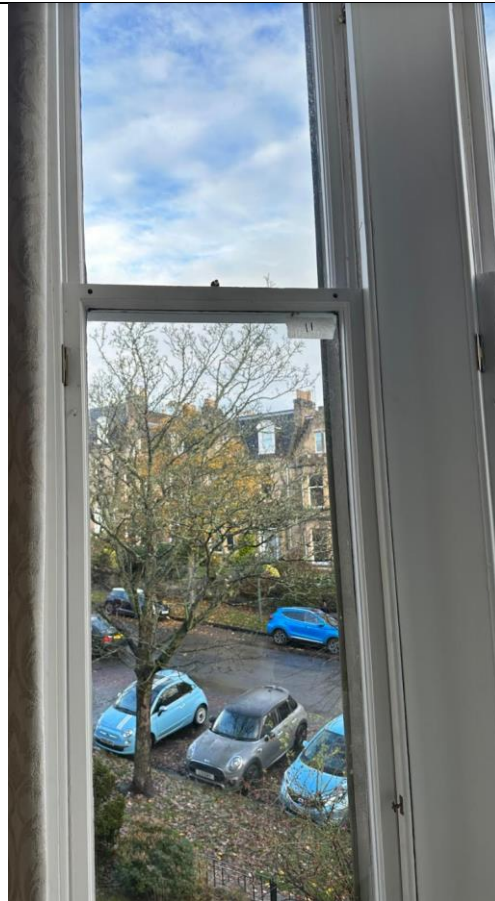
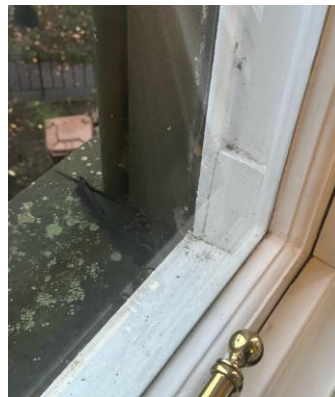
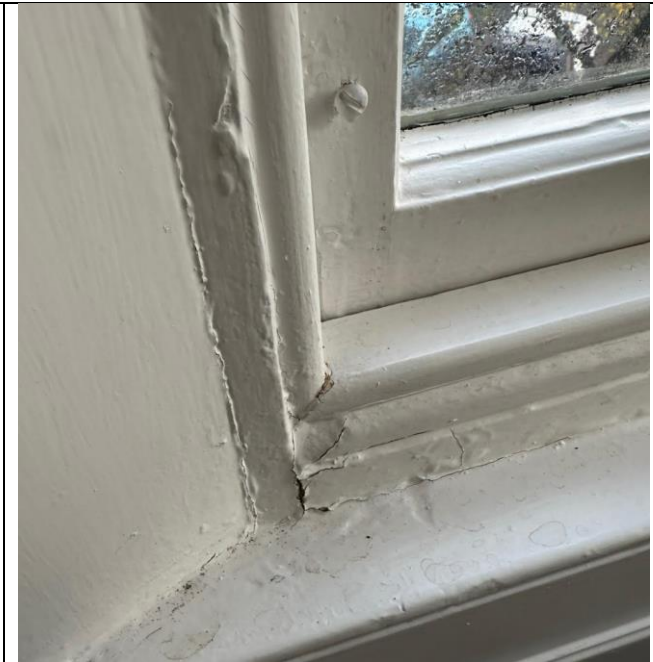
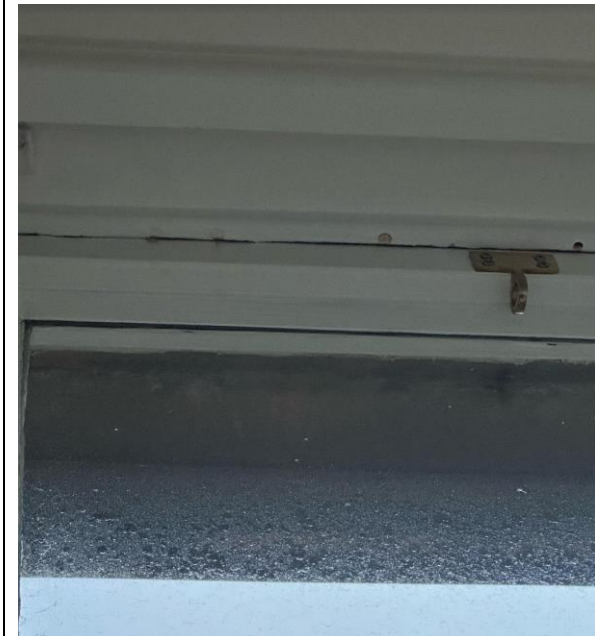
Elevation	Floor	No.	Room
Front	1st	7	Drw rm

- Non-original top sash and lower also looks newer. Likely fitted during previous renovation
- Cracking of paint along the lower rails corner joinery indicative of swelling/contraction of the timbers due to increased moisture content
- Non-original sill blocks within casement. Sill not correctly fitted
- Paint has been heavily overlapped onto glass panes, trapping moisture towards the timber
- Significant damage to mastic. Likely water ingress to cases
- Evidence of water ingress on top sash

- 6/1 sash and case

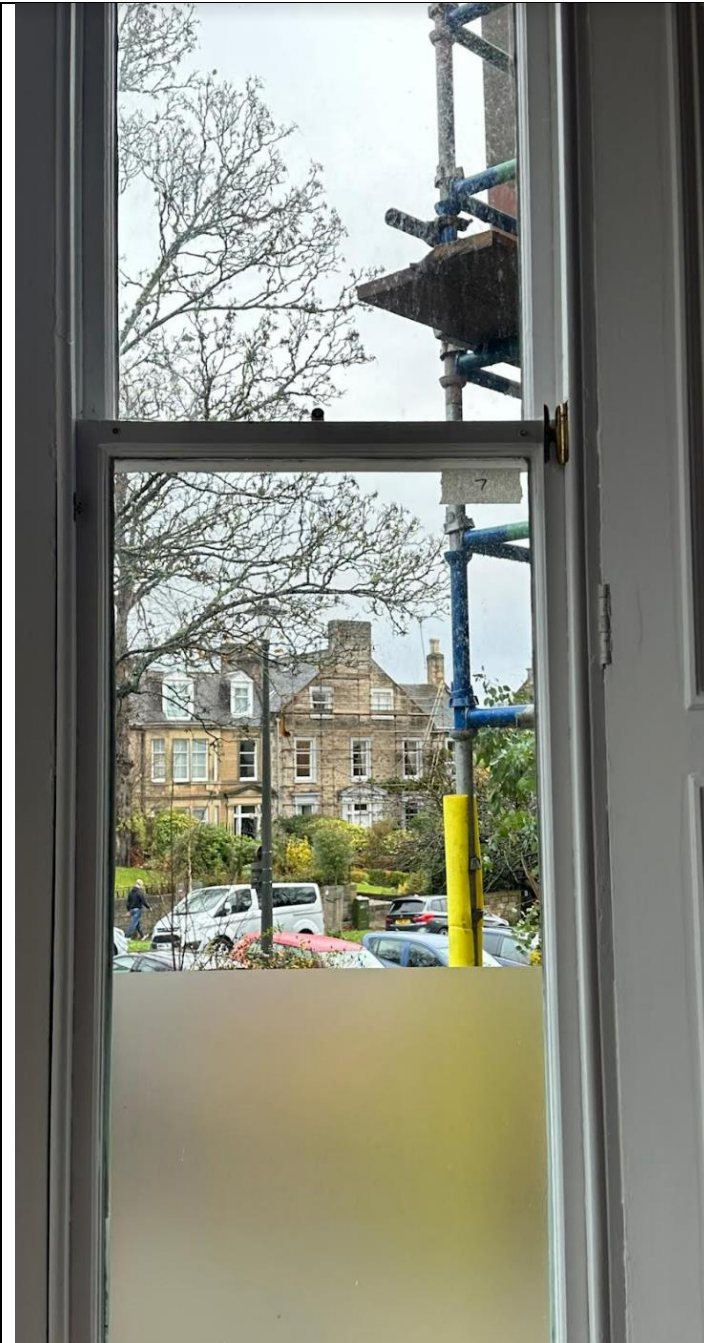
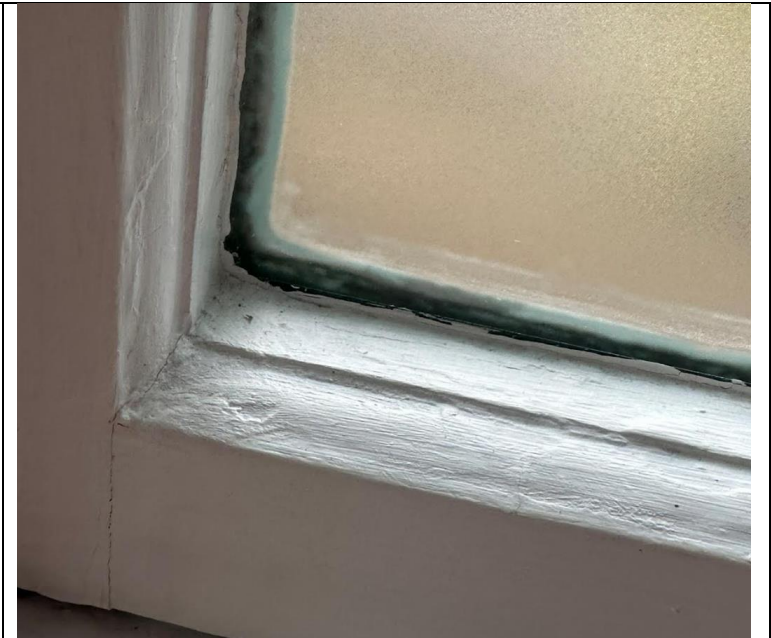
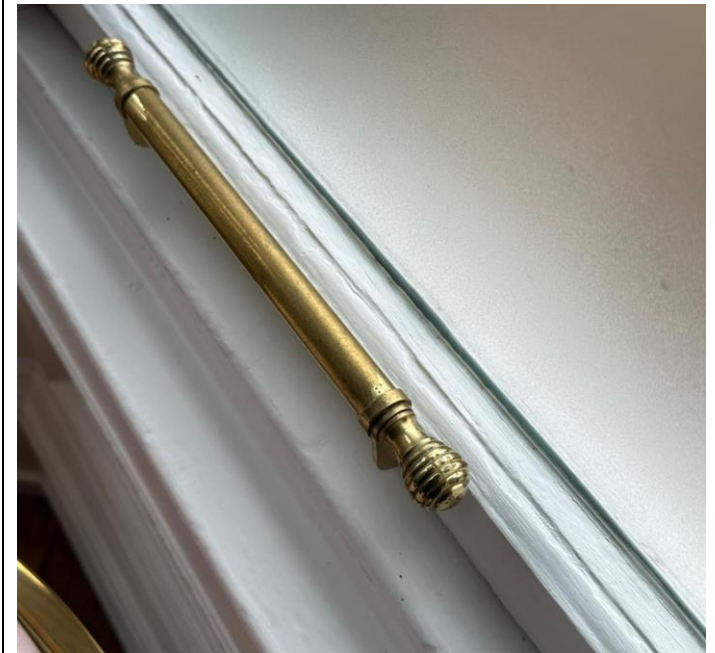
Elevation	Floor	No.	Room
Front	Grnd	8	Liv rm

- Non-original top sash and lower also looks newer. Likely fitted during previous renovation
- Paint has been heavily overlapped onto glass panes, trapping moisture towards the timber
- Loss of moulding detail due to repair work/ sanding/ overfilling

- 6/1 sash and case

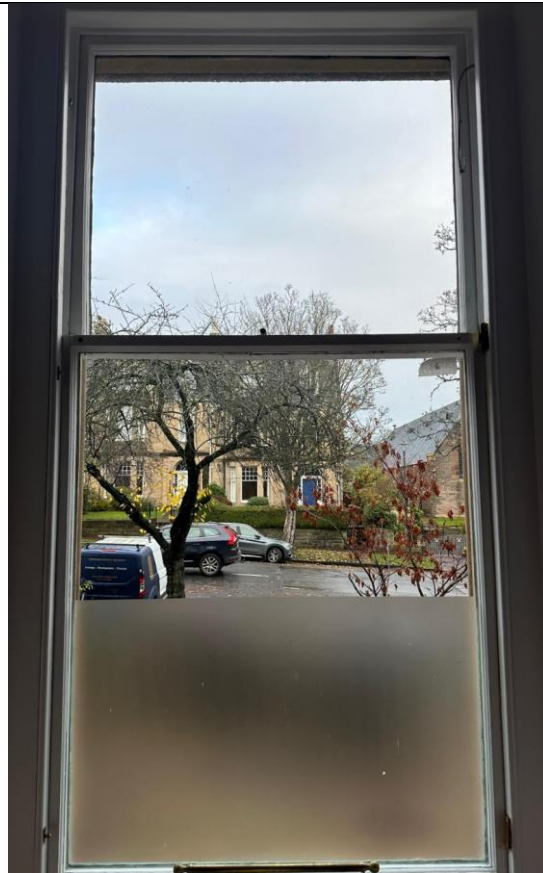
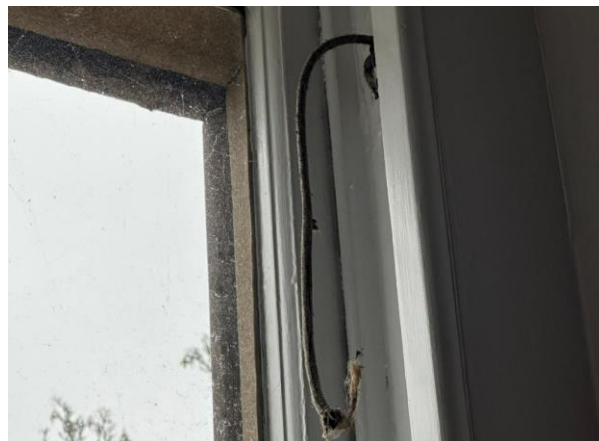
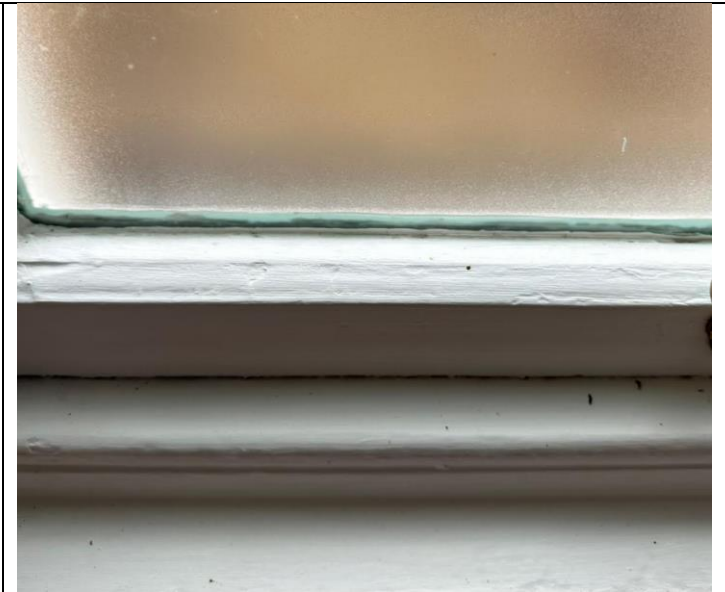
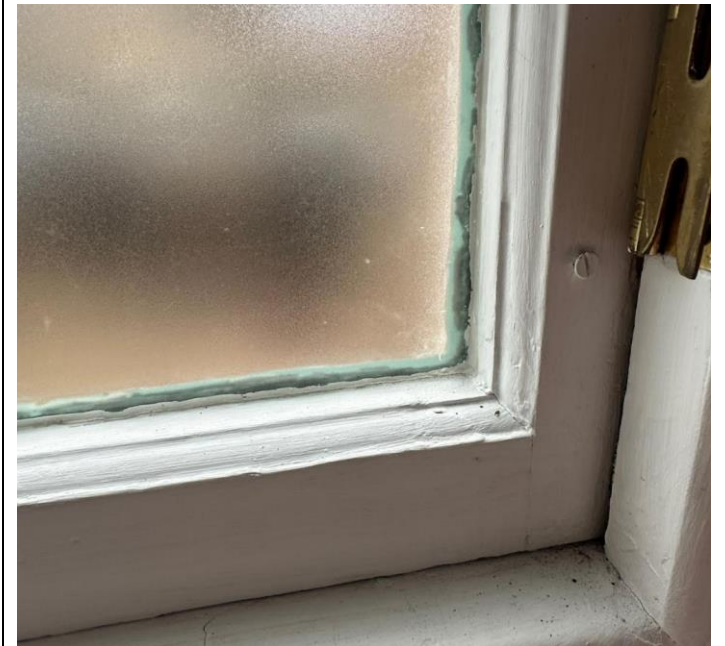
Elevation	Floor	No.	Room
Front	1st	9	Drw rm

- Non-original top sash and lower also looks newer. Likely fitted during previous renovation
- Paint has been heavily overlapped onto glass panes, trapping moisture towards the timber
- Loss of moulding detail due to repair work/ sanding/ overfilling
- Rope has frayed and snapped

- 12/1 sash and case

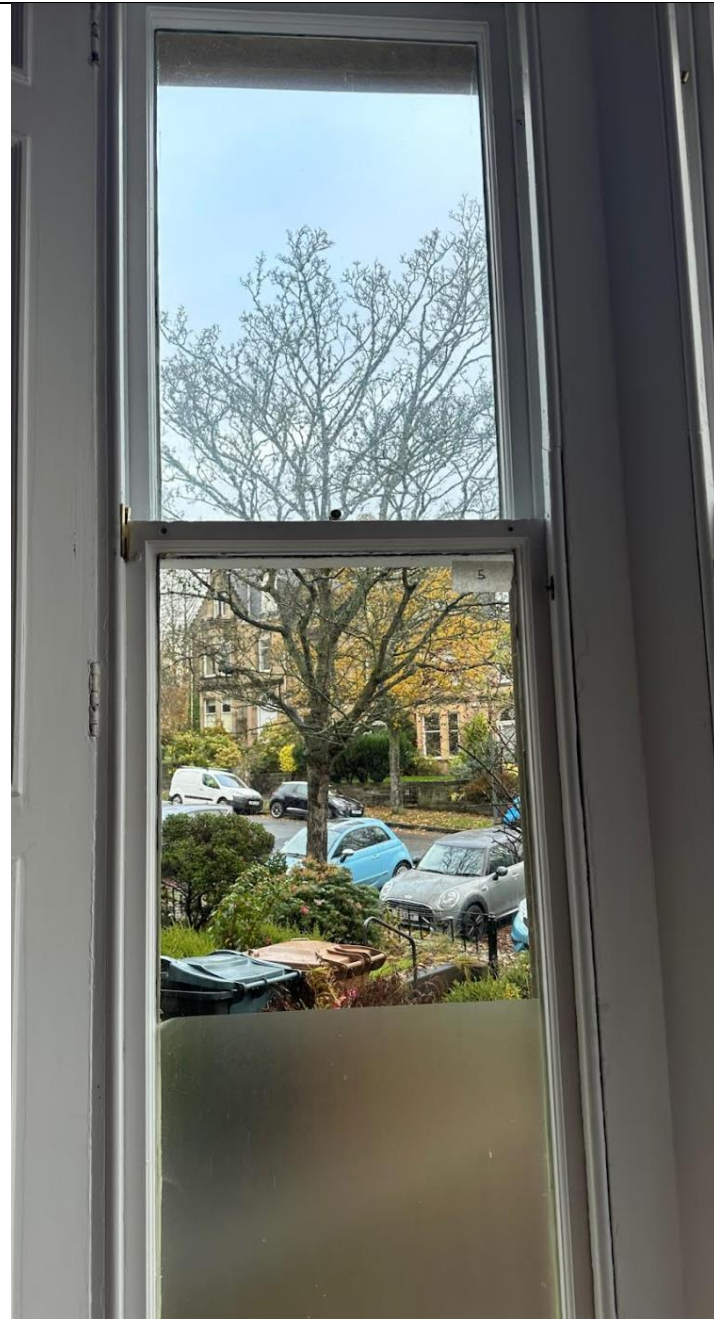
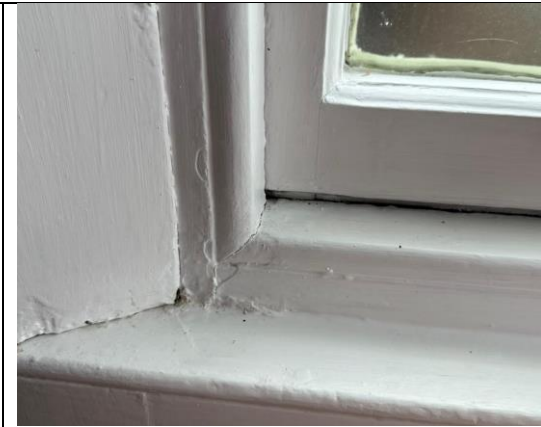
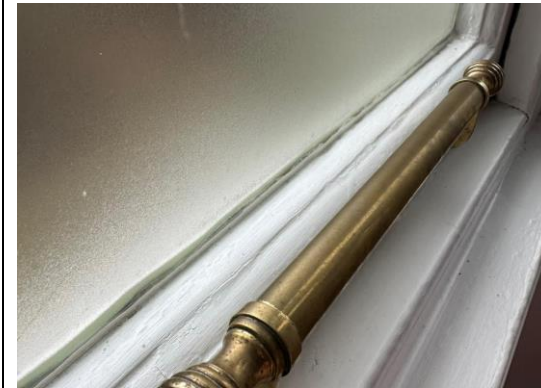
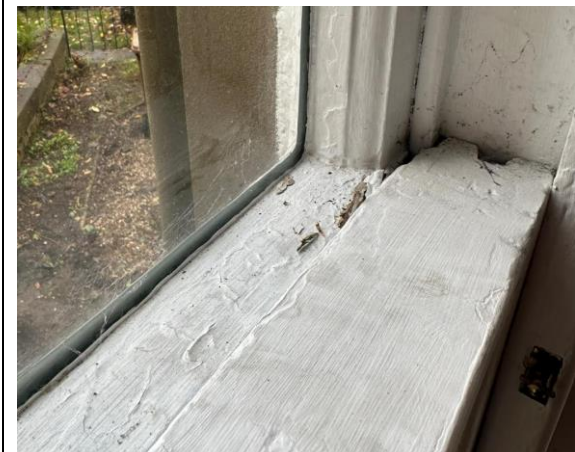
Elevation	Floor	No.	Room
Front	Grnd	10	Liv rm

- Non-original top sash and lower also looks newer. Likely fitted during previous renovation
- Paint has been heavily overlapped onto glass panes, trapping moisture towards the timber
- Loss of moulding detail due to repair work/ sanding/ overfilling
- Damage to counter check and lower sash not closing completely indicates expansion likely due to water permeation

- 6/1 sash and case

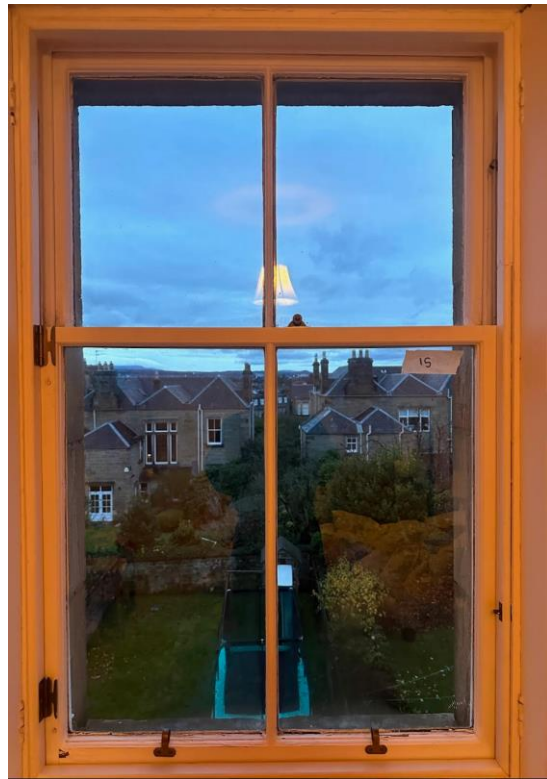
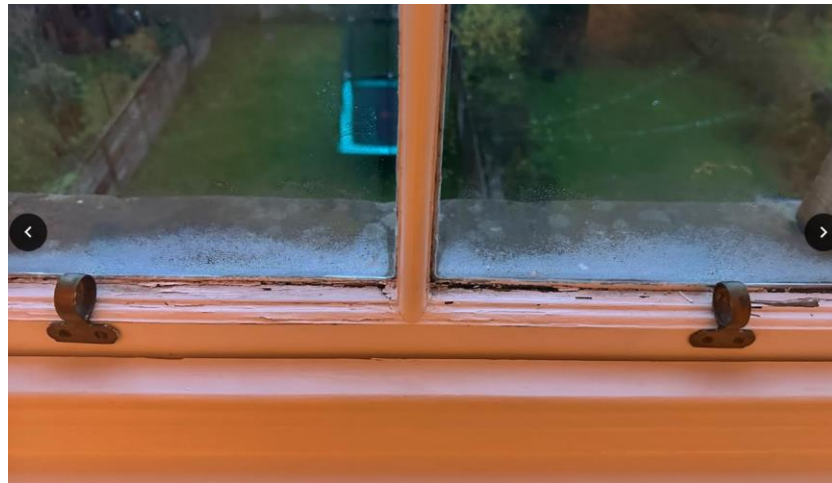
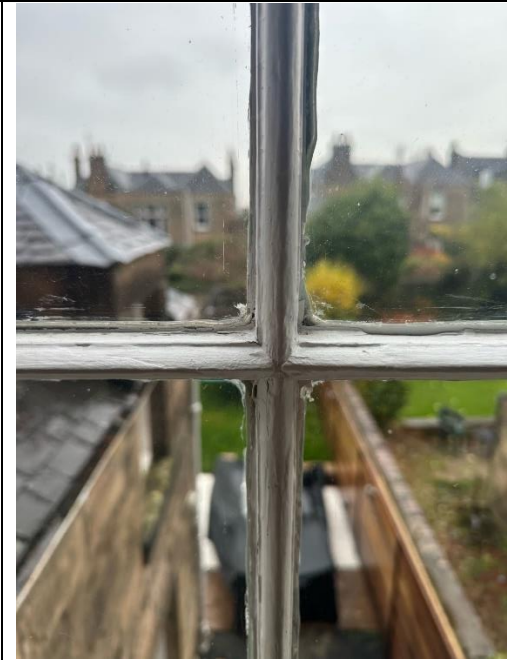
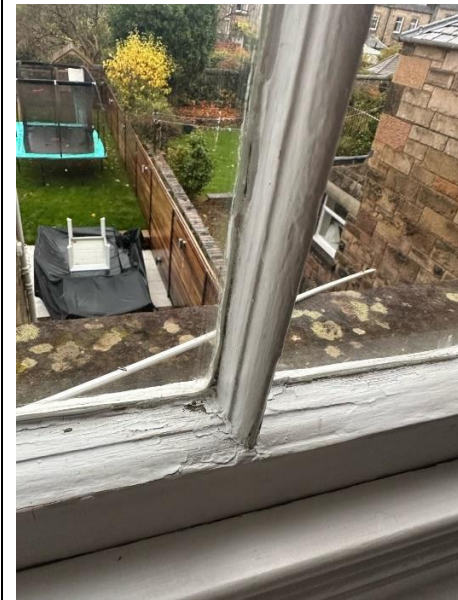
Elevation	Floor	No.	Room
Rear	2nd	11	Bed3

- Loss of original moulding detail due to over-sanding/filling and previous repairs
- Previous repair work visible under paintwork
- Heavy condensation damage to the internal horizontal rails and astragals
- Paint has been heavily overlapped onto glass panes, trapping moisture towards the astragal timbers.
- Overlapping paint gives impression of wider and uneven astragals

- 2/2 sash and case

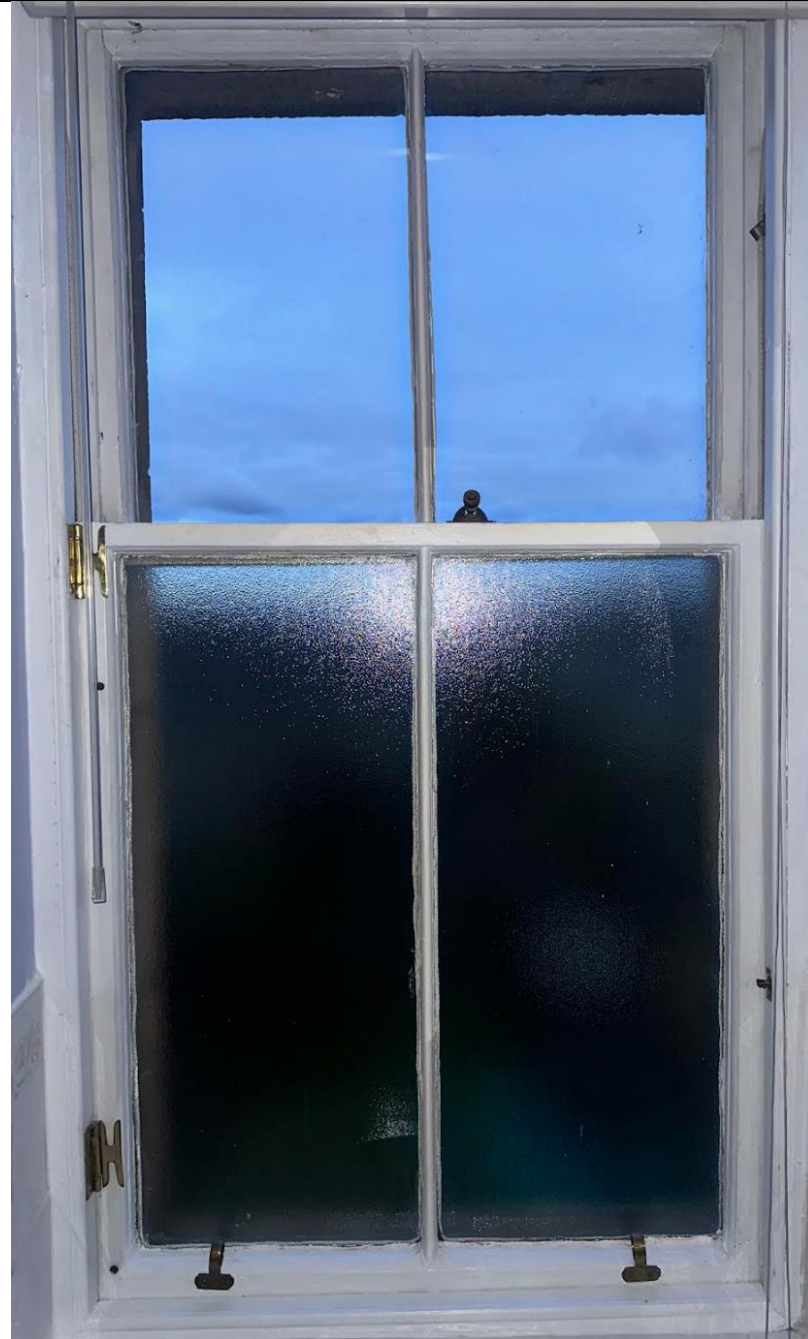
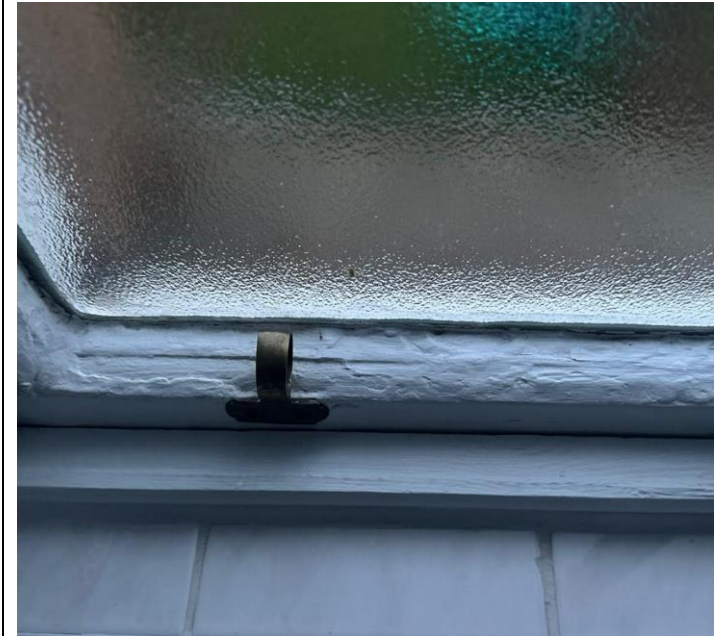
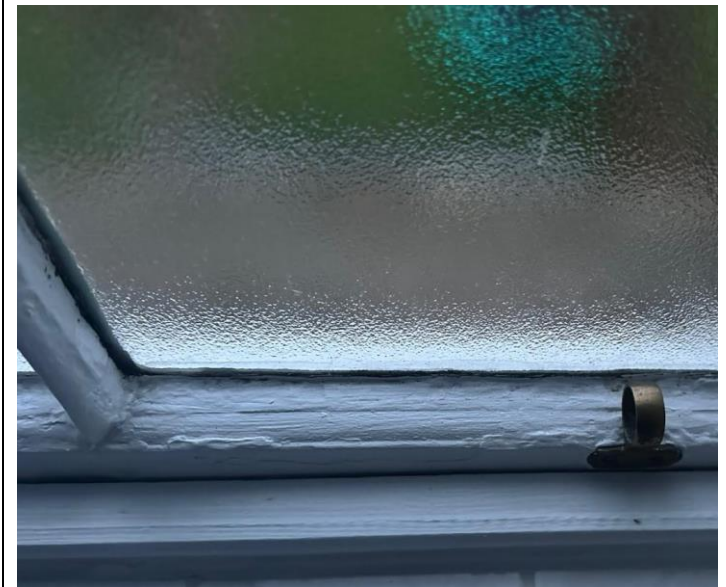
Elevation	Floor	No.	Room
Rear	2nd	12	w/c

- Loss of original moulding detail due to over-sanding/filling and previous repairs
- Previous repair work visible under paintwork
- Paint has been heavily overlapped onto glass panes, trapping moisture towards the astragal timbers.
- Overlapping paint gives impression of wider and uneven astragals

- 2/2 sash and case

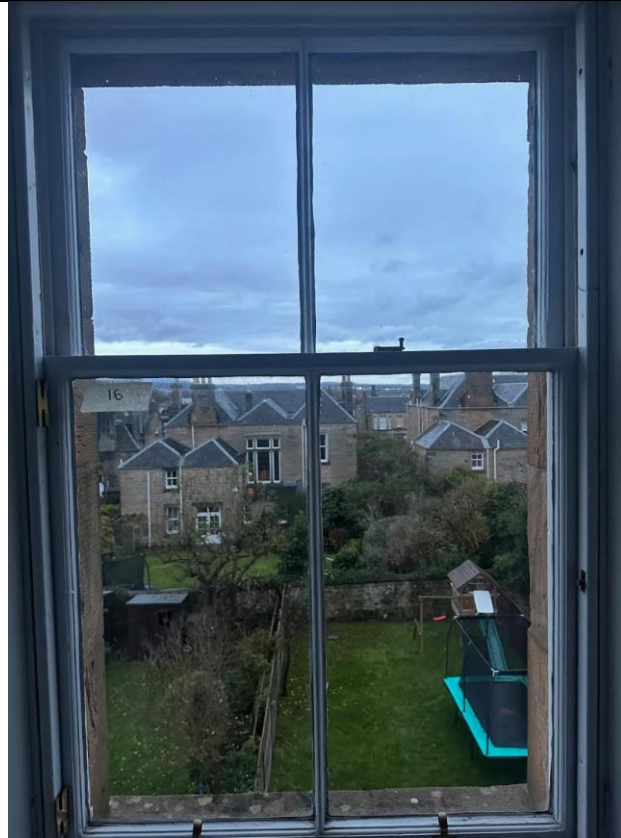
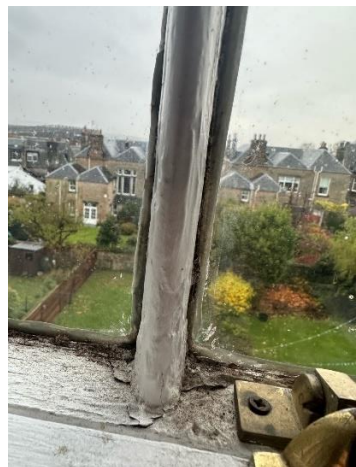
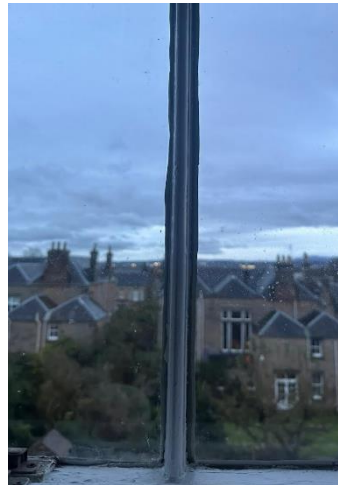
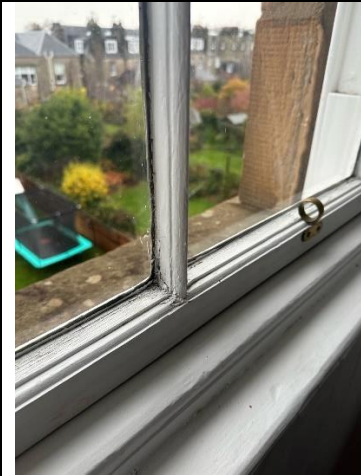
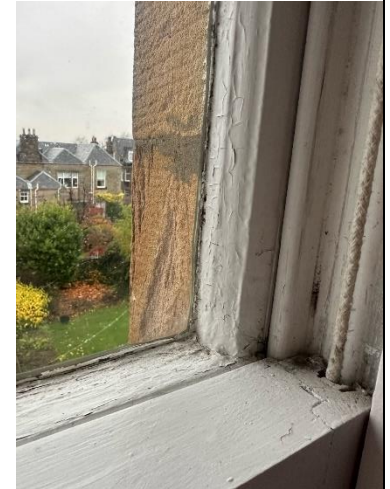
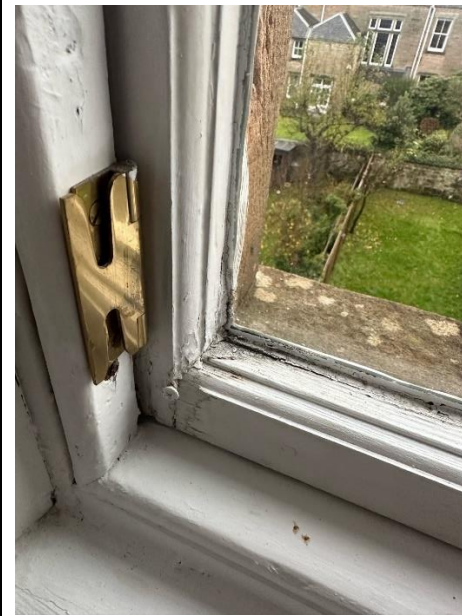
Elevation	Floor	No.	Room
Rear	2nd	13	Bed4

- Previous repair work visible under paintwork
- Condensation damage to the internal horizontal rails and astragals
- Paint has been heavily overlapped onto glass panes, trapping moisture towards the astragal timbers
- Cracking of paint along the lower rails corner joinery indicative of swelling/contraction of the timbers due to increased moisture content
- Overlapping paint gives impression of wider and uneven astragals

- 2/2 sash and case
