Condition Survey Report	Date: 17/11/2023	Client Name: Mr and Mrs Hawthorn	Address: 20 Murrayfield Avenue Edinburgh EH12 6AX

Specification:	Mould detail: Lambs tongue	Glazing notes: Proposed: 14mm (4/6/4) slim lite IGUs
Category C Listed		Timber: Redwood

Overview:
At the front, the client requests the installation of slim lite double glazing by replacing the front top sashes and returning these to the original astragal pattern, while also refurbishing the bottom sashes and installing slim lite IGUs.

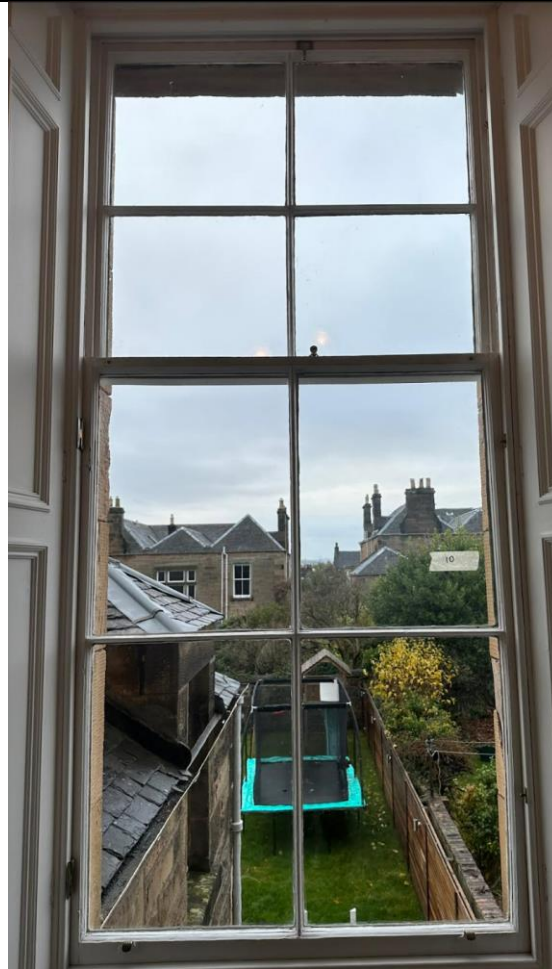
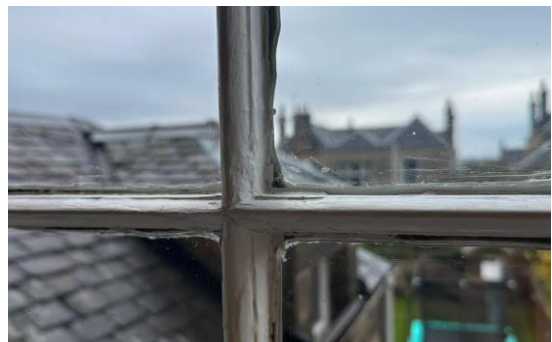
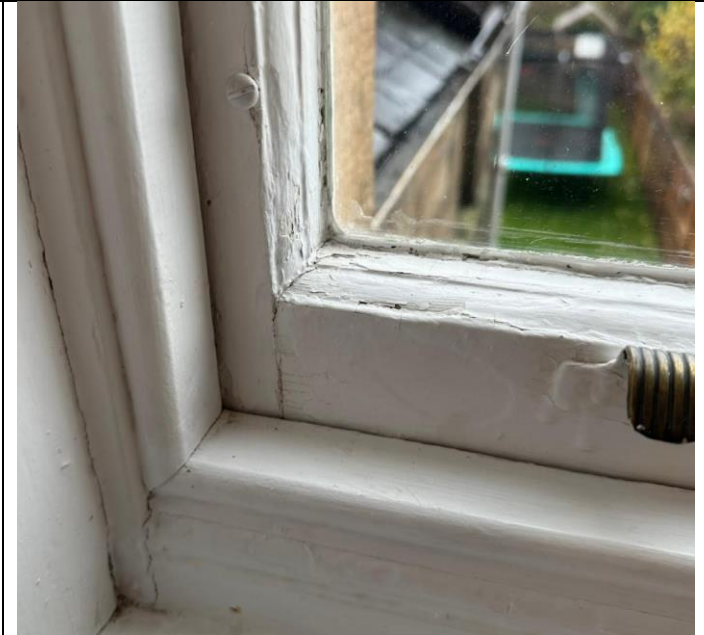
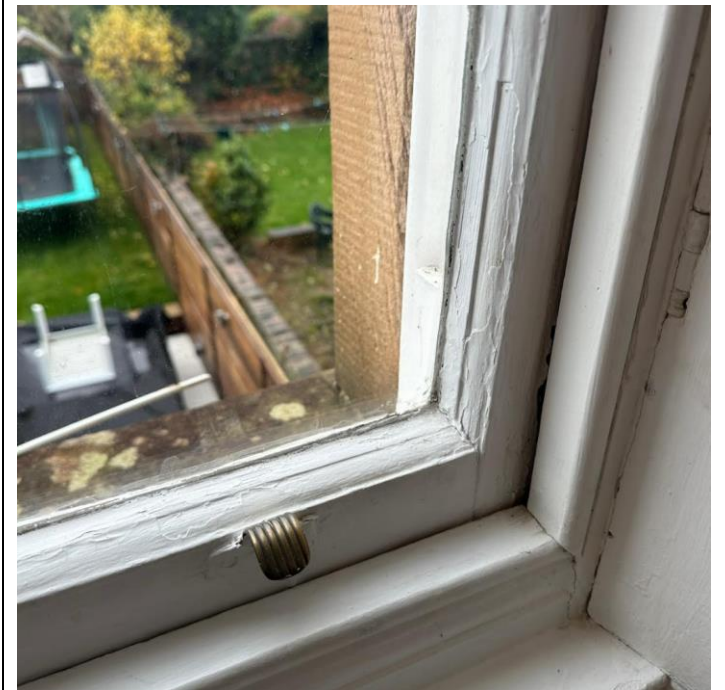
Elevation	Floor	No.	Room
Rear	1st	14	Bed5

- Previous repair work visible under paintwork
- Loss of moulding detail due to repair work/ sanding/ overfilling
- Paint has been heavily overlapped onto glass panes, trapping moisture towards the astragal timbers
- Cracking of paint along the lower rails corner joinery indicative of swelling/contraction of the timbers due to increased moisture content
- Overlapping paint gives impression of wider and uneven astragals

- 4/4 sash and case

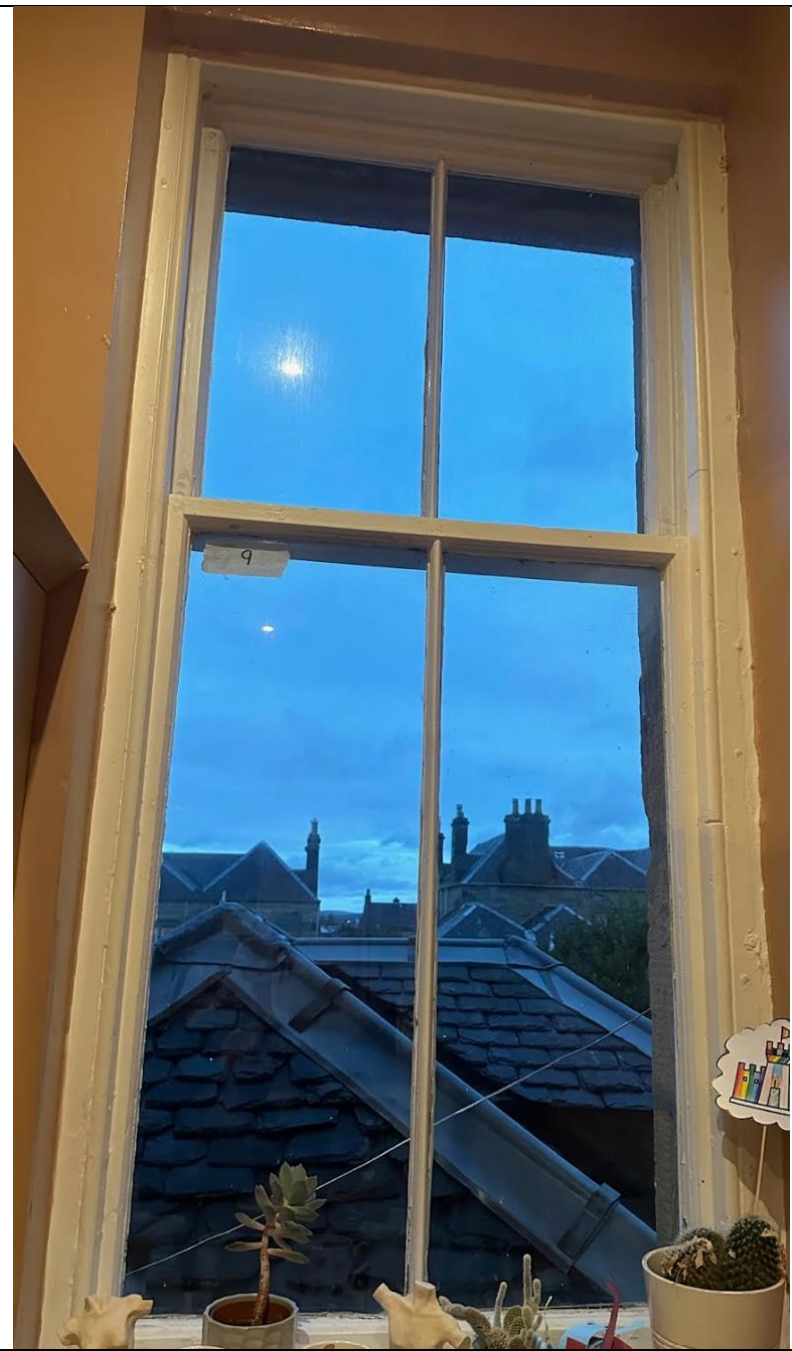
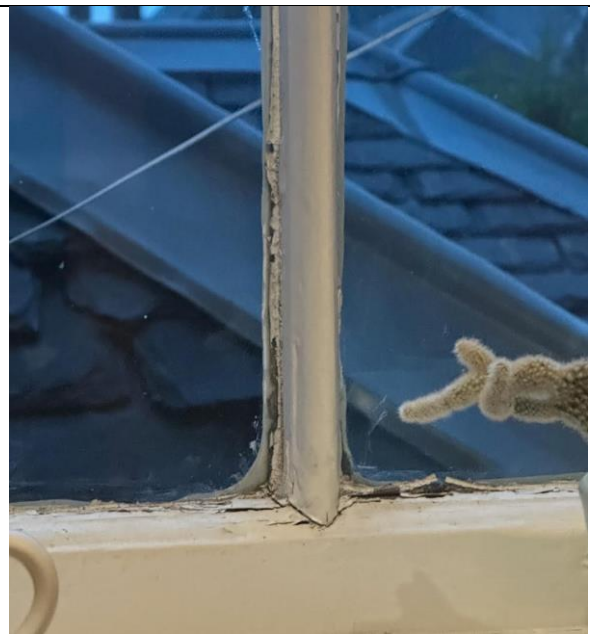
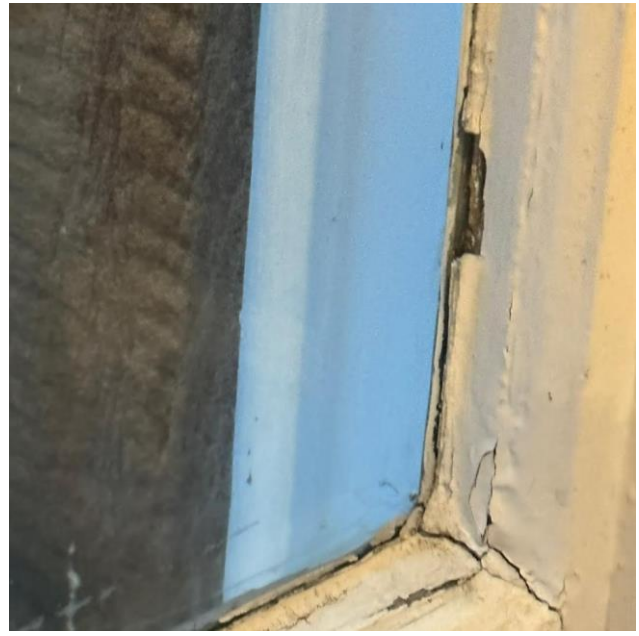
Elevation	Floor	No.	Room
Rear	1st	15	Kitch

- Original function lost – painted shut, no weight or rope
- Paint has been heavily overlapped onto glass panes, trapping moisture towards the astragal timbers
- Loss of moulding detail due to repair work/ sanding/ overfilling
- Cracking of paint along the lower rails corner joinery indicative of swelling/contraction of the timbers due to increased moisture content

- 2/2 sash and case

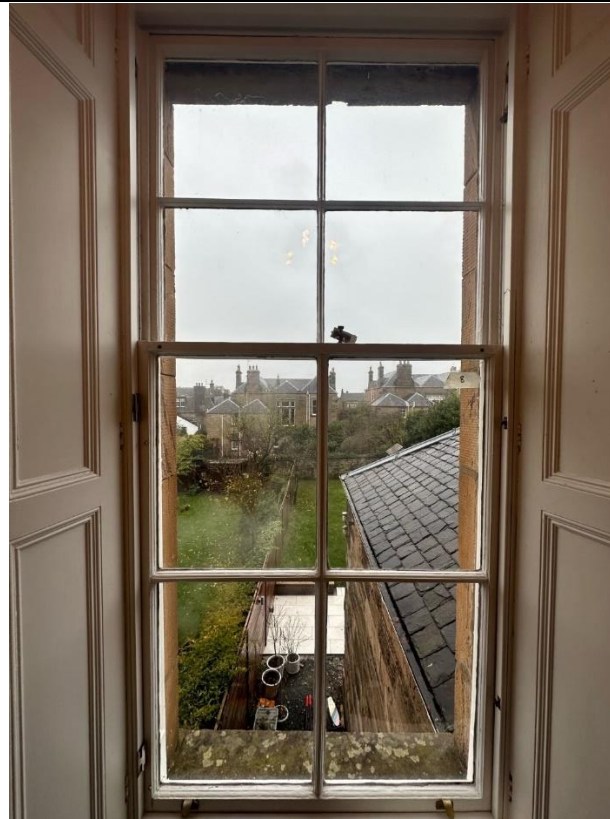
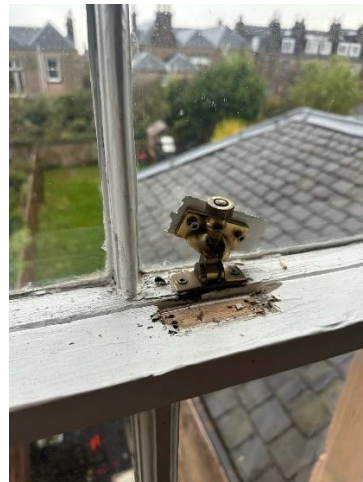
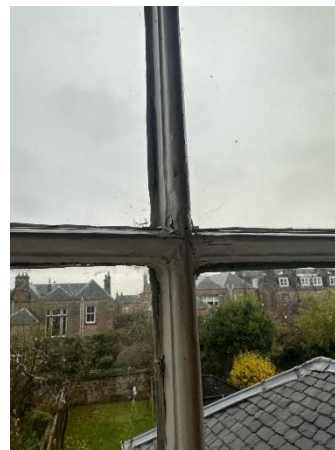
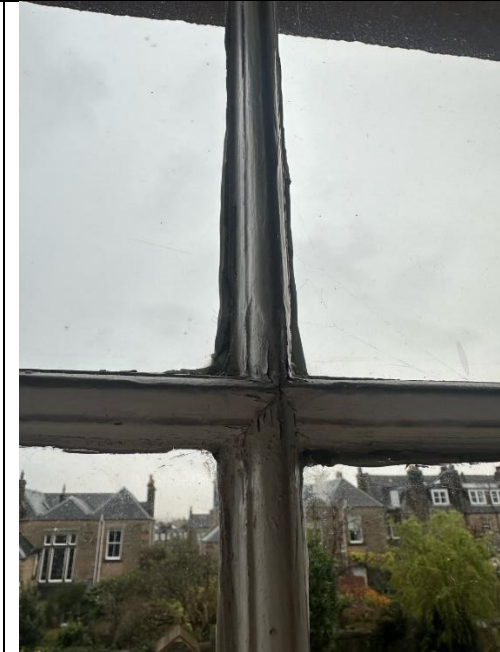
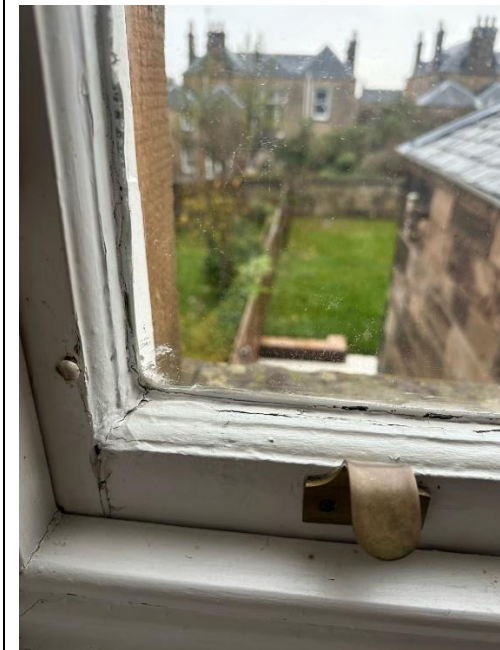
Elevation	Floor	No.	Room
Rear	1st	16	Kitch

- Bottom sash moulding is not original and different to the top sash
- Previous repair work visible under paintwork
- Condensation damage to the internal horizontal rails and astragals
- Paint has been heavily overlapped onto glass panes, trapping moisture towards the astragal timbers
- Cracking of paint along the lower rails corner joinery indicative of swelling/contraction of the timbers due to increased moisture content
- Incorrectly fixed locking mechanism has ripped out of the sash causing damage
- Non-original sill blocks within casement. Sill not correctly fitted

- 4/4 sash and case

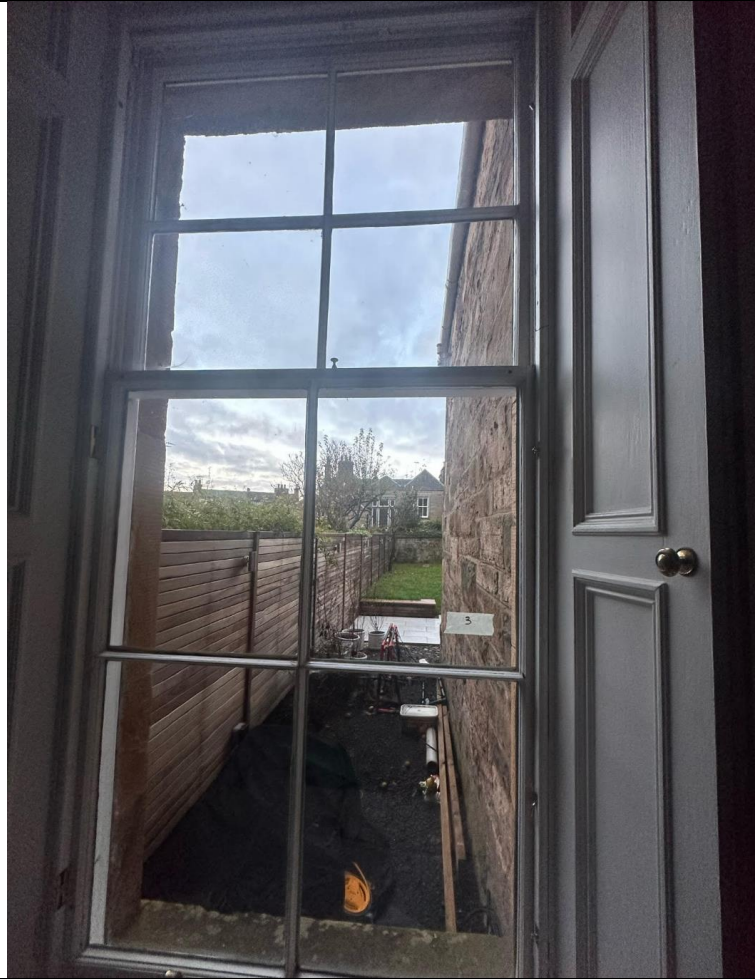
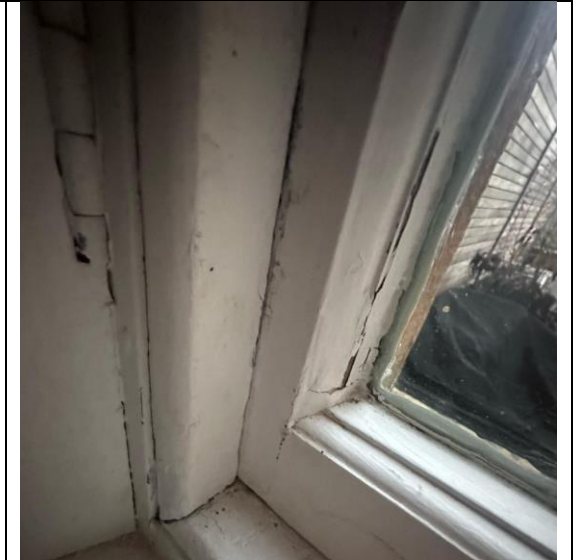
Elevation	Floor	No.	Room
Rear	1st	17	Bed6

- Cracking of paint along the lower rails corner joinery indicative of swelling/contraction of the timbers due to increased moisture content
- Paint has been heavily overlapped onto glass panes, trapping moisture towards the timber

- 4/4 sash and case
