Seabrook Design Limited

Condition Survey

Planning for refurbishment, repairs, loft conversion, internal alterations, garden workshop, rear canopy, and changes to shopfront.

86 West Street, Oundle, Peterborough PE8 4ES

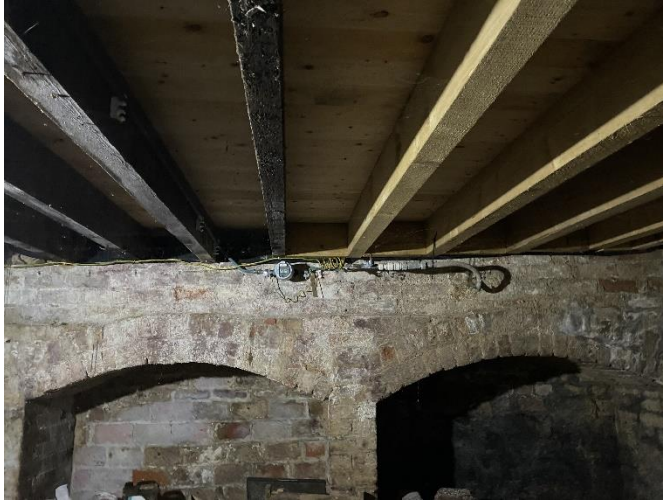
1

Existing floor joists to kitchen demonstrating repair works previously undertaken.

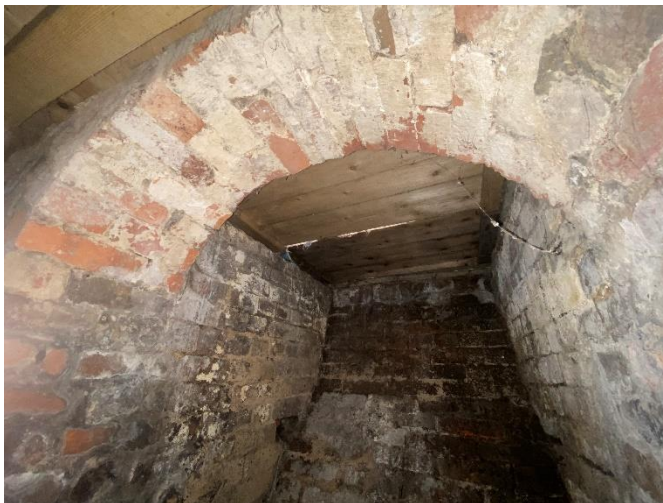
2

Existing timber hatch to cellar, opening into rear garden. We propose replacement with structural glazing panel for natural light to complement the cellar renovations. We intend to tank the cellar for dry storage.

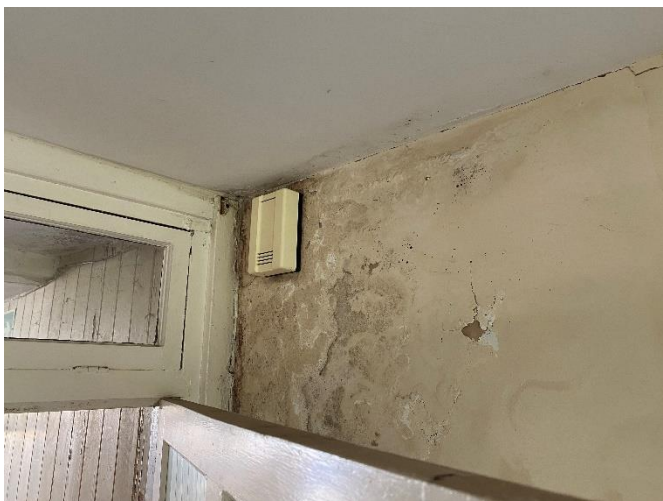
3

Signs of damp/mold on walls. Located under valley between roofs, likely due to poor roof drainage and condition of flashings. During the roof repairs and alterations, we will ensure water tightness and repair damage caused by previous ingress.

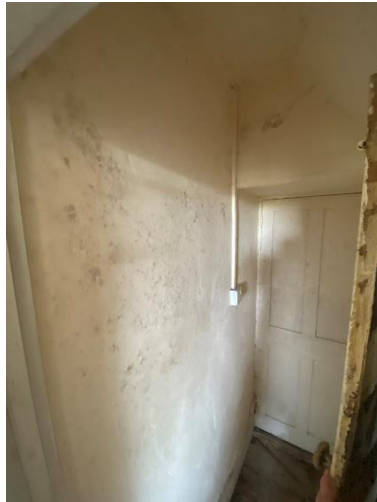
4

Signs of damp/mold on walls. Located under valley between roofs, likely due to poor drainage and condition of roofs as mentioned in image reference 3.

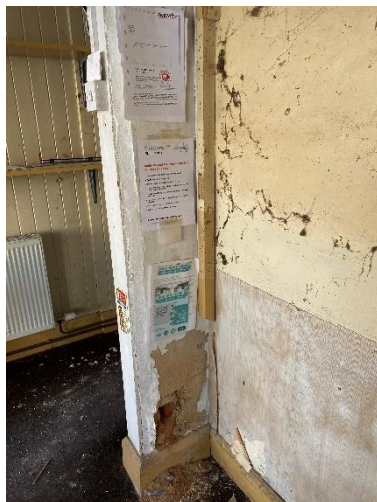
5

Brick pier below gas meter crumbling at base. Demonstrating requirement for further repair works in the shop front.

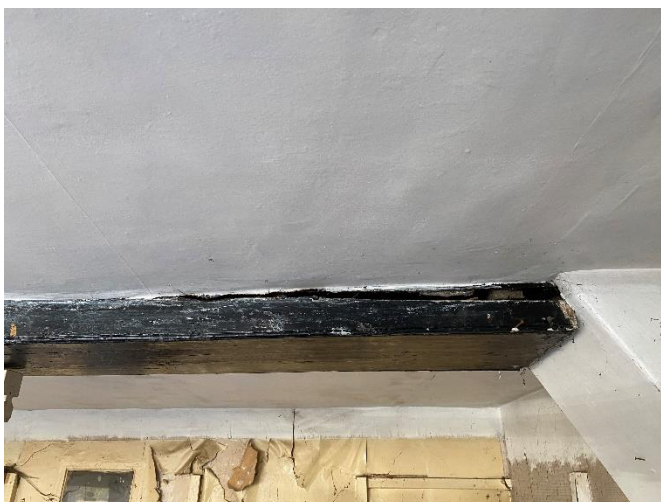
6

Split and cracking in timber beam supporting shop front ceiling. Further intrusive investigations required to identify supported elements, and beam requirement.

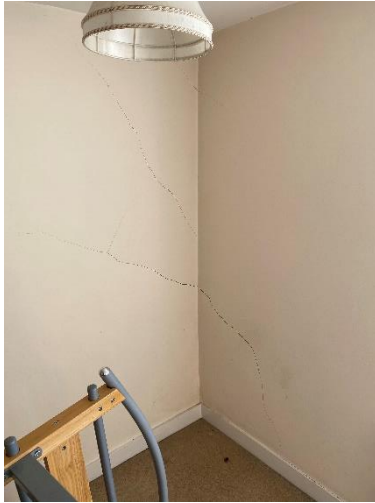
7

Structural cracking through exterior walls. This has now been repaired with Helifix bars and pointed in lime mortar to prevent further damage.

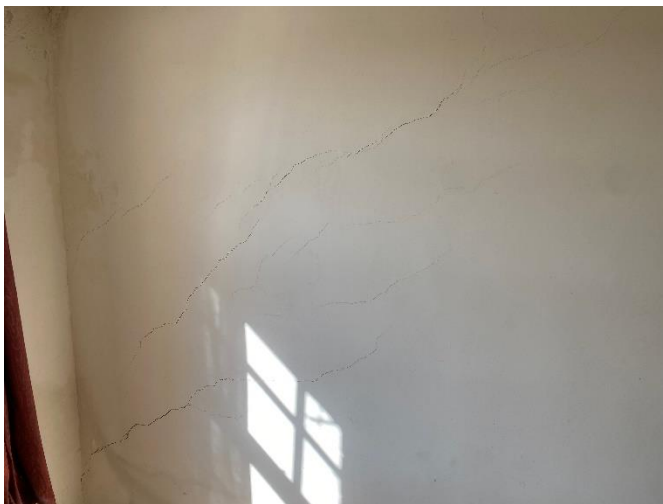
8

Structural cracking through exterior walls. This has now been repaired with Helifix bars and pointed in lime mortar to prevent further damage. The plaster to the right hand wall has not been reinstated, as the wall presents a perfect opportunity to an exposed brick feature.

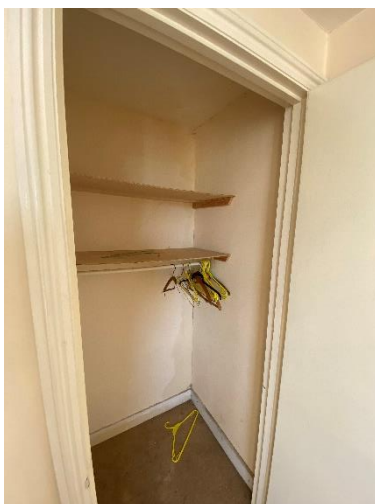
9

Minor signs of damp - Located under valley between roofs, likely due to poor drainage and condition of roofs.

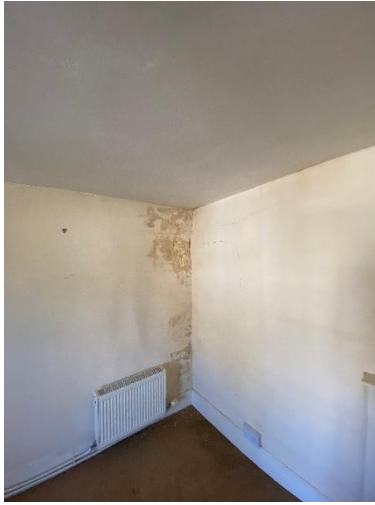
10

Signs of damp - Located under valley between roofs, likely due to poor drainage and condition of roofs.

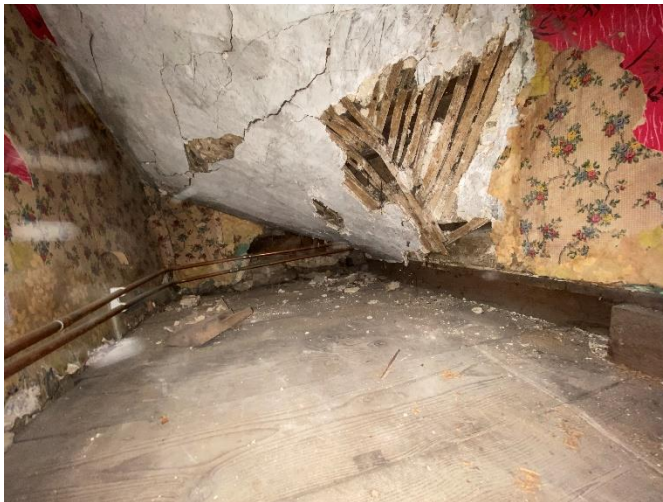
11

Underside of stairs. Demonstrating general condition and safety issues.

We propose to remove this staircase to allow space for a new bathroom.

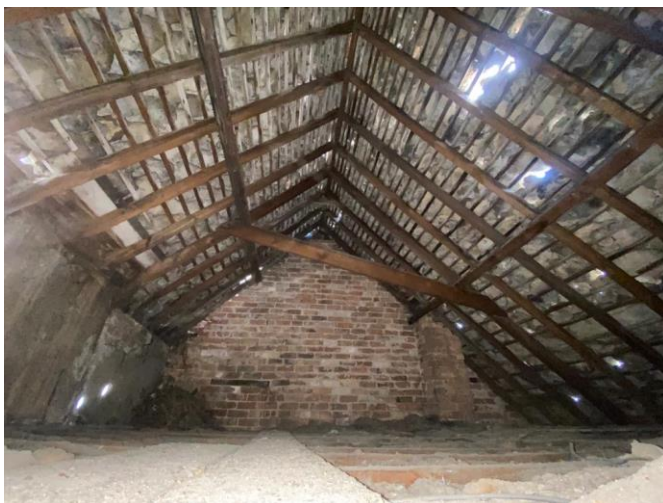
12

Immediate requirement for roof and gable repair to make weathertight, preventing further damage to rooms below. Existing structure requiring structural investigation to identify requirements for replacement of

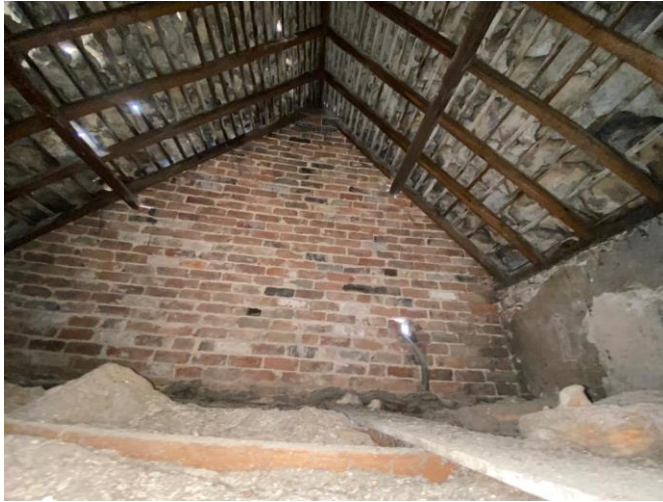
13

Immediate requirement for roof and gable repair to make weathertight, preventing further damage to rooms below. Existing structure requiring structural investigation to identify requirements for replacement of

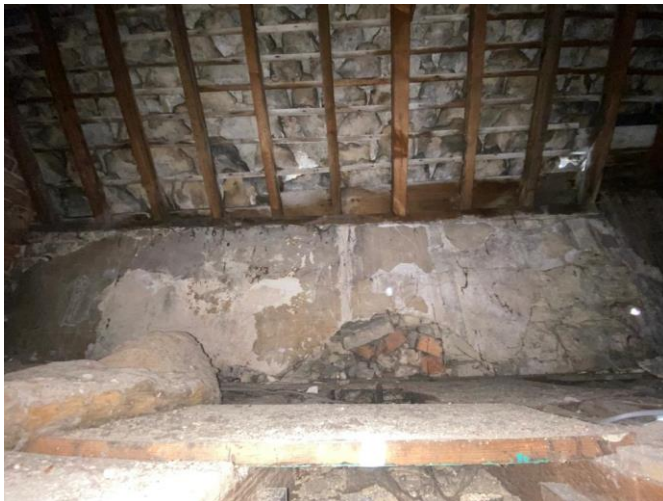
14

Damage to wall under roof valley. Requiring repair. This is the wall location where we intend to create a portal through to the adjacent roof, allowing movement through the loft spaces.

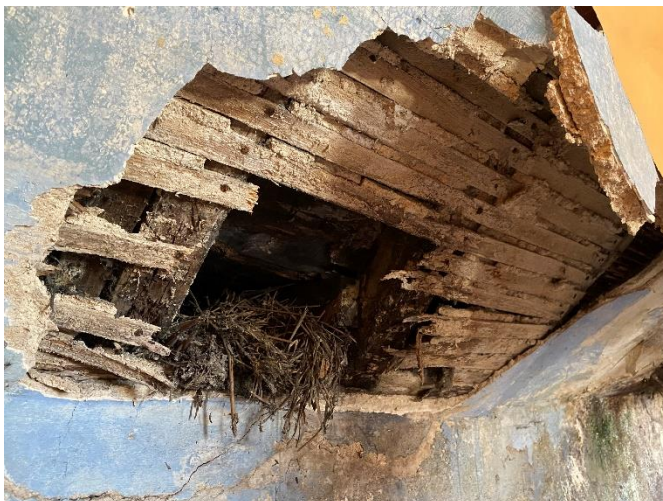
15

Roof deteriorating badly near valley. Requiring repair to ensure watertightness and protection.

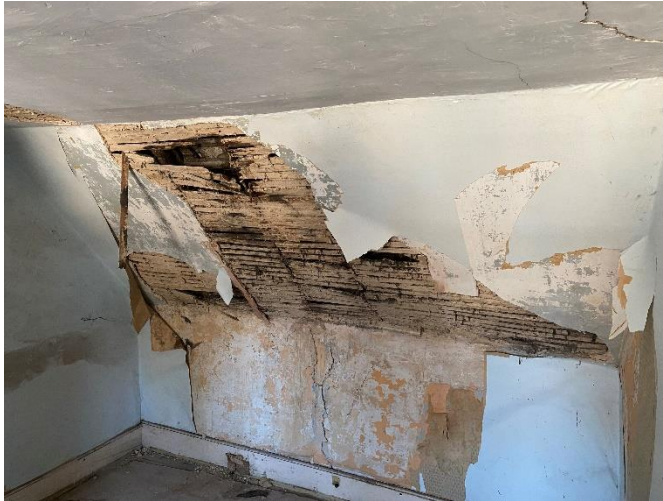
16

Roof deteriorating badly near valley. Signs of damp from poor valley roof condition

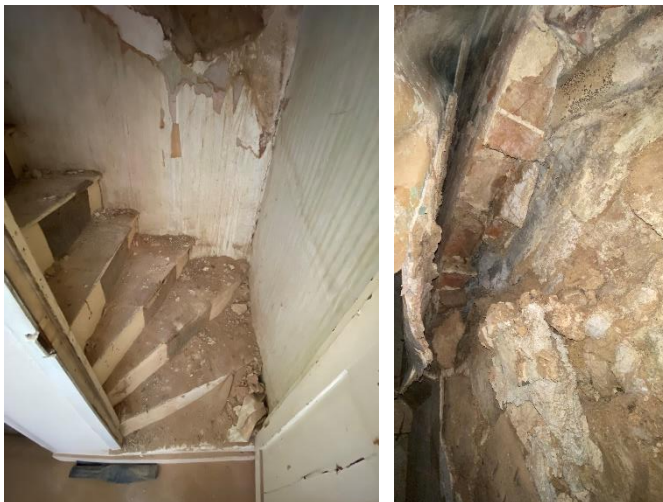
17

Gable wall above staircase which has now been repaired like for like with new timber lintel and brickwork repairs. As a matter of urgency to ensure safety of occupants and pedestrians of West Street.

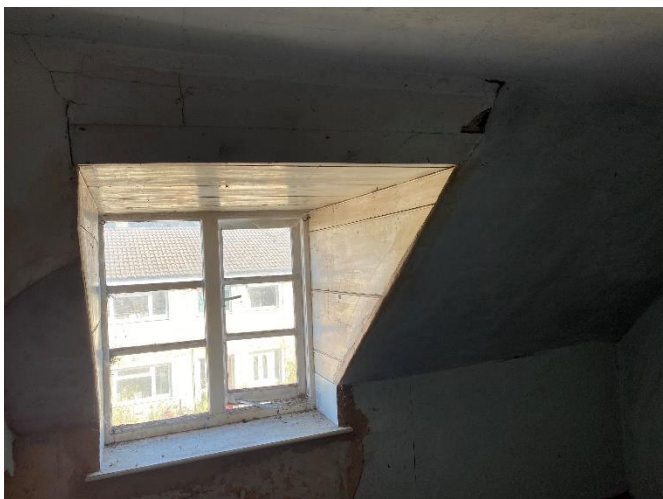
18

General disrepair around dormer cheeks and surrounding areas. Demonstrating requirement for intrusive investigation and like-for-like rebuild.

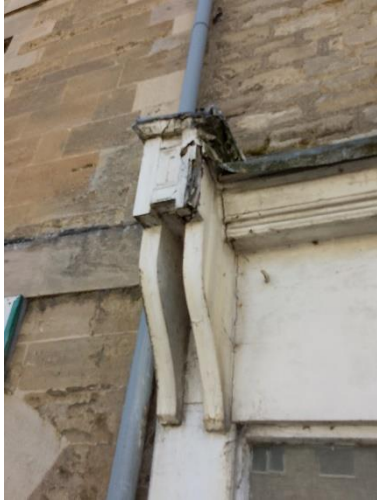
19

Damaged timber detail on shop front.

Believed to be water damage from poor drainage of gutter/hopper above and lead flashing over shop frontage.

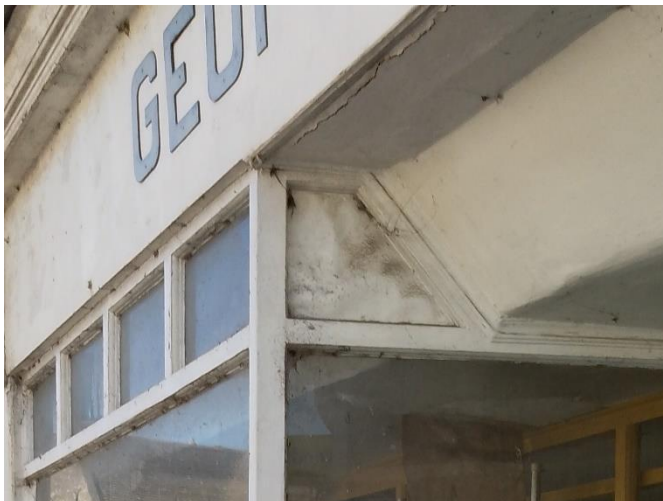
20

Missing glazing, previously filled in with timber and painted. We propose to make good as part of our shop front renovations

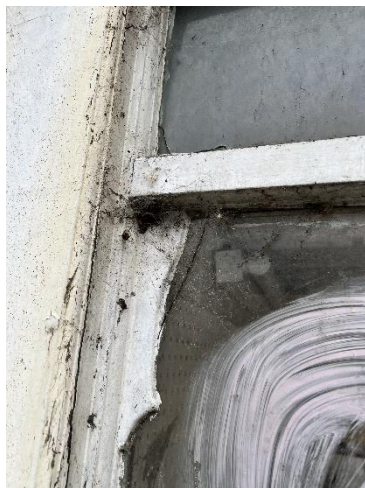
21

Crack in pane of glass to shopfront requiring replacement panel.

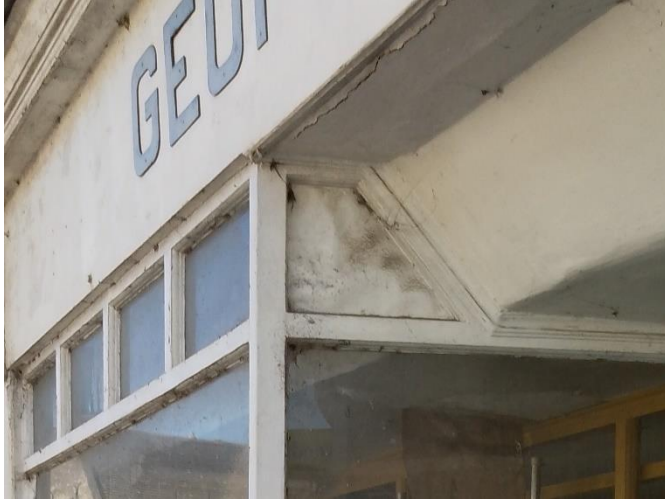
22

Glass missing and previously infilled. We propose to retrofit a new glass pane.

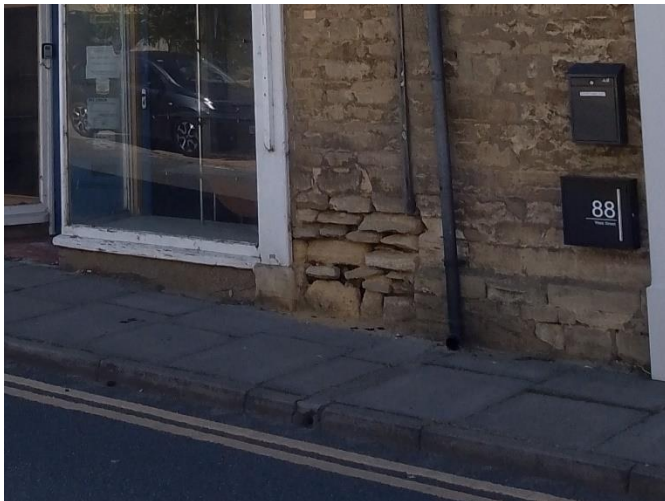
23

Section of loose coursed rubble stone. This has now been repointed to prevent further damage.

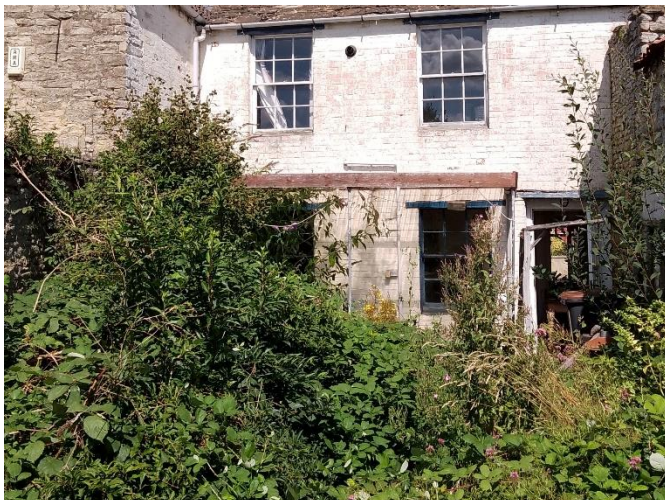
24

Existing canopy, poor condition, and little historic interest. We propose to replace this with a more traditional cast iron canopy.

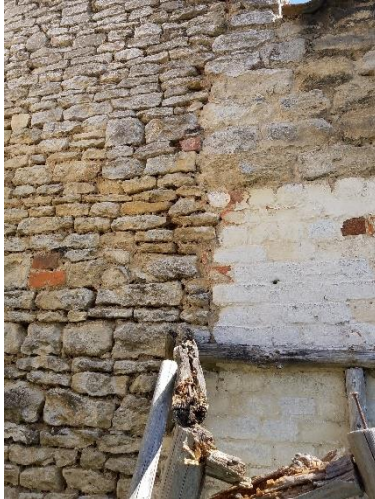
25

Poor condition of stone boundary wall. This has been repaired and repointed to prevent risk of further damage.

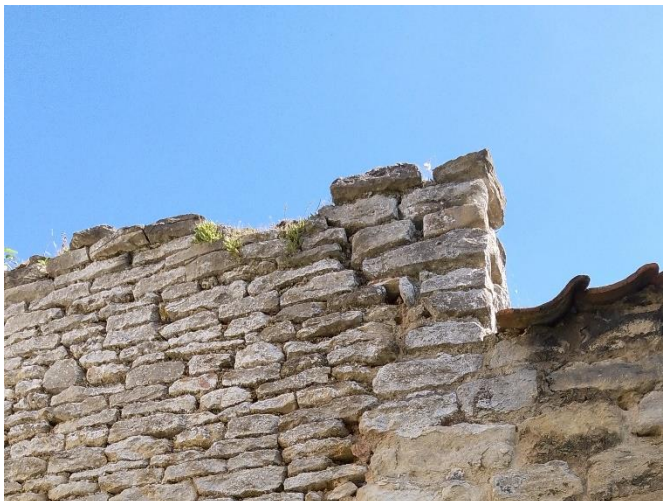
26

Rubble stone garden wall requiring pointing and repair. We propose a lime mortar capping to prevent water ingress and subsequent further damage.
