SITE INVESTIGATION FACTUAL REPORT

Report No: SI-521890
Client: Crawford Claims Management
Site: 69 Elmroyd Avenue
Hertfordshire
Client Ref: SU2203004
Date of Visit: 31/10/2022

Investigation Layout Plan

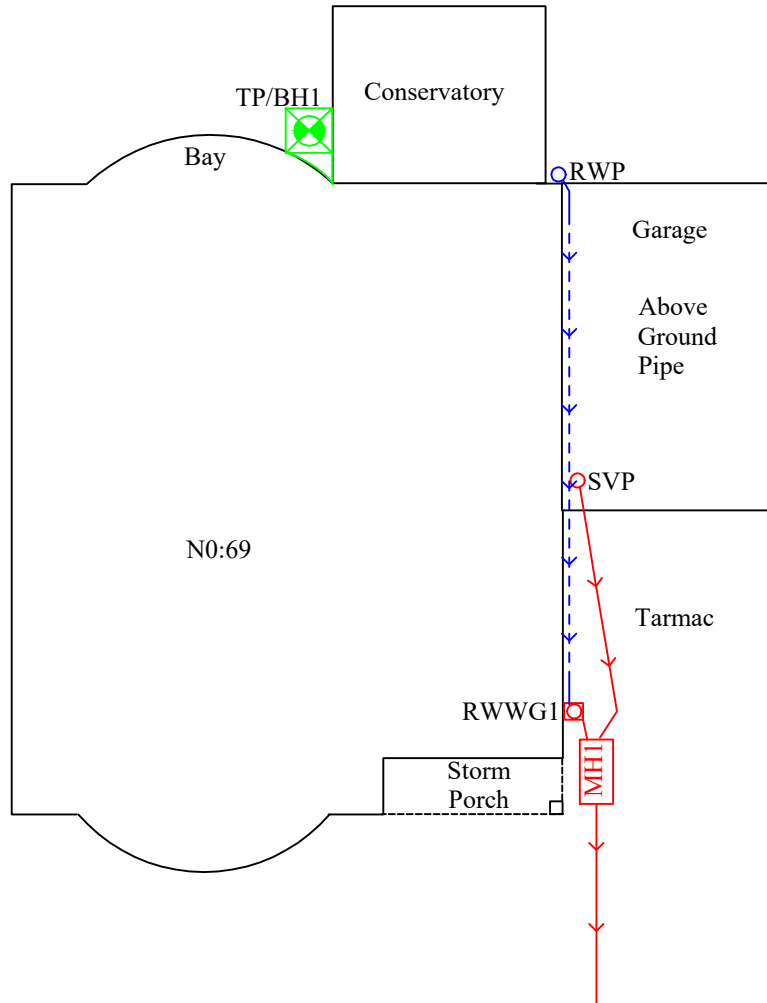
Oak Tree
HT=16.0M
D=16.0M

Conifer Tree
HT=13.0M
D=12.0M

2X Oak Trees
HT=15.0M
D=20.0M
Aprox

ON SITE TREE IDENTIFICATION FOR GUIDANCE ONLY. NOT AUTHENTICATED.

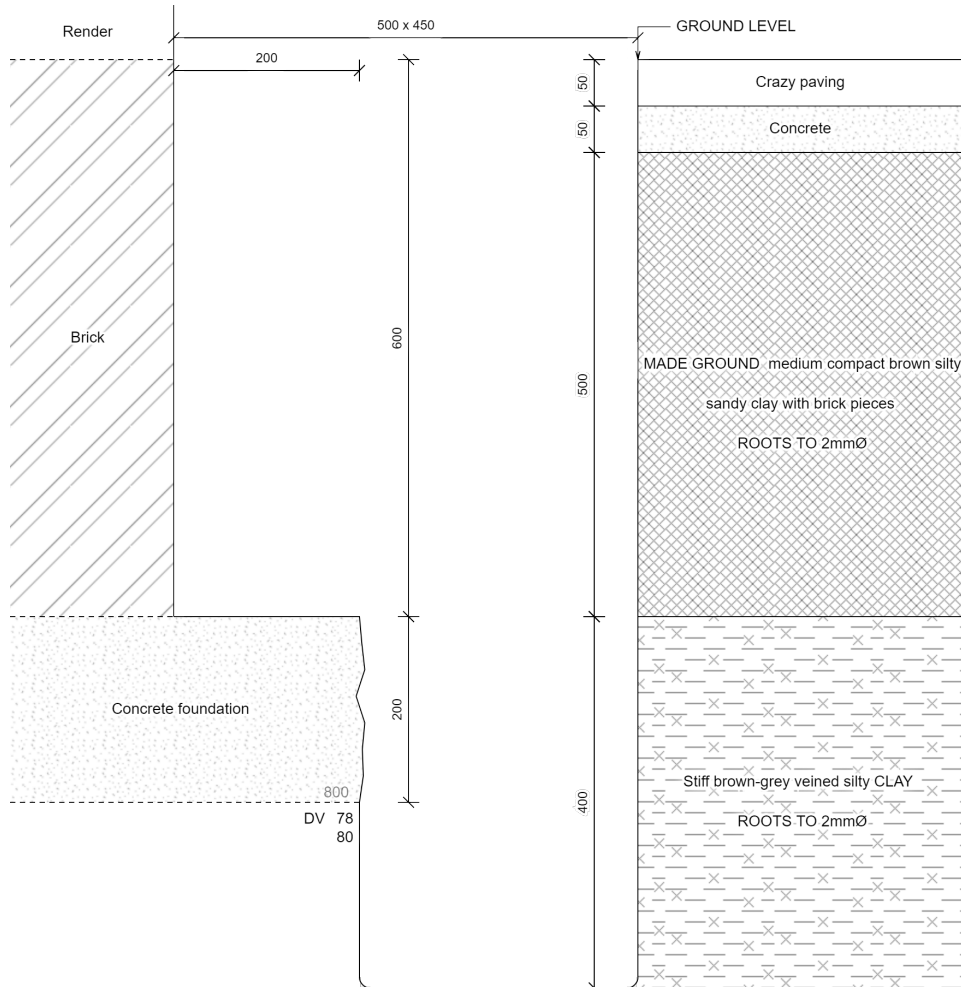
TEST REPORT: Trial Pit
REPORT NUMBER: C1068562 / 217891.1.1.1
TRIAL PIT REF: TP1A Bay **DATE:** 31/10/2022
CLIENT: Crawford & Co **SITE:** 69 ELMROYD AVENUE
JOB NO: 521890 **WEATHER:** Dry
EXCAVATION METHOD: Hand tools

For Strata below 1000mm see Trial Pit log

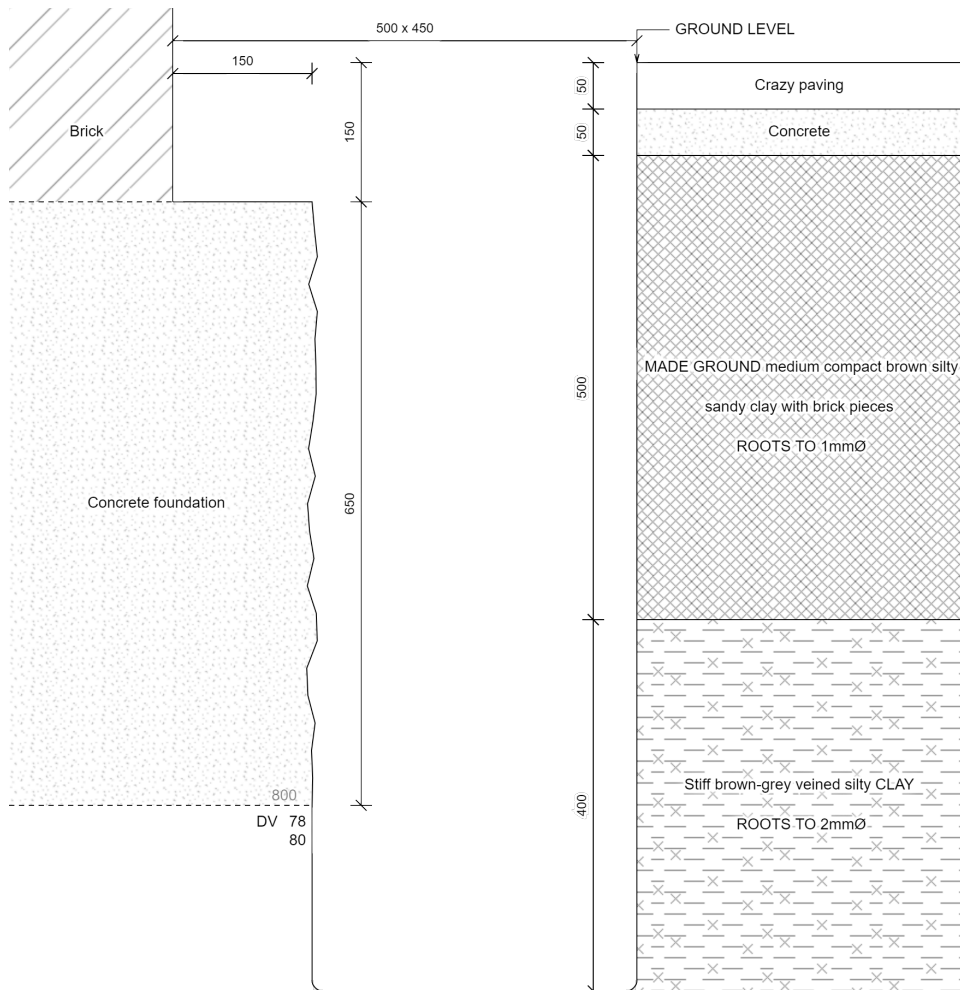
TEST REPORT: Trial Pit
REPORT NUMBER: C1068562 / 217891.1.1.2
TRIAL PIT REF: TP1 B Conservatory **DATE:** 31/10/2022
CLIENT: Crawford & Co **SITE:** 69 ELMROYD AVENUE
JOB NO: 521890 **WEATHER:** Dry
EXCAVATION METHOD: Hand tools

For Strata below 1000mm see Bore Hole log

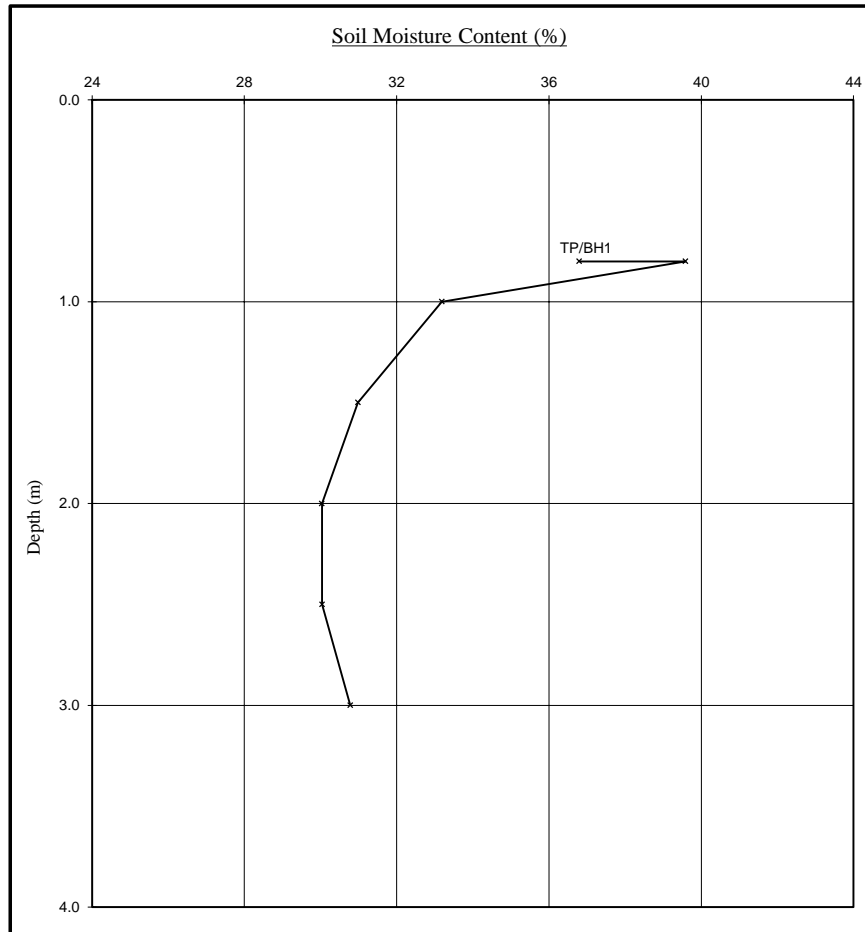
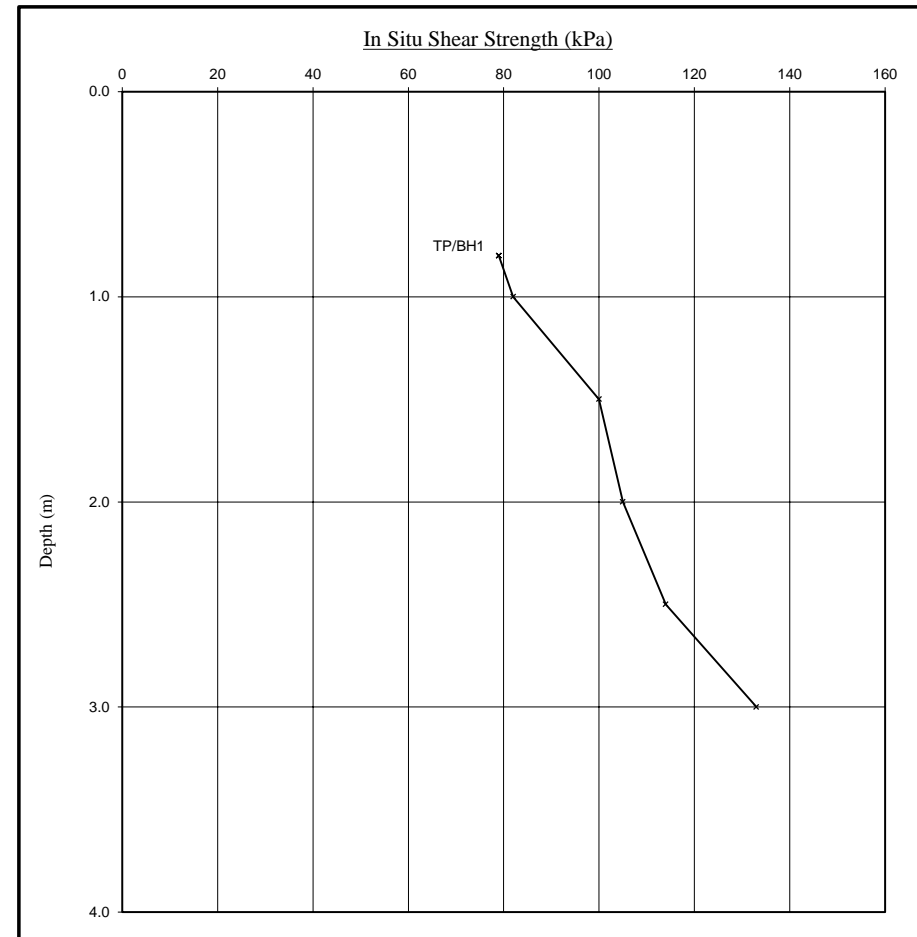
Moisture Content Profiles

1. If plotted, 0.4 LL and PL+2 (after Driscoll, 1983) should only be applied to London Clay (and similarly overconsolidated clay) at shallow depths.
2. Unless specifically noted the profiles have not been related to a site datum.

1. Unless otherwise stated, values of Shear Strength were determined in situ by CTS using a Pilcon Hand Vane the calibration of which is limited to a maximum reading of 130 kPa.
2. Unless specifically noted the profiles have not been related to a site datum.
