Arboricultural Appraisal Report

Subsidence Damage Investigation at:

69 Elmroyd Avenue
Potters Bar
EN6 2EF

CLIENT:	Crawford & Company
CLIENT REF:	SU2203004
MWA REF:	SUB230316-12684
MWA CONSULTANT:	Andy Clark
REPORT DATE:	30/06/2023

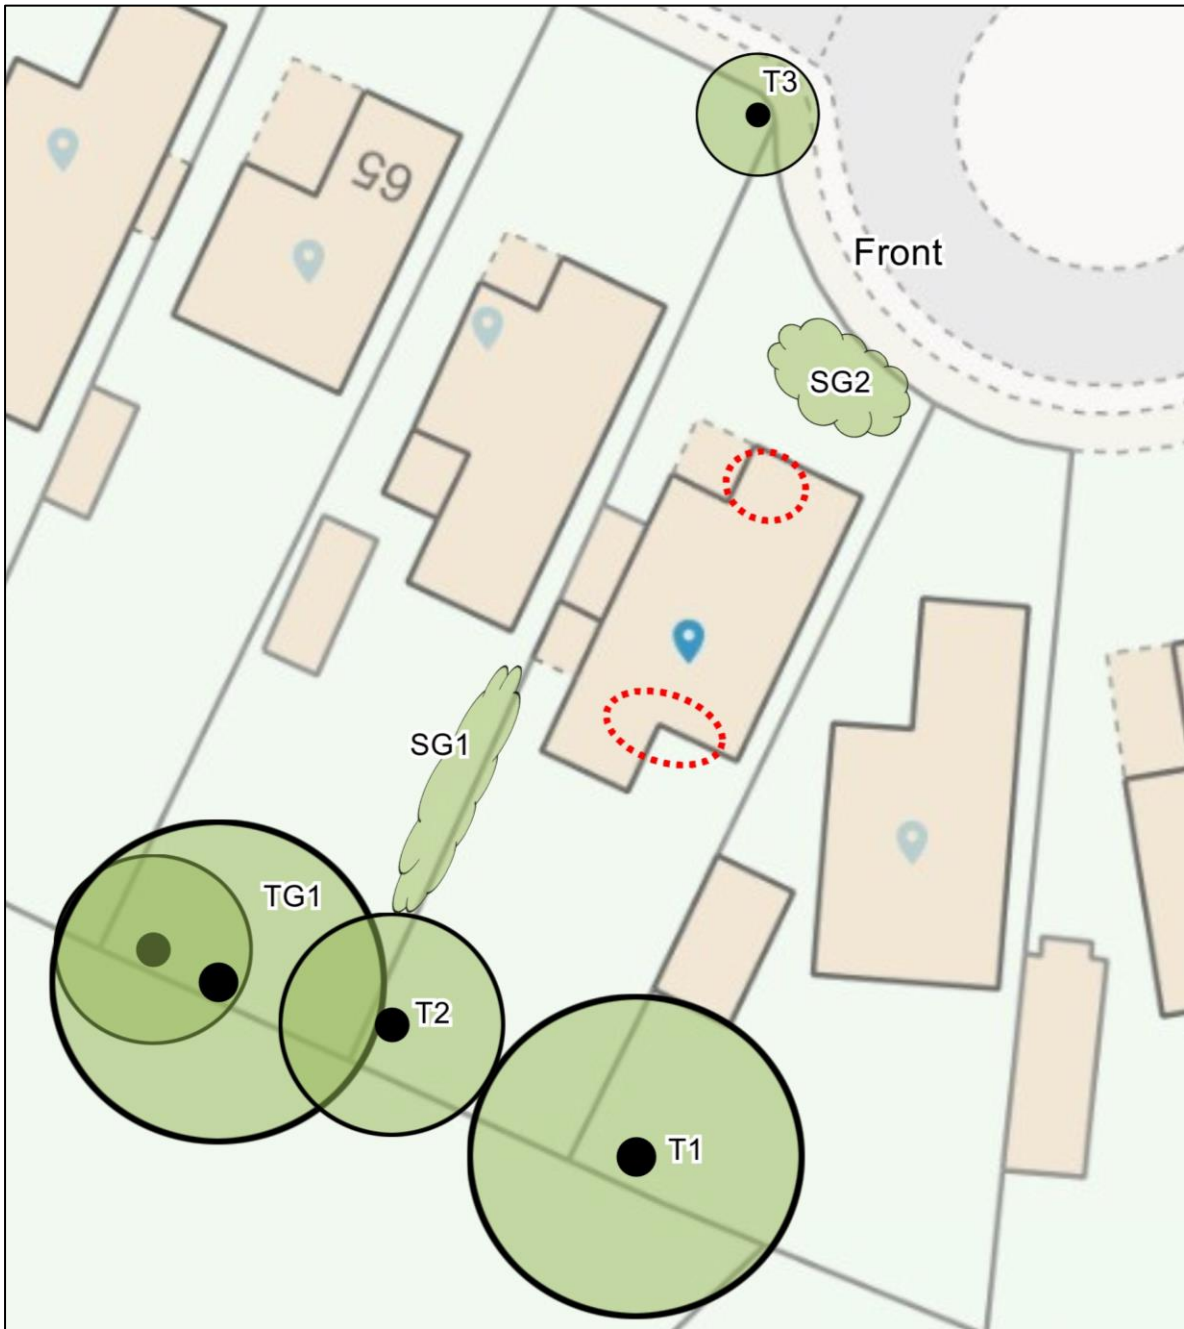
Site Plan

Approximate areas of damage

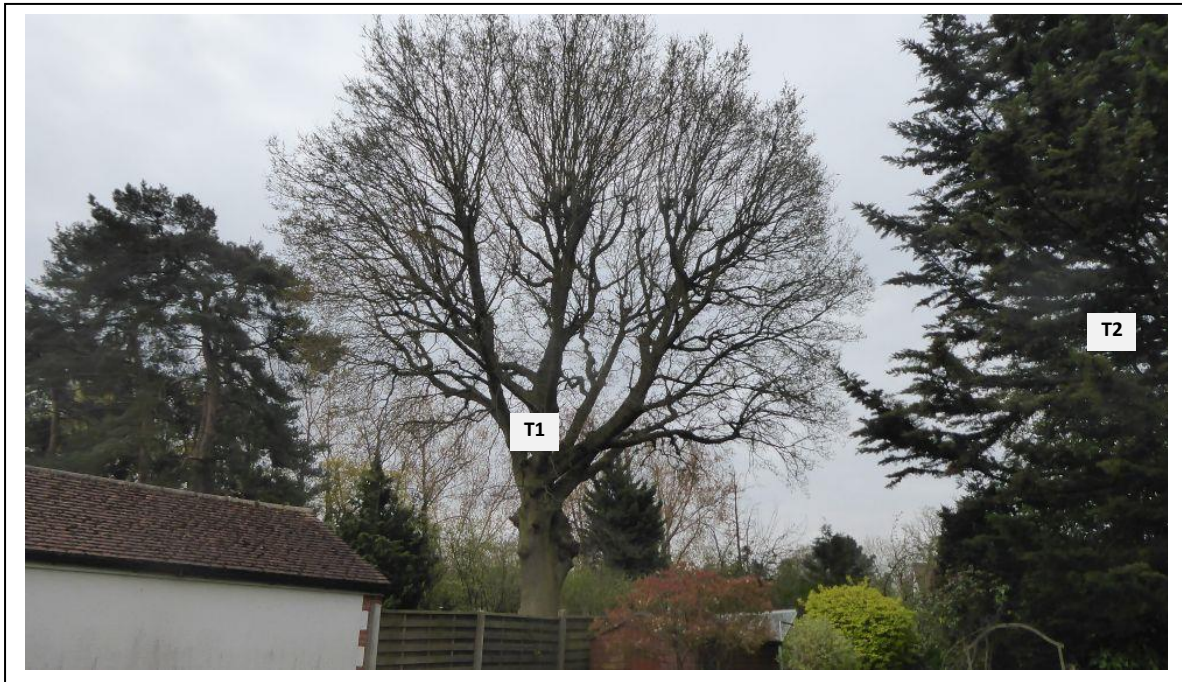
Tree No.	Species	Ht (m)	Dia (mm)	Crown Spread (m)	Dist. to building (m)	Age Classification	Ownership
T1	Oak	19.0	800 *	17.5	17.5 *	Older than extension(s)	Third Party 71 Elmroyd Avenue EN6 2EF
Management history		Subject to past management/pruning - previously crown reduced / pollarded at approx. 13.0m.					
Recommendation		Reduce/re-pollard to previous points to leave at approx. 13.0m high by 12.0m spread and thereafter re-prune on a triennial cycle to maintain at broadly reduced dimensions.					
T2	Cypress (Monterey)	17.5	520	12.0	14.2	Older than extension(s)	Policy Holder
Management history		No significant past management noted.					
Recommendation		Remove (fell) to near ground level and treat stump to inhibit regrowth.					
TG1	Oak group	18.0	800 *	16.0	16.0 *	Older than extension(s)	Third Party 67 Elmroyd Avenue EN6 2EF
Management history		Subject to past management/pruning - previously crown reduced / pollarded at approx. 12.0m. Appears to be two separate stems, but may be 1x twin stemmed tree.

View of T1 Oak with T2 Monterey Cypress visible to right of frame

If an arboricultural solution is to be implemented to mitigate the influence of the trees/shrubs considered to be responsible for the damage at the property frontage we recommend that the Magnolia of SG2 group is removed. Movement/damage at the rear will be attributable to the T2 Monterey Cypress and the Oaks T1 and TG1 Oak group, and initial recommendations are made at this stage for the removal of the T2 Monterey Cypress combined with significant crown management of the Oaks.

Recommendation		Reduce/re-pollard to previous points to leave approx. 12.0m high by 12.0m spread and thereafter re-prune on a triennial cycle to maintain at broadly reduced dimensions.					
SG2	Mixed spp. group of mostly Rose, Magnolia, Pieris and Rhododendron with Herbaceous understorey	2.0	60	2.0	1.9	Younger than Property	Policy Holder
Management history		Subject to past management/pruning - appears regularly pruned.					
Recommendation		Remove (fell) Magnolia to near ground level and treat stump to inhibit regrowth.

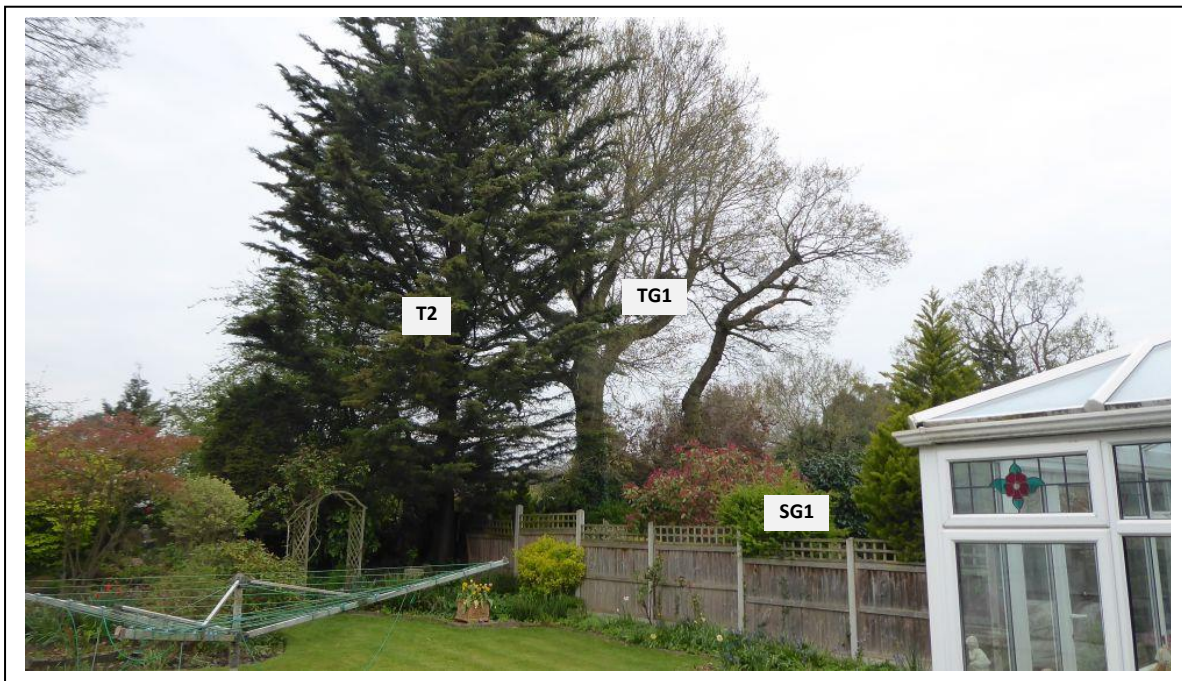
View of T2 Cypress with TG1 Oak group visible beyond and SG1 group to foreground

Tree No.	Species	Ht (m)	Dia (mm)	Crown Spread (m)	Dist. to building (m)	Age Classification	Ownership
T3	Rowan	5.0	170 *	5.0	12.9	Younger than Property	Third Party 67 Elmroyd Avenue EN6 2EF
Management history		No significant past management noted.					
Recommendation		None at present.					
SG1	Mixed spp. group of mostly Photinia, Cypress and Pyracantha	3.5	70 Ms *	2.0	2.0	Older than extension(s)	Third Party 67 Elmroyd Avenue EN6 2EF
Management history		Subject to past management/pruning - appears regularly pruned.					
Recommendation		Maintain broadly at no more than current dimensions by periodic pruning.

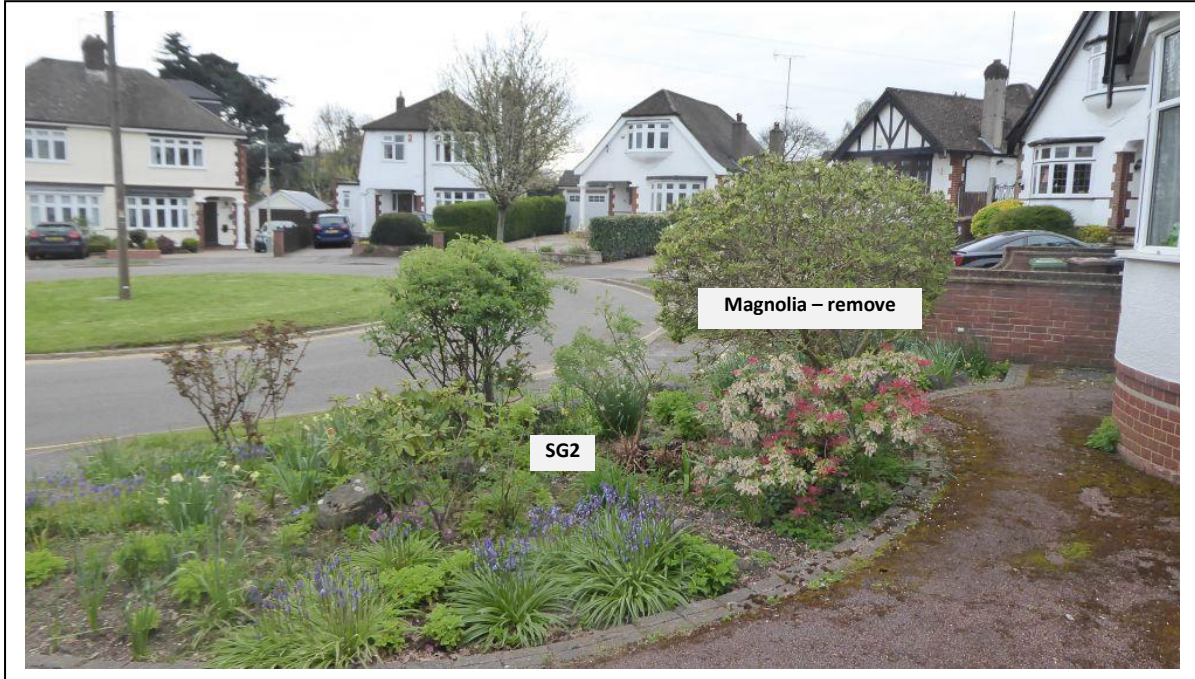
View of SG2 at property frontage

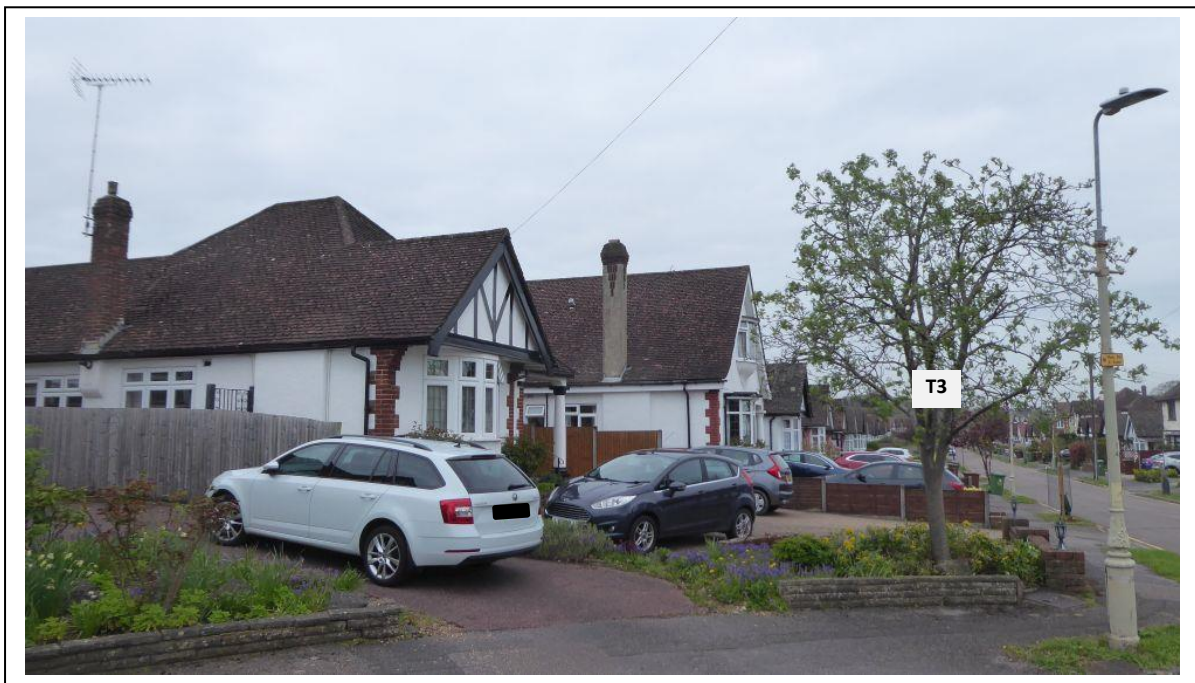
View of T3 Rowan
