Preliminary Roost Assessment and Survey for Evidence of Nesting Wild Birds at 24 Sheinton Street, Much Wenlock, TF13 6HY

With regard to the proposed re-roofing of the listed building at 24 Sheinton Street, Much Wenlock, Shropshire TF13 6HY, ECO TECH Ecological Consultancy was commissioned to undertake a Preliminary Roost Assessment in relation to bats and a check for nesting wild birds, in order to assess potential impact on, and legal obligations for, these species groups.

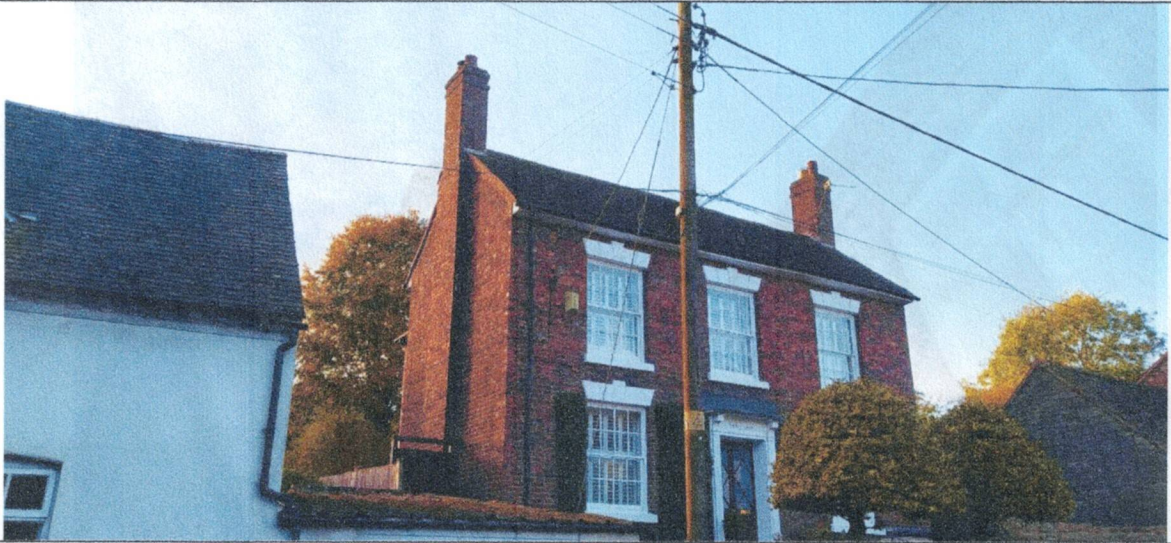
Photo 1 – shows the east and south-facing elevations.

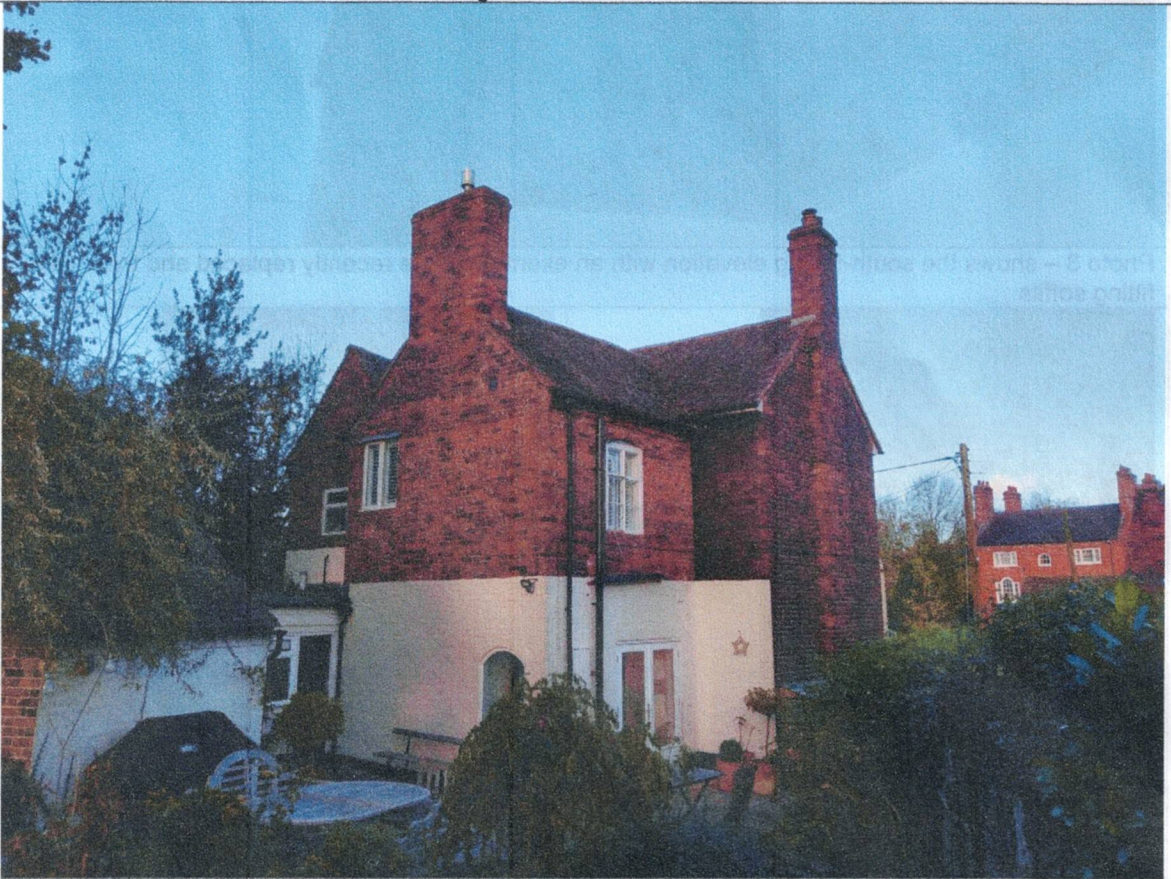
Photo 2 – shows the west and south-facing elevations

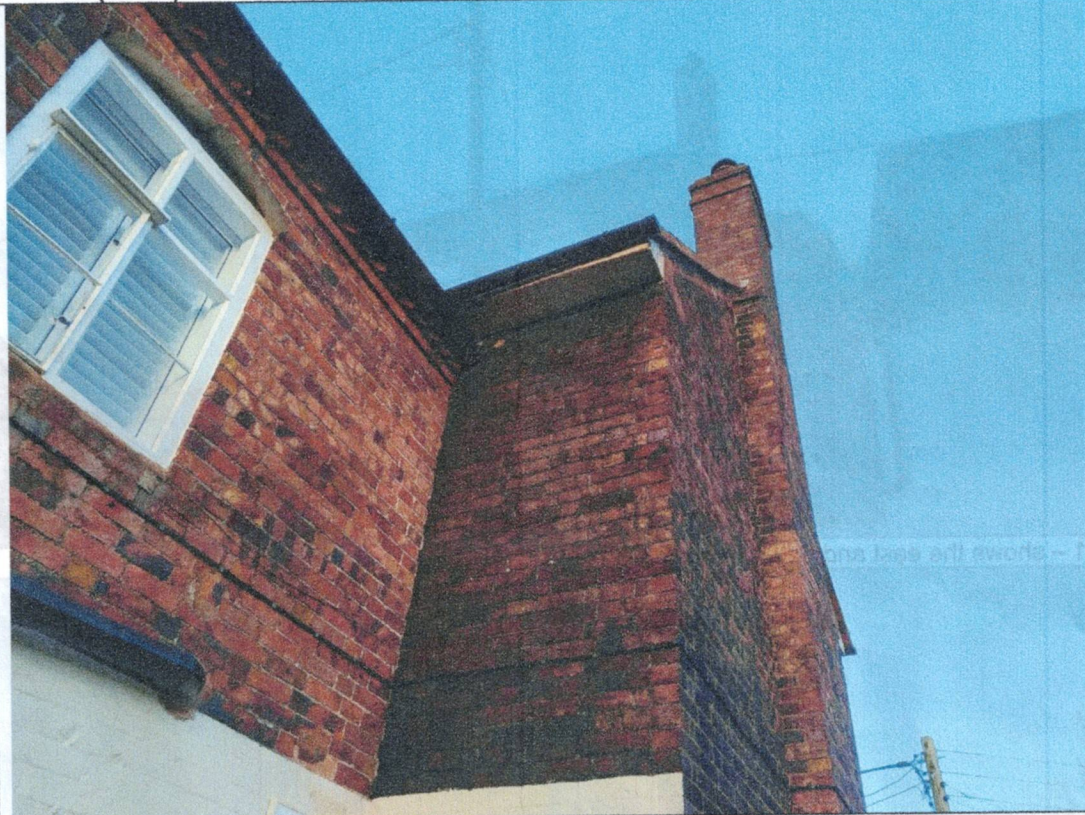
Externally, the walls are in very good condition with no cracks or gaps in the pointing. The soffits are understood to have been recently replaced and are tight fitting with no gaps seen (see photo 3). The clay tiles are raised in places and there are dislodged tiles that allow daylight and potentially bats into the roof void. Mortar is missing from the edges of some ridge tiles also allowing daylight and potentially bats into the roof void (see photo 4). The tiles on roof edges on all pitches are mortared in with no gaps (see photo 1 to 3). The brick chimneys are good condition with no missing mortar seen and the flashing around all of the chimney base appearing gap free.

Photo 3 – shows the south-facing elevation with an example of the recently replaced and thus tightly fitting soffits

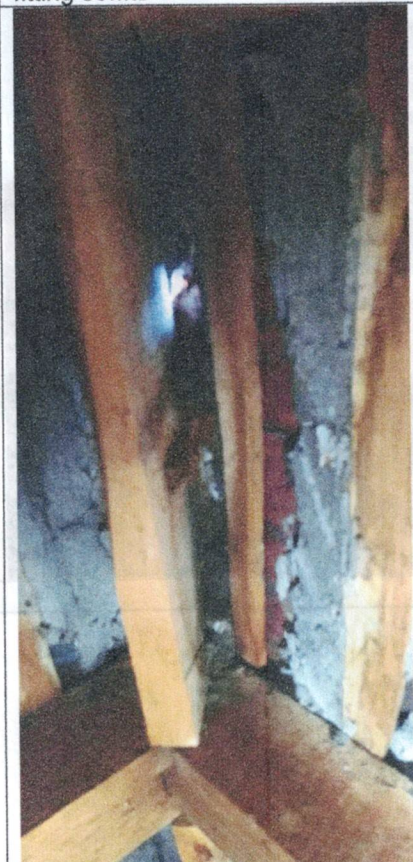
Evidence of previous nesting was seen in a gap under a ridge tile. This is likely to have been house sparrow.

Photo 4 – missing mortar from the ridge tile allowing light and, potentially, bat ingress

- A condition or an informative suggesting appropriate timing of the works to avoid damage or destruction of an active nest (eg: work to commence in the period September to February inclusive) and/or due diligence by contractors during the works period. For example, in the very unlikely event that an active wild bird nest is encountered during any part of the development, then works should cease immediately, or an offence may be caused. A consultant ecologist and/or Natural England should be consulted before works recommence.

- If commencement in the timeframe noted above is not possible, it is suggested that the roof is subject to a survey for bird nesting activity by a suitably experienced individual, no more than 48 hours before works commence. If no active nests are found or considered likely, then no offence in regard to this species group is likely.

- One 'woodstone' sparrow terrace (or direct equivalent) should be provided in the locality of the application. An example can be found [here](#) (accessed November 2023). Further information about the erection of boxes can be found [here](#) (accessed November 2023).

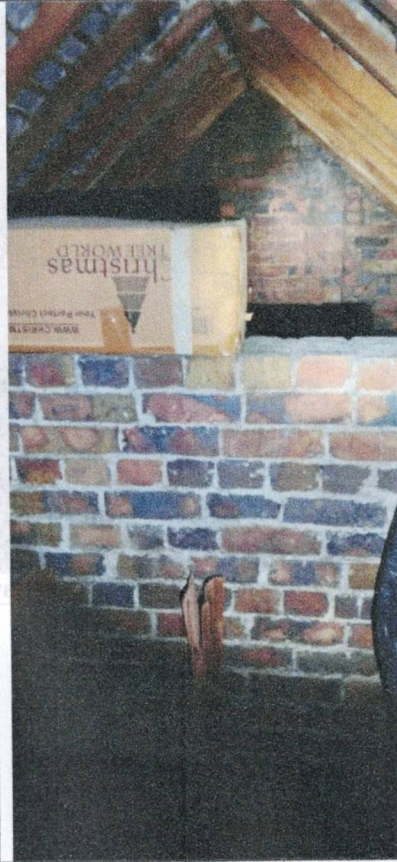
Internally, the main loft space is reasonably large (around 2m tall at the highest point) but somewhat cluttered as it is used for storage (see photo 5). The other roof spaces are contiguous with this main space but are considerably smaller. There appears to be fibreglass insulation between all joists. Below the clay tiles there is no membrane, only torching (see photo 4). There are abundant cobwebs, showing no recent passage by flying bats has occurred. There was visible light ingress into the loft in a number of places. Despite these apparent bat access points, no evidence of bats was seen in the roof void at the time of survey. Given the good access for survey, lack of membrane, and the clear views of the insulation and stored items, any bat droppings would have been very visible, had they been present.

Photo 5 – showing the somewhat cluttered main roof void
