Stileways, Wraxall

Arboricultural Report containing:

Prepared by:
Deb Randall BSc
Arboricultural Consultant
April 2023

Arboricultural Survey Stileways, West Hill, Wraxall

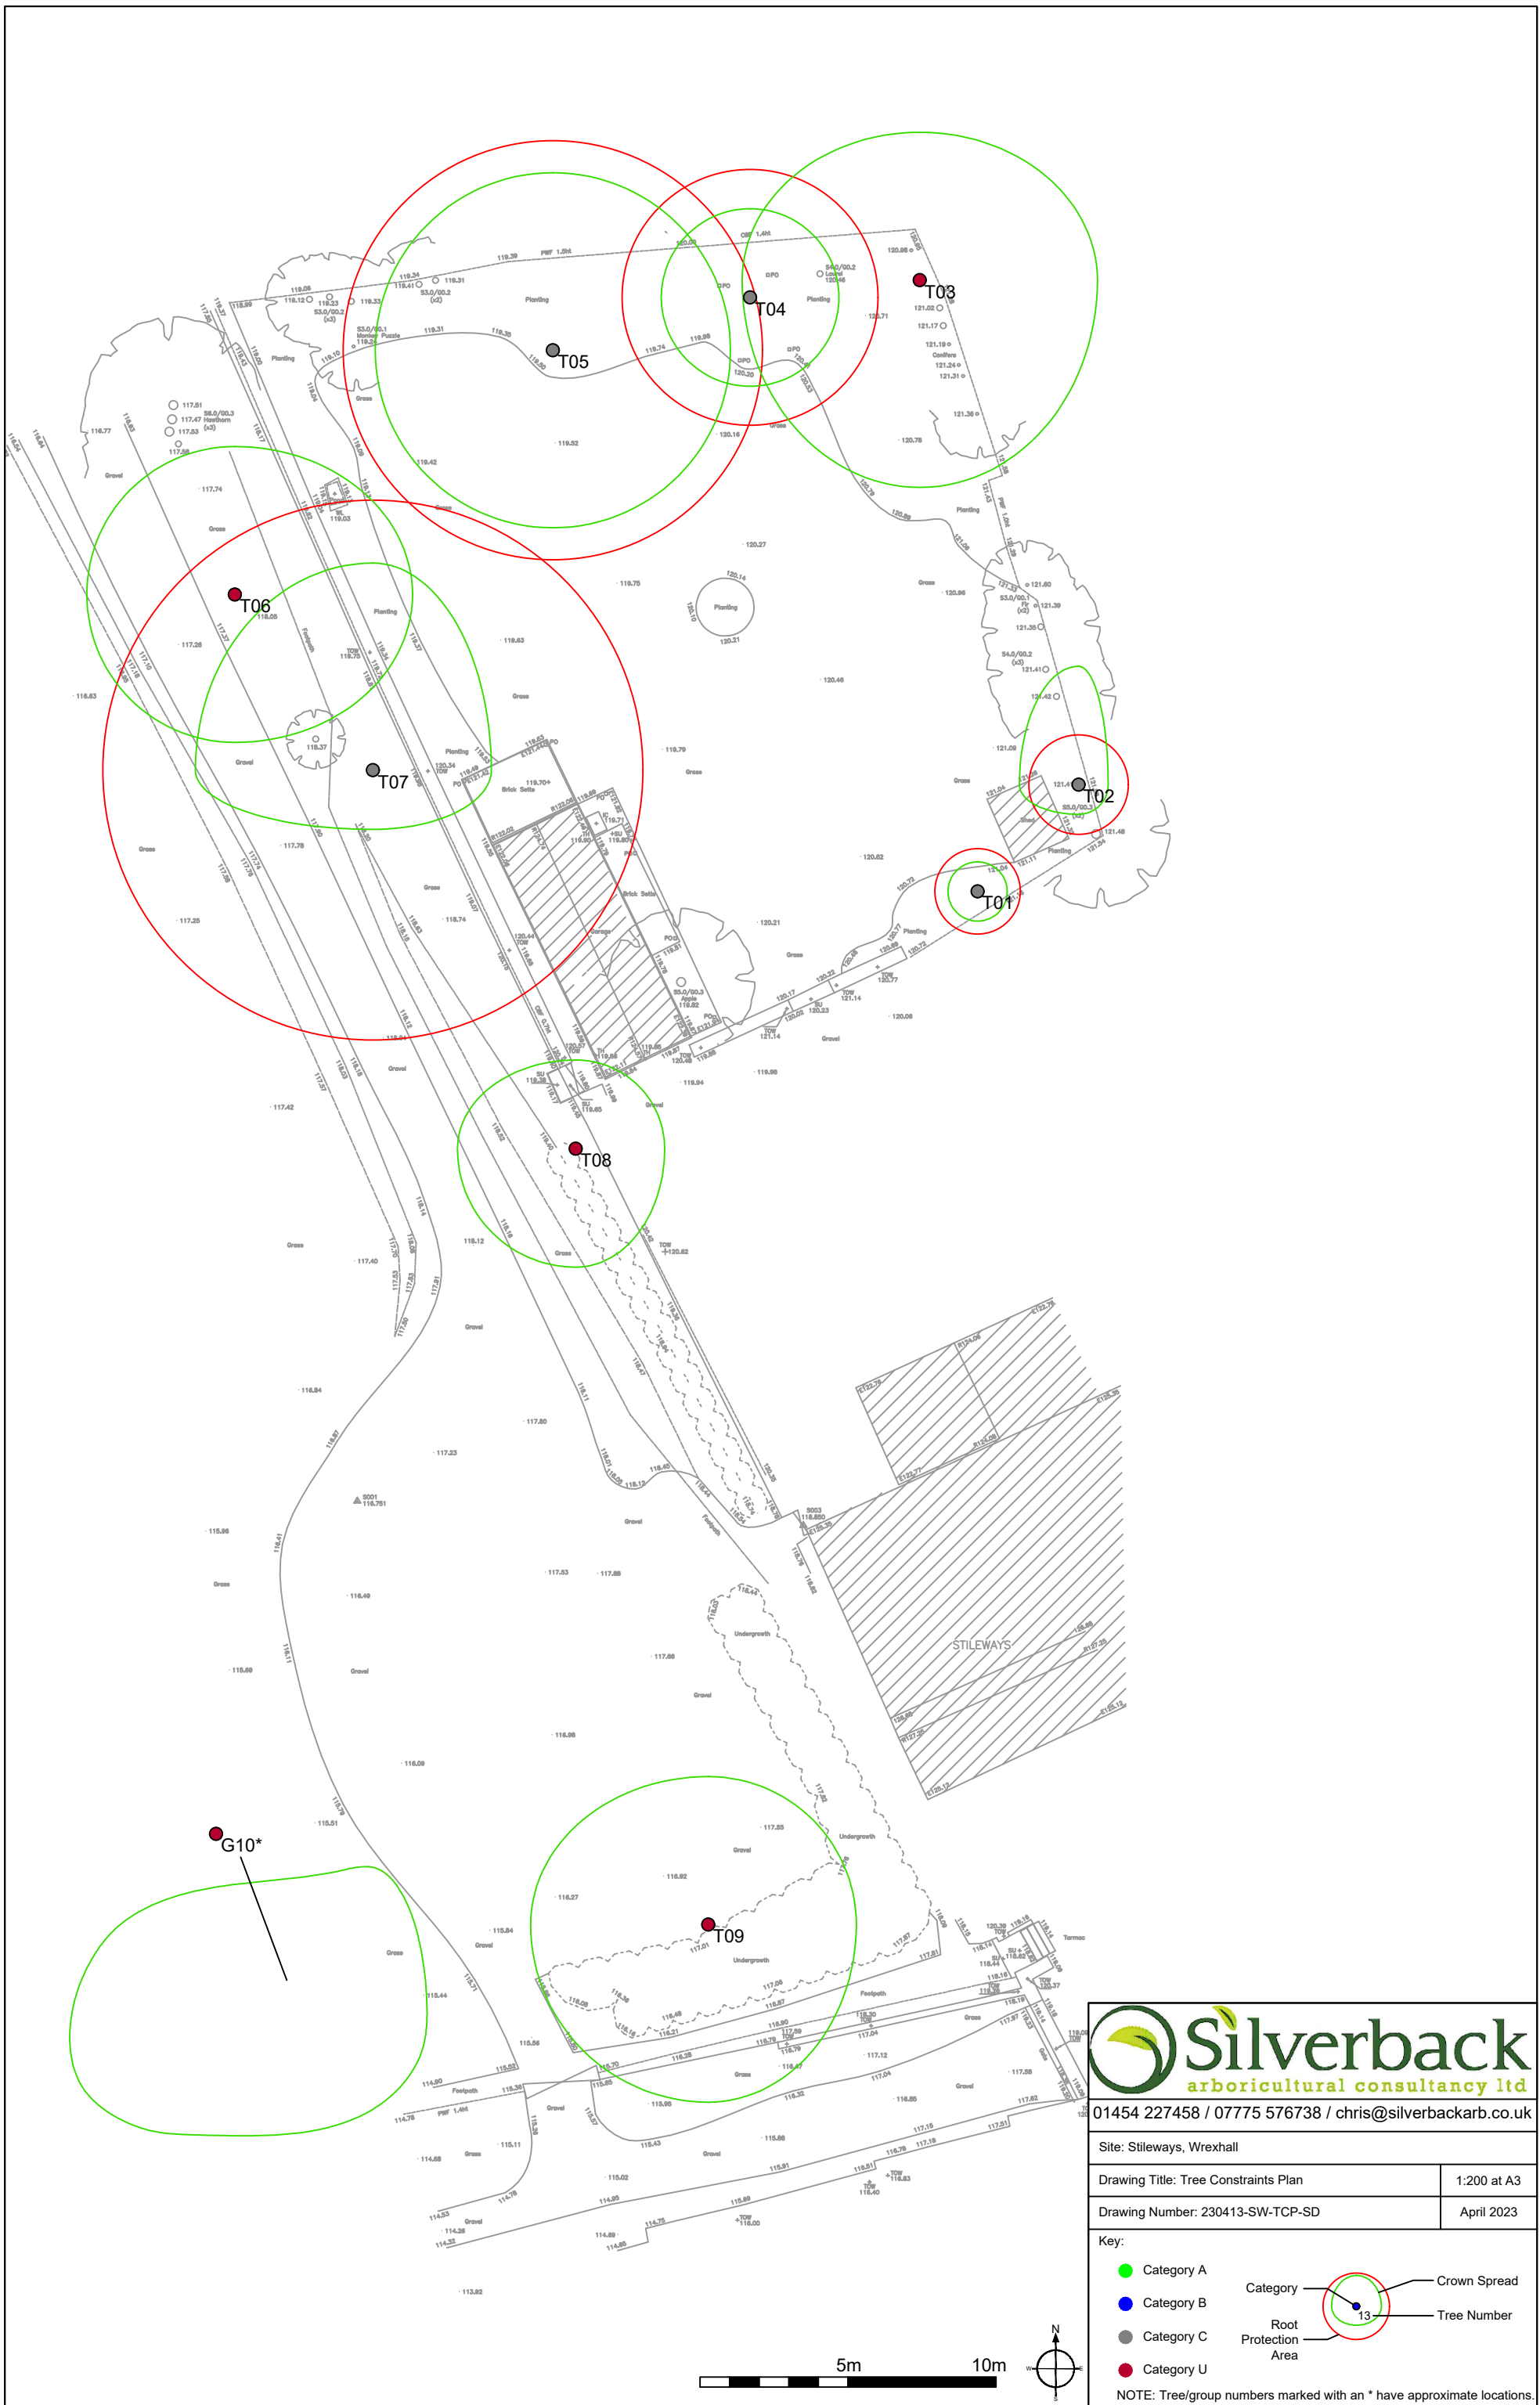
Site: Stileways, Wrexhall	
Drawing Title: Tree Constraints Plan	1:200 at A3
Drawing Number: 230413-SW-TCP-SD	April 2023

- 5.1 The site consists of the rear garden of the house and part of the adjacent field to the west. There are trees growing around the boundary of the garden and the field. There is a public footpath within the adjacent field where the majority of trees are Ash. T08 is an over mature Sycamore growing on the site boundary's western edge. The tree has extensive decay within the main stem and major dieback within the canopy.

- 5.2 On inspection, evidence was found that all the surveyed Ash trees are infected by Ash dieback disease (*Hymenoscyphus fraxineus*). This was evident in the few remaining leaves in the canopies of the trees and the leaf litter around the base of the trees. Ash dieback disease destroys the tree's phloem and xylem, which results in the tree being unable to move water and nutrients around its structure. This lack of water and nutrient movement will cause the branches of the tree to fail and the tree to 'die back'. The ongoing loss of nutrition and water plus the depletion of energy reserves due to the lack of foliage causes the tree to become brittle, lose branches and make it susceptible to other pathogens such as Honey Fungus (*Armillaria*).

- 5.4 The latest evidence nationwide and from local tree surgery teams, is that infected trees can decline rapidly becoming structurally unsound in a matter of months. It is therefore considered that the Ash trees have a very short useful life expectancy and should not be considered as a constraint to the approved development.

- 5.5 Nine trees and one group of trees were surveyed. Of the trees surveyed four trees and one group of trees was categorised **U**, the remaining trees were categorized **C**. The trees were assessed and graded in accordance with the Cascading Chart of Tree Quality Assessment contained within BS5837:2012.
