Singular Horse Chestnut Tree Report 2023

34A Baker St

Waddesdon, Aylesbury HP18 0LQ

3rd October 2023

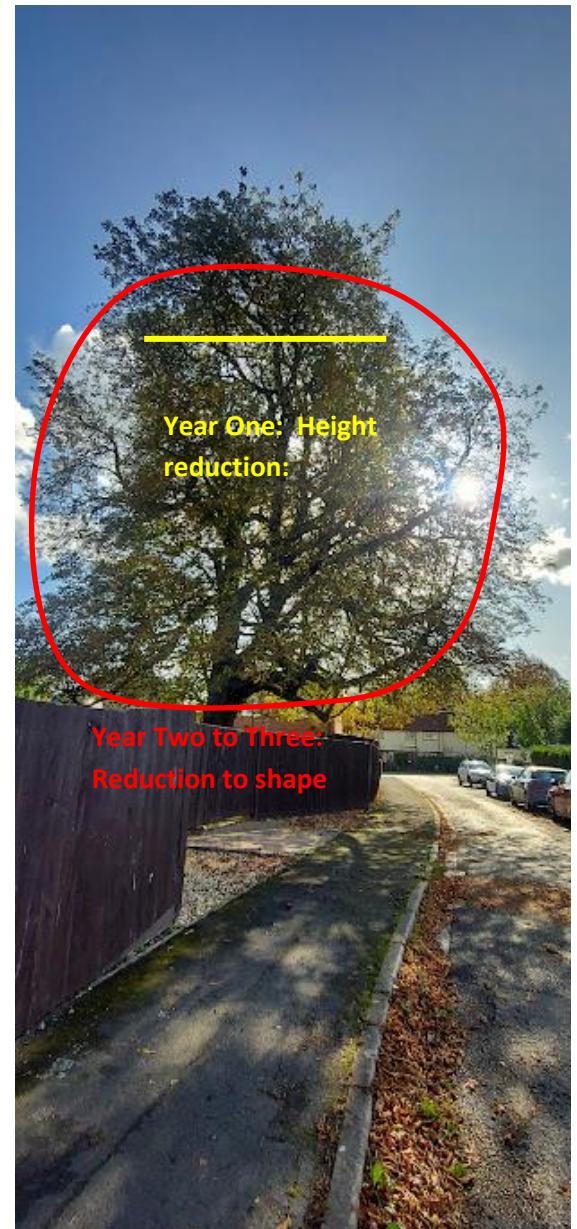
There are currently no concerns regarding fungal issues or structural problems at the tree's base. However, due to its age, the tree bears scars from past branch failures. Additionally, there are visible cavities and openings in the midsection to the upper part of the main stem. Notably, there is a slender open fissure running through the entire trunk at about 12 meters above the ground. While there is sturdy reaction wood on both sides of this fissure, it's essential to recognize the resulting structural weakness.

3. **The reduction Plan.**
Year One Mid-summer Works: Selectively pruning the longest and highest limbs (see Fig. 1) by approx. 4m to 5m making the cuts at an area of hollowing to minimise the open wound. This will be severe but no other works will be done to allow for recovery. As much foliage will be kept on the rest of the tree to allow for maximum photosynthesis.
