PE/WK 23/1289 16 October 2023

Schedule of Reinstatement for the former Crown and Thistle Public House

The property comprises a detached two storey building with single storey additions.

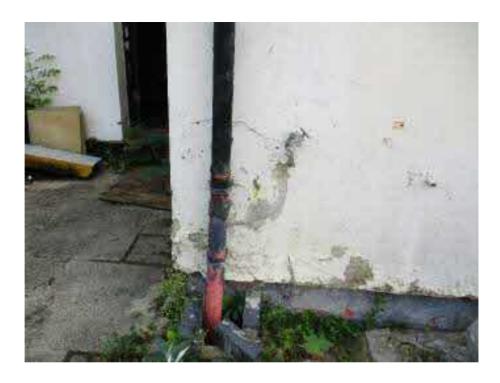
Blocked and leaking downpipe and loose render

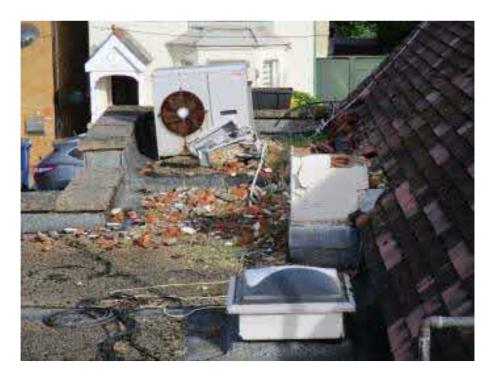
Collapsed chimney on flat roof

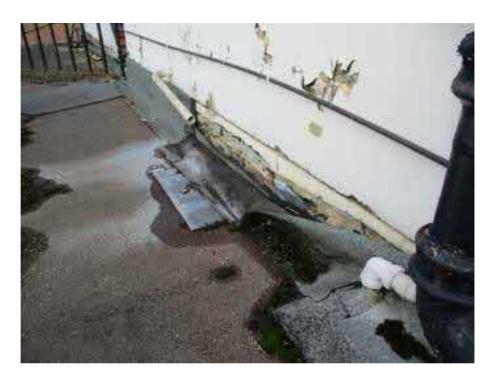
Flashing pulled away

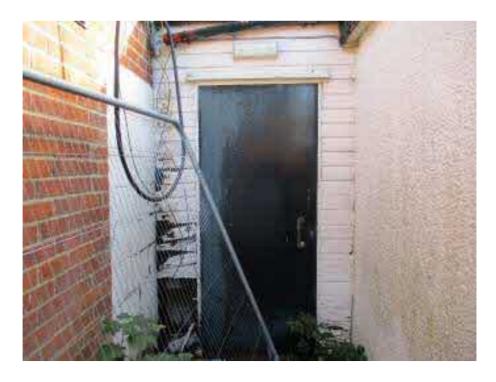
Rotten side entrance

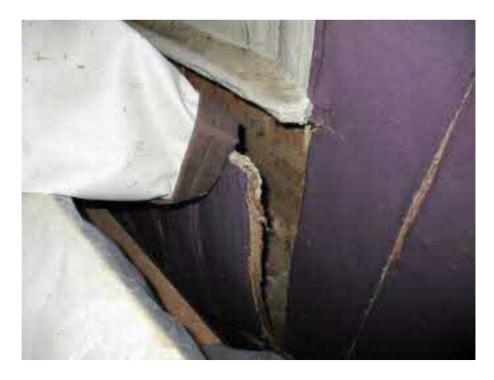
Damaged panelling in bar area

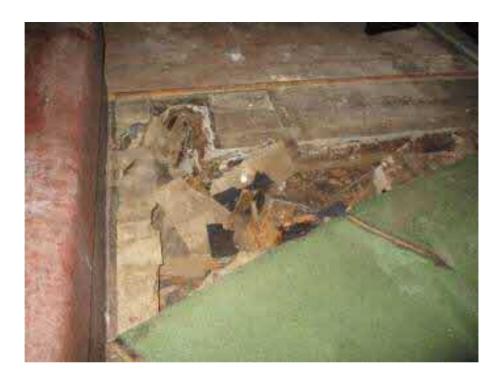
Collapsed bar floor

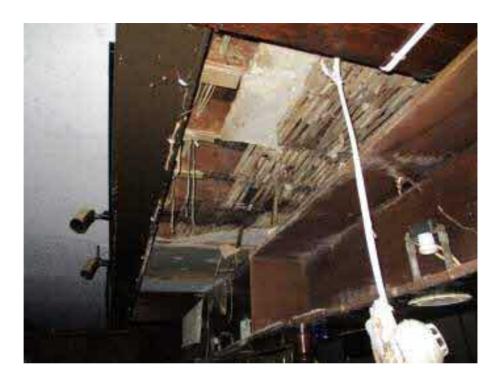
Water damaged ceiling above bar
