**McCombie Smith Architects**  
71 Main Street , Greetham , Rutland , LE15 7NJ

Site visit with Noel McLaughlin, structural engineer  
14 March 2023

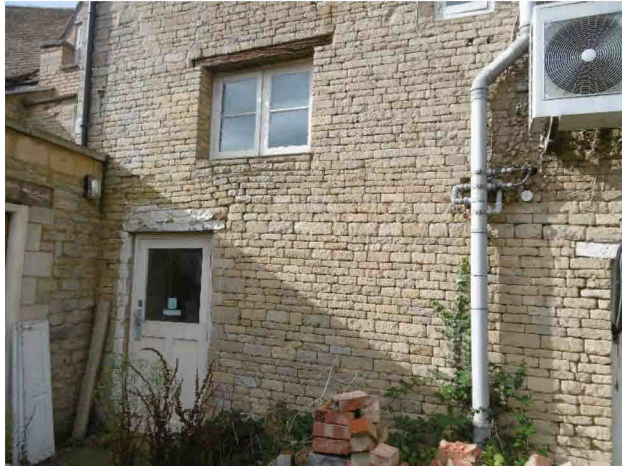
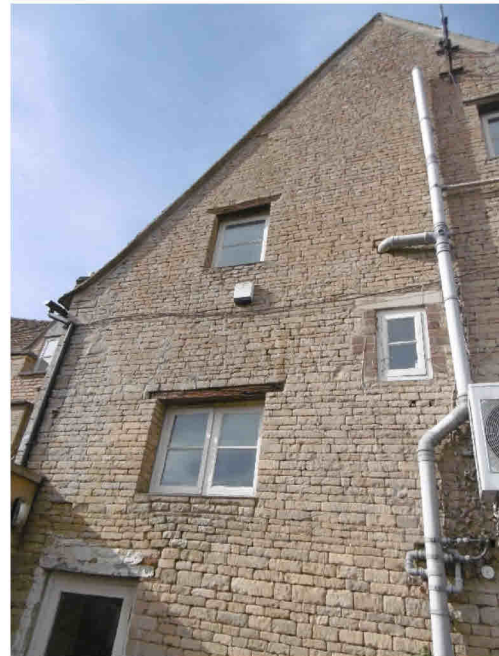
X1 On viewing the rear elevation it is clear that there is movement on the rear wing of the building. Coursing is non level and cracks in the masonry are visible in a vertical line approximately above the entrance door. Further evidence is visible internally .

Action X1, X2, X2:

Movement at corner requires investigation. Drain CCTV to be undertaken to confirm condition of drains that may be exacerbating problem with subsoil. The construction of the proposed extension should consider underpinning the corner of the original building, along with stonework repairs (helifix should be considered to stitch the cracking).

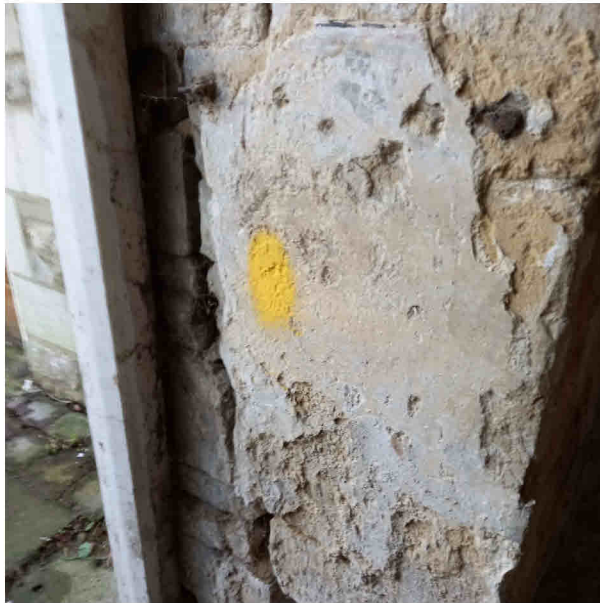
X2 Masonry pulling apart at doorway.

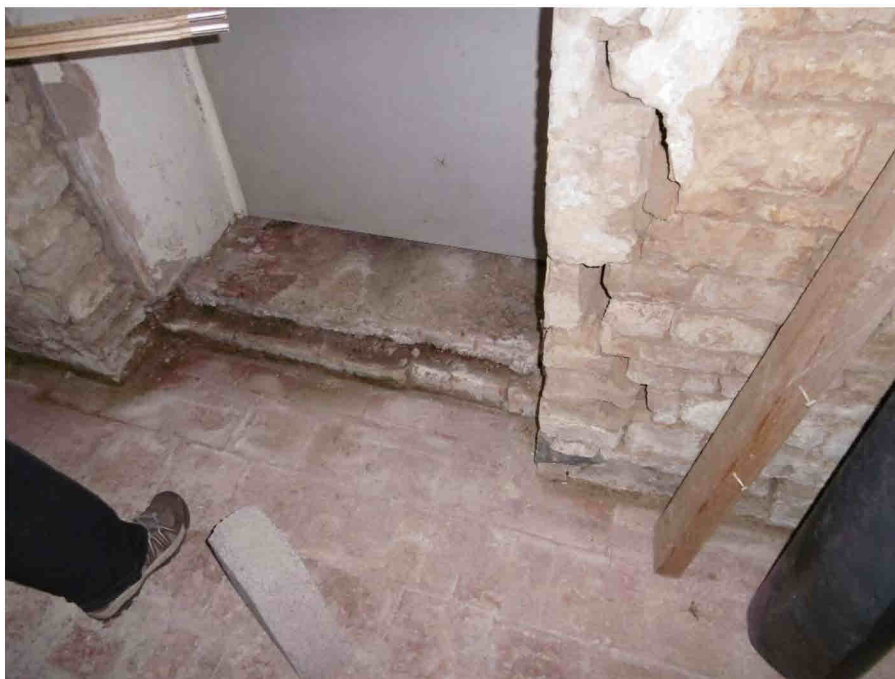
X3 Masonry pulling apart to RH side of door opening

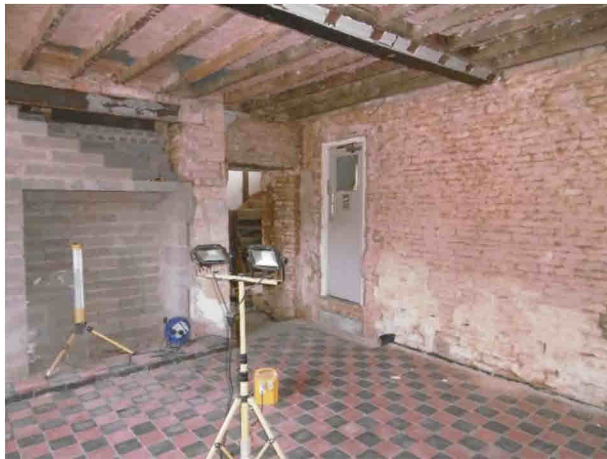
X4 Masonry Pulling apart at opening. This opening is planned to be closed up.

Action X4: bond in opening to stabilise panel.

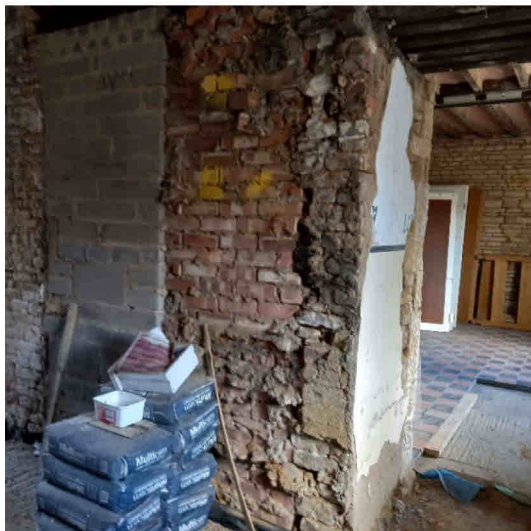
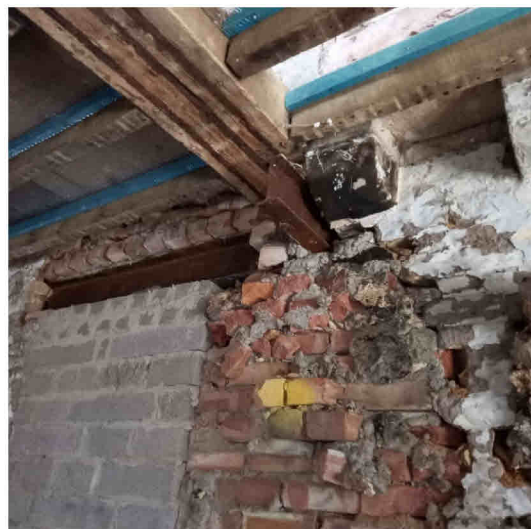
X5 masonry not coursed, facing stone presumably removed previously, with projecting steel beam at high level.

Action X5: add masonry to tie in.

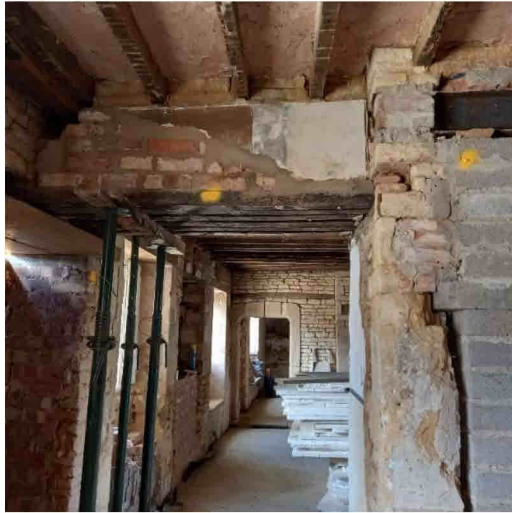
X6 timber lintels over opening, supported by across.

Timber lintels over opening, X6

Action X6: replace with small section steelwork 152UC set side by side, face with oak on both sides.

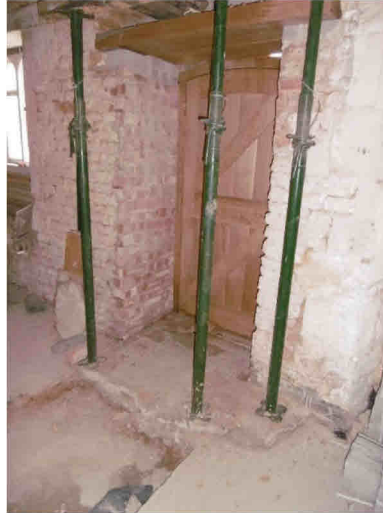
oak lintels to front door, X7

X7 new oak lintels over door opening

Action X7: replace with small section steelwork 152UC set side by side, face with oak internally.

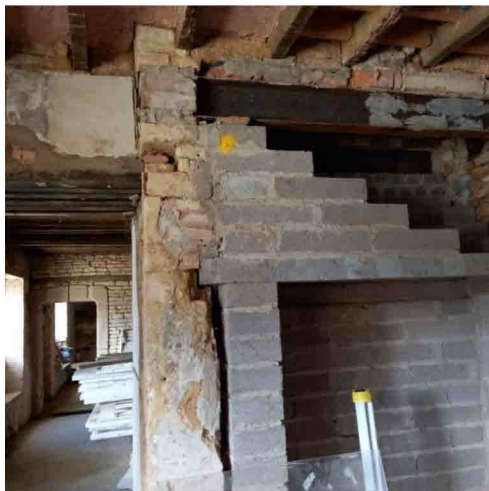
X8 steel beam LH bearing missing at LH end

Action X8: rebuild bearing

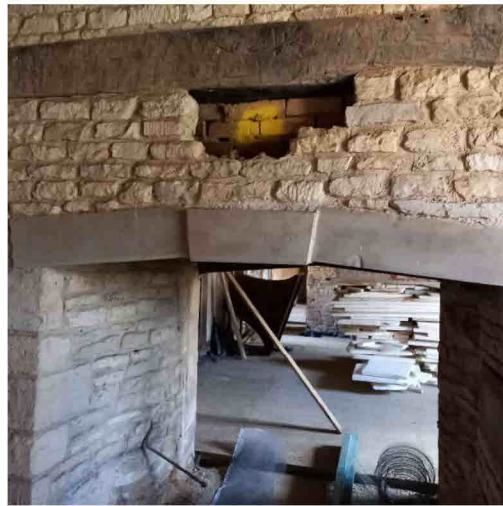
Fireplace when in use

X10 low arch to fireplace opening. This has been there some time.  
Action X10: add soft joint under oak lintel (above stone arch), to relieve loading on shallow arch.

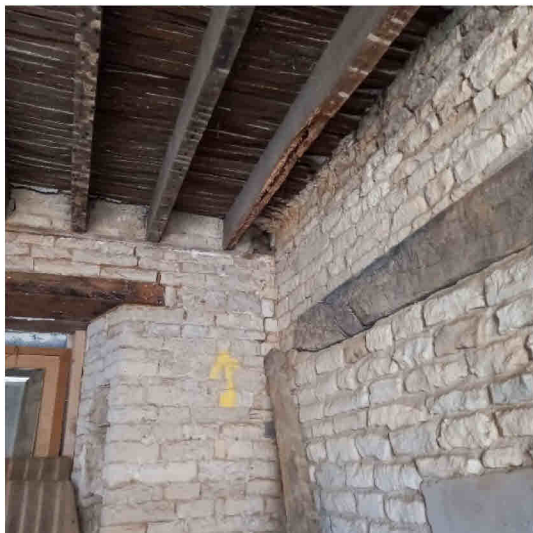
Lintels over fireplace

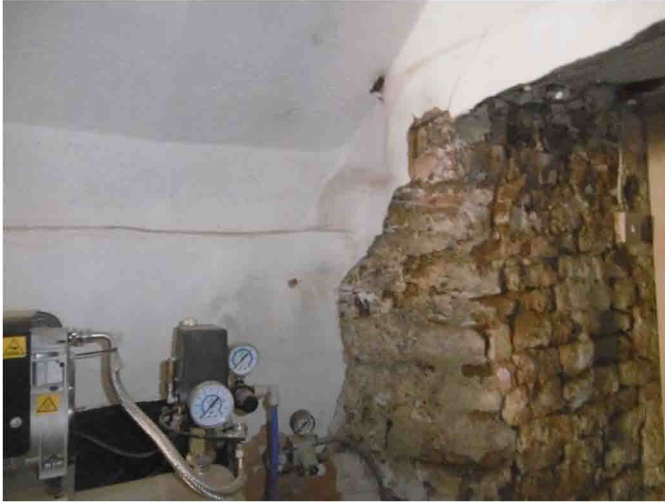
X12 Cracking at door opening in cellar area. It is planned to block up this opening following removal of lean-to.

Action X12: bond in opening and repair as required.

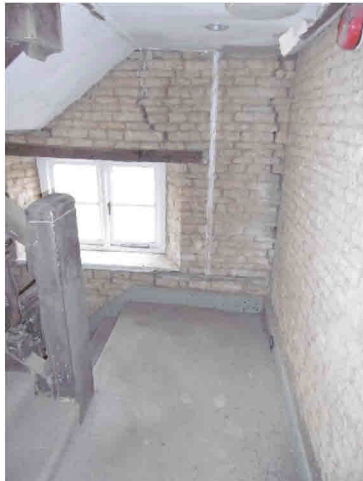
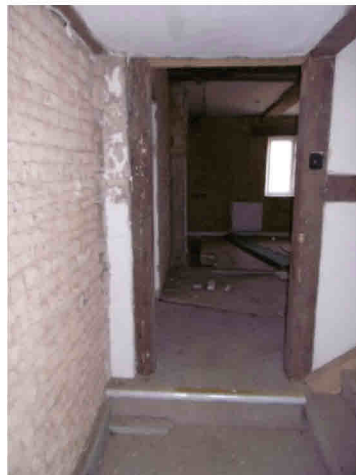
X13 and X14 Movement cracks over window and to RH side of window in corner of staircase.

Action 13, X14: Repair cracks with helifix after stabilising corner foundation.

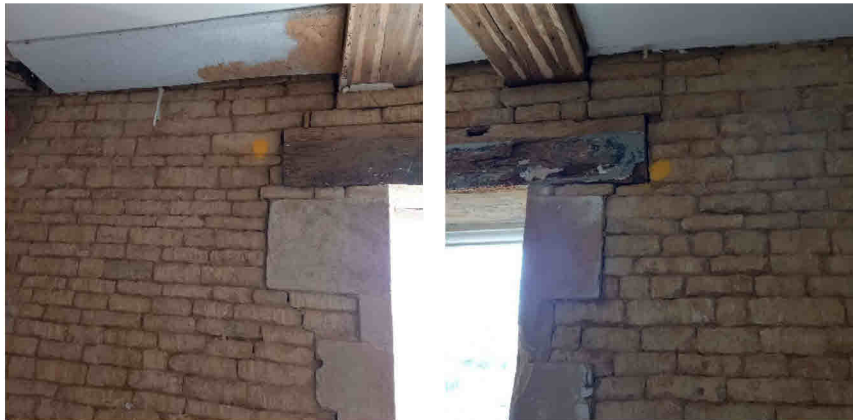
Cracks on landing X11, X12 cracking at abutment of masonry to timber framed wall. X15

X15 Movement crack at junction of masonry to rear extension to main building.  
Action X15: Repair cracks with helifix

X16 Movement crack in masonry at high level  
Action X16: Repair cracks with helifix

X17 Floor missing.  
Action X17: replace flooring to match existing.

X18 Movement at High level around lintel to window at both ends. May be slightly aggravated by the fact that the stone window surround is slightly proud to enable plaster to be finished flush.  
Action X18: form helifix lintel above existing lintel

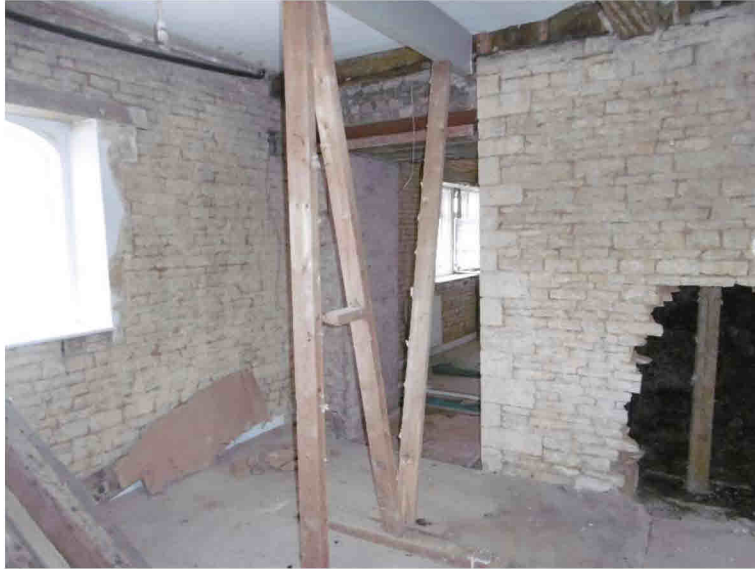
X19 modern floor beam split in two and currently supported by remnants of timber partitioning.  
Action X19: support beams to be replaced and bearing reinstated.

X20 modern floor beam unsupported at one end; bearing has been removed and end bearing been reduced by end cutout. Currently supported by timber props  
Action X20: reinstate bearing.

X20 with missing bearing,

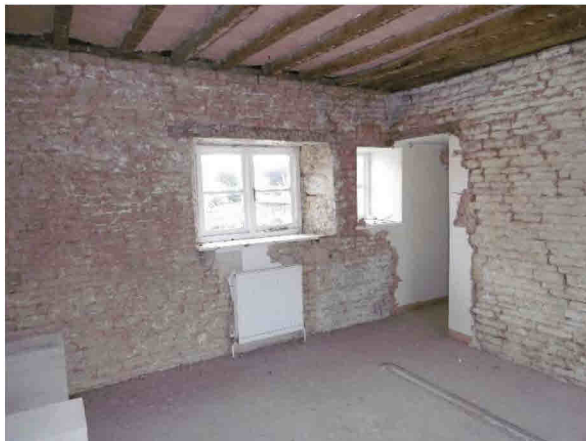
X21 Masonry bearing for lintels over opening questionable.  
Action X21: rebuild bearing

X22 Floor joist above ceiling joists undersized  
Action X22: strengthen existing joists as required.

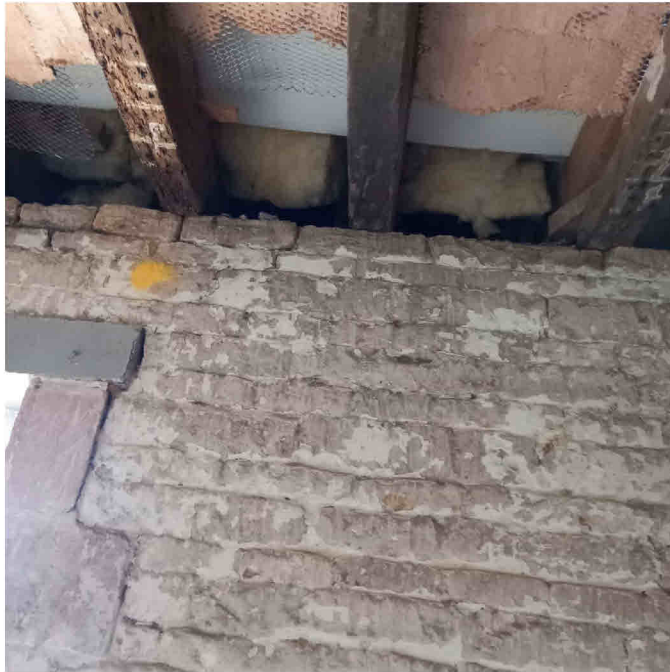
X23 Bearing for floor joists above (ceiling joists) minimal.  
Action X23: sister joists to extend to provide sufficient bearing.

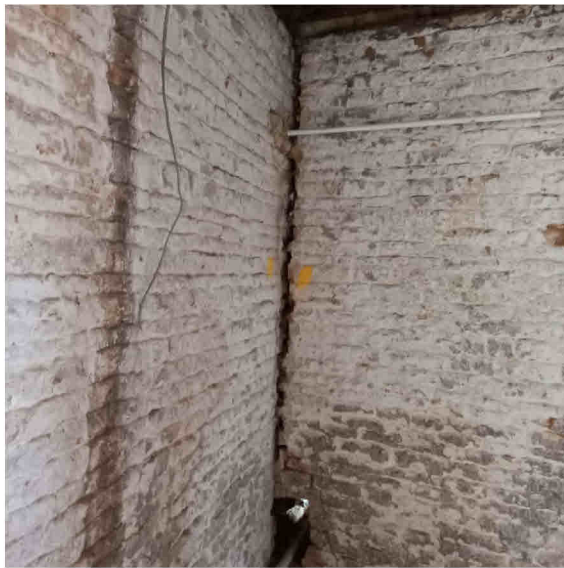
X24 Corner of building not tied together, and crack opening up. Note tie bar.  
Action X24: helifix repairs.

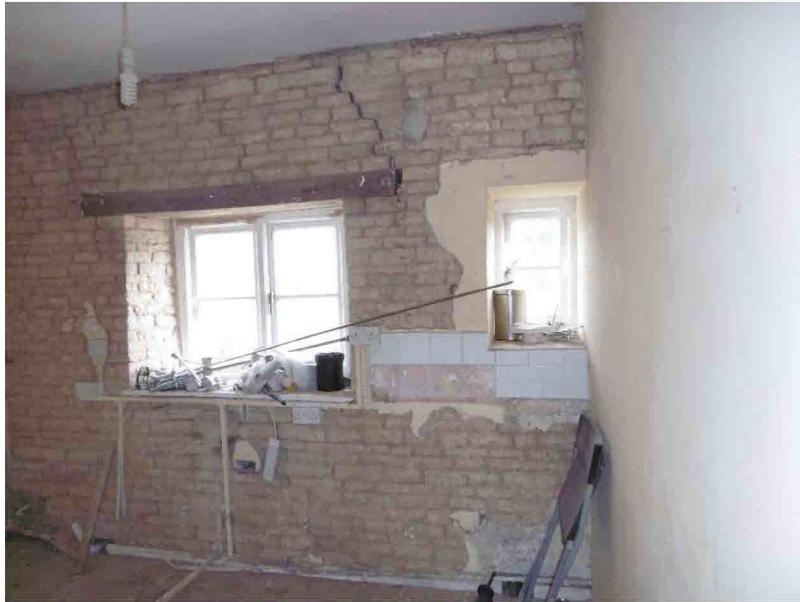
X25 Movement cracks in masonry over lintel  
Action X25: form helifix lintel above existing lintel.

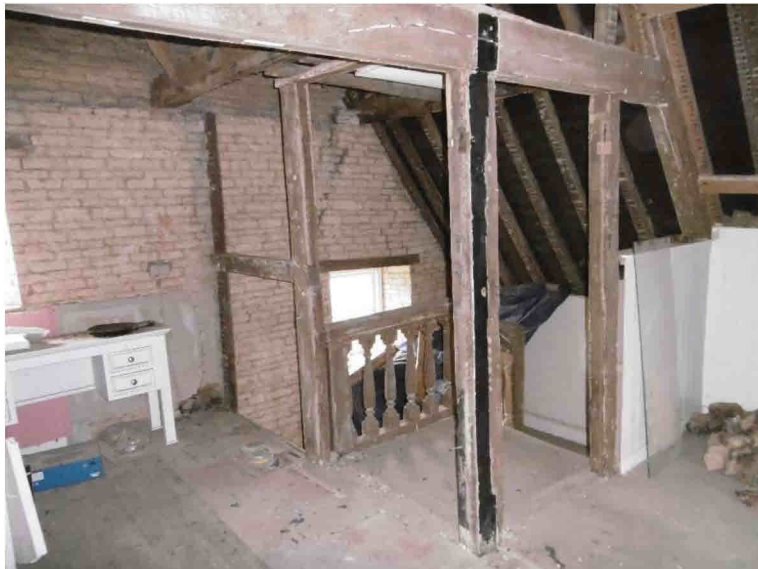
X26 Movement cracks in masonry over window  
Action X26: helifix repairs.

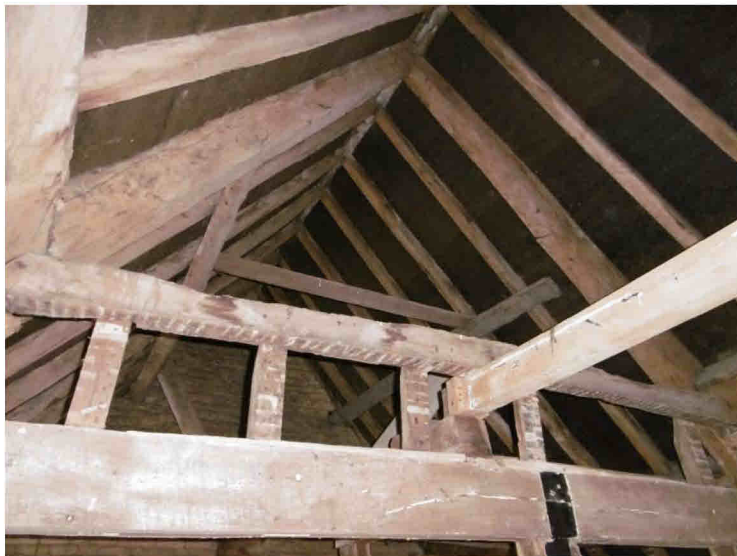
X27 Bearing on purlin has failed and ceiling joists require replacement  
Action X27: new purlins to be added from gable to principle truss, and restate ceiling joists to resist spread.

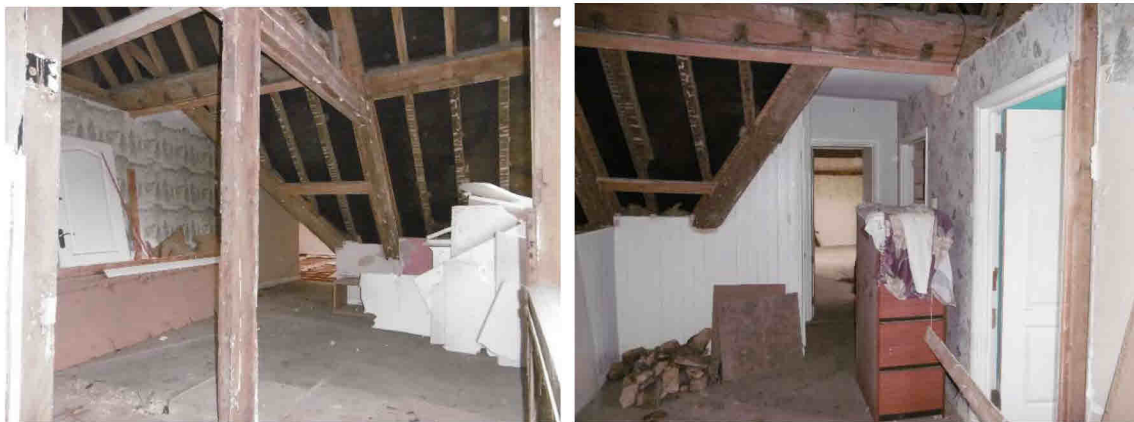
X28 Ceiling joists have been removed and require replacement.  
Action X28: reinstate ceiling joists to resist spread

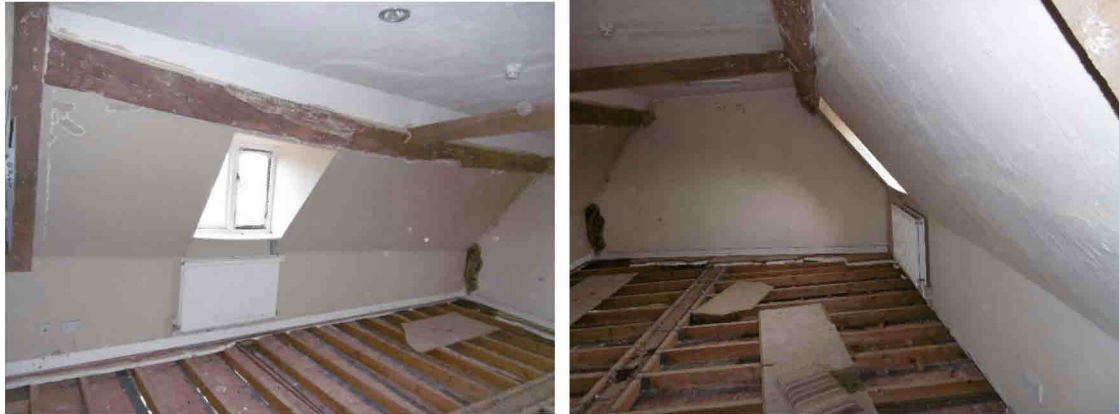
X29 Modern floor laid above existing floor undersized: currently 100 x 50 at 400mm centres.  
Action X29: replace floor construction (above existing ceiling joists below).
